Support to the Promotion of Cultural Diversity

III.Study Area Assessment

Case Study on Urban Rehabilitation Neighborhood of the Regional Tourism Centre

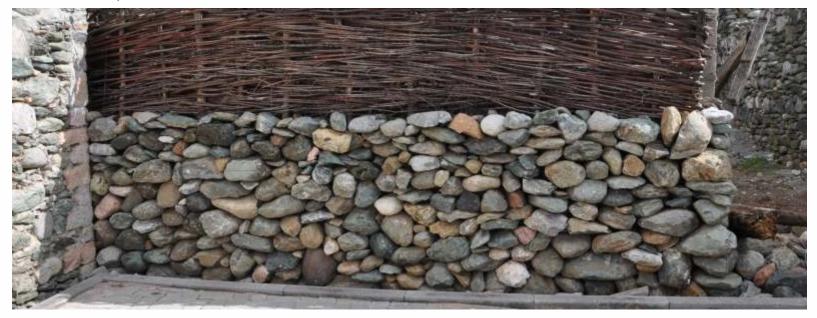
Reconstructed boundary wall located south of the kulla

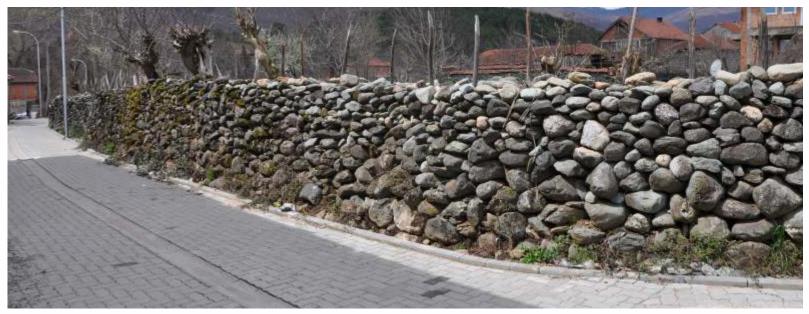
Wall built of river stone and wicker

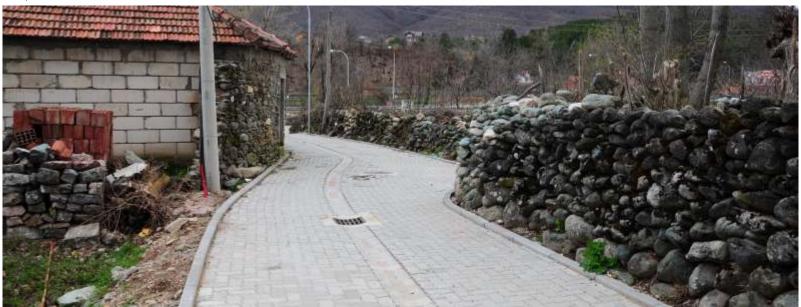
New pavement of the street with concrete slabs

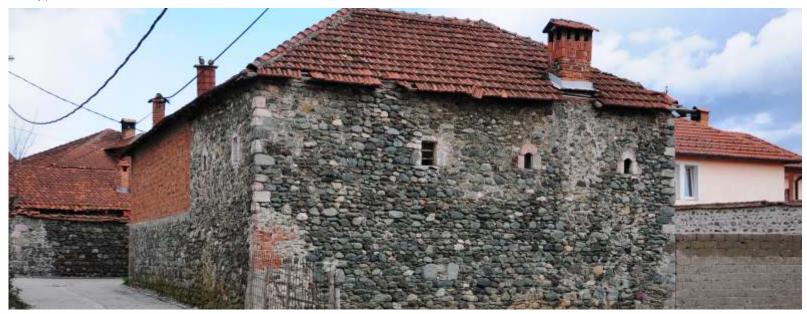
A section of the building façade (located on the CP No. 2065-0) presents the only preserved original residential stone structure located on this side of the street. At the same time, many inappropriate interventions undertaken in the past could be noticed; Cement ring beam was constructed on the lower section of the old stone wall as a foundation for the upper part/floor, whereas the upper floor was constructed using different types of blocks of brick. These "restoration" works are quite contrary and incompatible with the preserved older section of the building which was originally constructed as a two-storey kulla with very modest appearance to the street.

Partially preserved traditional kulla

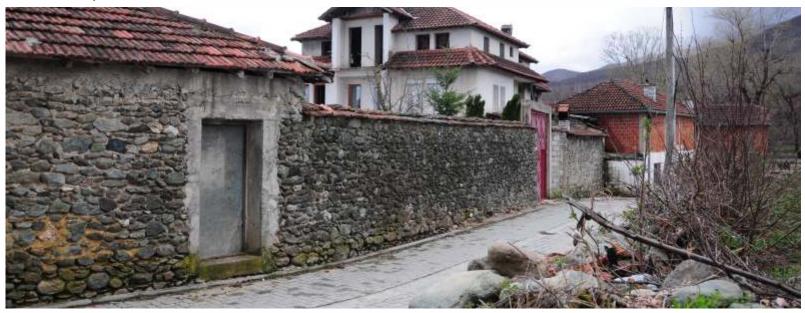
Traditional boundary wall made of stone set in lime mortar
