**Integrated Rehabilitation Project Plan / Survey of the  
Architectural and Archaeological heritage (IRPP/SAAH)**

**Regional Programme  
for Cultural and Natural Heritage  
in South East Europe  
2003 - 2005**

**PRELIMINARY TECHNICAL ASSESSMENT REPORT  
ON THE RELIGIOUS BUILDINGS/ ENSEMBLES AND CULTURAL  
SITES DAMAGED IN MARCH 2004  
IN KOSOVO**

Immediate protection action plan and overall restoration perspectives

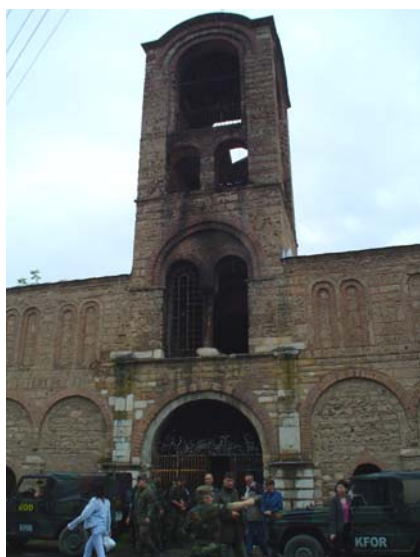
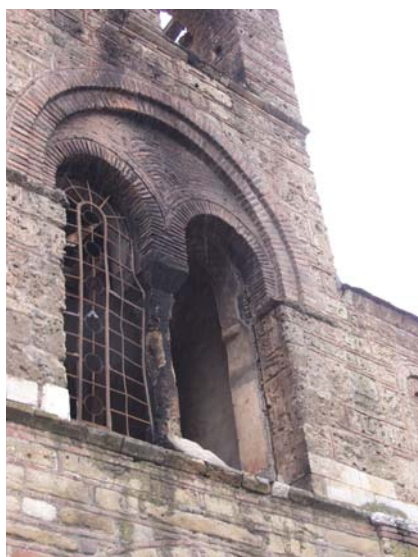
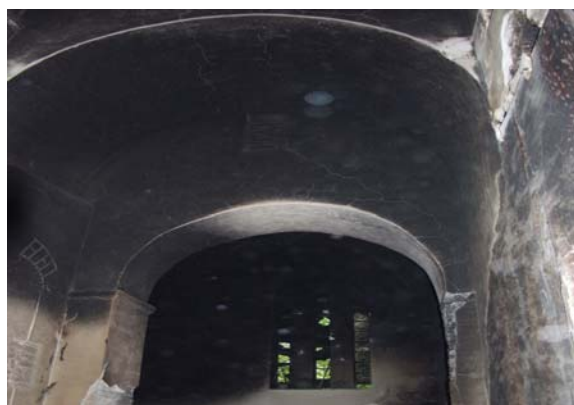
Photo after the riot

C.1. Very badly damaged wall-paintings, by fire and – after that – mortar chipped away by hammer (the most serious damages in lower parts).

C.2. Burned timber lintel over the main entrance to the church.

C.3. The supporting marble column of the biforium, over the main entrance to naos, is cracked and its timber beam is burned. It is possible that a small crack had already appeared in the past. Even if it is like that, the crack has been definitely wide opened after the developing of high temperature.

**All these put under urgent unstable static condition the opening and, consequently, the upper part of the western internal façade.**

C.4. Burned timber roofing with access to the bell-tower.

C.5. Badly damaged lower part of the entrance to the bell-tower, by fire and demolition.

**The famous fresco painting of Virgin Mary Ljeviska with Christ is very badly damaged: firstly by fire and, after that, chipped away by hammer (about 0.50m<sup>2</sup>).**

- 1.1.1 Western façade, on the bell-tower, over the main entrance: replacement of the existing stone column or temporary propping. Repairs to the masonry. Adding metallic rain-water pipes on the roofing.
- 1.1.2 Over the internal western entrance: fix two stainless steel rings on the column and replace the timber beam.

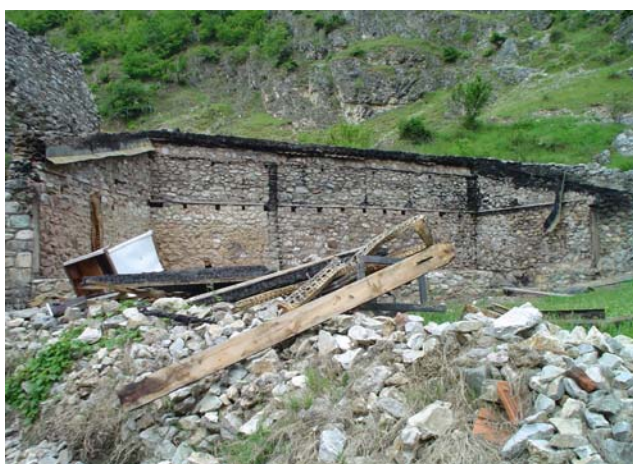
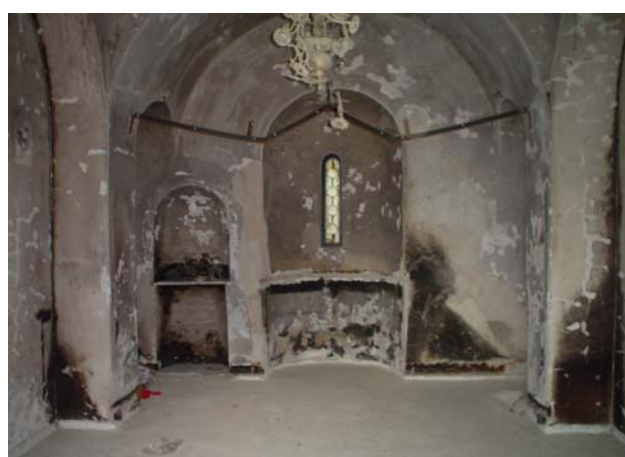
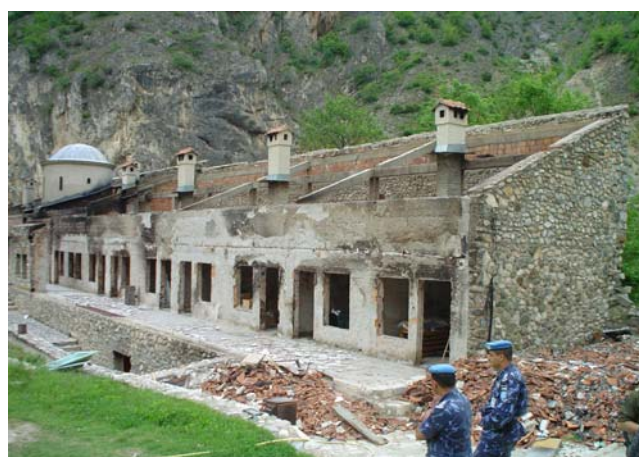
Photo after the riot

The internal side of the wall between the altar apse and the prothesis was damaged by fire and needs immediate preservation. The marble tombstone of King Stefan Dusan has been demolished.

Walls: Part rubble stone, part clay block rendered, all badly damaged by fire.

Ceilings: Hollow block, render 90% damaged.

Carved stones should be put into store. An area of the existing walling has been damaged by fire and should be cleaned.

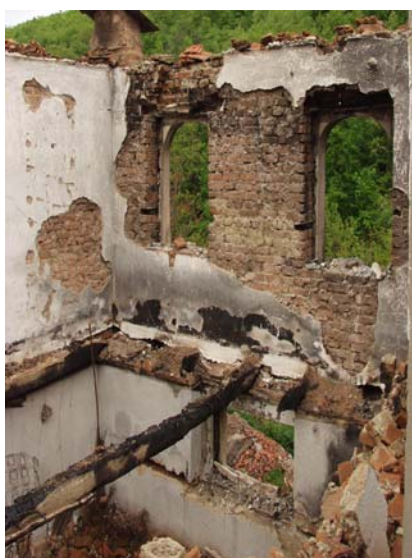
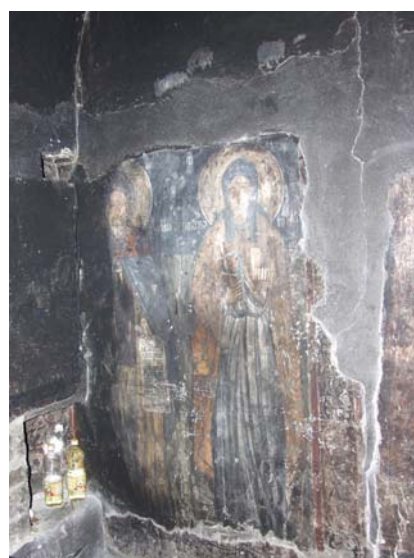
Photo after the riot

The timber roofing of the katholikon and the added annex is currently under reconstruction. Lead covering over the E part (apsis and parecclesion) has been removed.

Interior: Very badly damaged by fire and graffiti on frescoes.

Interior walls: partially destroyed by fire and totally covered with smoke damaged.

Floor: stone pavement, partially destroyed. Broken tombstones.

Wall – paintings (second half of 15<sup>th</sup> and 19<sup>th</sup> c.): Partly saved and conserved in the past, now badly damaged by fire and smoke.

Iconostasis (new) and icons burned.

B. All the monastery buildings, including: the refectories, the wing with sisters' cells, shelter, the wing with guests' cells, work-shop, storage, stables, garages have been almost totally destroyed by fire: only perimeter walls remain, in unstable condition. Repair of the buildings is not practicable.

C. Parecclesion of St. John: The lead roof covering has been removed.

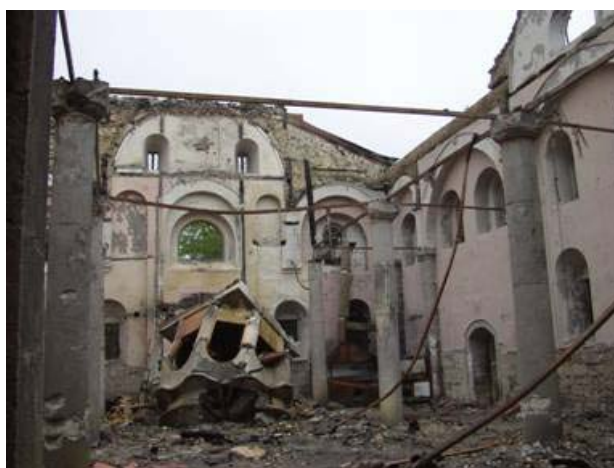
After the riot

Completely burned down, roof collapsed, interior gutted, only perimeter walls remain.

Walling of rubble stone with good pointing damaged by the collapse of the upper parts of the construction and by fire and by hammer demolition.

Dome and bell-tower: collapsed. Stone drummed columns have been seriously damaged by the collapse of the upper parts of the construction and additionally by hammer. In an unstable position.

Door and windows ornamented lintels damaged by fire and by hammer.

Fire damage on the northern, western and southern facades.

- Clear site
- Strengthening perimeter walls, probably by concrete repair on the cornice or internal concrete walling.
- New timber roof construction. Dome and bell tower to be added later.
- Robust grating, secure openings and windows.
- Perimeter (additional) grating of the church site, robust gates on main entrances and on the access to the site.

- Repair of interior damage.
- Dome and bell tower additions.

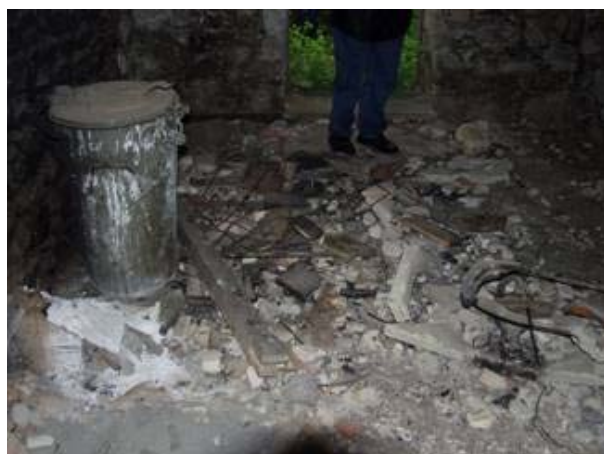
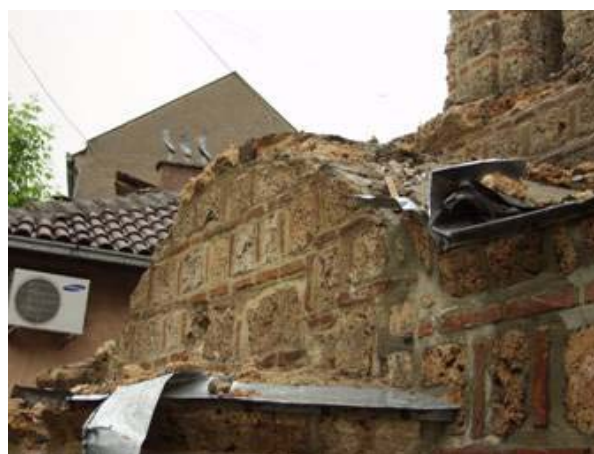
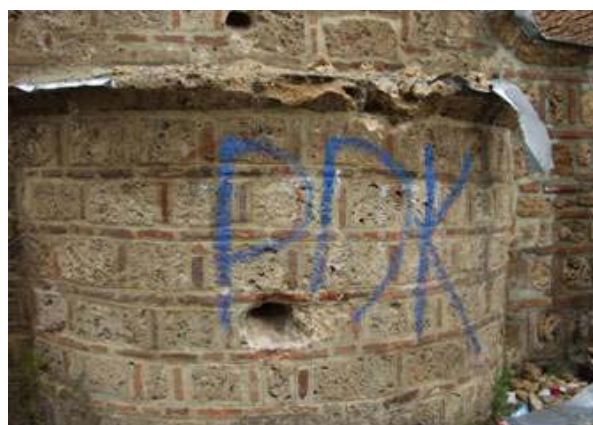
Photo after the riot

Exterior: the dome drum and the E façade (especially the apses and the cornice of the drum) are vandalized (badly damaged by hammering).

Interior: Badly damaged by fire.

Floor: marble pavement, destroyed 80%. Damaged mediaeval marble pieces with architectural ornaments (spolia).

Now the wall paintings are badly damaged by fire.

The perimeter fence is damaged and partially lost.

- Repair of the internal damage, conservation of the wall paintings.

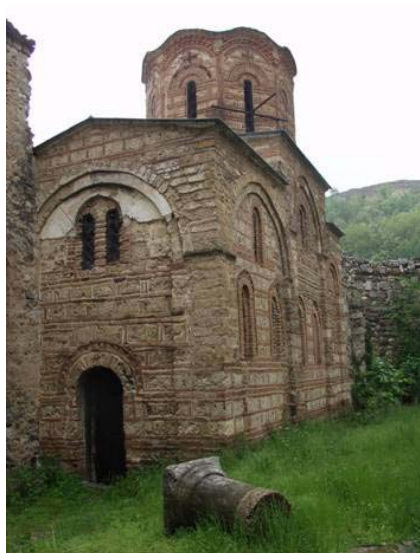
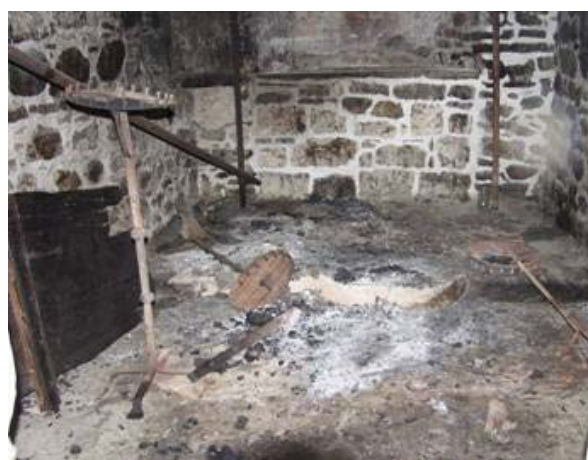
After the riot

Exterior in good condition.

Interior fire damaged.

Wall paintings: Valuable, rich iconographic program, in good condition of preservation before.

Openings: Wooden door and windows damaged.

Doors and windows decorated lintels damaged by fire.

Concrete bell tower: in unstable condition.

- Demolition of the concrete bell tower.
- Metal doors and windows with iron frames.
- Repair of the upper parts of the external walls in order to avoid rain penetration and further demolition.
- Perimeter wall to church site and a metal gate.

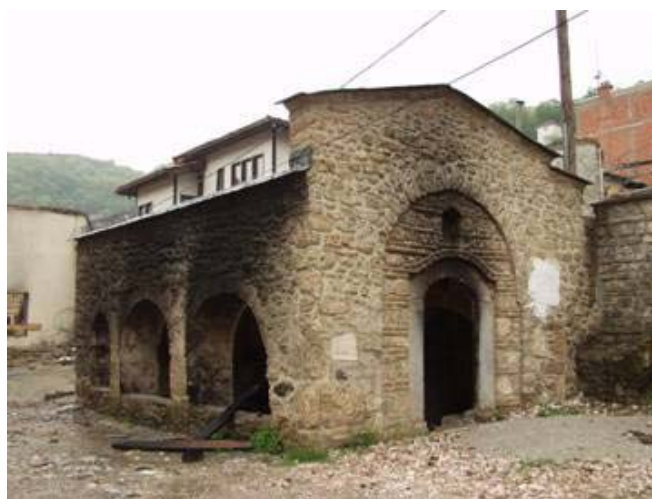
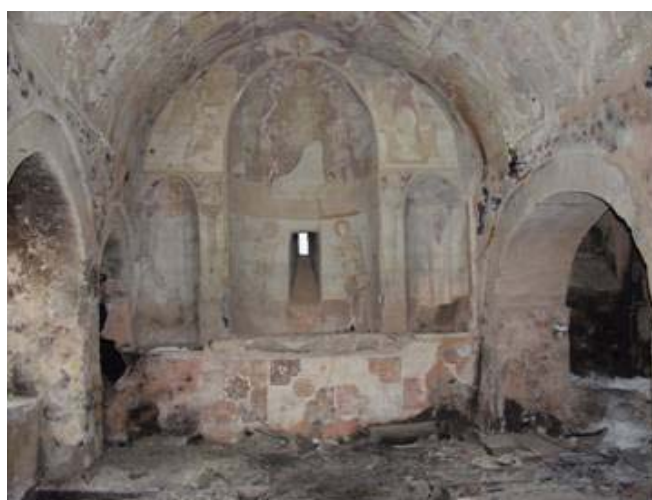
Interior damaged by explosion and fire.

Internal side of the walls: Partially damaged by fire, visible cracks on the walls.

Floor: stone covering in bad condition.

Wall paintings: Valuable, rich iconographic program. Partially damaged by fire.

Door and windows decorated lintels damaged by fire.

- New metal door and openings iron frames
- Repair internal damage.
