Assessment Mission on the situation of the cultural heritage in the conflict zone in Georgia

Technical Assessment Report

Report prepared by: Mr David Johnson
20 October 2008

POST-CONFLICT IMMEDIATE ACTIONS
FOR THE SOCIAL AND ECONOMIC REVITALISATION
OF COMMUNITIES AND CULTURAL ENVIRONMENT
IN THE MUNICIPALITY OF GORI, GEORGIA (PIAG)

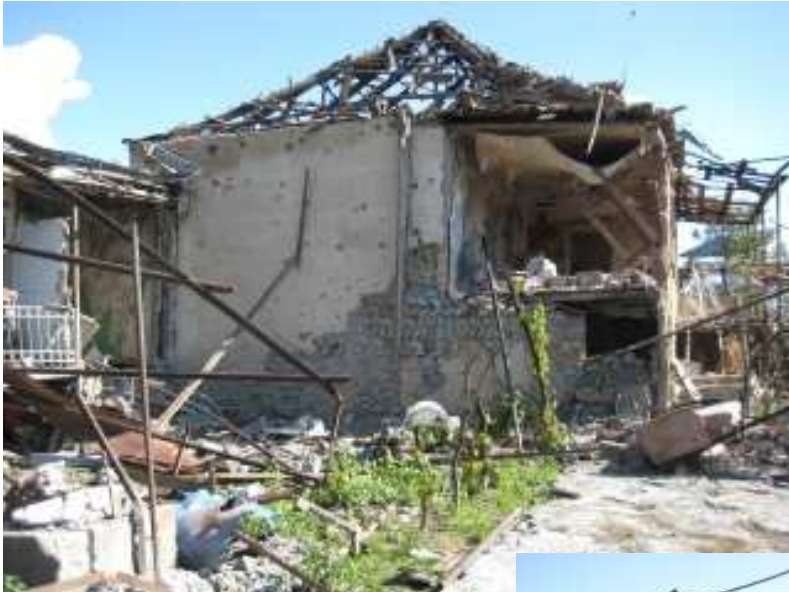
Photograph 1 Tkiavi

The first group of buildings the delegation was shown appeared to be a farm house with outbuildings. A bomb blast had caused severe damage to these buildings and several surrounding buildings. The roofs in several cases were completely lost, and large sections of walling had collapsed. (Photos 1, 2)

The constructions were generally solid wall with some traditionally built stone and render, and some 20th century concrete block built. The stonework was in horizontal coursing in a herringbone pattern. There was also some clay tile coursing. Roofs were a mixture of tile and modern profiled metal and asbestos sheeting.

In some cases the buildings appeared to be beyond repair, although it might be possible to use the solid external walling constructions and foundations as a base for rebuilding. Less affected buildings could be restored, most with new roof coverings.

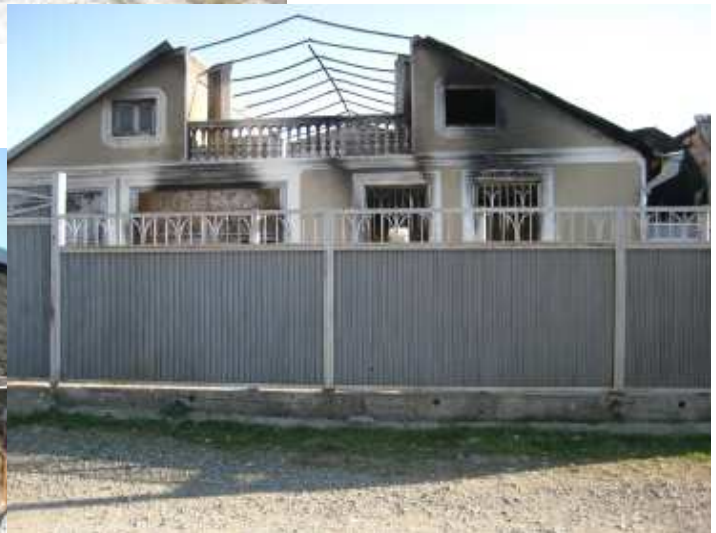
Photograph 3

On a return visit to Tkiavi the delegation was shown two modern houses that had been badly fire damaged. These two buildings could be repaired subject to a closer inspection of possible fire damage to the structures. (Photo 3)

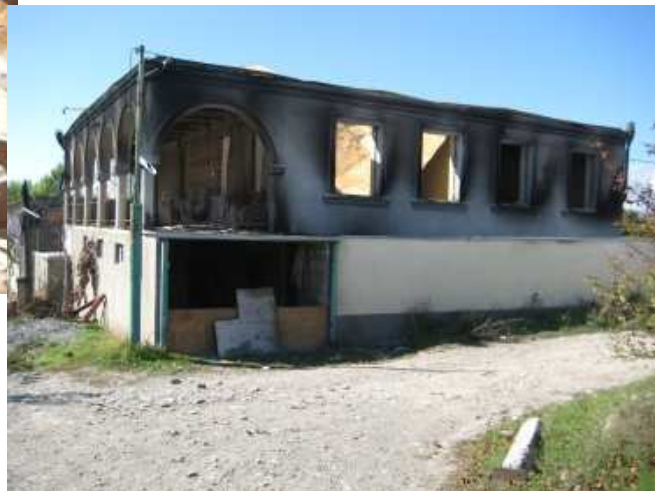
Photograph 4: Erdgneti

The delegation was advised that 152 houses had been damaged by bomb blast and fire. The buildings inspected were mostly 20th century with some traditional stonewalling. (Photo 4). In some cases the buildings appeared to be beyond repair. Other less damaged buildings could be restored mostly with new roof coverings.

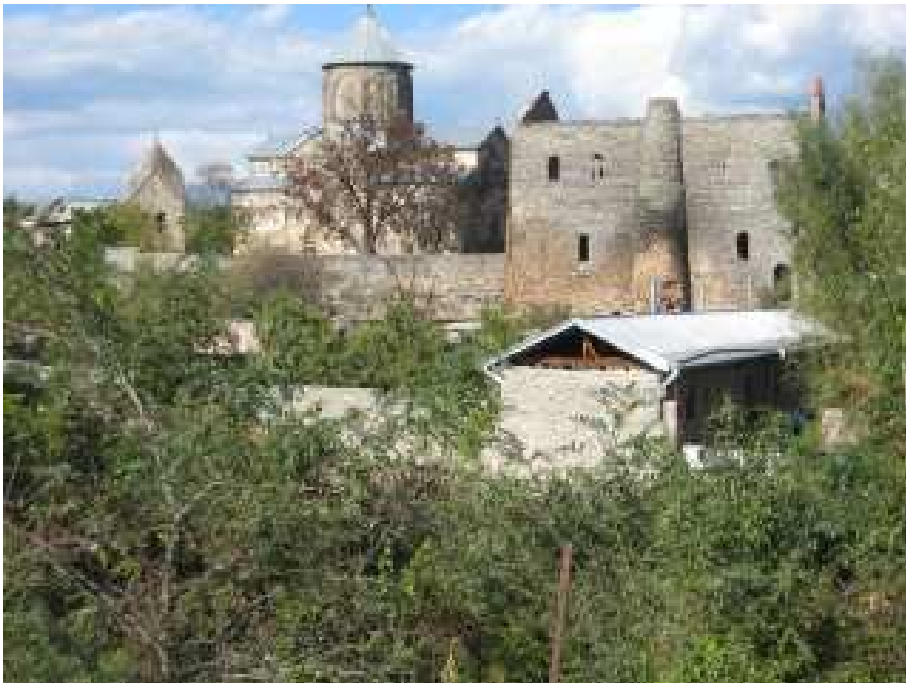
Photograph 5 General view of Nikozi Monastery from South

Nikozi Village and the Churches of Gvtaeba and Archangel (Photo 5)

The monastery of Nikozi comprises a number of important historic buildings including the 5th century Church of Gvtaeba set to the south of the complex and currently undergoing repair works. It appears undamaged by the recent conflict. The monastery complex is entered from the west via a fine stone built gatehouse. The main courtyard is dominated

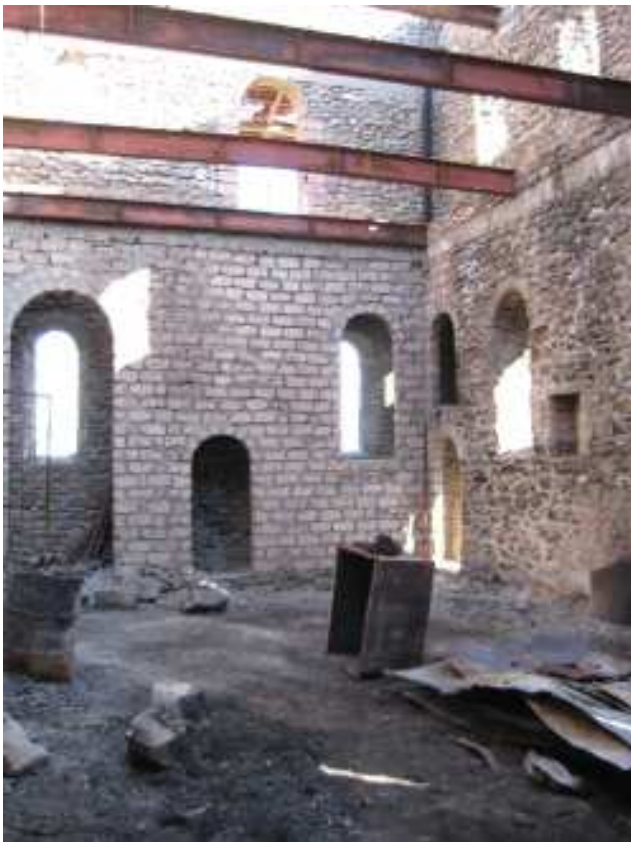
Photograph 6 Bishops Palace Interior

Drawings have been provided dating from 2006 illustrating detailed proposals for the reconstruction of the Bishop Palace to form or restore three levels of accommodation, a double height ground floor space and two upper levels. (Diagram 3) The building is stone built in uncarved rubble stone with clay tile detailing around door and window openings. The walling is generally undamaged except on the south elevation adjacent to the location where the bomb fell. The stonework on this elevation has been damaged particularly at the chimney position. The clay tile roof of the building has been completely destroyed exposing a steel beam structure, which has been inserted at what appears to correspond to the proposed floor levels. It is unclear how much of the interior had been restored prior to the bomb damage. (Photo 6)

The restoration works that have been completed by the church need to be carefully assessed. The use of the intermediate steel structure and concrete and cement are incompatible with the historic significance of the building.

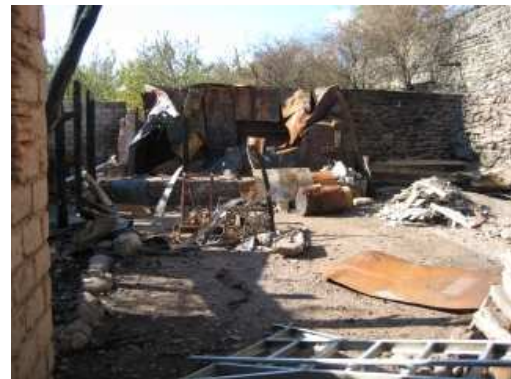
Photograph 7 Former Residential buildings

The ensemble of buildings of the "Domestic Wing", which formed the principle residential and workshop accommodation immediately to the south of the Palace, have been largely destroyed. (Photo 7)

From historical photographic evidence they appeared to be composed of a two storey building of residential accommodation with workshops above, brick built. The remaining buildings were single storey of mixed construction, part timber, and part block work with metal roof coverings. (Diagram 4)

With the exception of the two storey building, there is little fabric to be recovered and full reconstruction would seem appropriate. Architecturally these buildings do not appear to be of particular significance.

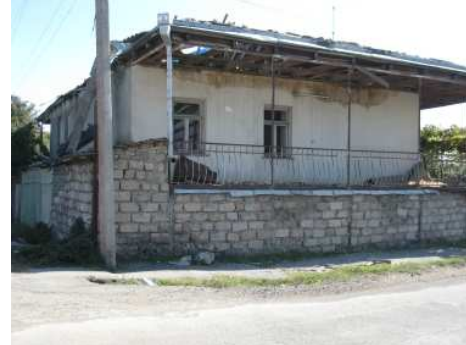
Photograph 8 Variani

The delegation was shown one house, which has suffered serious damage through bombing. This was an early 20th century house. Most of the roof had collapsed and the bomb had penetrated through the basement of the building causing structural damage to the floors. There was some evidence of earlier water penetration to the street elevation. (Photo 8). The delegation was told that arrangements had been made by the municipality for urgent repairs to be carried out on the roof to prevent water damage.

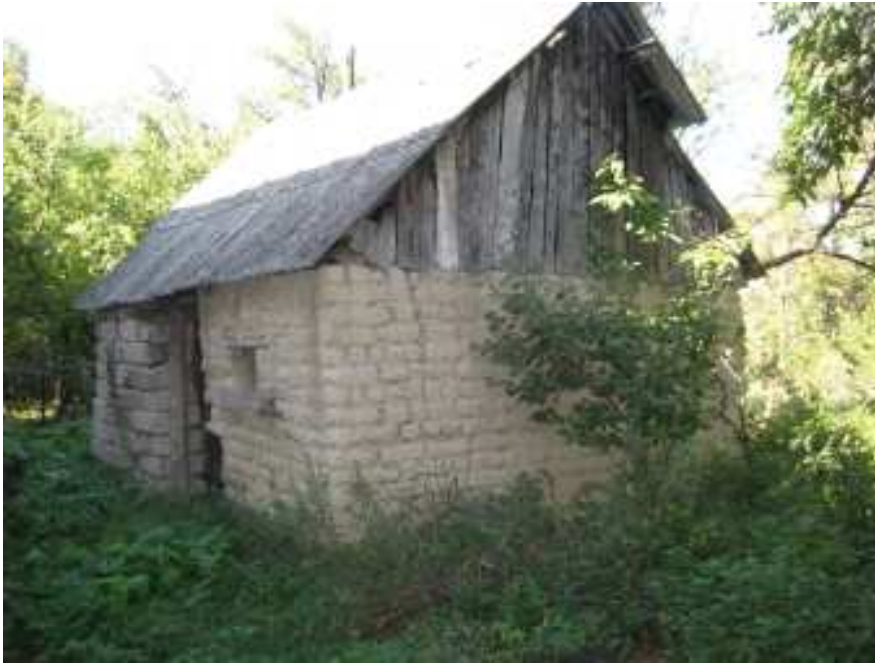
Photograph 9 Shindisi, earth brick building

The Delegation did locate a number of earlier constructions in this village including some earth brick and timber framed buildings. These were surviving examples of the vernacular architecture and construction techniques of the region albeit in poor condition. (Photos 9, 10, 11)

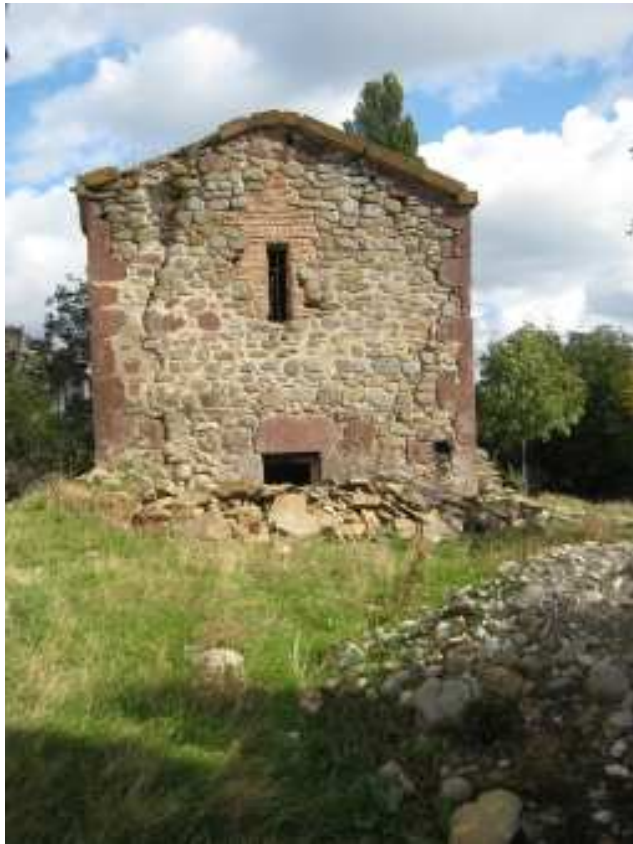
Photograph 12 Arbo

No apparent damage to the buildings in this village. Arbo has three churches which we visited. The small 10th century stone built basilica church is in very poor condition having suffered from subsidence possibly caused by earthquake. The roof covering appears to have failed and many stones are being dislodged from the walling. There are no immediate plans to repair the building which will deteriorate quickly. (Photo 12)

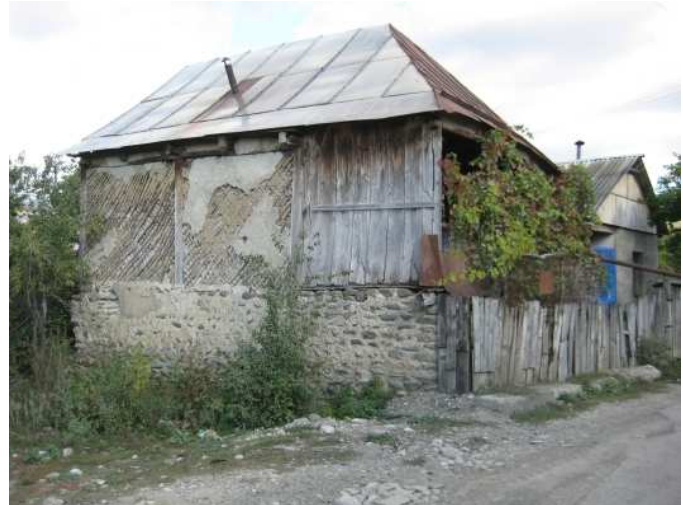
Photograph 13 Mereti

No apparent conflict damage to the buildings in this village, but further examples of vernacular style building techniques in a number of timber framed dwellings and an example of render and lath over timber frame construction. (Photo 13)

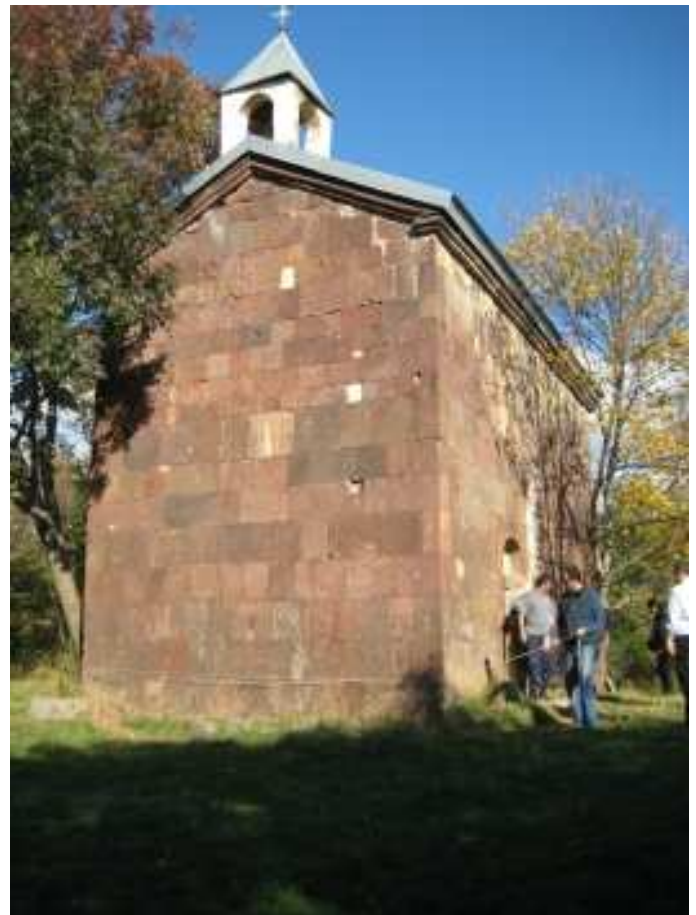
Photograph 15 Karbi

The stone built Church of the Trinity was located a short distance from the village. The church was built out of what appeared to be red sandstone with finely jointed coursing to three sides. The fourth side was less ordered constructionally. Here were the remains of an earlier church. There were three interesting relief mouldings and carvings on the west elevation. The church was in reasonably good condition. (Photo 15)
