Shorezone Functionality

Skadar/Shkodra Lake

Implementing the EU Water Framework Directive in South-Eastern Europe

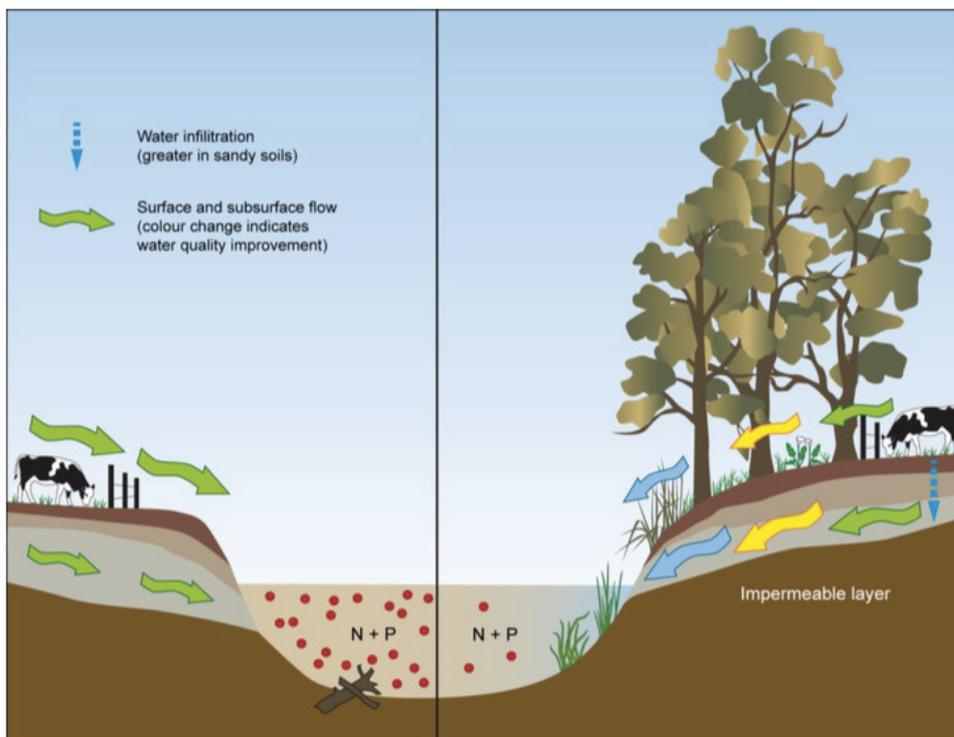
Figure 1. Nutrient interception by riparian vegetation (Dosskey et al. 2010)

The lake's riparian vegetation plays an important role as a buffer that helps to protect the aquatic ecosystem against degradation caused by human activities (Dosskey et al. 2010). Studies by Osborne and Kovacic (1993) have shown that the riparian zone can efficiently intercept nutrients emanating from nearby agricultural areas, diminishing by over 90% the nitrogen and phosphorus content of both the superficial and sub-superficial waters flowing into the water body.

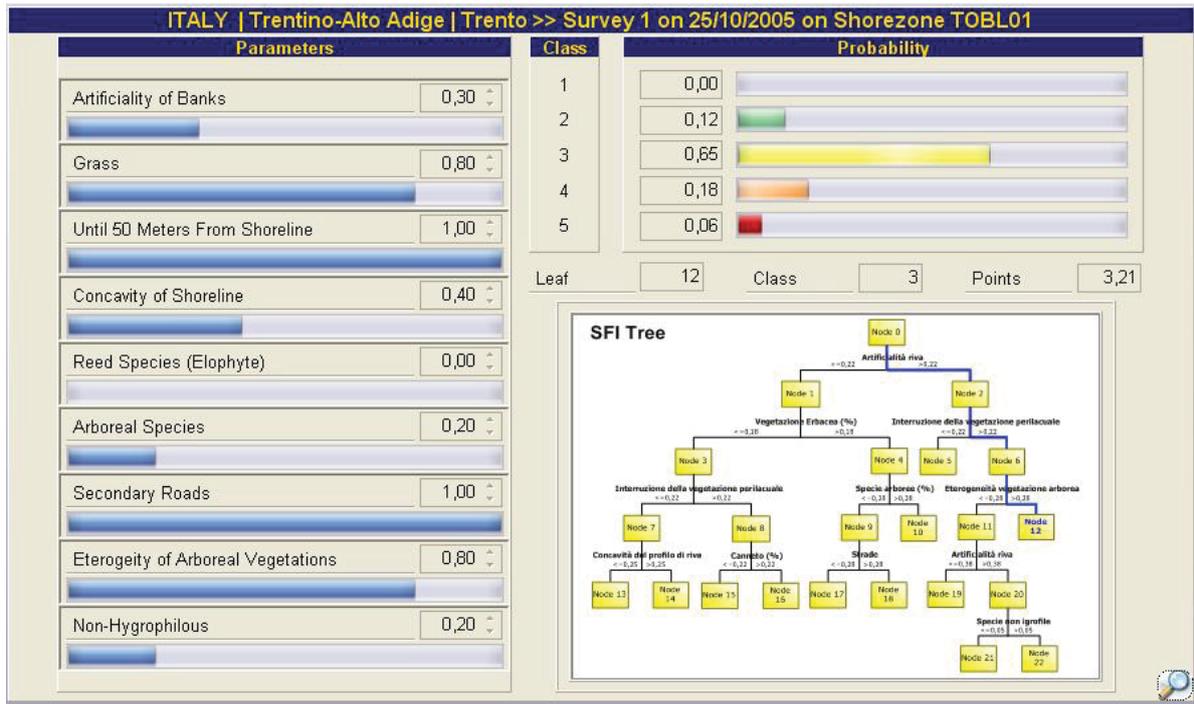
Figure 4. Example of the results output by the SFINX02 software package for a given homogeneous stretch

The classification tree is run for each homogeneous stretch to obtain the final functionality value. Each leaf (box) of the tree indicates the probability that the stretch will fall into one of the five categories. The higher probability percentage will determine the final level of functionality (Figure 4).

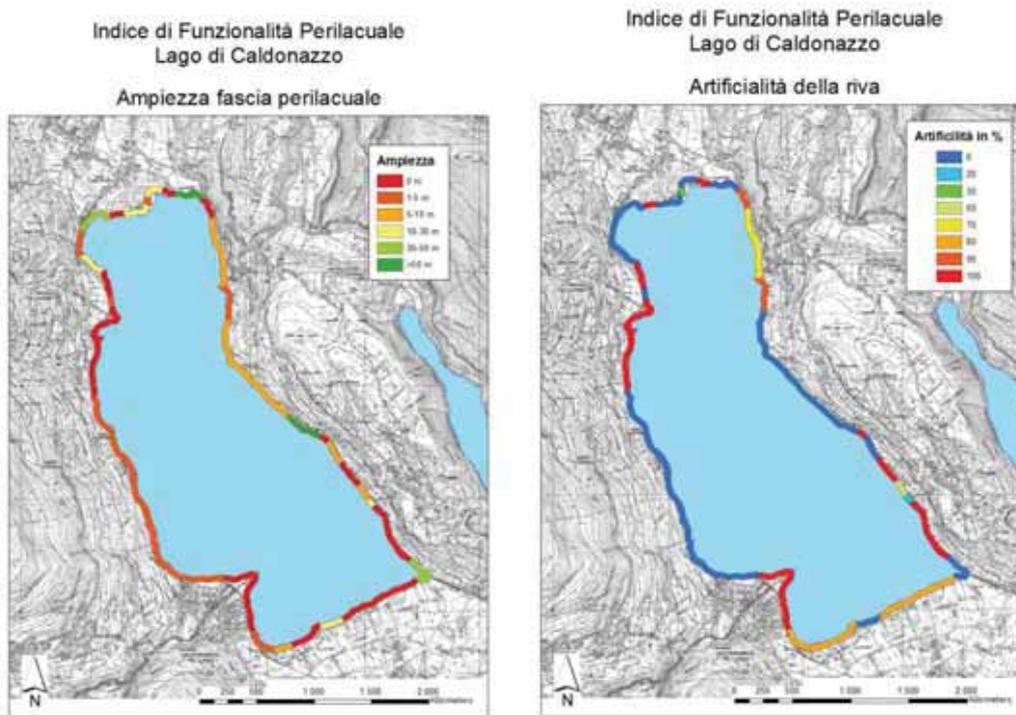
Figure 6. Thematic maps for Caldonazzo lake, with the left-hand map showing the width of the shorezone (red = 0 m, green = more than 40 m) and the right-hand map showing the artificiality of the shorezone (red = wholly artificial, blue = wholly natural)

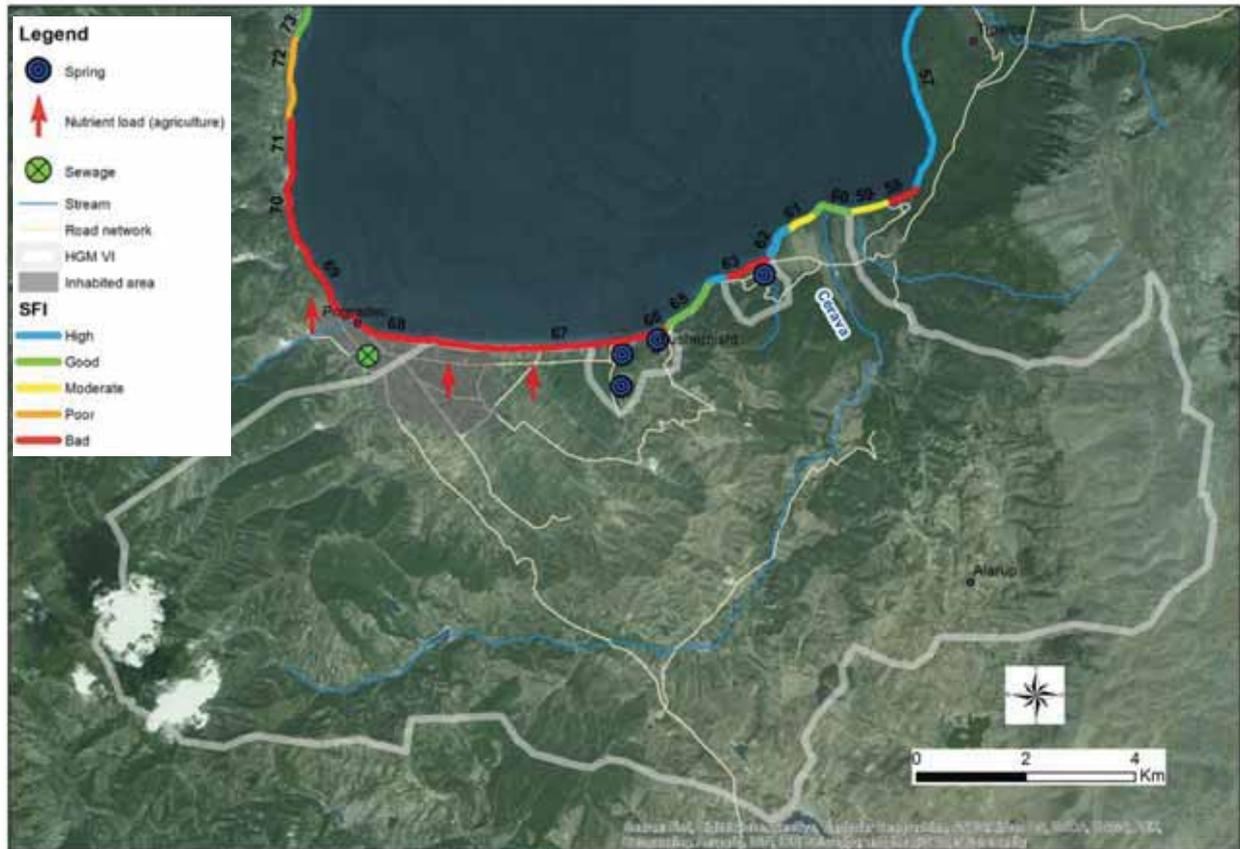
Figure 7. Example of an identified hydrogeomorphological (HGM) area by Ohrid Lake, Albania – the map shows the boundary of the HGM area (grey line), the presence of environmental stressors (i.e. the nutrient load from agriculture), hydrological factors (streams and springs), and the values produced when applying the Shorezone Functionality Index

The potential of the SFI method lies in its ability to produce a synthetic value for the shorezone functionality of a lake. With the SFI approach, it is possible to complete studies on the internal dynamics of a lake, which are often altered by productive activities, recreation and tourism. By basing a lake's shorezone management on the concept of its functionality, the human uses of the lake can be reconciled with its environmental protection, which facilitates ecologically sustainable town and country planning and watershed management. Lake managers and stakeholders can use these results to develop a sustainable ecosystem-based approach to watershed management (Figure 7).

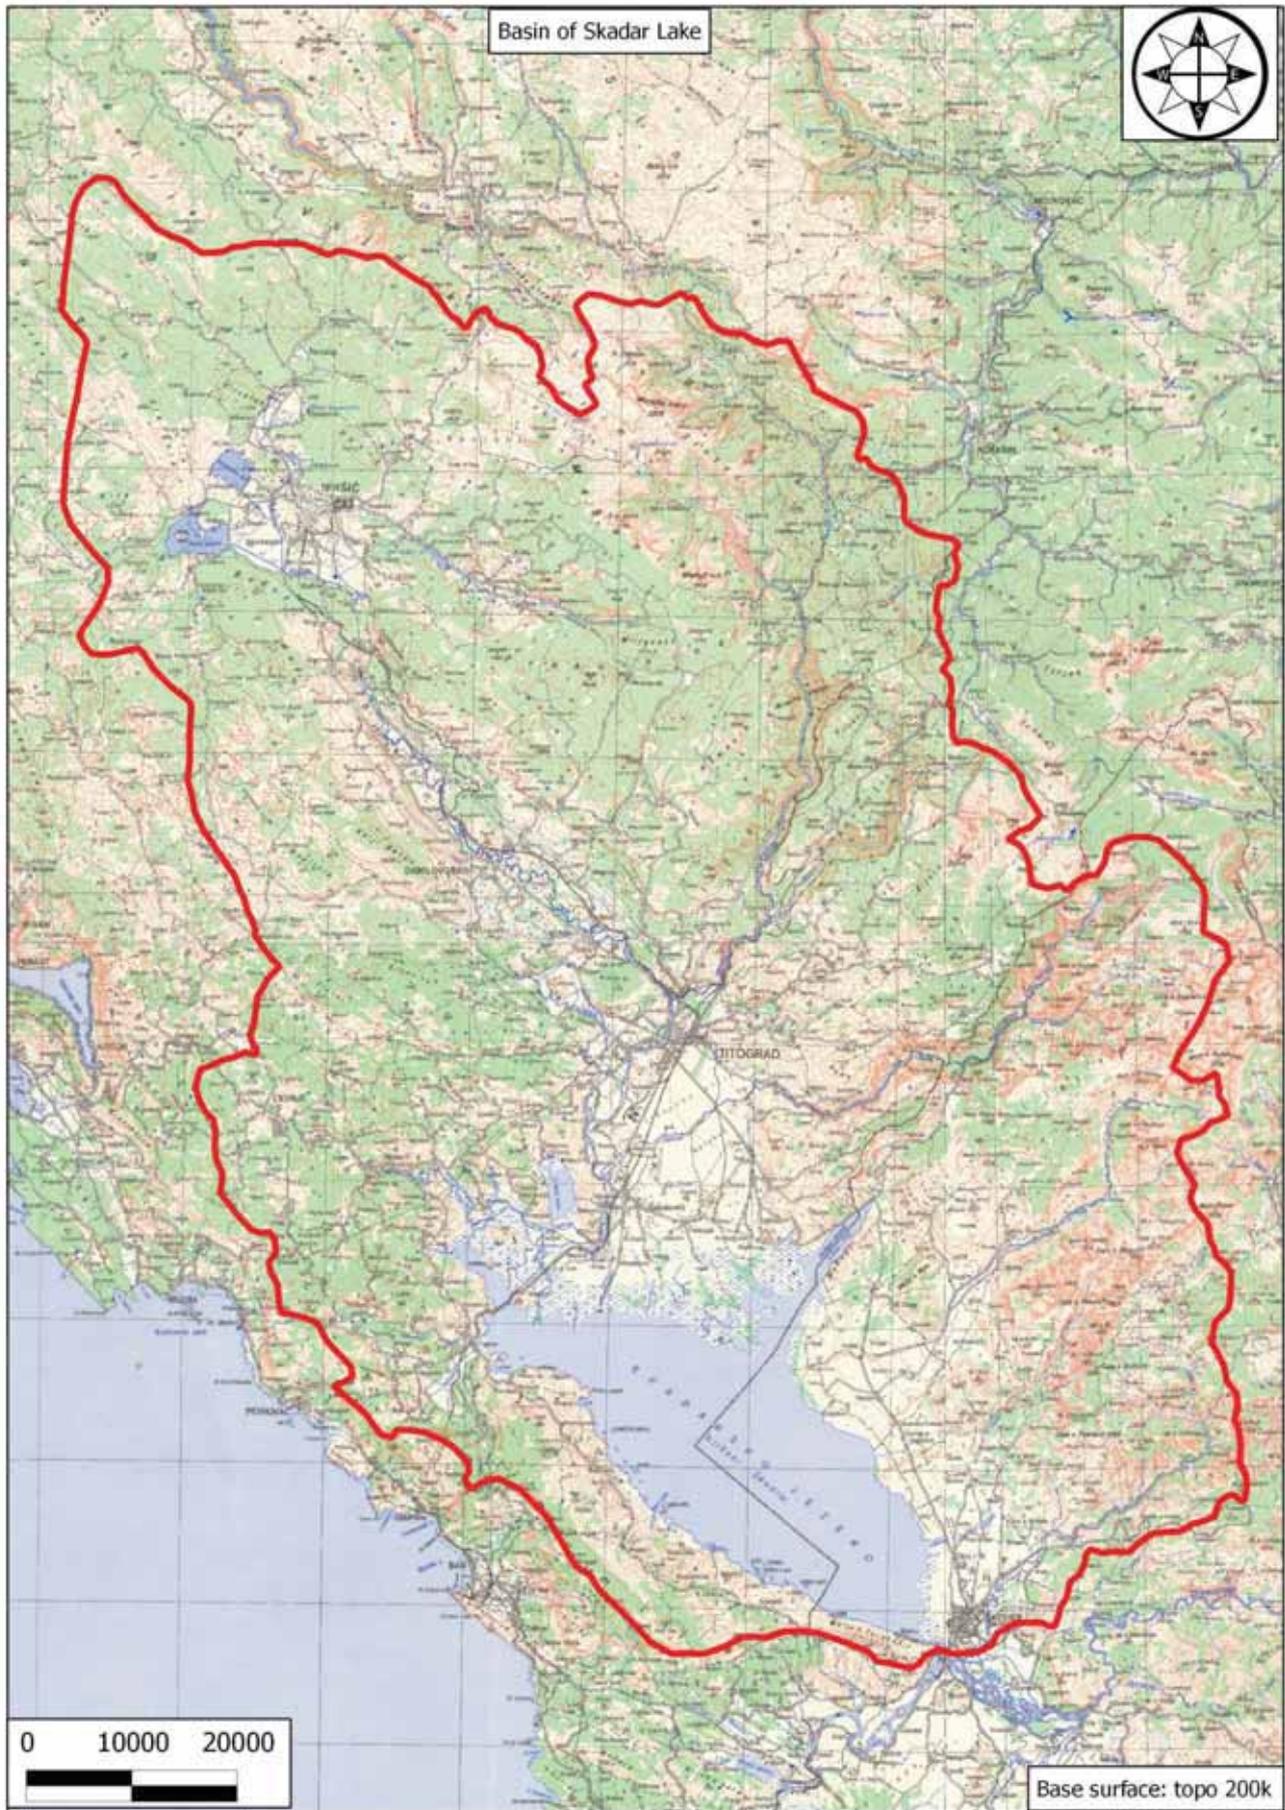
Figure 10. Drainage basin of Skadar/Shkodra Lake marked on a 1:200,000 topographical map

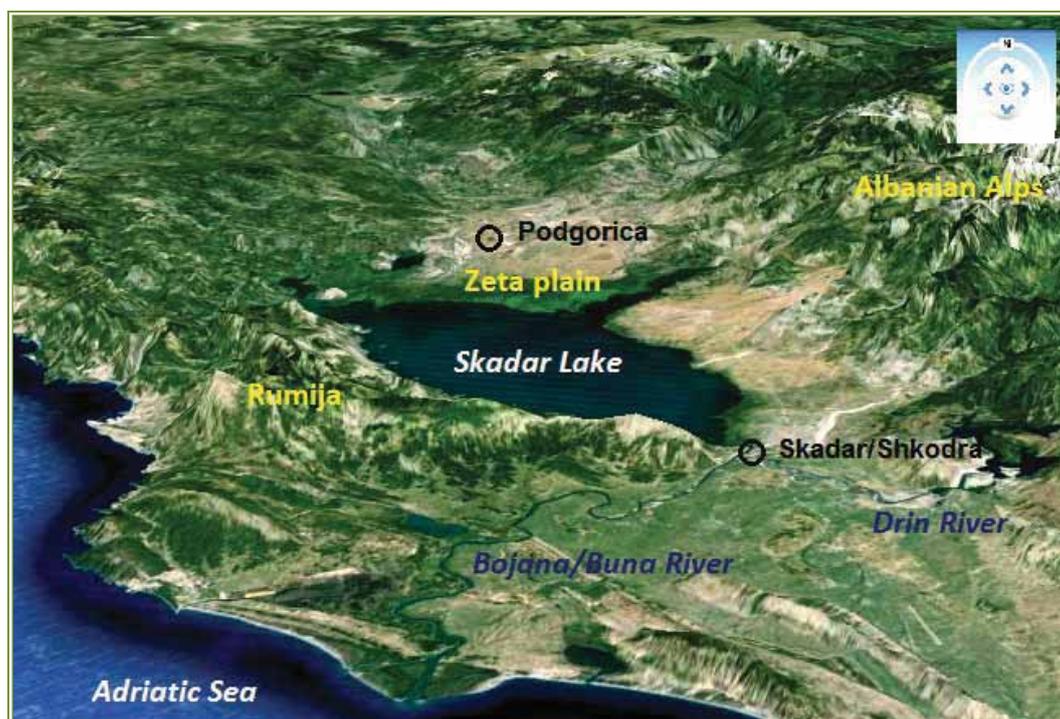
Figure 11. Terrain of Skadar/Shkodra Lake in 3D (Google Maps 2016)

The basin (Figure 11) is a depression running northwest–southeast, parallel to the Adriatic coast. The Zeta Plain in Montenegro extends northward from the lake, and the Albanian Alps rise up to its east. The coast of Skadar/Shkodra Lake is flat on these northern and eastern sides. The southwestern coast is defined by the ridges of the Sutorman, Rumija and Tarabosh Mountains, and is therefore steep and rugged. It is this mountainous zone that separates the lake from the Adriatic Sea. The only outflow from the lake is the Bojana/Buna River, which for most of its length also forms the border between Montenegro (MNE) and Albania (AL).

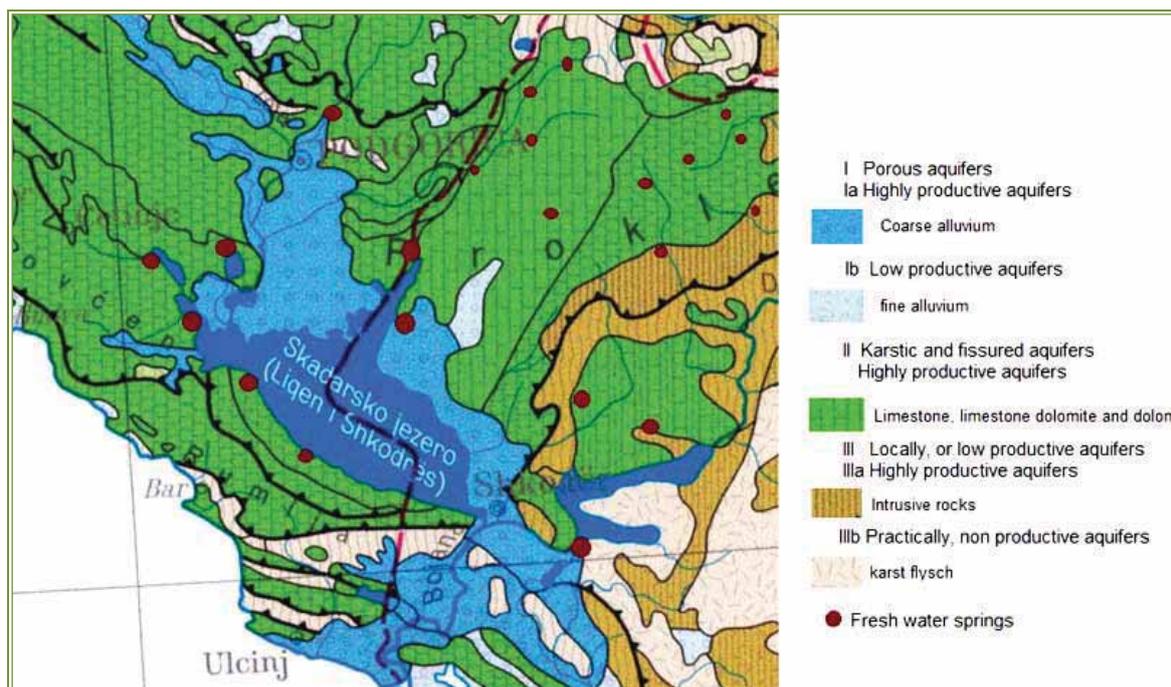
Figure 12. Simplified hydrogeological map of the Skadar/Shkodra Lake and Buna/Bojana River area (adapted from Eftimi R. 2010)

Two main groundwater bodies can be distinguished in the drainage basin: karst alluvium to the west, south-west and north-east of Skadar/Shkodra Lake, and porous aquifer (limestone and dolomite) mainly in the Zeta Plain in Montenegro and south of the lake (Figure 12). The groundwater in Zeta Plain stretches from the valley north of Podgorica, the mouths of the Zeta and Morača Rivers and the Ćemovsko, Zagoričko, Dinoško, Tološko and Lješko valleys to Skadar/Shkodra Lake. The area of this last aquifer is therefore around 158 km² and its thickness when charged with water varies from 20 m to 60 m, with the northern section being thicker. Elevations of the water table in this area vary from 35 m above sea level in the northern section to 10 m above sea level in the southern section. As a result, groundwater flows southwards from the northern part of the lake (Eftimi 2010).

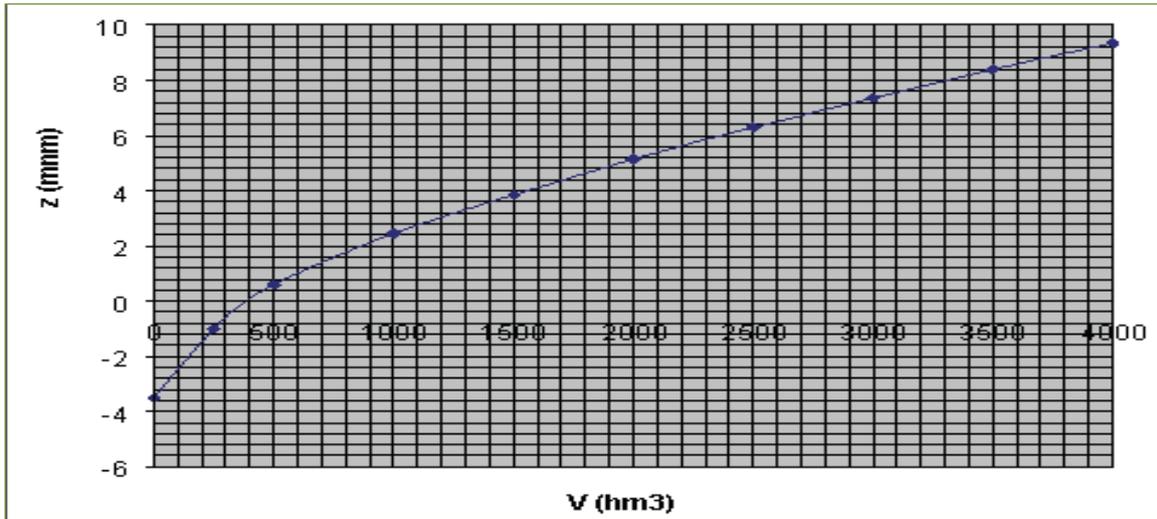
Figure 13. The total volume of Skadar/Shkodra Lake (x-axis) varies depending on the water level (y-axis, in metres above sea level) (Water Basis of Montenegro 2001)

When its water levels are at their lowest, Skadar/Shkodra Lake covers an area of 353 km² and has a volume of 1.75 km³; when they are at their highest, the lake covers 525 km² and has a volume of 4.25 km³. The difference between minimum and maximum volumes is therefore 2.50 km³. At its lowest elevation, the lake bed sits at about 2.50 m below sea level (making the lake a crypto-depression) and has an average depth ranging from about 4.4 m to 8.10 m.

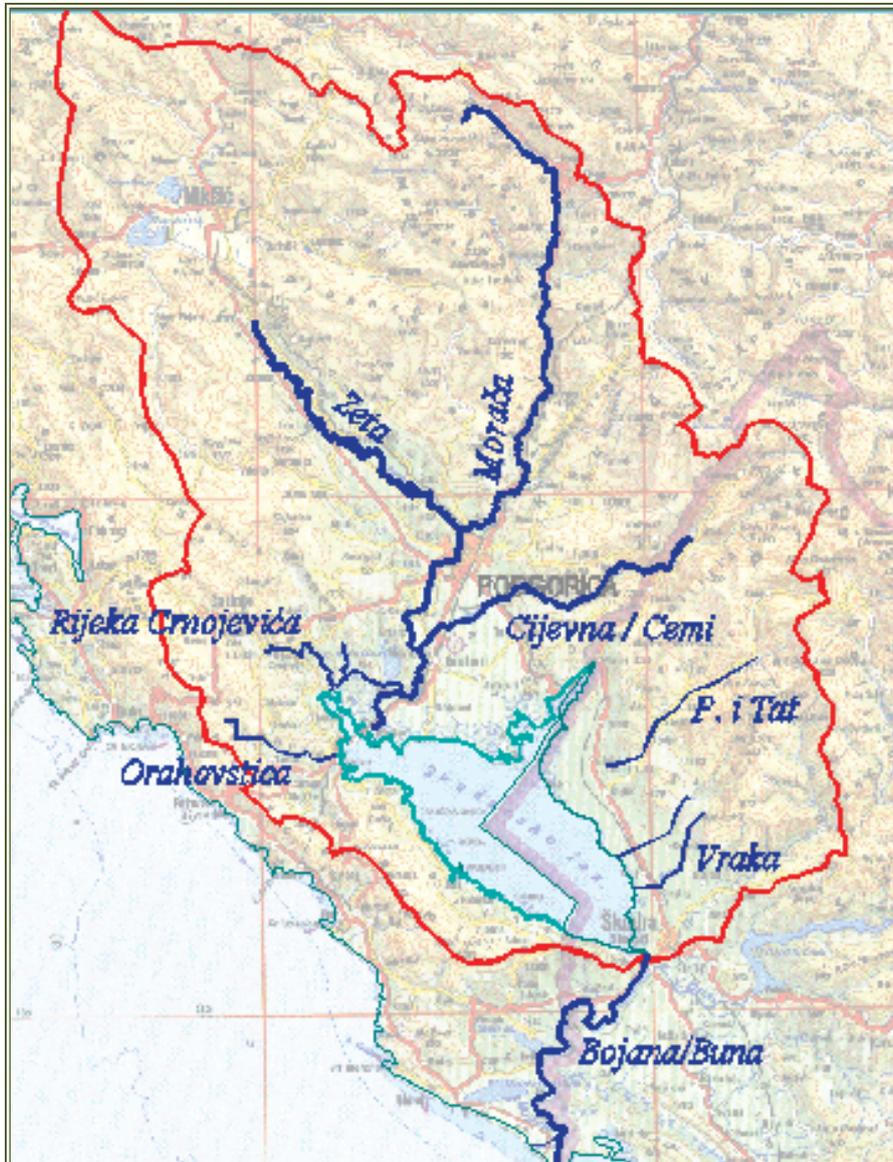
Figure 14. The main tributaries of Skadar/Shkodra Lake

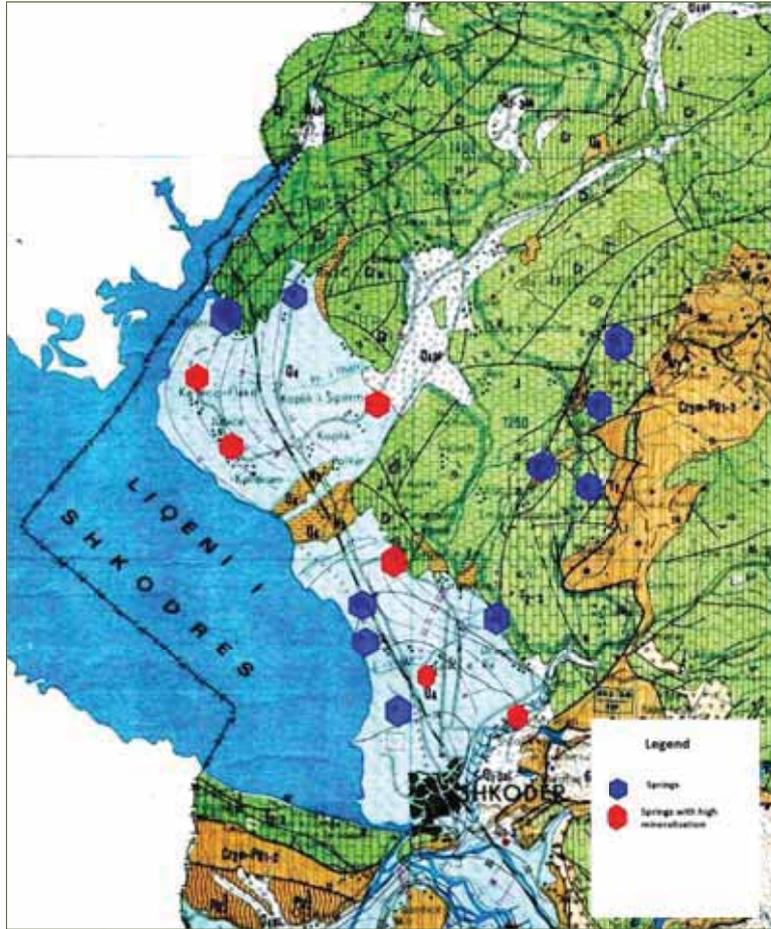
Figure 16. The springs and wells in the Albanian section of Skadar/Shkodra Lake (Hydrogeological Map of Albania 1:200,000, Albanian Geological Service)

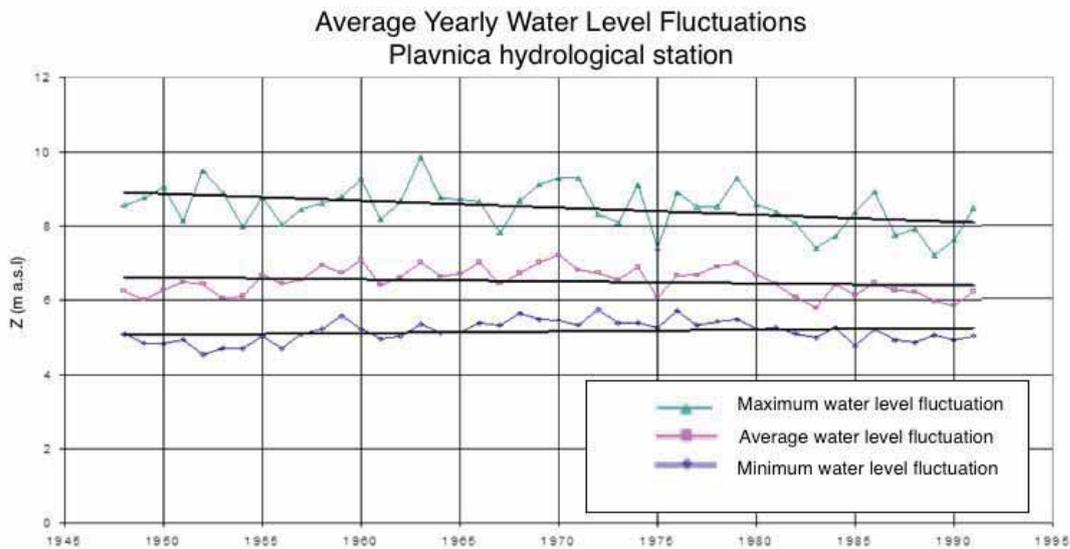
Figure 17. Trends in the characteristic water level (meters above sea level) of Skadar/Shkodra Lake recorded at Plavnica hydrological station (Water Base of Montenegro 2001).

The lowest observed value	4.54 (1952)
The average minimum	5.16
The average value	6.52
The average maximum	8.51
The maximum observed value	Natural: 9.86 (1963) Anthropogenic: 10.42 (2010)

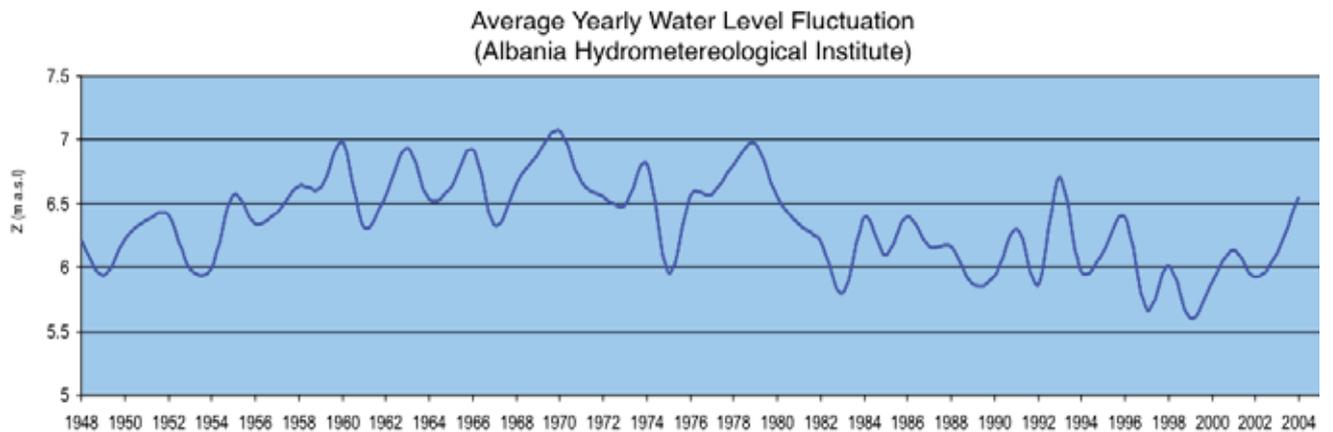
Figure 18. Average yearly fluctuation (meters above sea level) for Skadar/Shkodra Lake from 1950 to 2004 (Albania Hydrometeorological Institute)

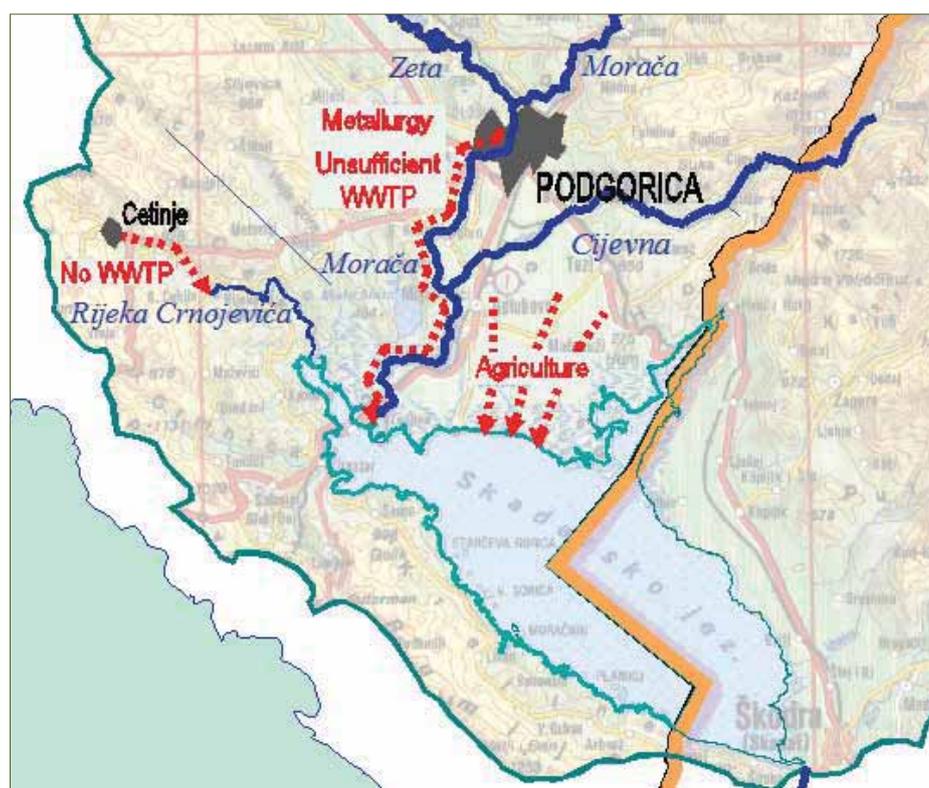
Figure 19. The main pollution pressures on the Montenegrin side of the lake

Aside from the diffuse pollution caused by agriculture, the largest inflow of nutrients comes from Podgorica's wastewater treatment plant (WWTP). Of the annual 10.2 million m³ of wastewater generated in the area of Podgorica, this treatment plant processes only 60%. The remaining 40% is discharged without treatment. The lakeside settlements Virpazar and Vranjina have built their own WWTPs. However, the town of Cetinje, which is located in the catchment area of the Rijeka Crnojevića tributary, does not have a WWTP, which means that pollution enters the tributary at its headwaters (Šundić, R. 2012).

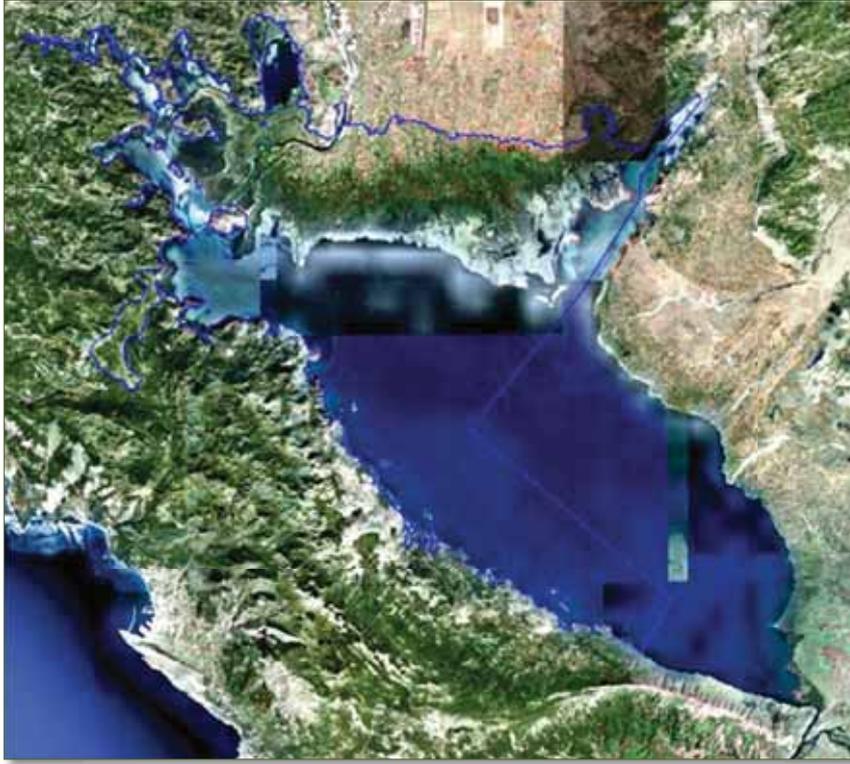
Figure 21. The territory around Skadar/Shkodra Lake that was flooded in winter 2010/2011, when high waters were augmented by the release of water from dams on the Drin River (Water Directorate of Montenegro, 2011)

The outflow of the Skadar/Shkodra Lake through the Bojana/Buna River is affected by high-water levels in the Drin River, which often result when water is released from artificial lakes upstream. Under certain conditions, the Drin's waters can even flow up into Skadar/Shkodra Lake, significantly raising its water levels (Academy of Sciences of Albania 2015). This phenomenon mostly occurs from December to February, but can also occur in other periods, depending on the quantity of water released from the hydropower dams (Vau i Dejes), which, in turn, depends on rainfall levels and electricity demand. Alterations in the water-level-fluctuation patterns of Skadar/Shkodra Lake exert pressure on its ecosystems as well as on local agriculture and microclimates. Skadar/Shkodra Lake is defined as a shallow floodplain lake with regular and extensive flooding of its low-gradient areas. The flooded areas are an essential habitat for maintaining the overall biodiversity of the lake. The flood regime – the timing and amplitude of changes in water levels – is an important factor for successful fish spawning. Furthermore, the increased frequency and intensity of flooding in the Skadar/Shkodra–Bojana/Buna area has, in recent years, given rise to detrimental socio-economic effects in the region. The latest bout of flooding was the most severe recorded in the last 80 years.

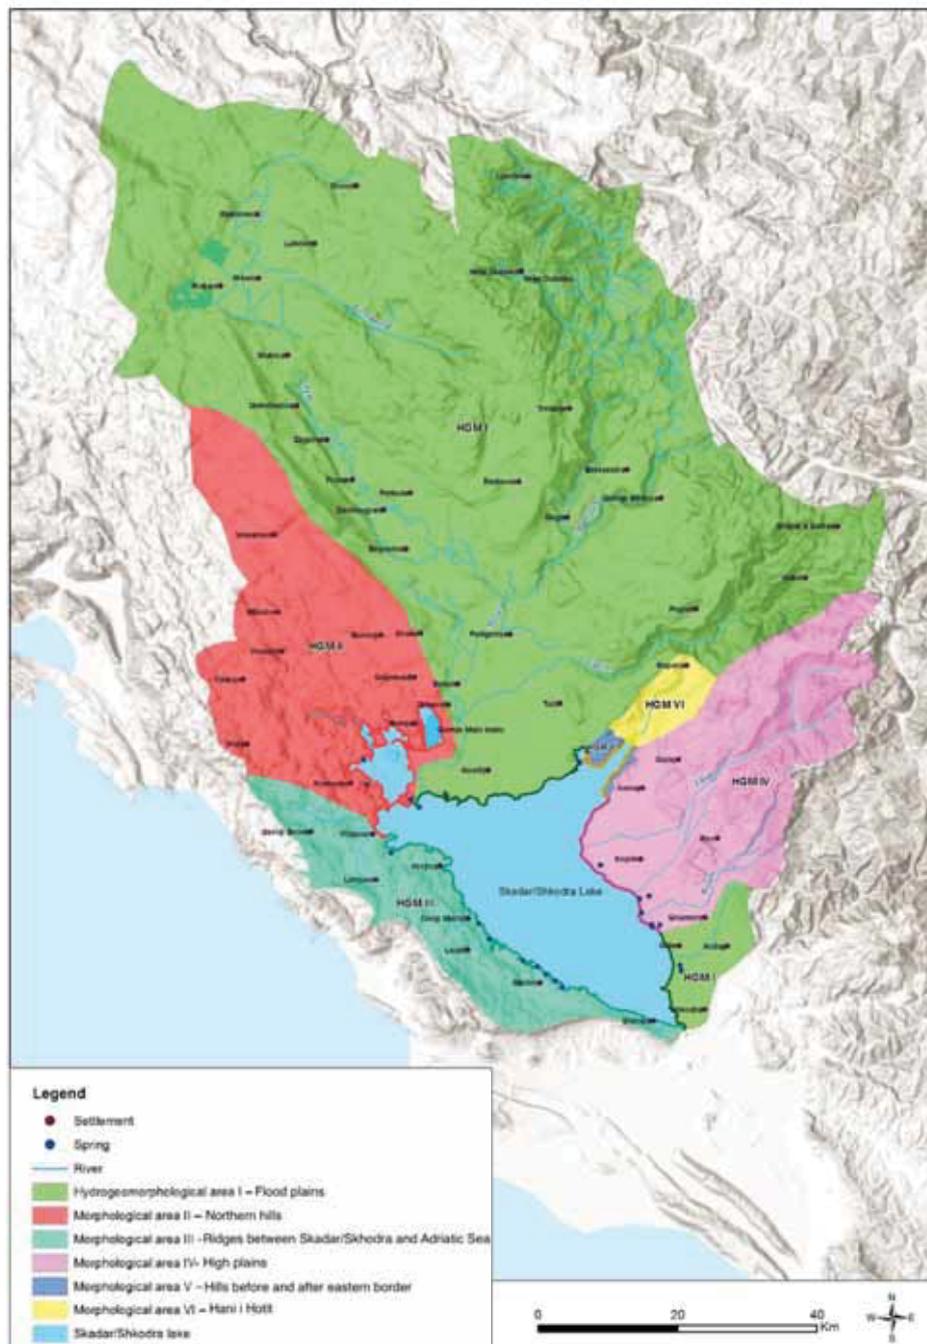
Figure 24. The six main HGM areas

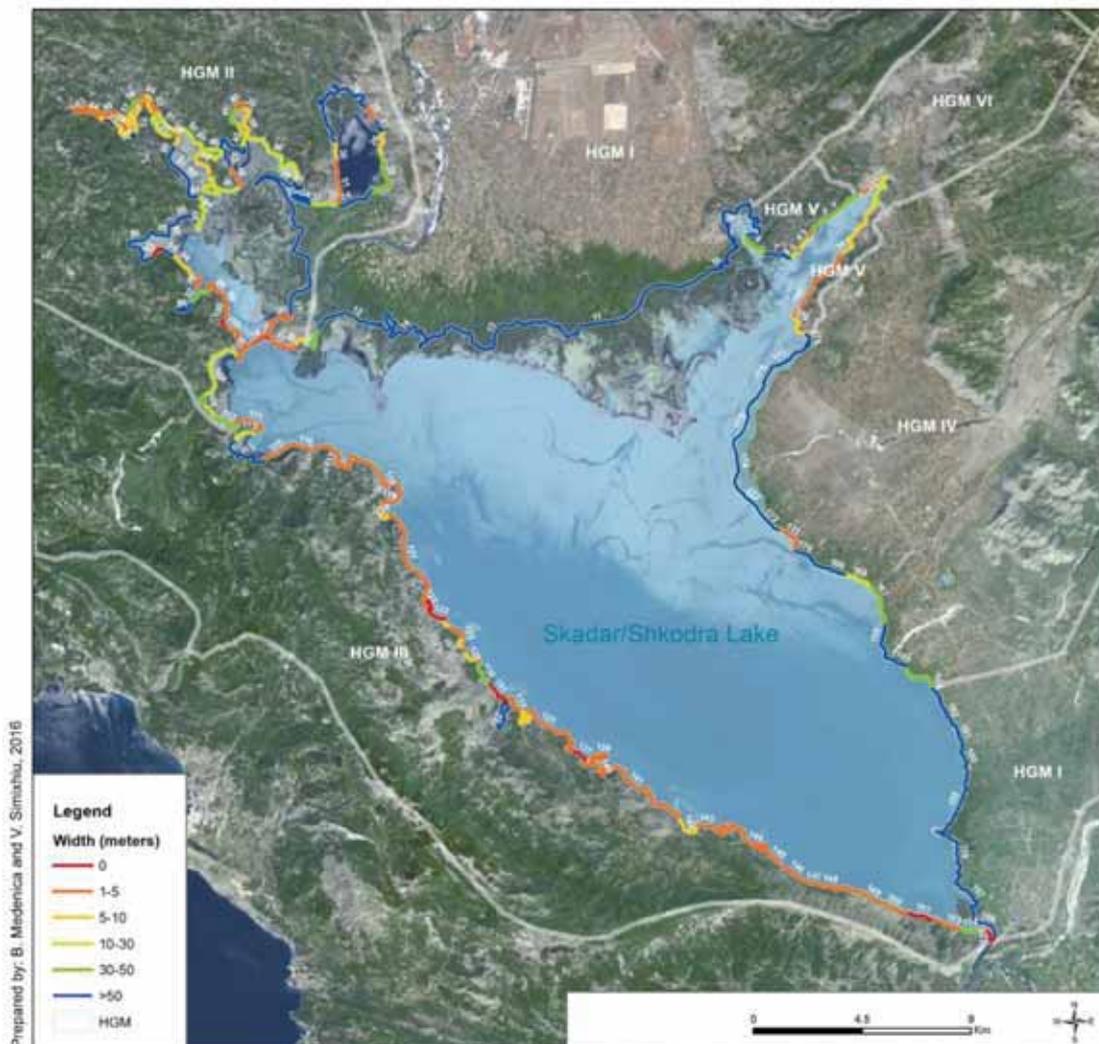
Figure 25. Width of the functional shorezone

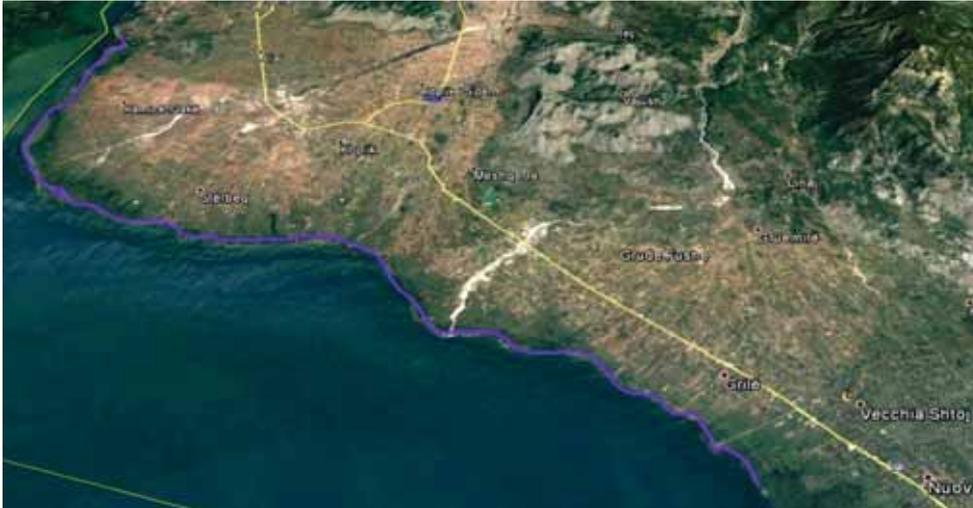
Figure 41. HGM area IV – High plains

These plains are slightly higher than those found in HGM area I and are therefore not subject to periodic flooding from the lake. While the area is mainly used for agriculture, some tourist infrastructure is present along the shore.

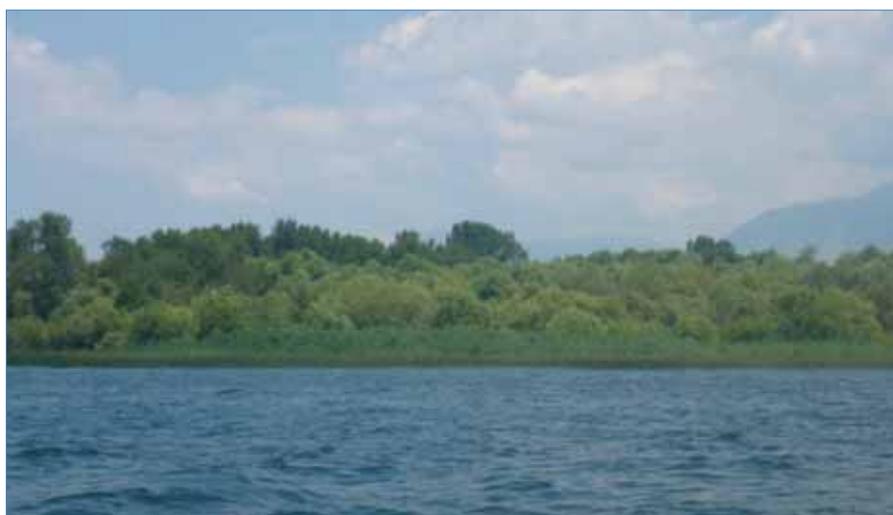
Figure 49. Example of a typology 1 shorezone: riparian vegetation (shrub and trees), with or without reeds, more than 50 m wide, natural, with a high value of complexity and functionality

Typology 1 is characterised by a thick belt (more than 50 metres wide) of riparian vegetation (shrub and trees), sometimes accompanied by reeds in the littoral zone. It provides a high value of complexity and functionality (SFI =1) and is typically found in HGM areas I-A and I-M (where A = Albania and M = Montenegro).

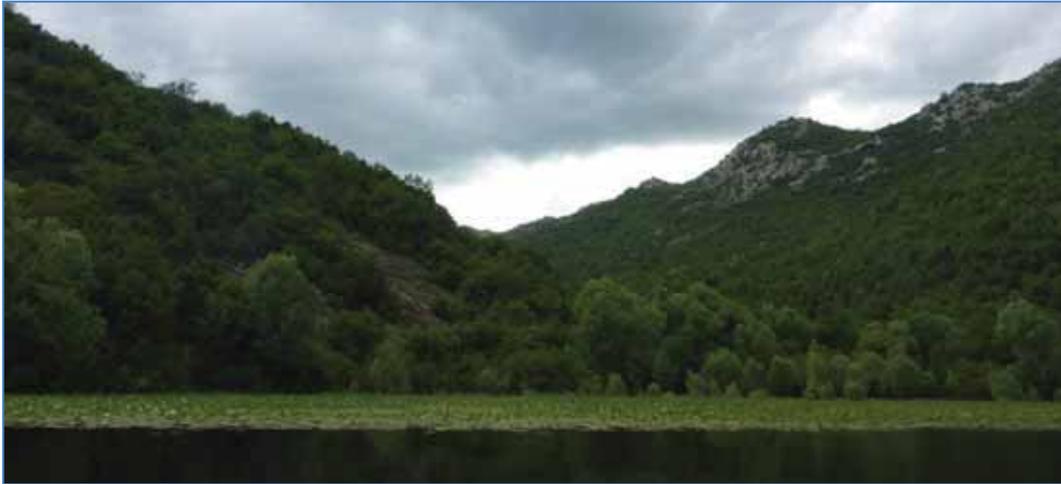
Figure 50. Example of a typology 2 shorezone: riparian vegetation (shrub and trees), with or without reeds, a width of 10 to 30 m, 100% natural, and a good value of complexity and functionality

Typology 2 is typically found in HGM areas II-M, V-A, V-M, mostly in the northern and north-western parts of the lake.

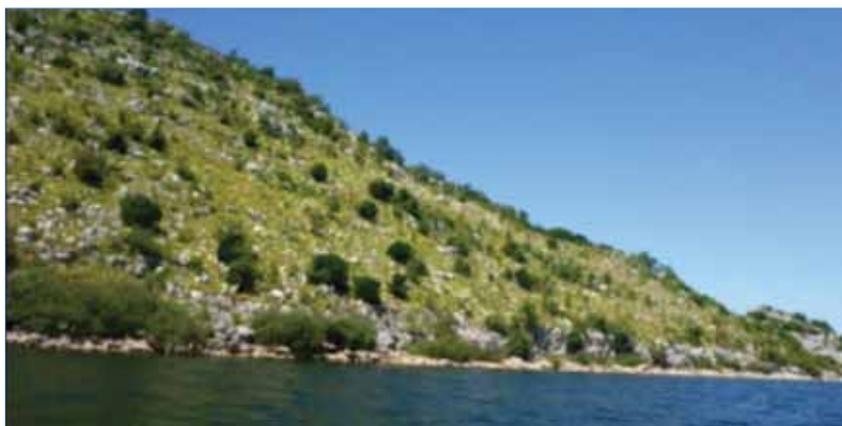
Figure 51. Example of a typology 3 shorezone: its shrubs have a lower value of functionality and it is less than 10 m wide

The limited growth of riparian vegetation is also, in certain stretches, due to high levels of anthropogenic pressure, such as uncontrolled grazing, that have occurred in the areas in question. This typology falls into the moderate SFI category (SFI = 3) and it is typically found in HGM areas III-A and III-M, which are mostly located on the western side of the lake.

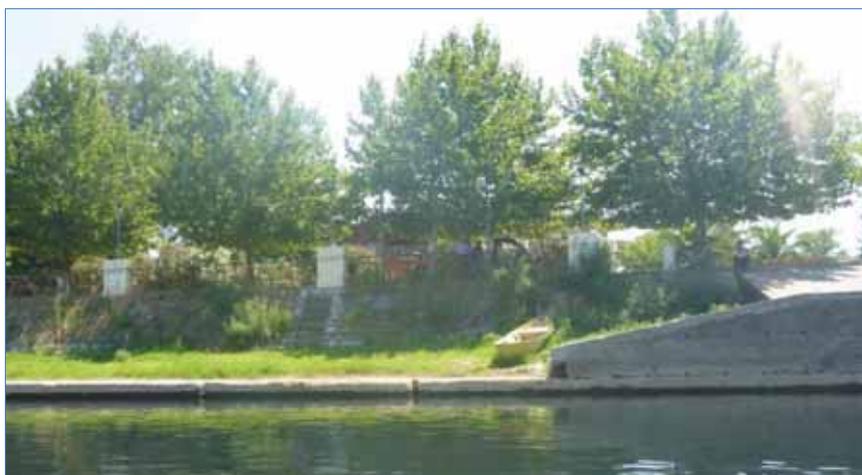
Figure 53. Example of a typology 5 shorezone: artificial

A mortar-bonded wall along the shorezone reduces its functional width to zero, limiting the buffering power of the riparian zone and interrupting its ecotone role between aquatic and terrestrial environments. Typologies 5 and 6 are found mostly in semi-urbanised or urbanised areas, which appear in a dispersed form all around the lake and in a concentrated form in the north-western section and the southern end of the lake.

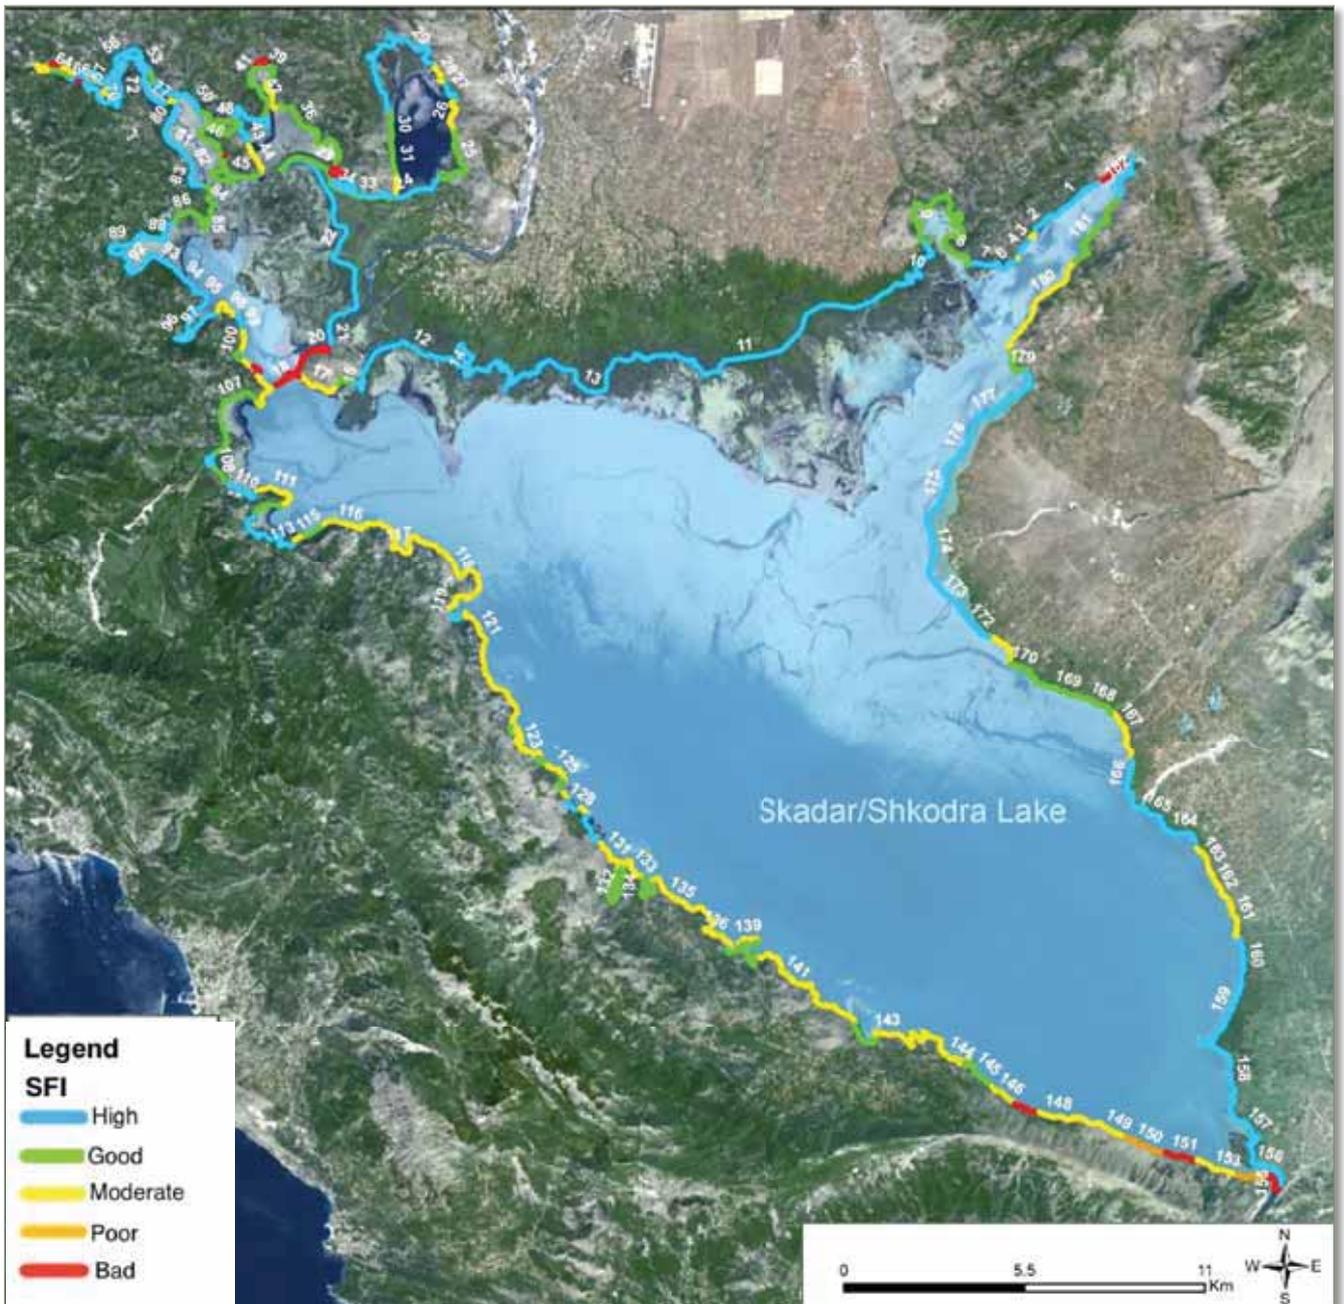
Figure 55. Map of the Shorezone Functionality Index percentages output by the software for the whole of Skadar/Shkodra Lake (both the Montenegrin and Albanian sides)

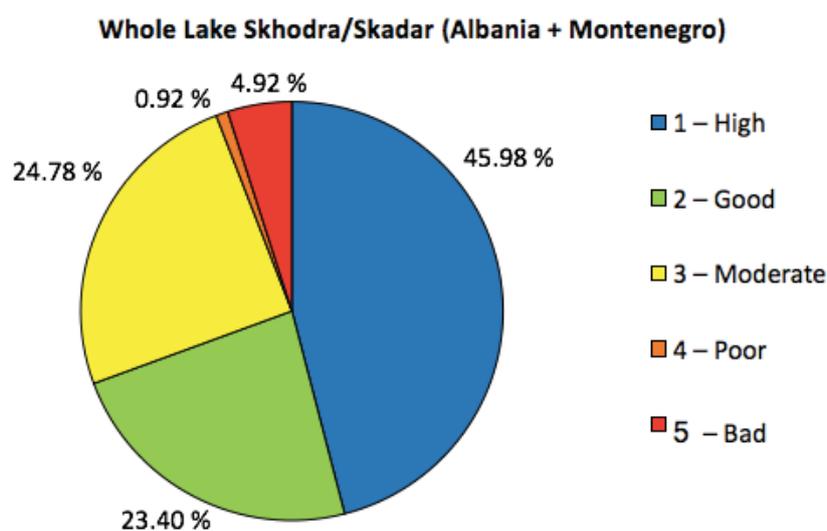
Figure 56. Shorezone Functionality Index percentages output by the software for the whole of Skadar/Shkodra Lake (both the Montenegrin and Albanian sides)

A large area of the lake’s shorezone is categorised as ‘good’ (39 stretches comprising 62.8 km or 23.40% of the total perimeter). Here, the shoreline has consistent cover of predominantly dense native hygrophilous vegetation, but it has a limited functional width. Shoreline categorised as good is found in the north-western and, to some extent, south-western sections of the lake (HGM area II).

A total of 51 stretches, comprising 66.5 km or 24.78% of the total perimeter of the lake, are categorised as ‘moderate’. The stretches that fall into this category are mostly dominated by a very narrow band of chaste trees (*Vitex agnus-castus*), or are rocky stretches with high naturality but low functionality. Shoreline categorised as moderate is usually found in the south-western and southern sections of the lake (HGM area III).
