Shorezone Functionality

Skadar/Shkodra Lake

Implementing the EU Water Framework Directive in South-Eastern Europe

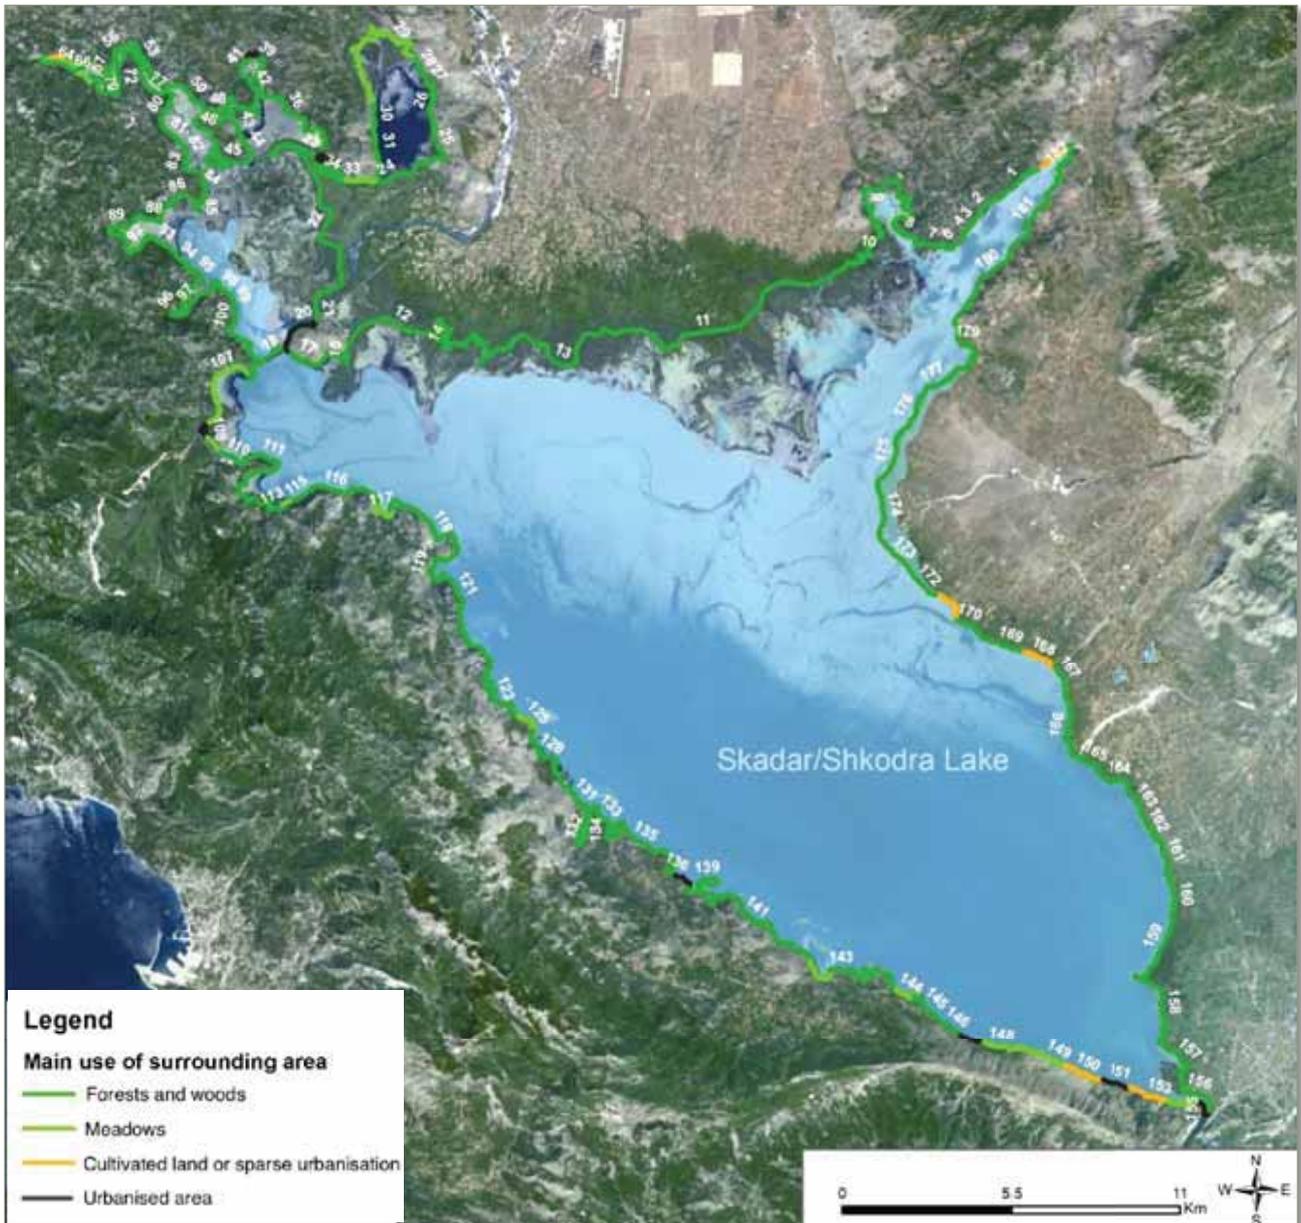
Figure 58. Map of the main uses of surrounding areas (0 to 200 metres inland from the shoreline)

As shown in Figure 58, most of the shorezone appears to be in a natural state. Sites of sparse urbanisation, fields under cultivation (yellow colour) and urbanised areas (red colour) are easy to discern. It should be noted that this parameter looks at the overall status of the homogeneous stretch identified, and the value corresponds to the most prevalent typology in that stretch. If a one-kilometre-long homogeneous stretch contains a small urbanised area and this settlement does not impact on its surrounding environment, it will be assessed using the ‘presence of interruption’ parameter. An interruption is any intervention or work that in any way can reduce, affect, or limit the functionality of the vegetation in the lake shore zone, for example house gardens, vegetable plots, parking areas or other infrastructures.

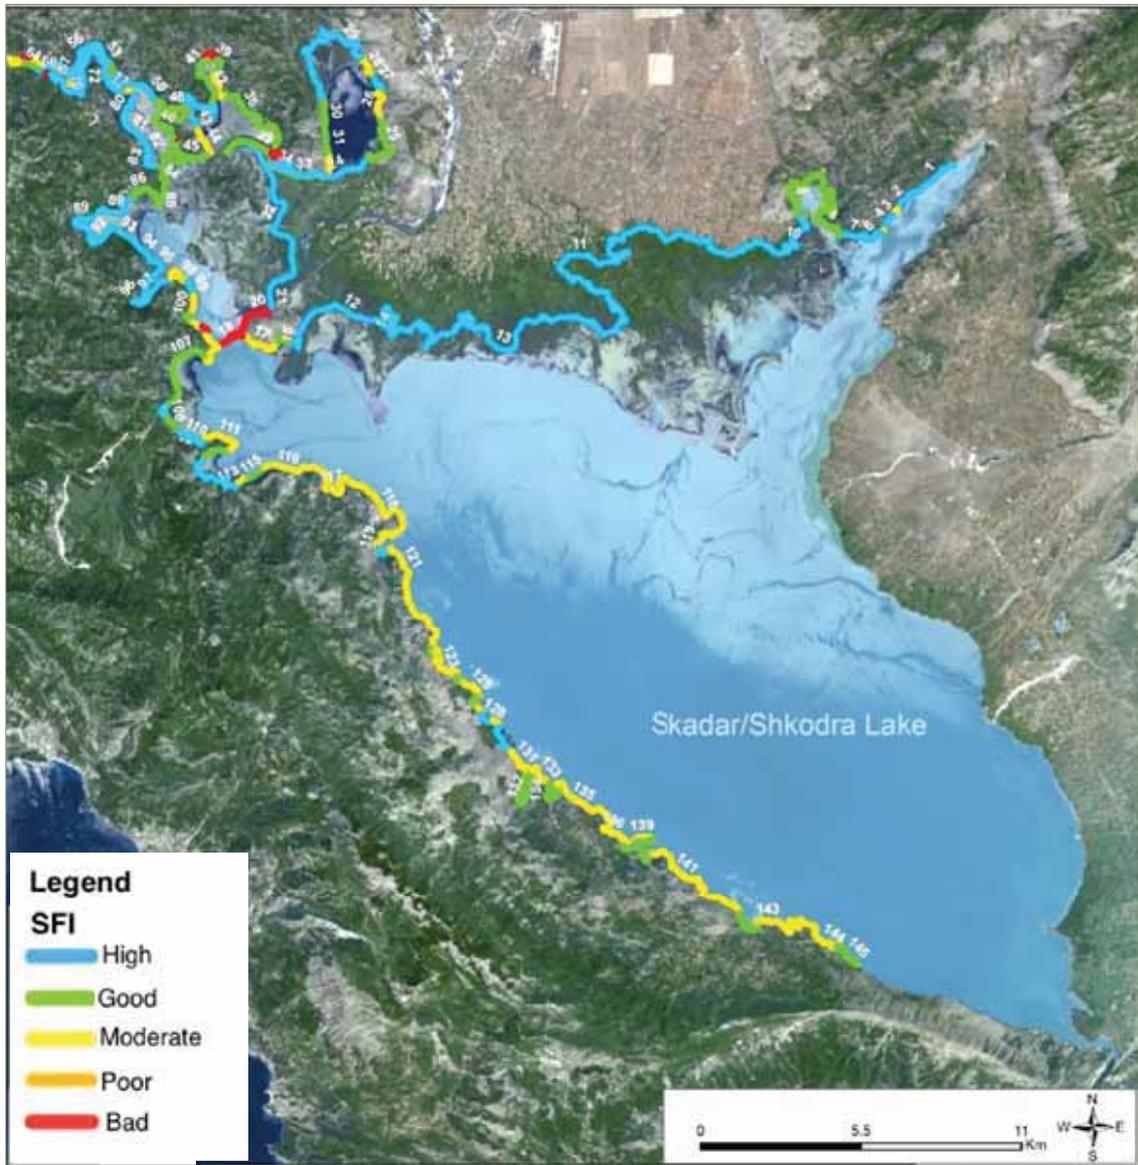
Figure 59. Map of the Shorezone Functionality Index results output by the software for the Montenegrin side of Skadar/Shkodra Lake

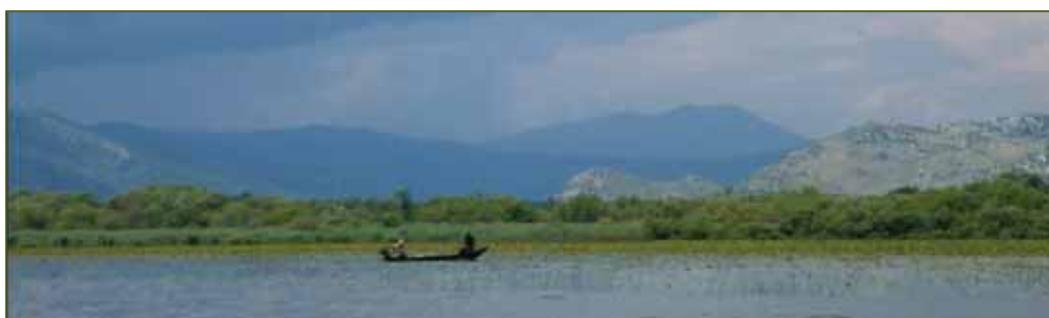
Figure 61. Example of the flat, non-urbanised shore in the northern part of the lake that is classified as SFI category 1

Category 1 areas are mainly found in the northern part of the lake where the environment is more pristine, there is less urbanisation, and there is a wide belt of white willow (*Salix alba*) mainly interspersed with narrow-leaved ash (*Fraxinus oxycarpa*) and wide reed beds along the shoreline, adjacent to the tree line.

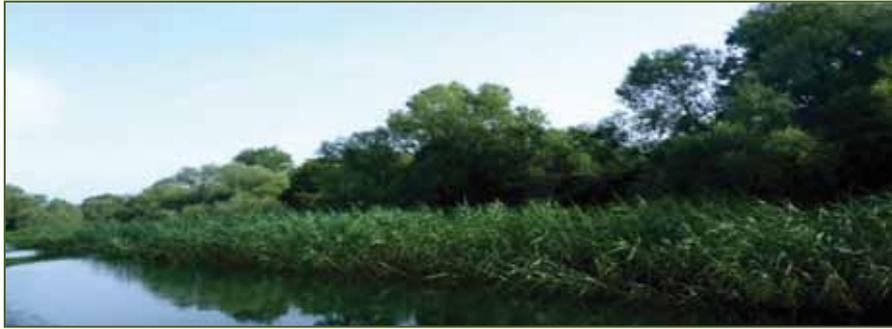
Figure 62. Example of a natural shorezone with good functionality that is classified as SFI category 2

A large area of the lake's Montenegrin shorezone (34 stretches, 26.18% or 54.660 km) is classified as SFI category 2 (good). It is characterised by consistent shoreline that is predominantly covered by dense native and mainly hygrophilous (arboreal-shrub and reeds) vegetation, which grows without interruption along the lake shore. A large part of the category 2 shoreline is found in (a) the north-west, in the natural area of Rijeka Crnojevića (Šanik, Pavlova Strana, Rudina, Prevlaka), which is in HGM area II, and (b) the northern part of the lake (Podhumski Zaliv Bay to Plavnica), which is split between HGM areas I and V. Also, a large number of category 2 stretches are found in bays situated in the south-western part of the lake where the shorezone is flat or has a very gentle gradient, and contains hygrophilous arboreal-shrub vegetation and very well-developed wet reed vegetation.

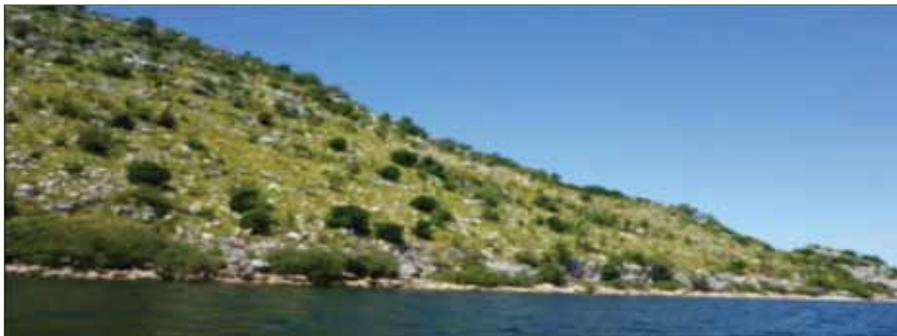
Figure 63. Example of a natural shore zone with lower functionality that is classified as SFI category 3

In all, 40 stretches, or 24.35% of the lake's Montenegrin shorezone (50.848 km), is classified as SFI category 3 (moderate). The stretches that fall into this category are usually found in the south-western part of the lake in HGM area III. Even though fully natural, the majority of the shoreline in this part of the lake has a lower level of functionality because the riparian vegetation has a limited width. It is generally formed by a very narrow band of shrubs and small trees (mostly chaste trees), separated with small with small areas of bare rock. For this reason, although there is a total absence of artificiality, these stretches' levels of functionality mean they can only attain SFI category 3. This is due to the steepness of the shore's topography and the nature of the substrate that stops functional riparian vegetation growing in wider belts upland.

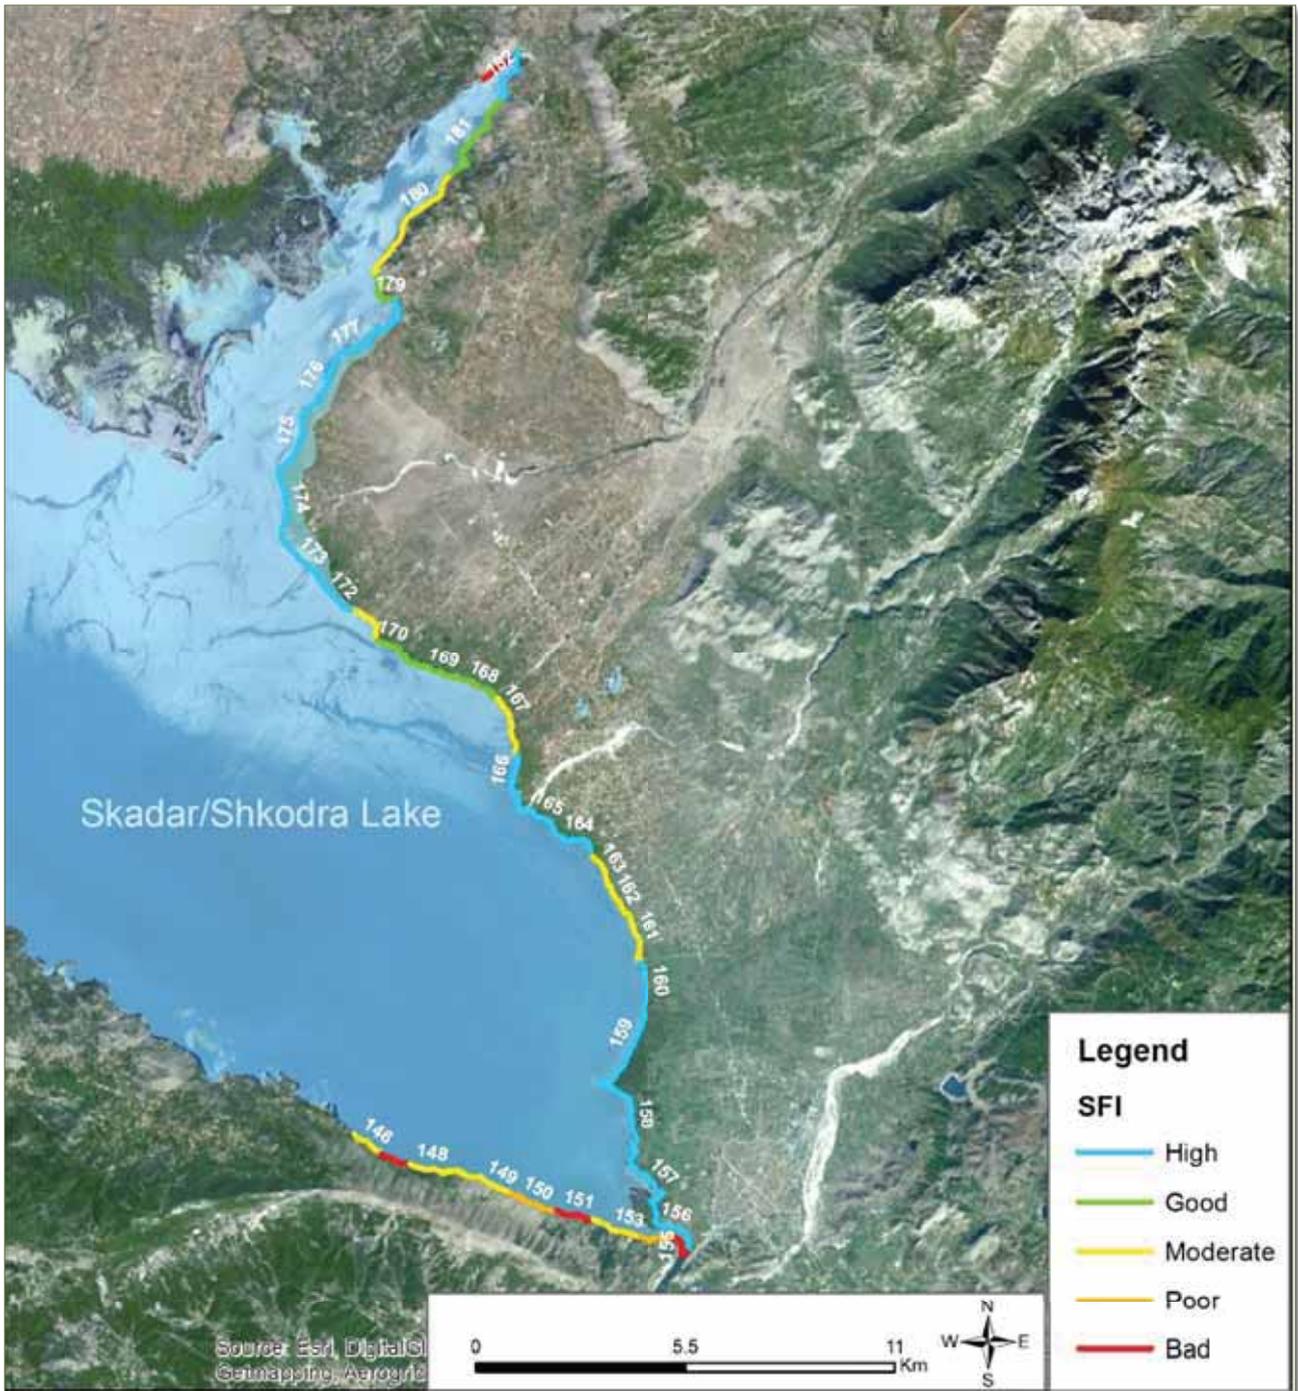
Figure 65. Map of the Shorezone Functionality Index results output by the software for the Albanian side of Skadar/Shkodra Lake

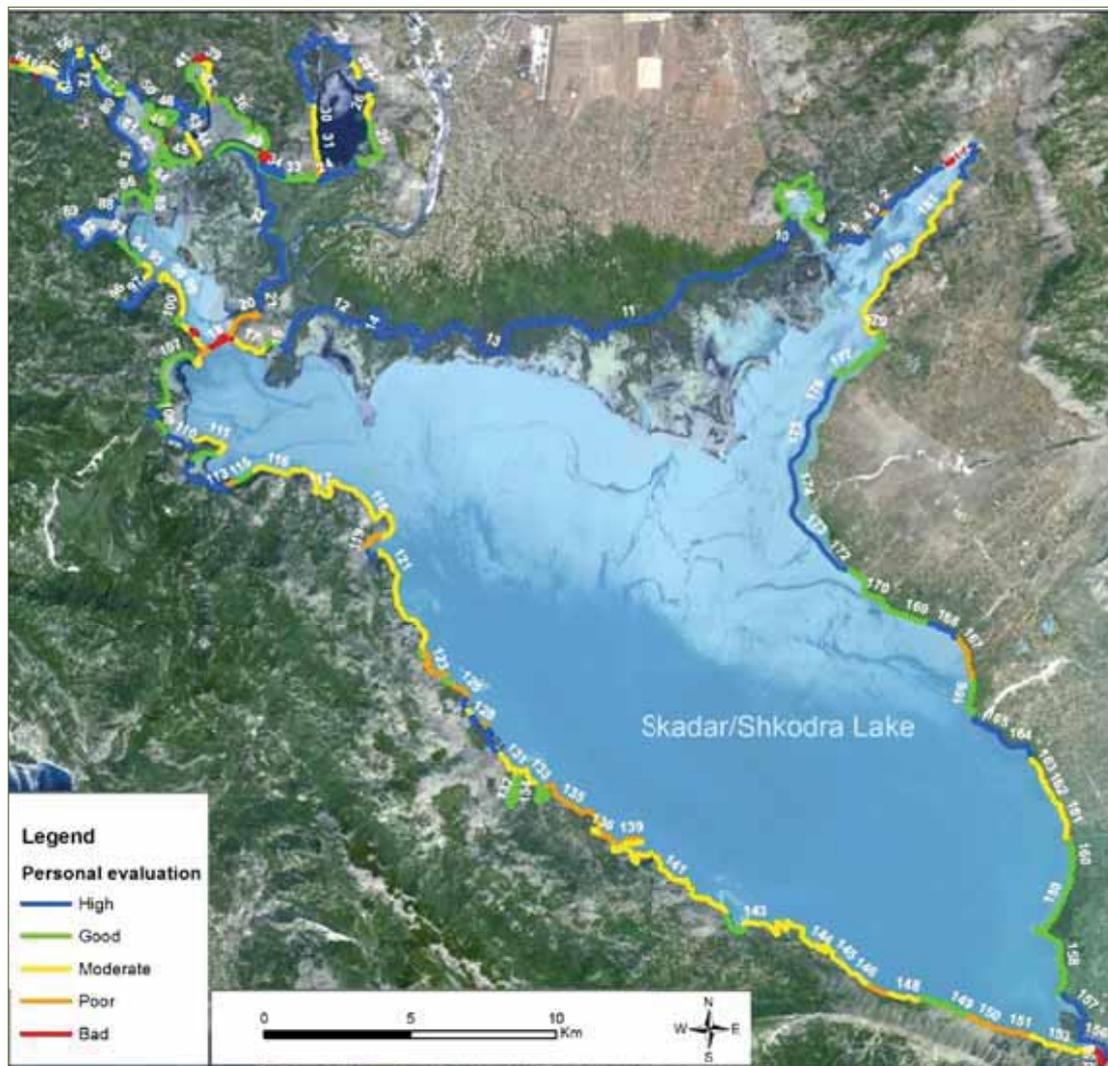
Figure 67. Map of Shorezone Functionality Index percentages, as determined by an expert, for Skadar/Shkodra Lake as a whole (both the Montenegrin and Albanian sides)

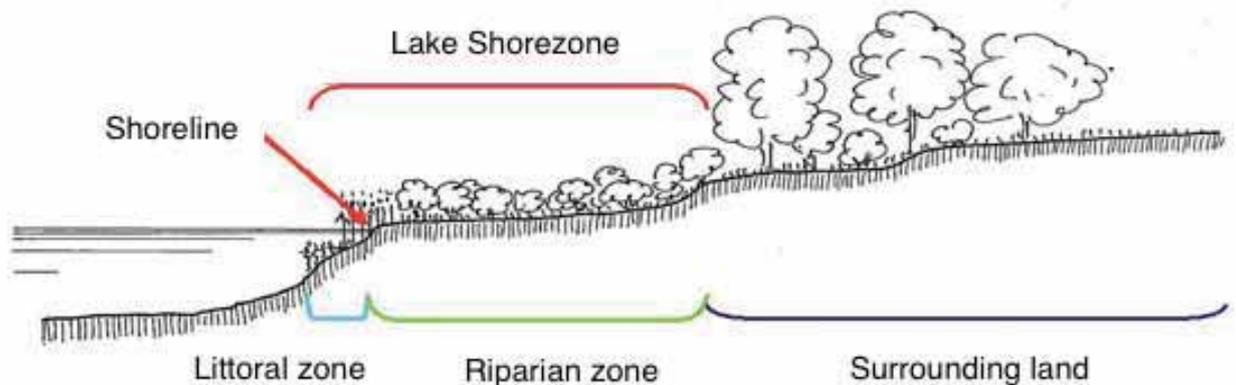
Figure 68. Structure of the lake shorezone
