Preliminary Technical Assessment

Rehabilitation of the Museum of History and Ethnography of Soroca

Soroca

November 2016

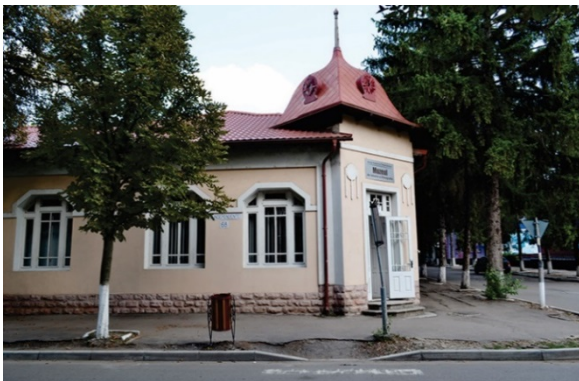
The Balter Pharmacy, façade from Independenței strada

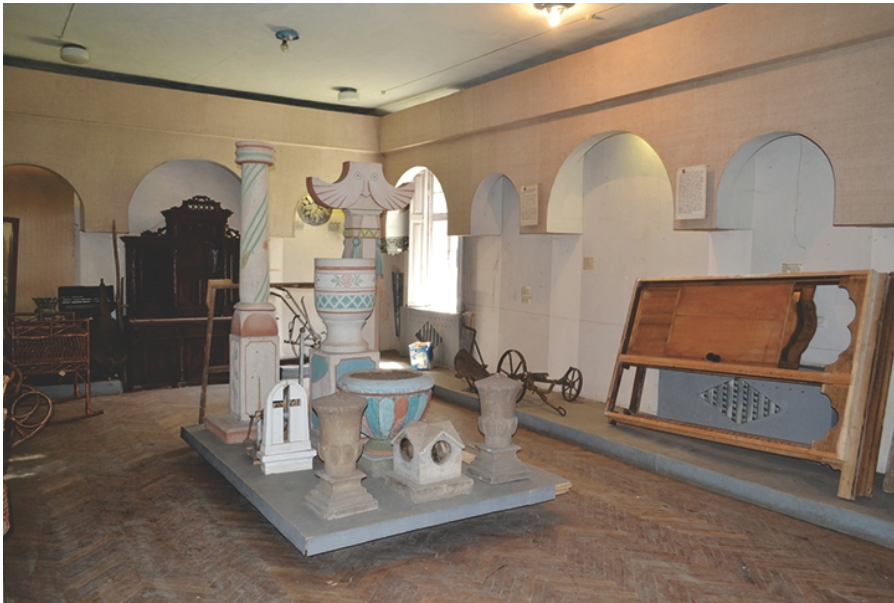
The interior of the Gendler House: illustration of inadequate construction and installations

- *full demolition of the roof structure and the tin covering;
- *reconstruction of the roof according to the initial design of the building;
- *restoration of the ceiling;
- repair and restoration of the wooden floors;
- restoration and repair of the interior and exterior wooden joinery according to the original design;
- removal of the plasterboard elements and of the provisional interior decoration;
- new exterior and interior finishes: plaster, paint, doors, windows, floors;
- repair of installations: water supply, sewage, heating, electrical.

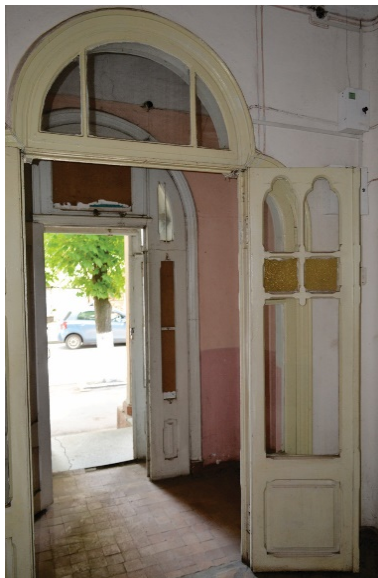
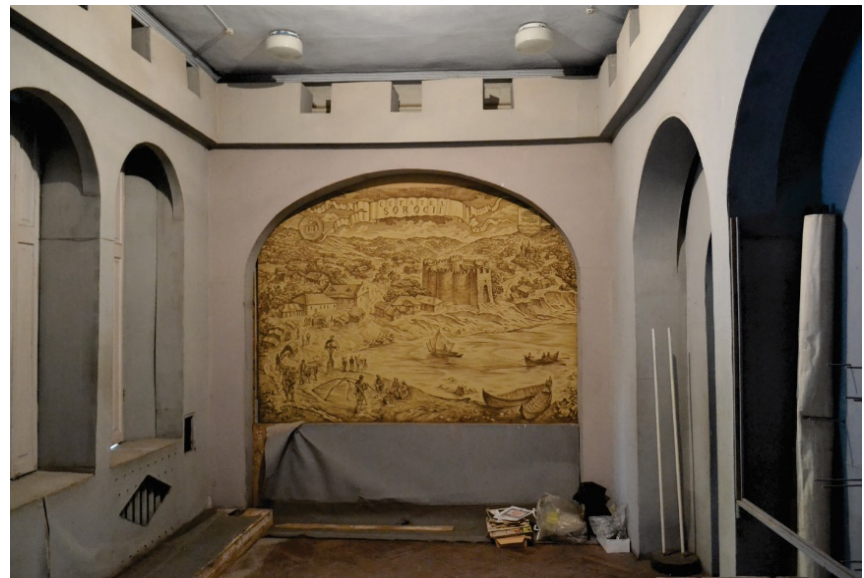
Inside the building – plasterboard plates were placed on the walls

For Gendler House, which suffered significant modifications, it is recommended that its authentic appearance be restored and temporary constructions from the interior be removed. The rehabilitation of the joinery, of the construction elements, of the finishes will be made with respect to the authenticity of the building.
