## Community-led Urban Strategies in Historic Towns (COMUS)

### Dusheti Local History Museum Rehabilitation-adaptation project

#### Feasibility study

Dusheti  
Georgia  
2017

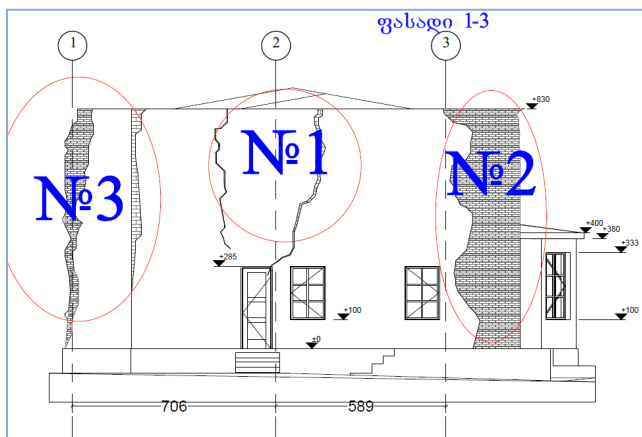
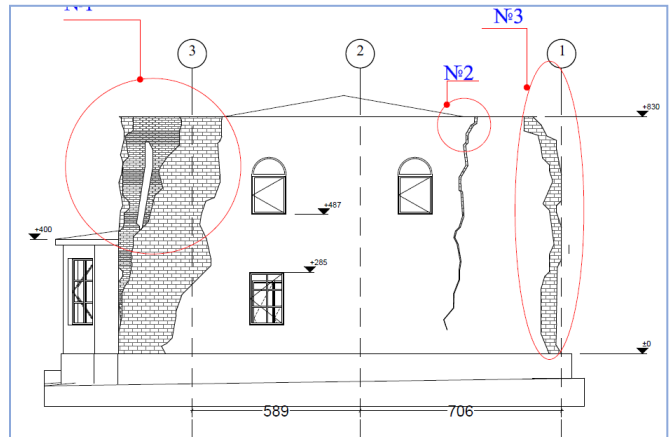
2. Facades 1-3 and 3-1, schematic measurement, L. Ketelaury, G. Sinjaradze, 2016

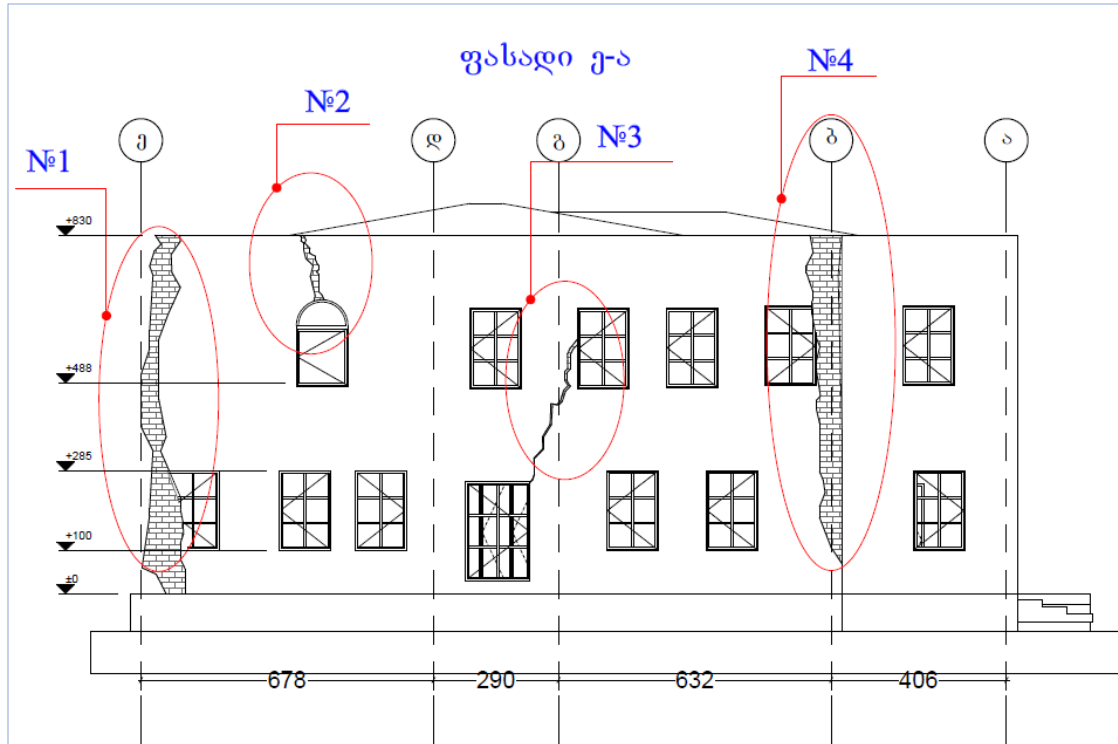
3. Façade e-a, schematic measurement, L. Ketelauri, G. Sinjaradze, 2016

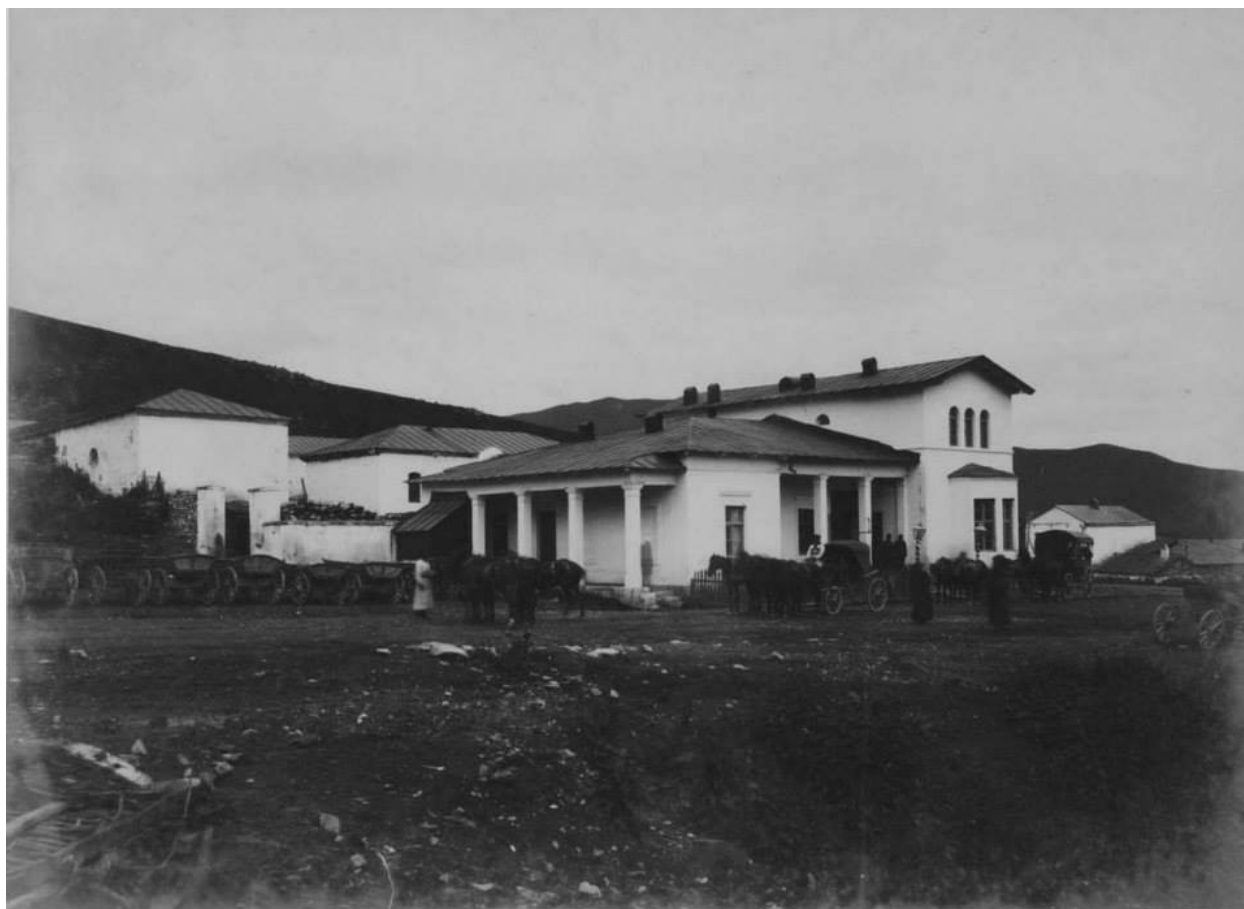
*2. Stanzia, archive photo, (provided by Shadi Hadadi).*

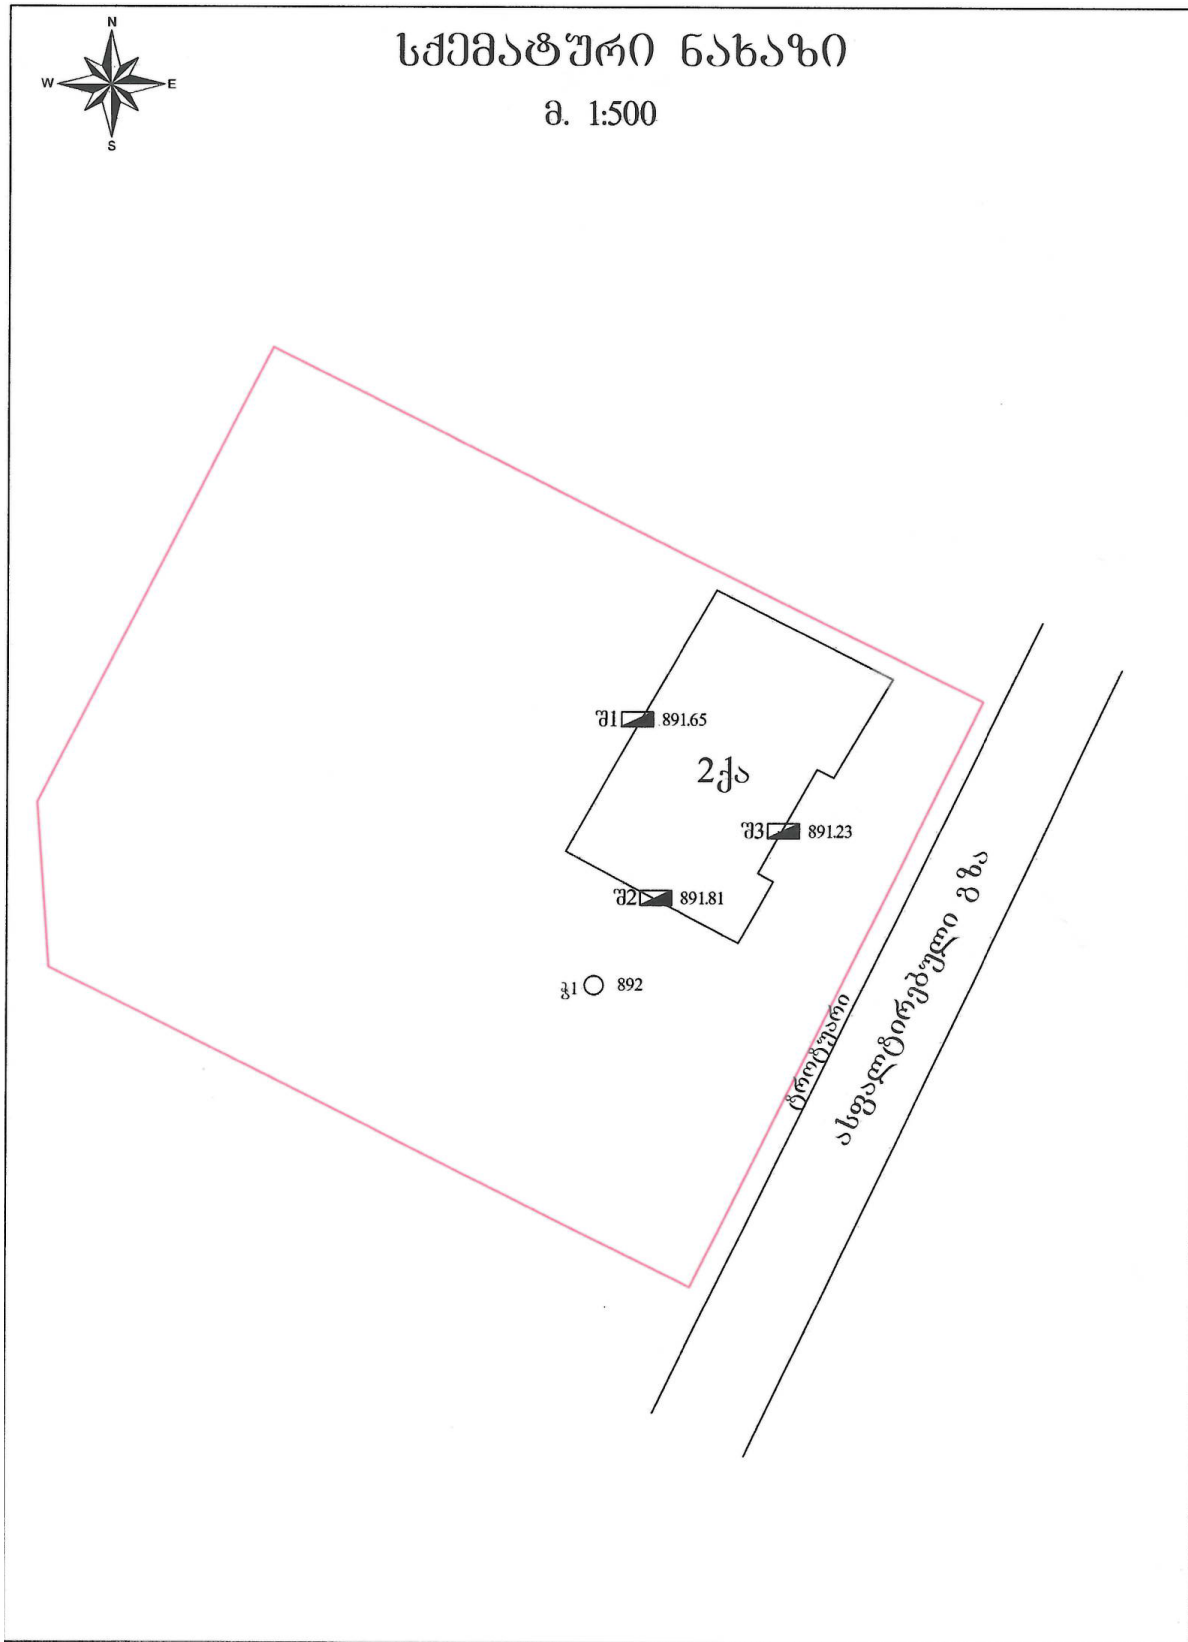
## საინჟინრო გეოლოგიური ბარათი

ჭაბურღილი №1 მასშტაბი 1:40 აბს. ნიშნული: მ

With the aim to determine the type of the foundation and the measurements, near east, west and south walls of the building, three holes were made manually at the depth of up to 1.30m.

The building is laid on 1.10-1.15m capacity lane foundation, the quadrates are used in the foundation, width 0.60 m. The foundation is in a satisfactory condition, there are no cracks, subsidence processes.
