Follow-up of Recommendation No. 95 (2002) on the conservation of marine turtles in Kazanli (Turkey)

Survey September 2017

37th Meeting of the Standing Committee Bern Convention

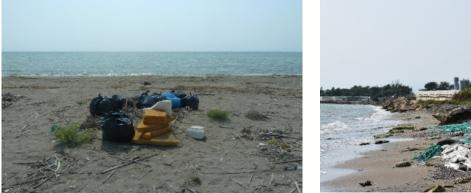
Marine debris was observed along the entire coast.

Garbage collected but not removed from the beach

Discarded greenhouse nets

Measure N° 3: Periodically removing the plastic debris from the beach

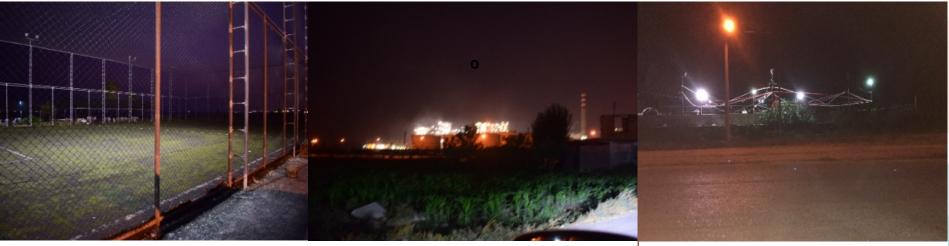
Photo-pollution on the beach is clearly evident. No light screening has been installed.

Artificial light from the football court (K2 section)

Soda-Chrome factory at night (K4 section)

Artificial light from the wedding hall (K2 section)

Measure N° 4: Screening the lights of the municipality of Kazanlı and the Soda-Chrome factory so as to avoid photo-pollution on the beach

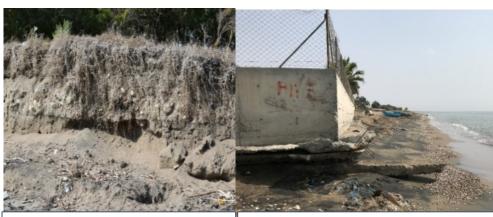
Coastline erosion has progressed rapidly and disastrously over the years.

The beach front at area K3 has decreased dramatically and can no longer sustain any turtle nests.

Effects of severe coastal erosion

Erosion of the coastline affecting the concrete wall of the local school yard

Coastal erosion in K3 area; ineffective use of rocks and concrete blocks to halt and control the severe erosion of the coastline

Measure N^o 6: Setting in place a monitoring of beach erosion, so as to take remedial measures as needed:

Effective remedial measures need to be applied as a matter of great urgency.
