**Wind energy: Possible threats to an endangered
natural habitat in Izmir (Turkey)**

- REPORT BY THE GOVERNMENT -

*Document prepared by
the Ministry of Forestry and Water Affairs, Turkey*

**REPUBLIC OF TURKEY****MINISTRY OF FORESTRY AND WATER AFFAIRS****21.02.2017****GOVERNMENT REPORT ON COMPLAINT NO. 2014/6 “WIND ENERGY: POSSIBLE THREATS TO AN ENDANGERED NATURAL HABITAT IN İZMİR (TURKEY)”****Background**

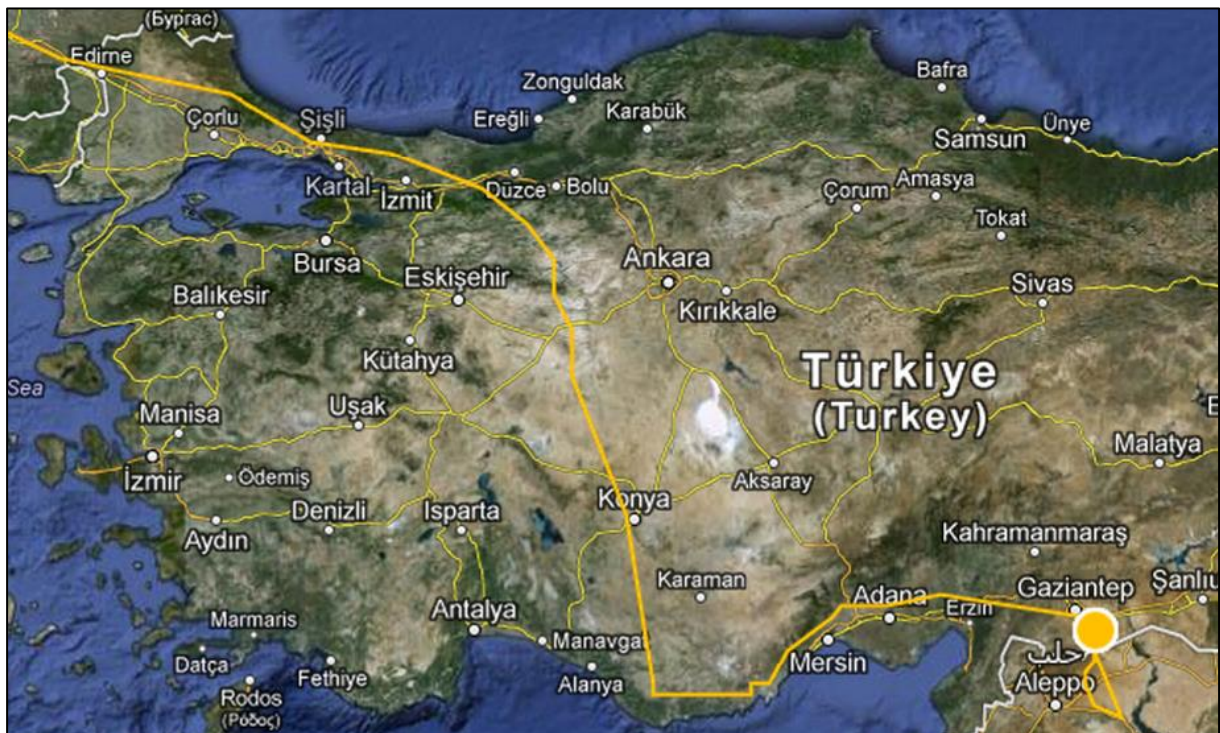
Figure 4. Migration route of imperial eagle tagged in Hungary

Some migration routes detected by satellite transmitters mounted on white stork (*Ciconia ciconia*), black stork (*Ciconia nigra*), imperial eagle (*Aquila heliaca*), lesser spotted eagle (*Clanga pomarina*), saker falcon (*Falco cherrug*), European honey buzzard (*Pernis apivorus*) are given in Figures 2-6, which Show that most of the migration routes are far from the Çeşme basin.

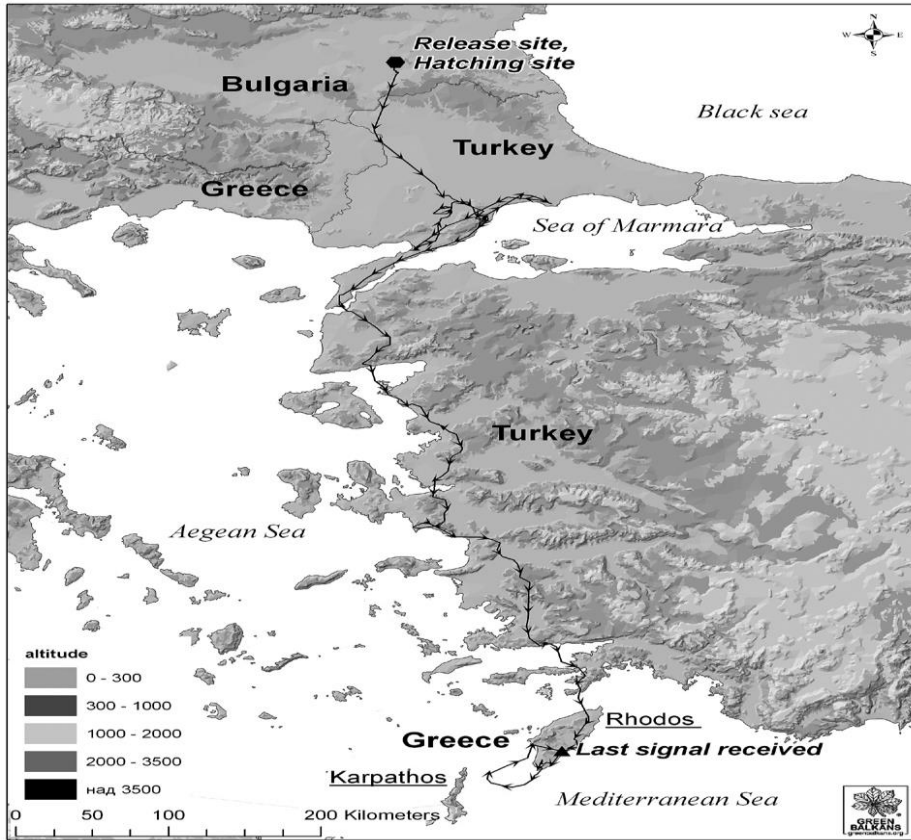
Figure 5. Migration route of another imperial eagle tagged in Hungary

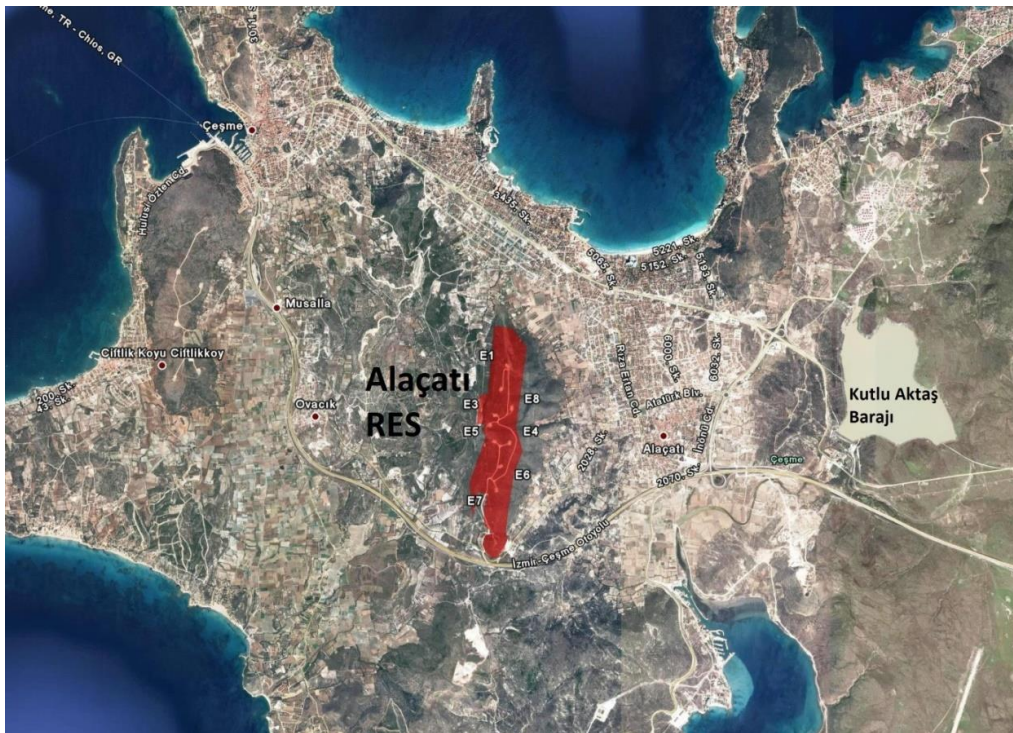
1- Alaçatı WEI

This WEI is located 2,2 km away from the from the North. There are 8 turbines in this installement. The closest distance between two turbines is 236 m. Main habitat type is maquis. The nearest protected area, Alaçatı Halici, is a wetland which is 2,2 km away from this installement. According to mid-winter waterfowl counts in this wetland there are 84 birds from 8 species. From these, only ruddy shelduck and yellow-legged gull was observed around WEI area.

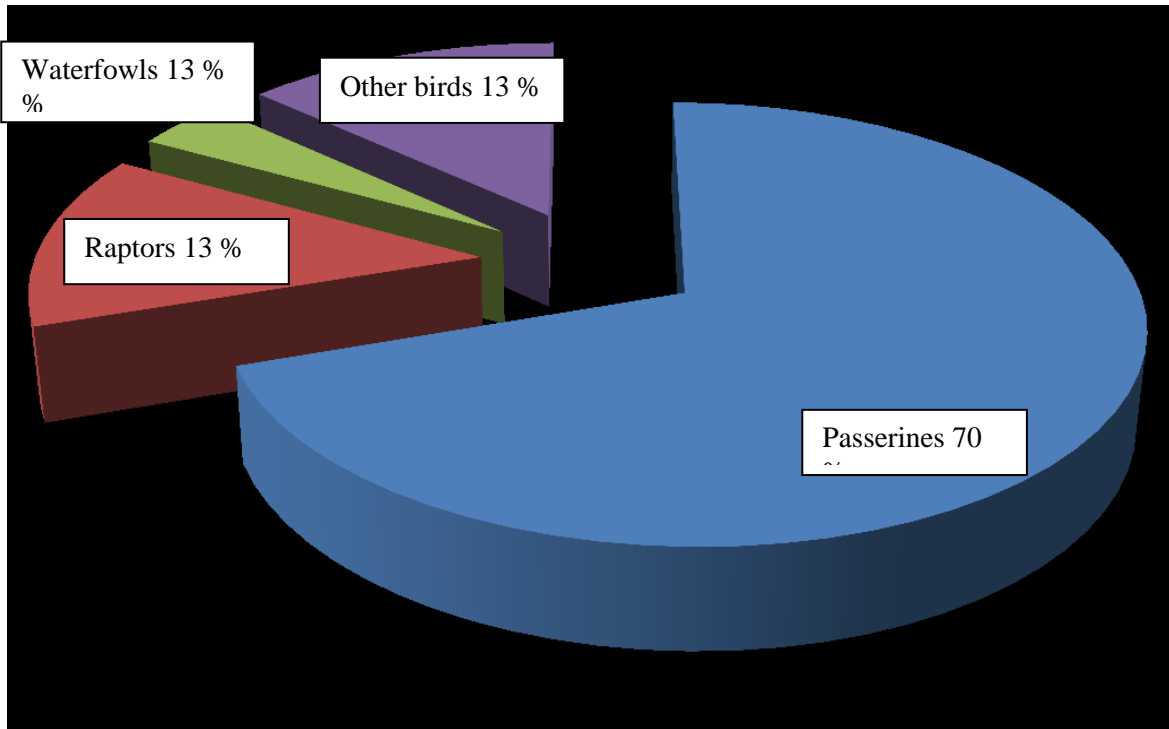
During the spring migration, 53 birds species in 23 families were recorded. Of these, 37 species are passerines, 2 are waterfowls, 7 are raptors and 7 belong to other groups. The figure above shows the distribution of bird species in a diagram. 27 species are resident, 13 are summer migrants, 10 are winter migrants and 3 are transit migrants.
