Preliminary Technical Assessment

Revitalization of the Decebal area Between the Stefan cel Mare and Maria Cebotari Streets

Soroca

November 2016

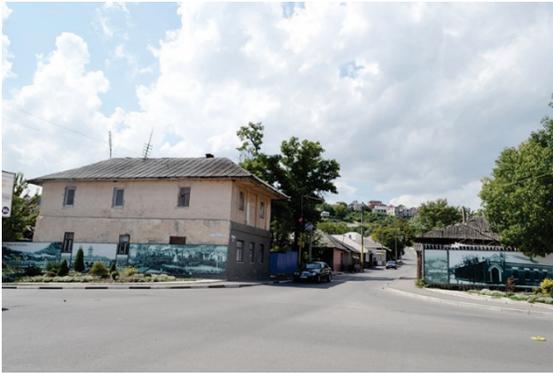
The intersection of the Decebal and Ștefan cel Mare, the building of the former Inn is in the foreground

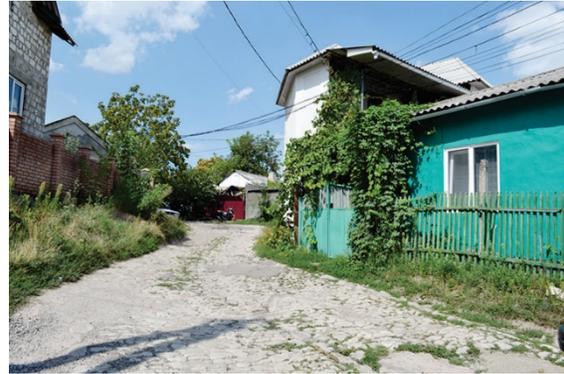
View of the Chișinăului street with a traditional Moldovan house and cobblestone paving

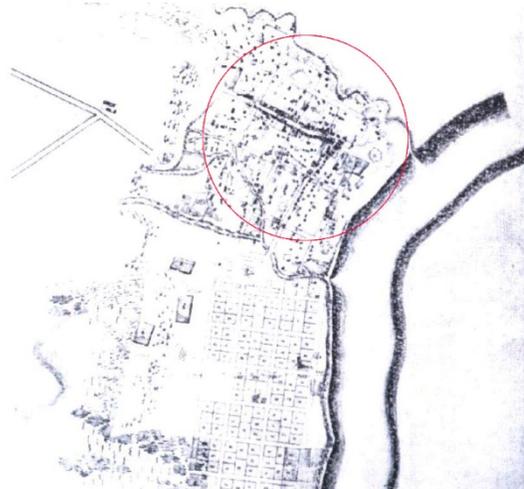
Development plan dating from 1846. The Old Road is visible and is the most densely built. In the southern part on the city the regular street grid is foreseen.

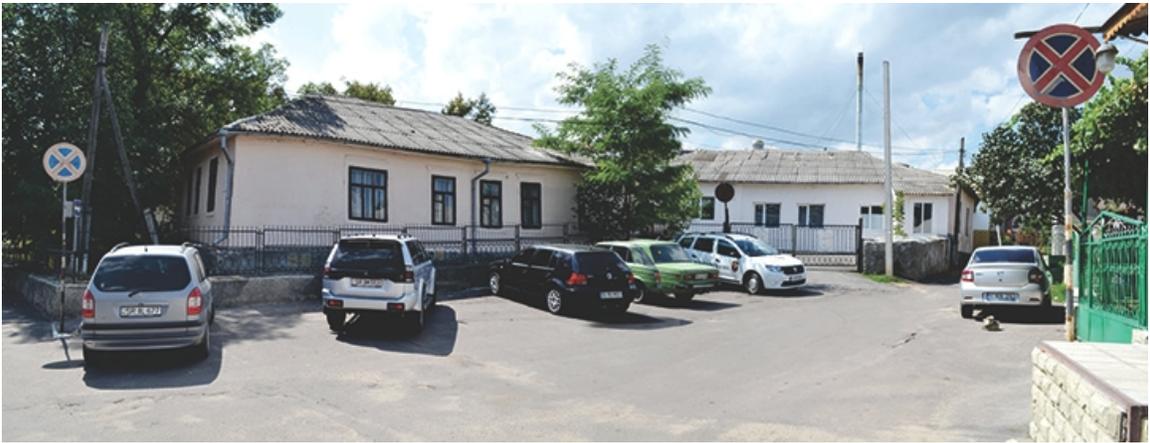
An example of inappropriate use of public space: the square near the College of Arts is used as a car park

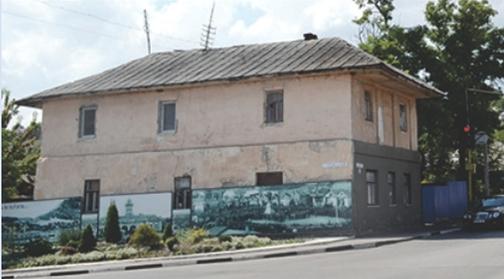
5 Decebal st. (The former Inn)	Current condition	Necessary interventions / repair	Estimated costs, thousands MDL
--------------------------------	-------------------	----------------------------------	--------------------------------

* - priority ** - non-priority	
Public utilities	Sewerage	Yes	No	
	Drinking water	Yes	No	
	Gas	Yes	No	
	Electrification	Yes	No	
Physical condition	Foundations	Good	No	
	Walls, structure	Satisfactory	*Consolidation	500
	Floors	Good	No	
	Ceilings, Slabs	Very bad	*Repair	400
	Doors, windows	Very bad	*Restoration	150
	Plasters, decor	Satisfactory	*Repair	600
	Balconies, verandas	Satisfactory	**Restoration	250
	Courtyards, gardens, fences	Satisfactory	**Repair	200
Roofs	Very bad	*Replacement	800	
Total costs				MDL 2900 = €131,818

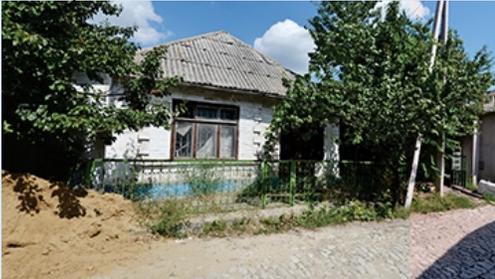
2 Chișinăului st.

Current condition	Necessary interventions / repair * - priority ** - non-priority	Estimated costs, thousands MDL
Public utilities	Sewerage	Yes	No	
	Drinking water	Yes	No	
	Gas	?	?	
	Electrification	Yes	No	
Physical condition	Foundations	Good	No	
	Walls, structure	Satisfactory	*Consolidation	250
	Floors	Good	No	
	Ceilings, Slabs	Satisfactory	*Repair	100
	Doors, windows	Very bad	*Restoration	70
	Plasters, decor	Good	No	
	Balconies, verandas	Good	No	
	Courtyards, gardens, fences	Satisfactory	**Repair	50
Roofs	Satisfactory	**Repair	50

Total costs	MDL 520 = €23,600
--------------------	--------------------------

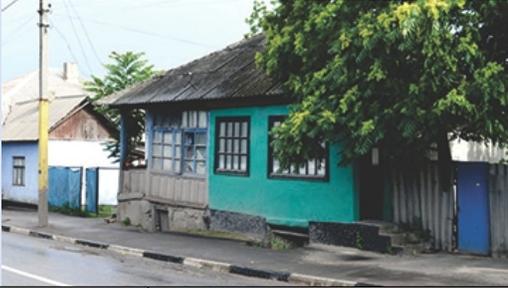
15 Decebal st.		Current condition	Necessary interventions / repair *- priority ** - non-priority	Estimated costs, thousands MDL

Public utilities	Sewerage	Yes	No	
	Drinking water	Yes	No	
	Gas	?	?	
	Electrification	Yes	No	
Physical condition	Foundations	Satisfactory	*Consolidation	150
	Walls, structure	Satisfactory	*Consolidation	150
	Floors	Satisfactory	*Repair	80
	Ceilings, Slabs	Satisfactory	*Repair	80
	Doors, windows	Satisfactory	*Repair	60
	Plasters, decor	Satisfactory	**Repair	70
	Balconies, verandas	Very bad	*Reconstitution	100
	Courtyards, gardens, fences	Satisfactory	**Repair	40
Roofs	Very bad	*Replacement	100	
Total costs				MDL 830 = €37,727
