**Habitat destruction in Mersin Anamur Beach (Türkiye)**

**-COMPLAINANT REPORT-**

#### **LOGGERHEAD SEA TURTLE (*CARETTA CARETTA*), GREEN TURTLE (*CHELONIA MYDAS*) & AFRICAN SOFT SHELL TURTLE (*TRIONYX TRIUNGUIS*) CONSERVATION MONITORING IN ANAMUR, MERSIN, TÜRKİYE**

### **DETAILED REPORT OF 2026 FOR ANAMUR SPA, TURKEY**

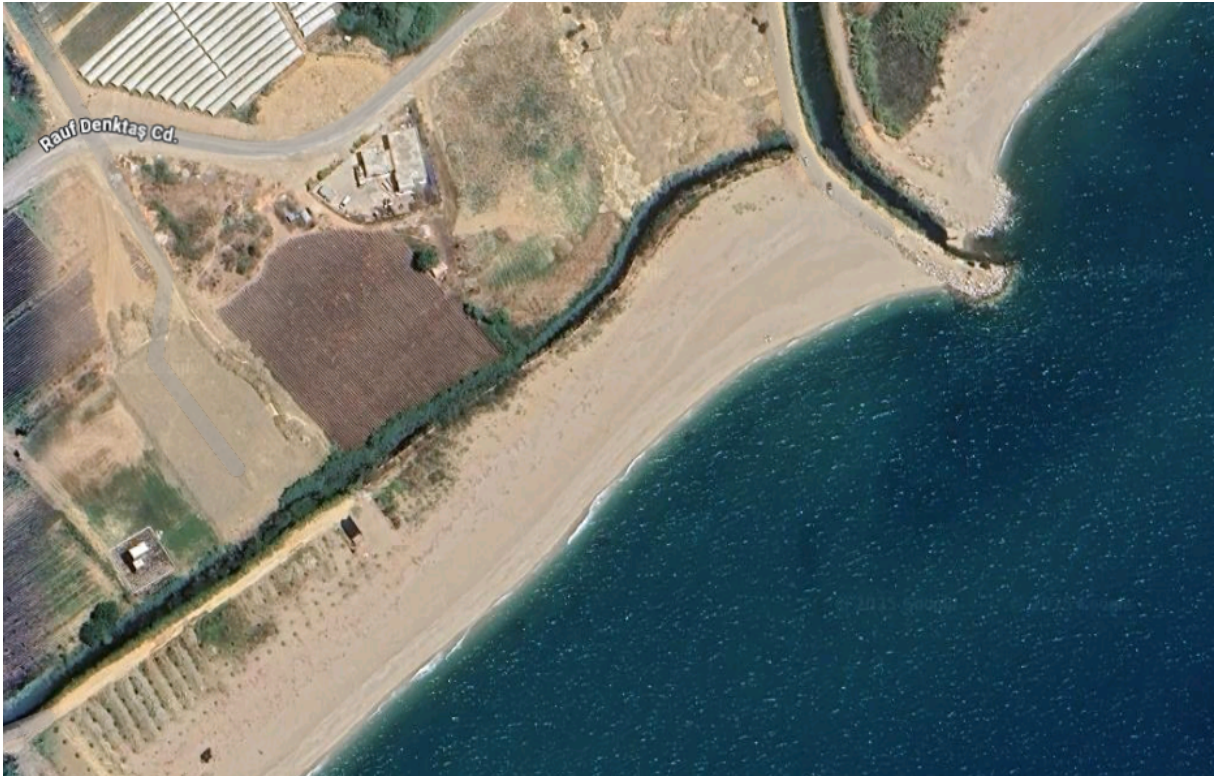
**Figure 1. Status of Karaağaç**

Karaağaç beach in June 2026: On the west part we observe a new plantation and on the east part the beach facilities are removed.

beach—and carried out non-native plant cultivation. (Figure 1 shows the photographs of the area)

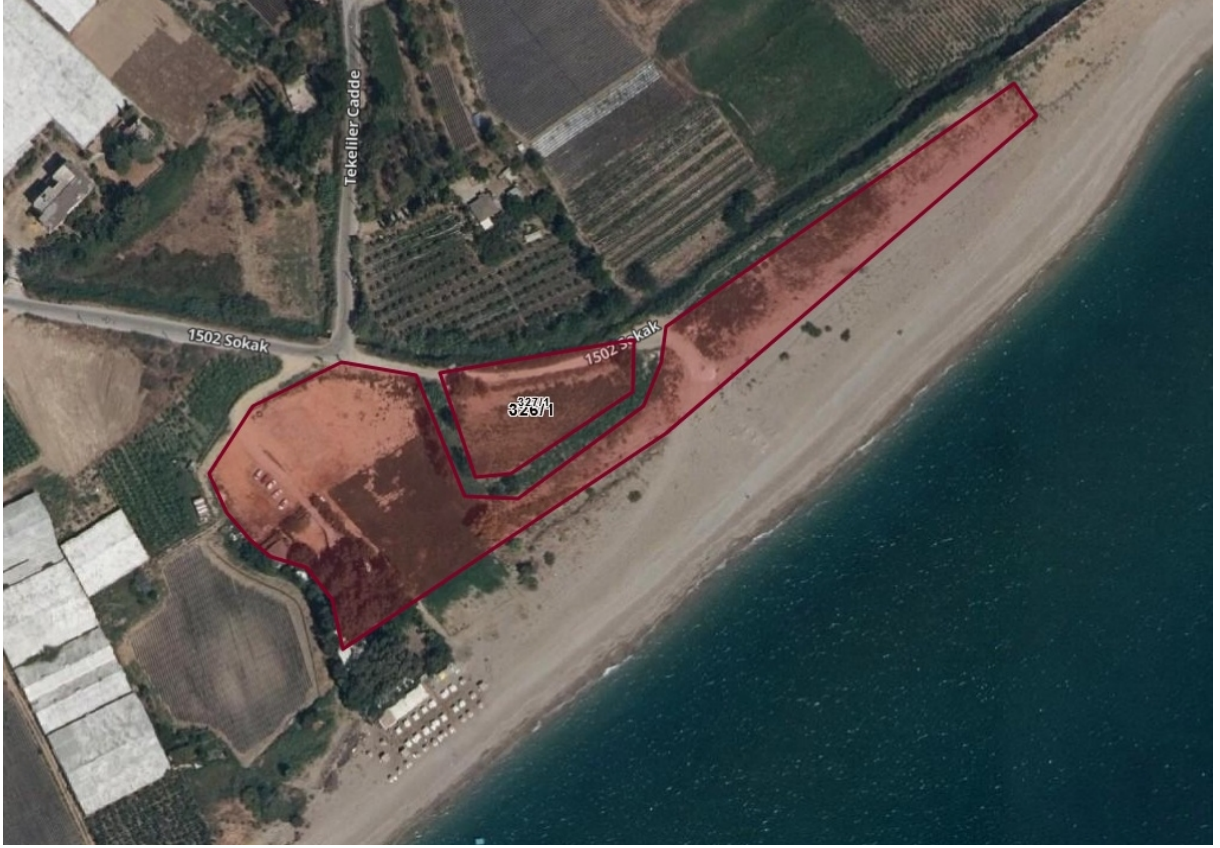
Legal Registered status of the expanded facility: Parcel number: 326/1, Total area: 13,786.00 m<sup>2</sup>, 327/1, Total area: 2,641.05 m<sup>2</sup>Field status: Farm land (July 2026)

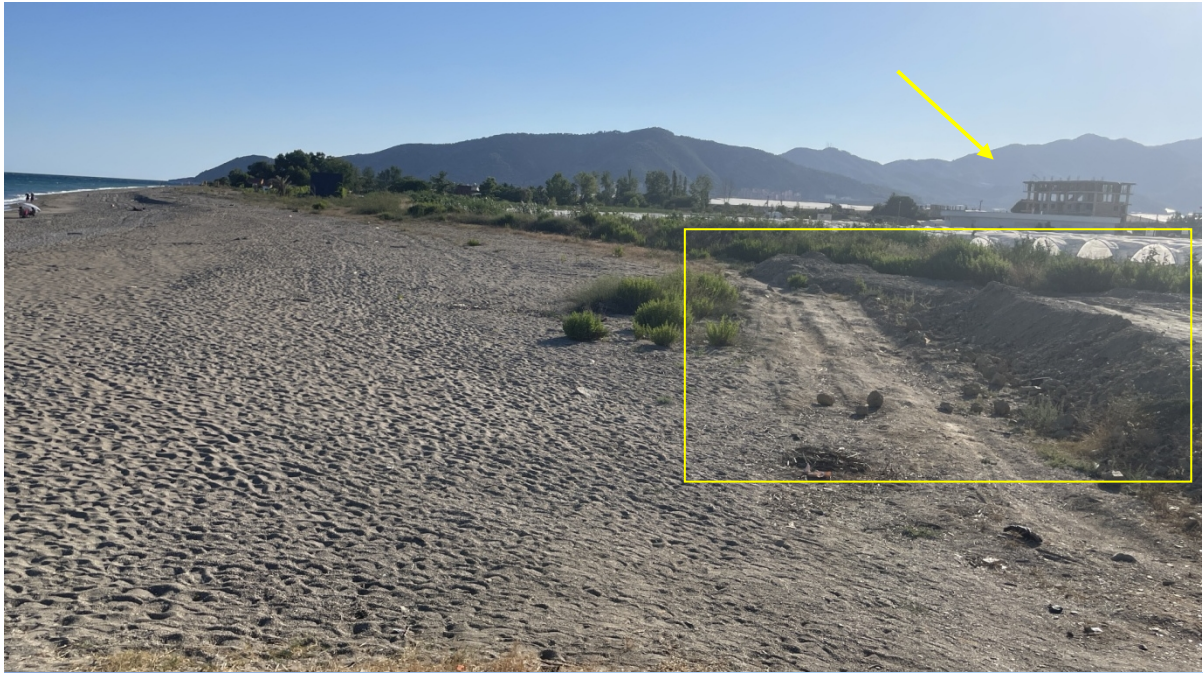
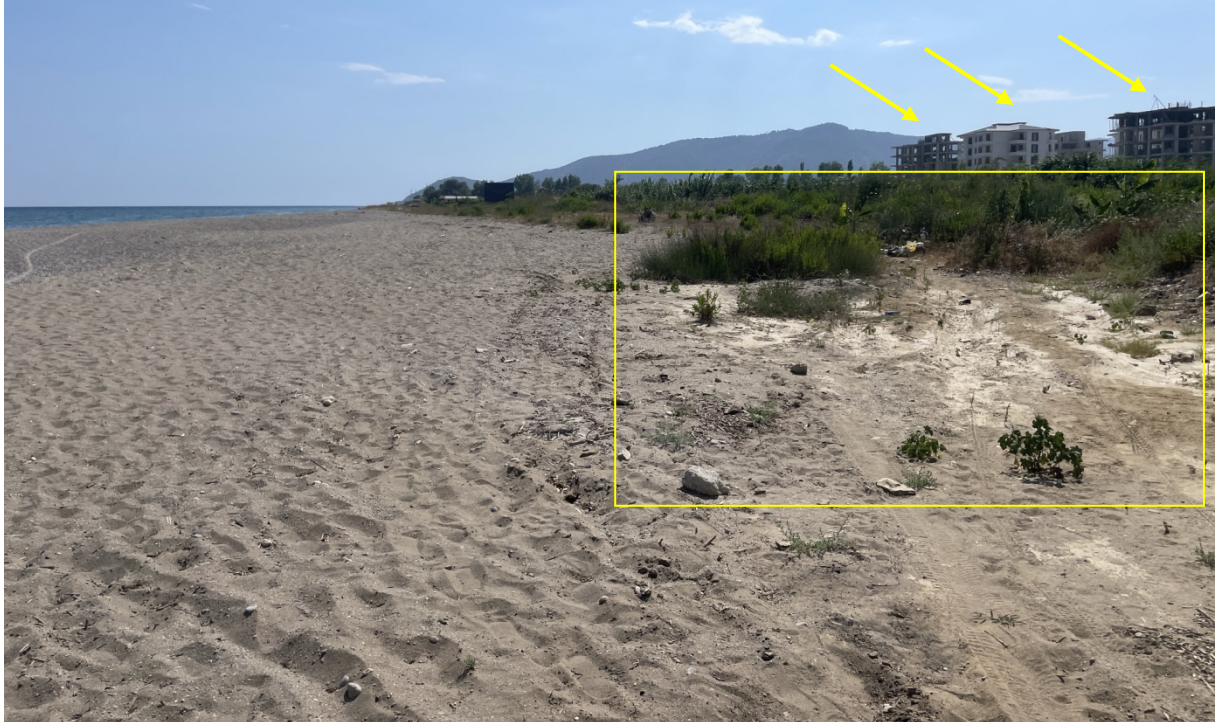
Karaağaç Rehabilitation Area, June 2025: A road embankment was constructed behind the rehabilitated area, and the final state as of June 2026 is indicated (yellow rectangles).

Although recovery has been observed in the rehabilitated dune area, the road filling work carried out behind this section has been halted, and the added fill material has been removed. However, due to the ongoing construction activities behind the beach, it has been observed that alternative access roads have been opened to facilitate transportation. The rising population density resulting from the increasing residential developments in the region leads to a visible increase in visitor pressure on the area. The addition of exterior facade lighting to completed buildings clearly demonstrates, at a concerning level, how severely even unoccupied structures contributes to light pollution.

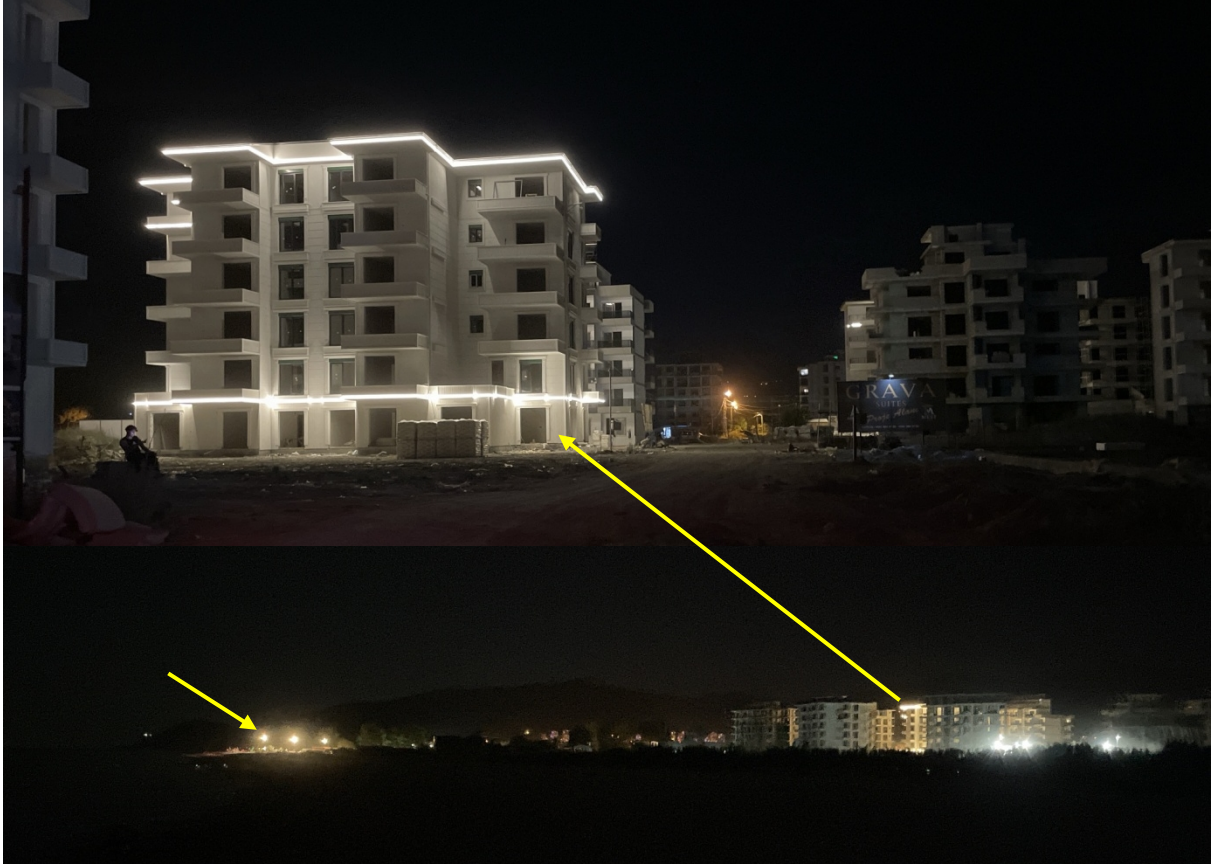
Newly constructed buildings with exterior facade lighting and the illumination sources of the bungalow enterprise visible in the background (yellow arrows).

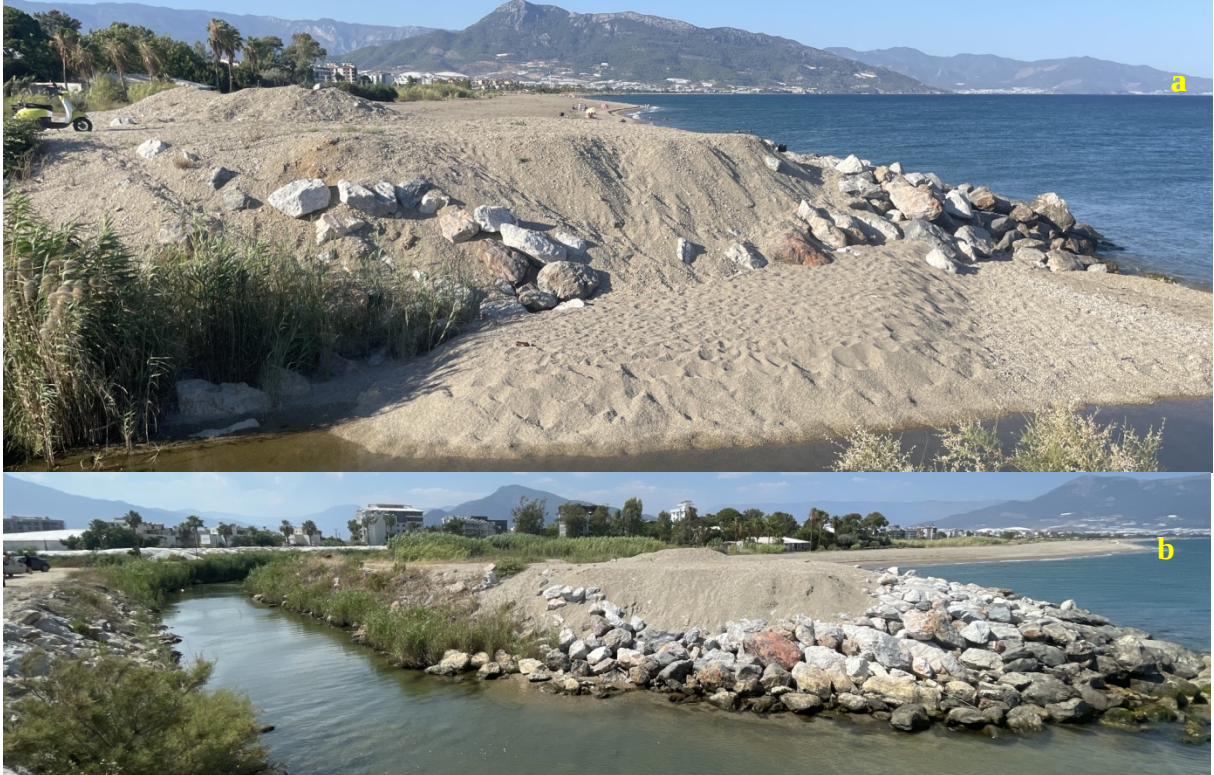
Rock-filling activities carried out in the coastal area where beach formation had begun: July 2025 (a) and June 2026 (b).

Of extreme concern, the natural structure of the rehabilitated river mouth has been compromised by adding extra rocks to the dune formation. Compared to previous years, the dune accumulation in the delta has been completely lost due to these interventions, eliminating any potential for the area to serve as an alternative habitat for the African Softshell Turtle (*Trionyx triunguis*) in the future.

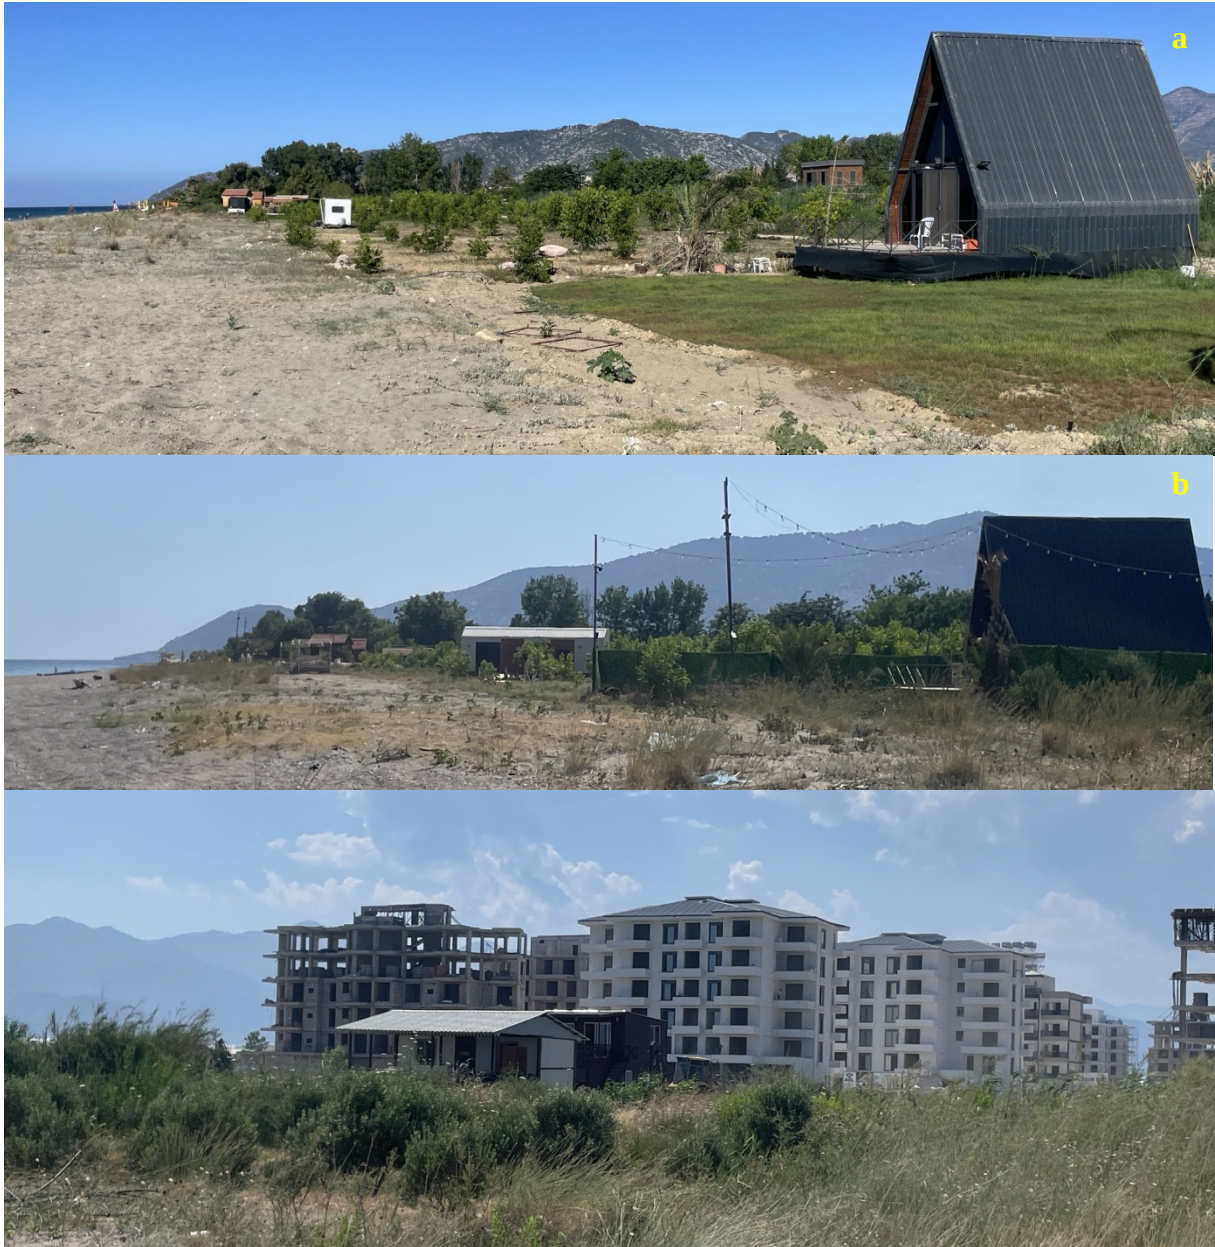
New lighting fixtures added to the bungalow garden and newly deployed tiny houses observed around the facility's perimeter. July 2025 (a) and June 2026 (b)

Another negative development was the observation that in addition to the bungalow that was situated on the Karaağaç beach in previous years, container-type houses and tiny houses have been introduced, and supplementary lighting has been installed in the bungalow's garden (Recommendation Point 3). It was observed that businesses in the region are expanding their facilities. Specifically, it was determined that the bungalow business added external sand—damaging the natural structure of the

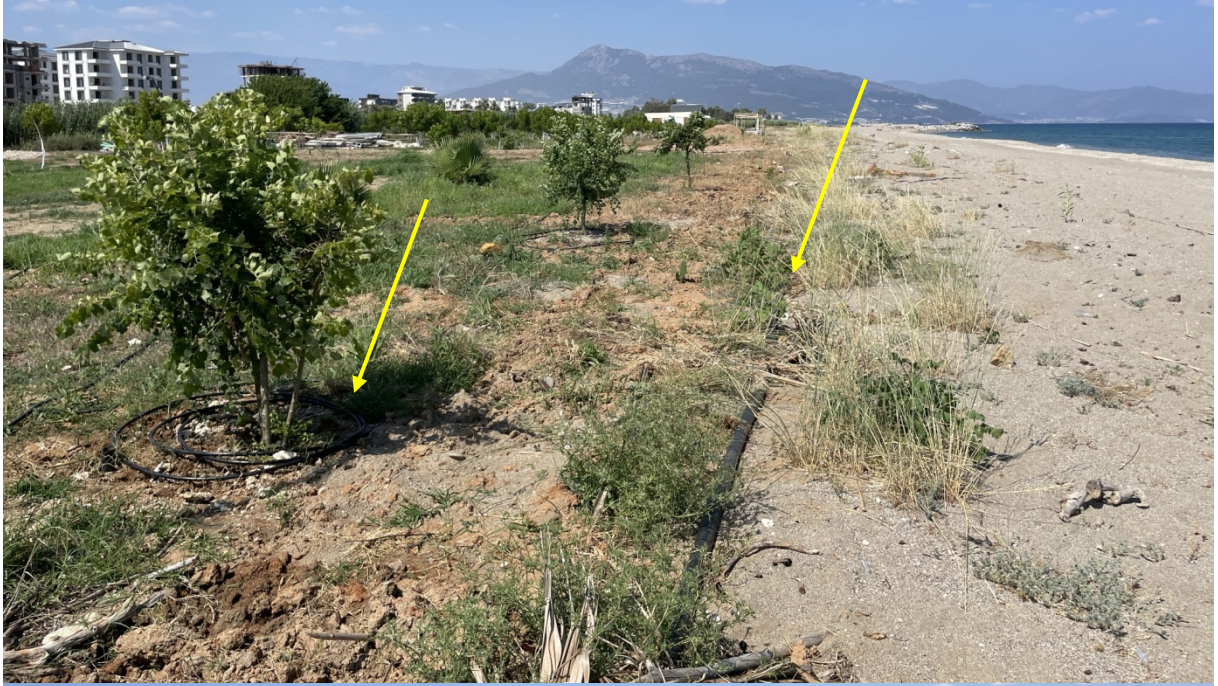
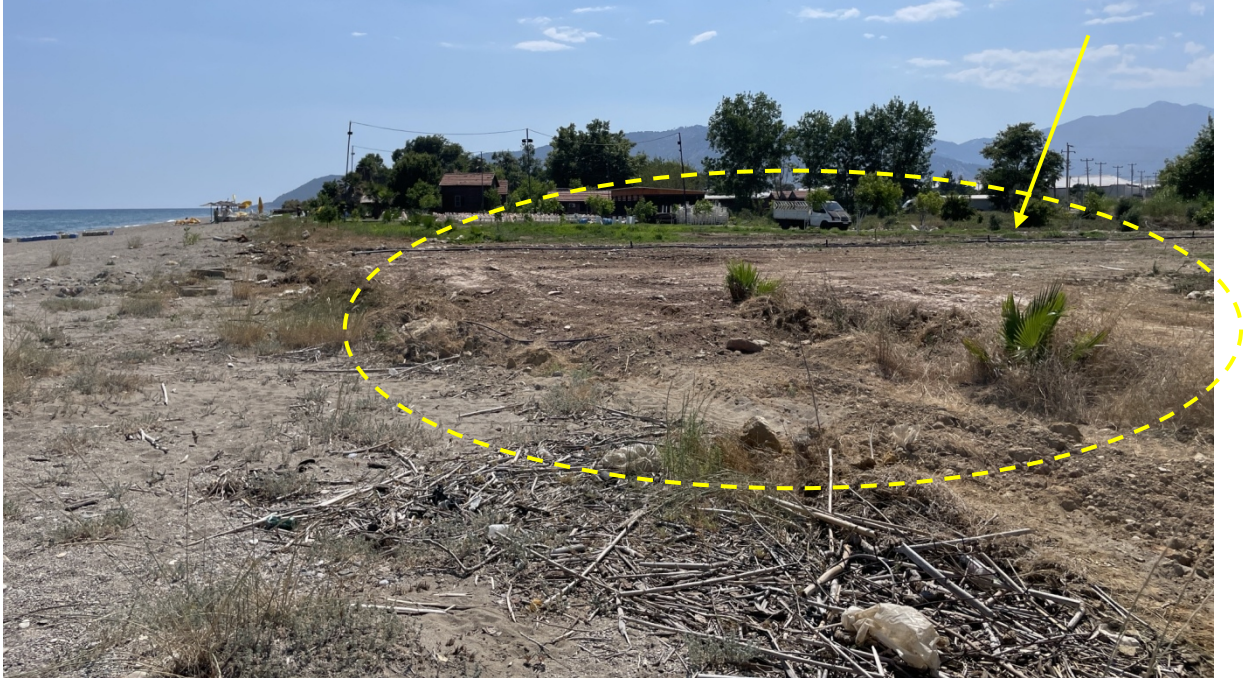
Karaağaç, June 2026: Fertile soil was brought in for saplings, and an irrigation system was installed.

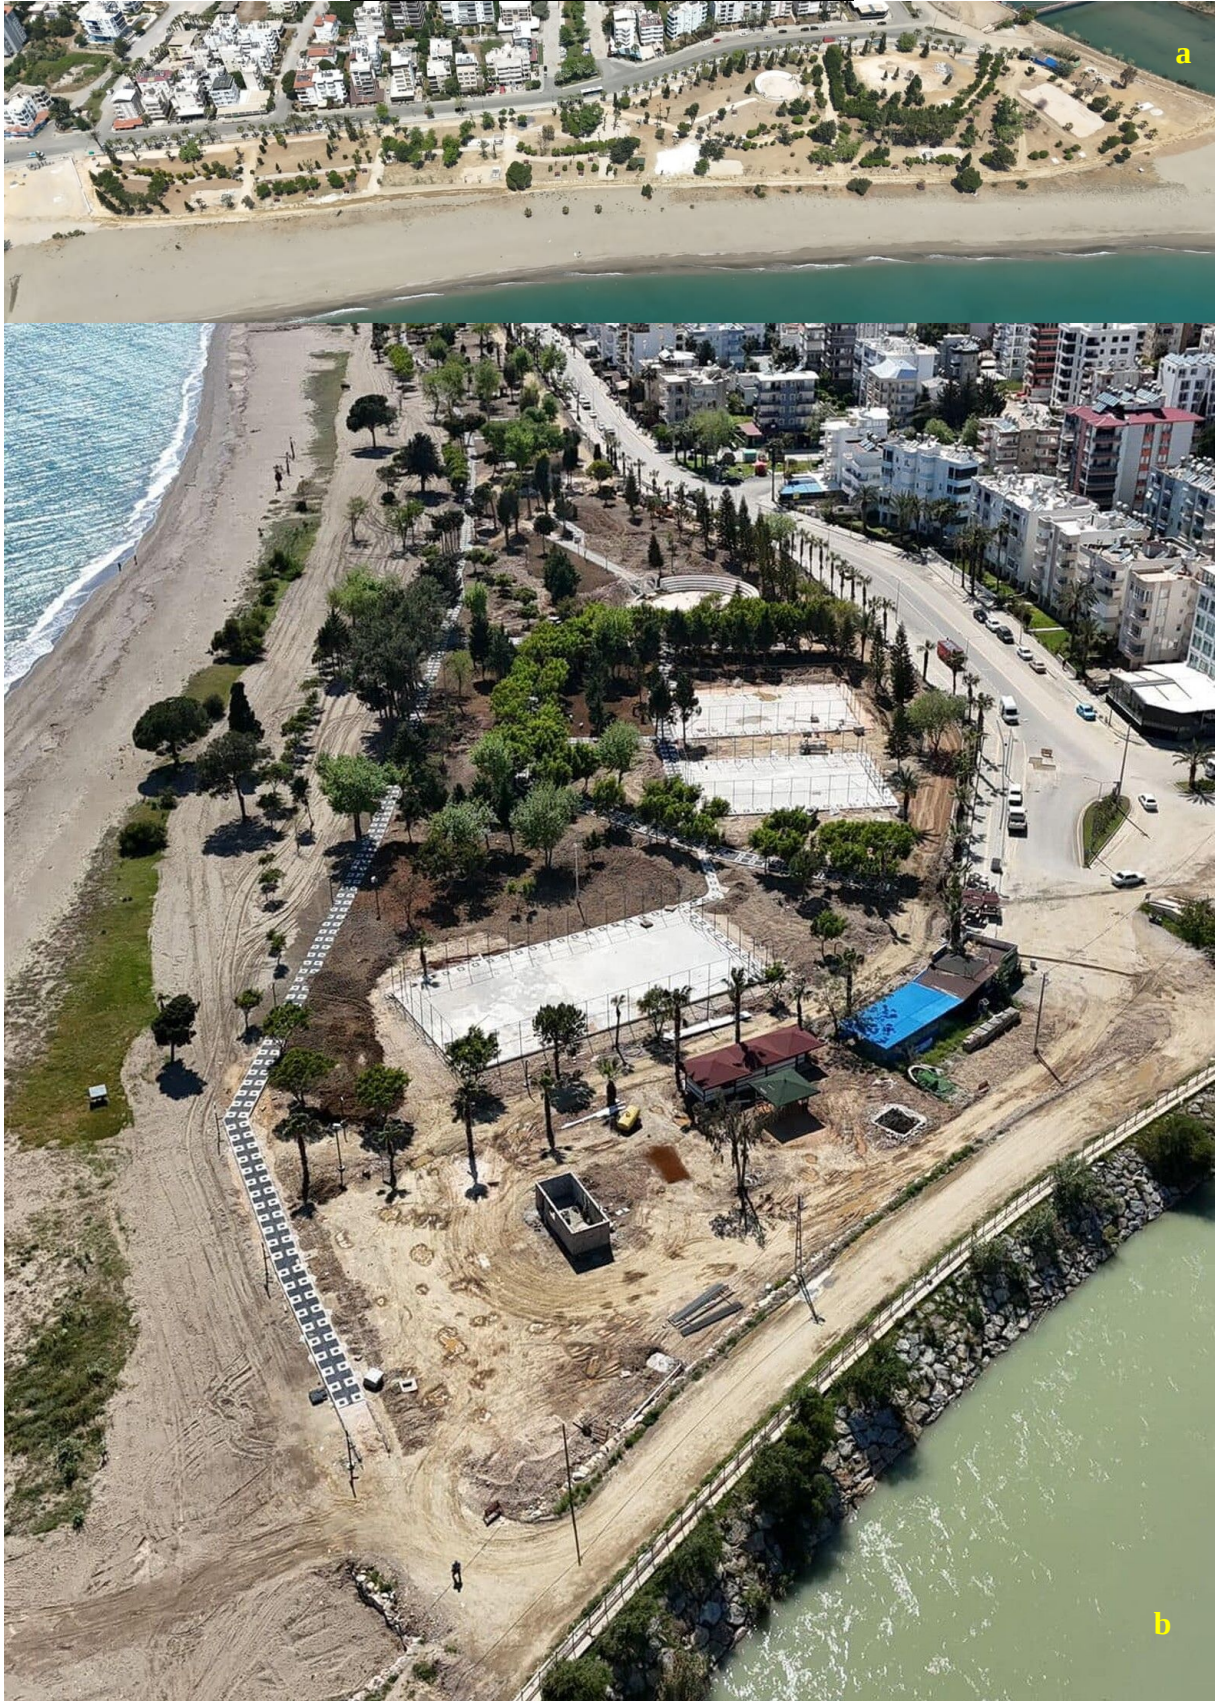
**Figure 2 Beach arrangement Project**

Comparative field images showing the expansion of the Rauf Denktaş Park project toward the beach area: May 2025 (a) and May 2026 (b).

However, the project in question falls within the beach's 1st Degree Conservation Zone (0–65 meters). Specifically, the widening of the walkway on the beach side of the park and the physical properties of the sand used as filling material have adversely affected the natural beach structure. Furthermore, artificial lighting fixtures oriented toward the beach have been installed along the filled walkway. Once the project is fully completed, these artificial light sources are projected to severely impact sea turtle behavior.

With the completion of the Rauf Denktas Park arrangement, it has been observed that the newly generated recreational areas have already increased human-induced usage pressure on the beach. This heightened recreational footprint—combined with factors such as artificial lighting, sunbed and umbrella usage, and littering—is assessed to

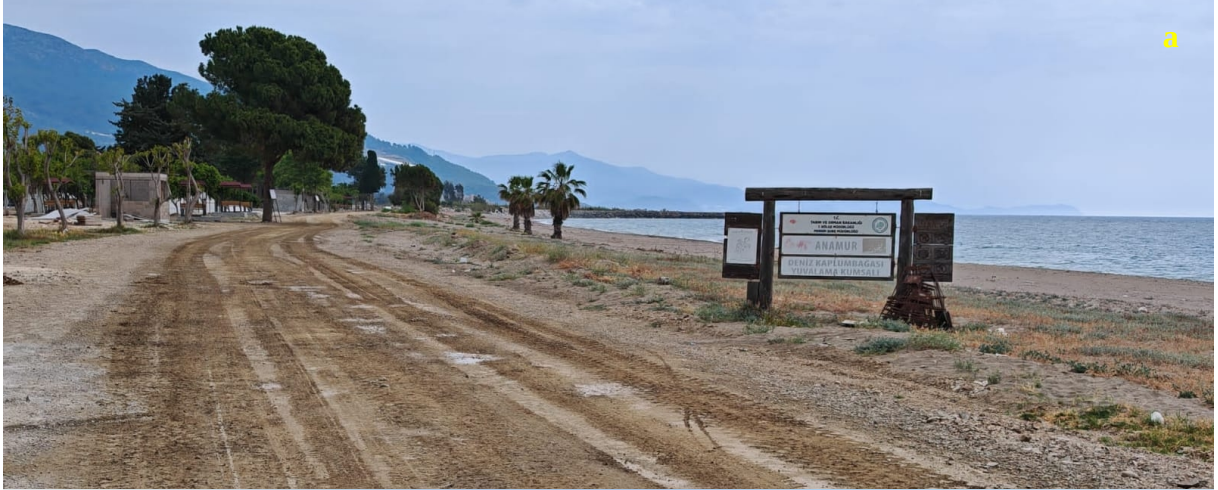
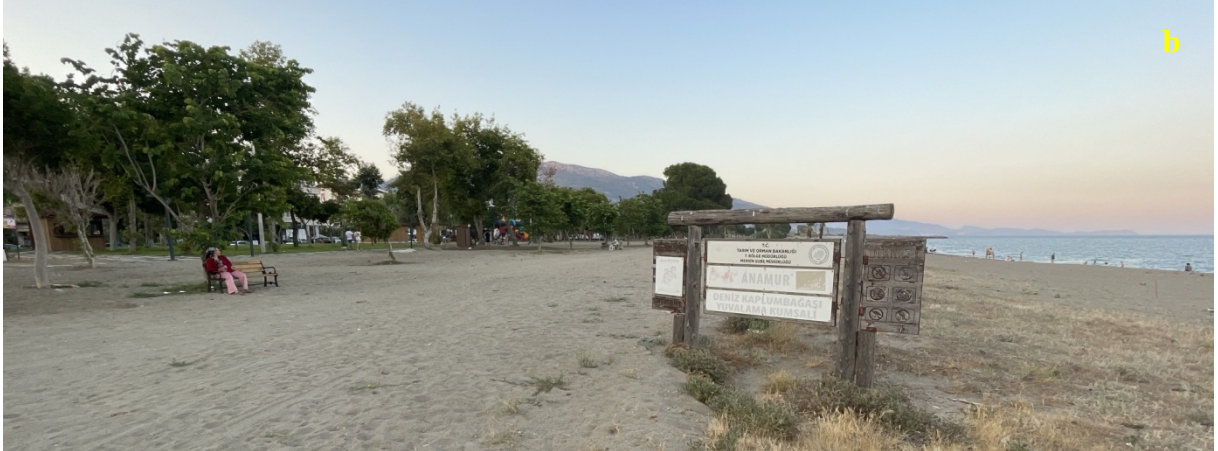
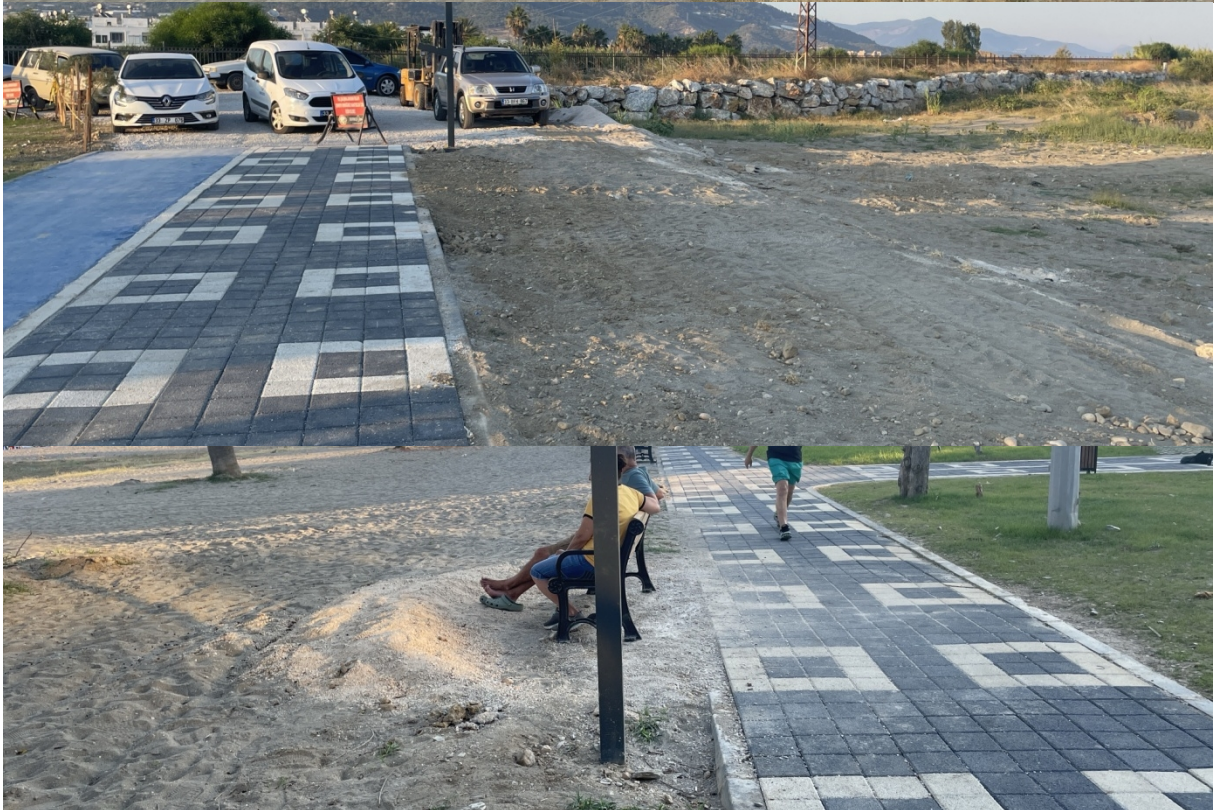
The setback/relocation of the walking path further inland at Rauf Denktaş Park: May 2025 (a) and June 2026 (b).

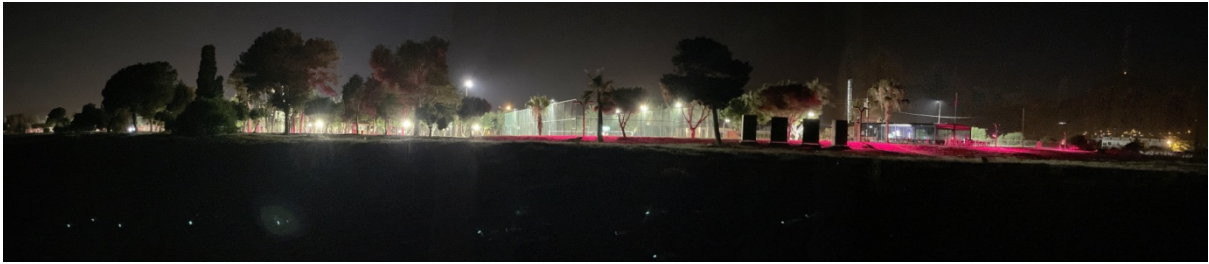
Artificial light sources from Dragon Park casting glare onto the beach area and their potential light pollution impact on the nesting grounds.

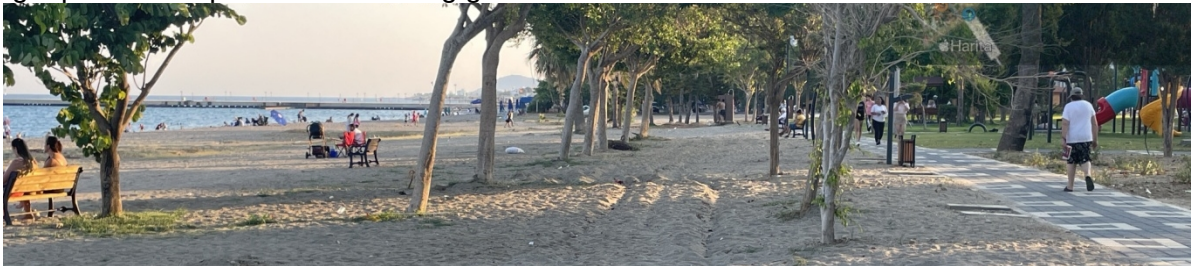
Increased human-induced usage pressure and recreational impact on the beach area following the official opening of the park.

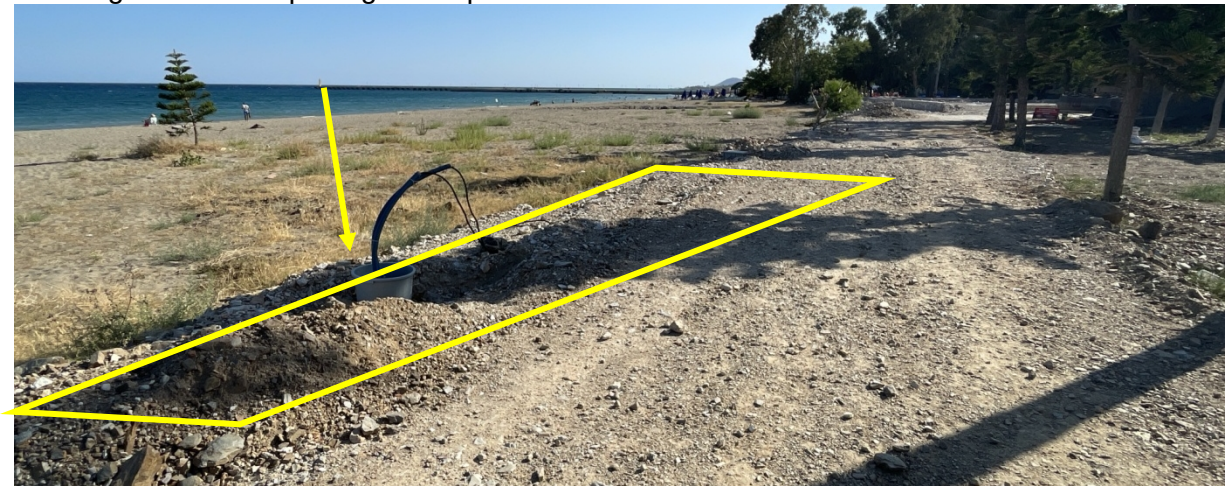
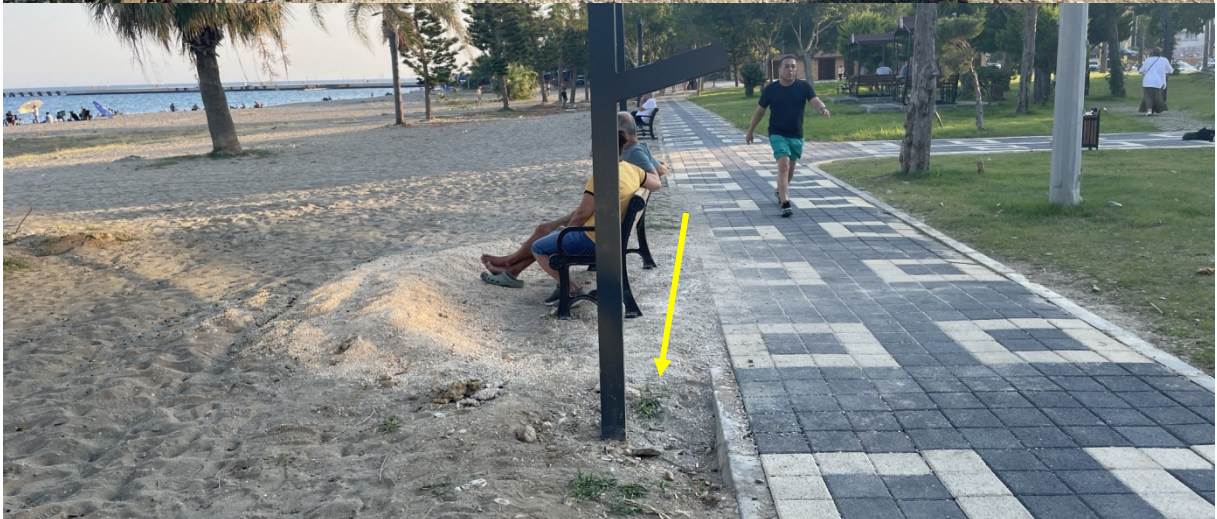
Electrical wiring installed in July 2025 to illuminate the park's walking path, and the subsequent park lighting fixtures installed in June 2026 (area marked in yellow).

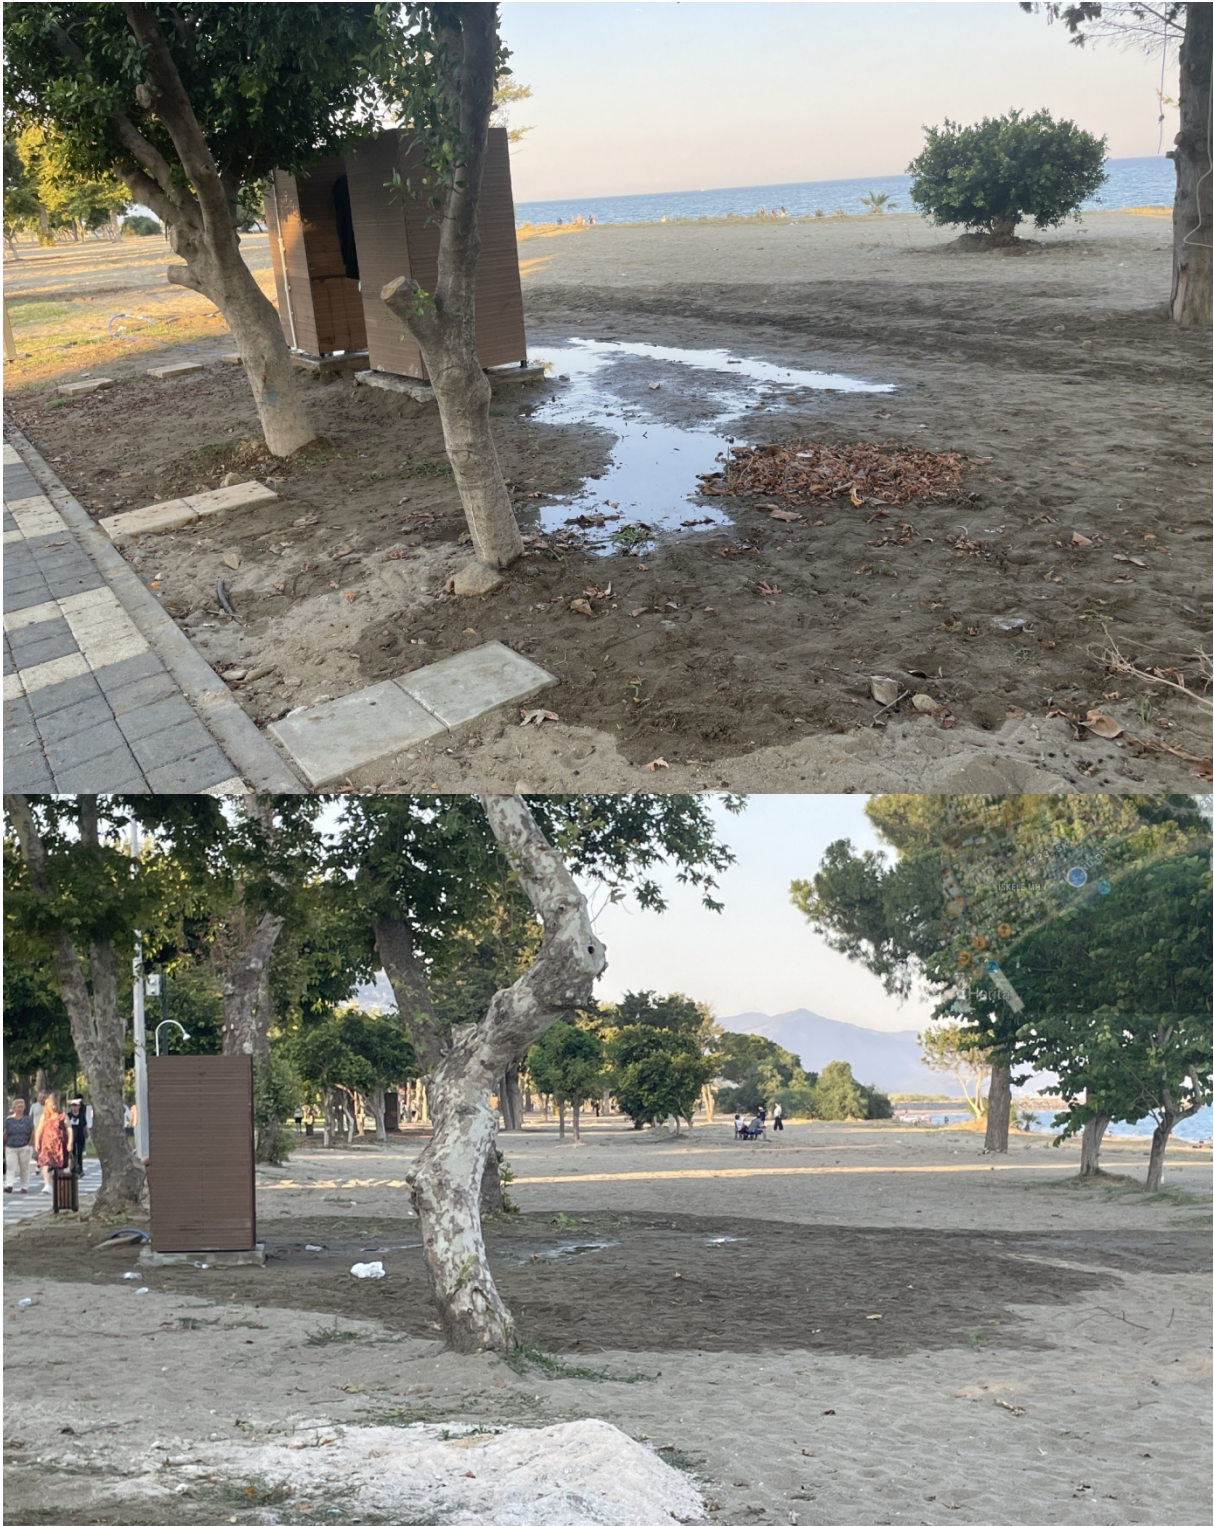
Newly installed shower cabins and the direct discharge of their wastewater onto the beach, which is projected to cause alterations in coastal vegetation and sand compaction (hardening) in the future.

15. Fix the showers in Beach Arrangement Project (Devlet Bahçeli Park) to prevent water flows to the beach,
16. Remove the concrete floor in front of the Teacher's Guest House that narrows beach and causes nests to be submerged,

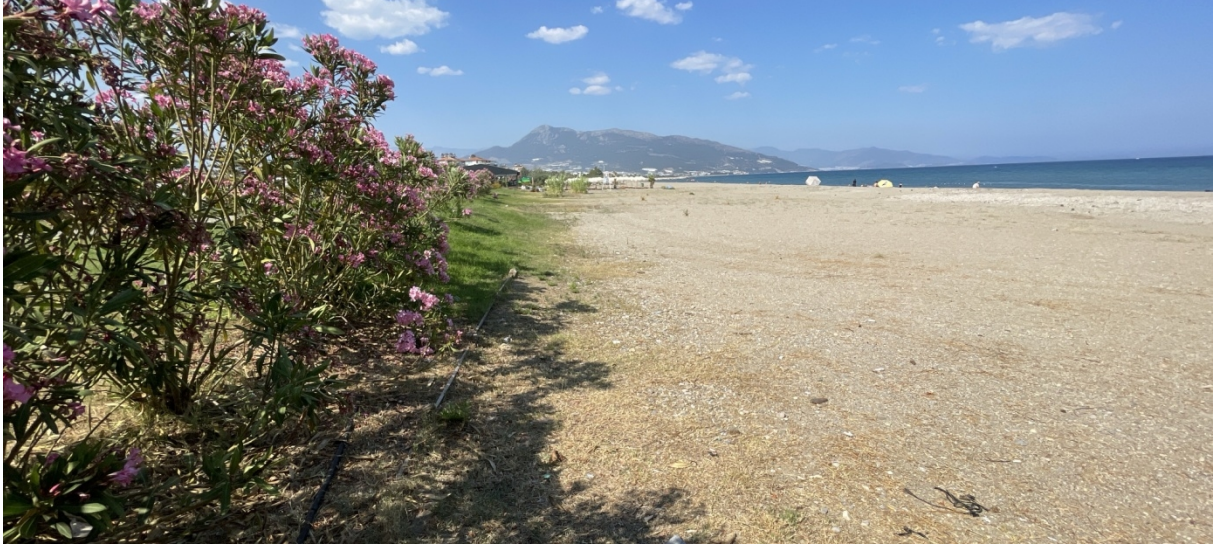
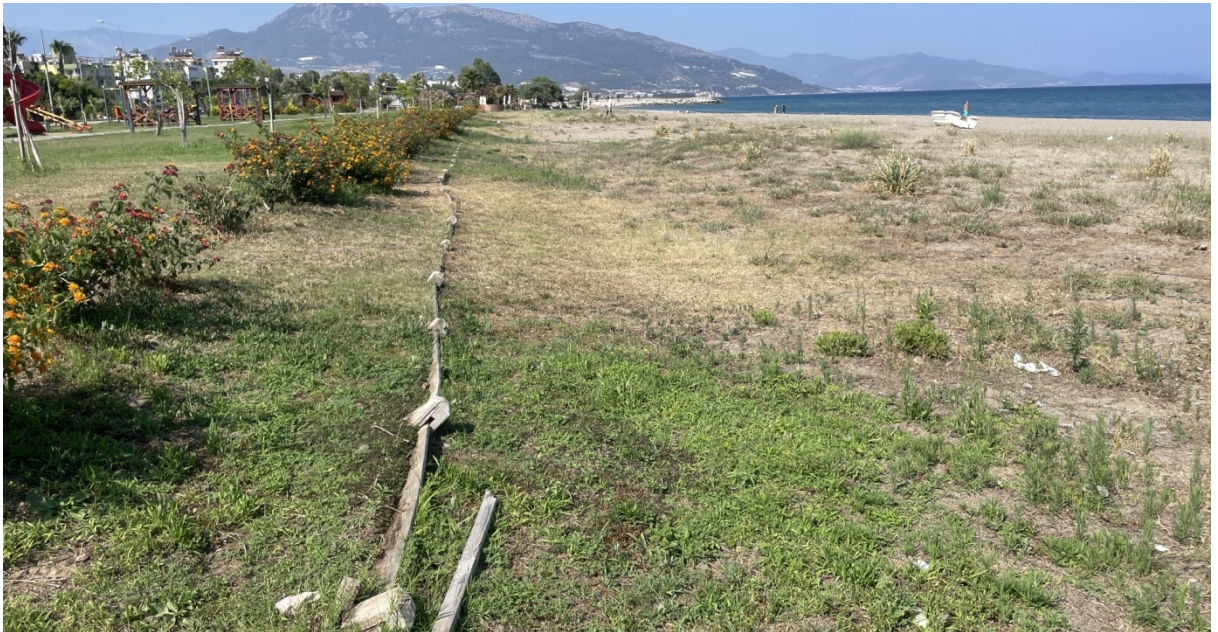
**Figure 3. Sand extraction**

Degradation and adverse impacts caused to the dune structure by the activities of businesses operating in the Karaağaç region, alongside the physical interventions within Devlet Bahçeli and Rauf Denktaş parks in the beach areas.

Generally, no direct sand extraction was detected during the observations along the beaches. However, it was determined that the activities conducted by businesses within Devlet Bahçeli and Rauf Denktaş parks, as well as in Karaağaç, have damaged the dune structure. Particularly, rainwater drainage lines cause degradation and erosion on the beach. Additionally, restoration and rehabilitation works carried out on riverbeds and deltas render modifications to the beach structure inevitable. (Figure 3. Sand extraction)

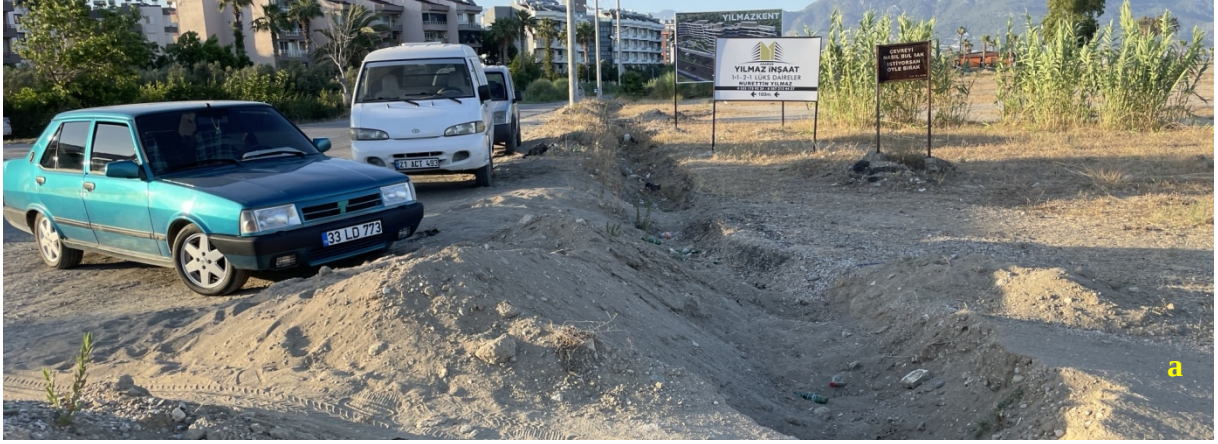
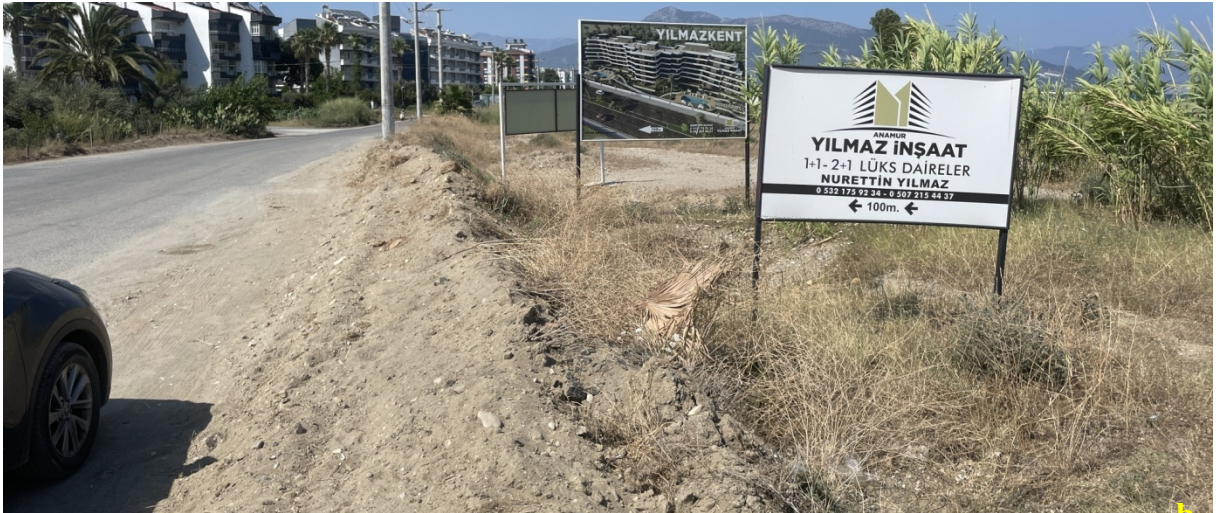
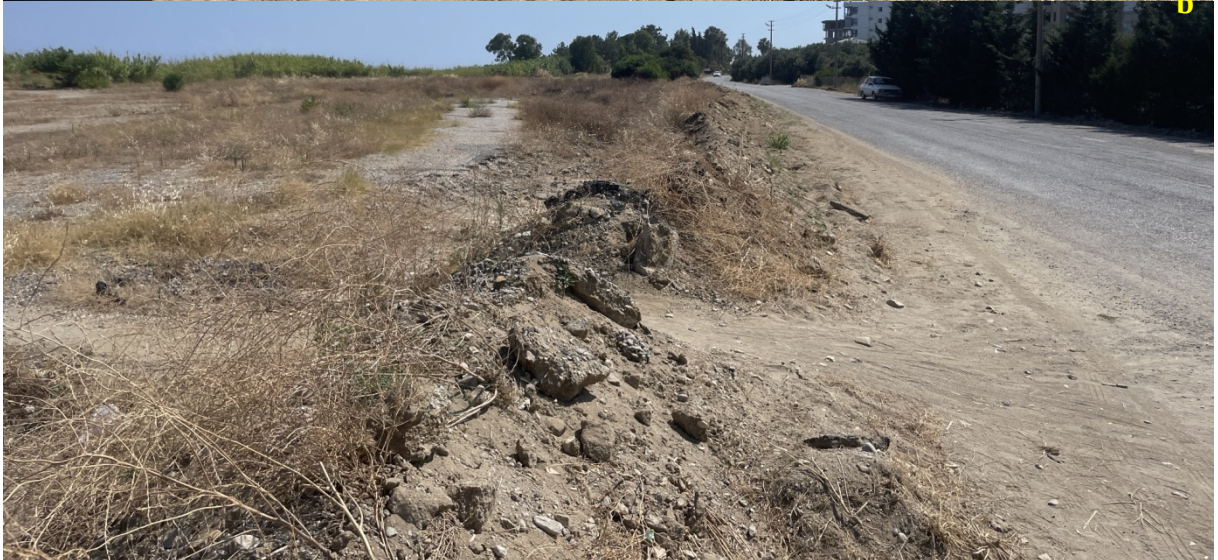
**Figure 4. Illegal vehicle entrance**

Deep trenches dug at Cerenler Beach to block vehicle access remained intact in 2025 (a) and 2026 (b);

During on-site field observations, direct vehicle entry onto the beach was not detected, except in a few localized areas (Recommendation Point 1). However, motor vehicle tracks were encountered on the beach surface. Particularly on Cerenler Beach, although vehicle access from the highway has been restricted by digging deep trenches, the passage of light vehicles such as motorcycles cannot be completely prevented. It has been observed that these illegal vehicle entries onto the beach are not subject to any punitive sanctions or enforcement. (Figure 4. Illegal vehicle entrance)
