**Habitat destruction in Mersin Anamur Beach (Türkiye)**

**-COMPLAINANT REPORT-**

#### **LOGGERHEAD SEA TURTLE (*CARETTA CARETTA*), GREEN TURTLE (*CHELONIA MYDAS*) & AFRICAN SOFT SHELL TURTLE (*TRIONYX TRIUNGUIS*) CONSERVATION MONITORING IN ANAMUR, MERSIN, TÜRKİYE**

### **DETAILED REPORT OF 2026 FOR ANAMUR SPA, TURKEY**

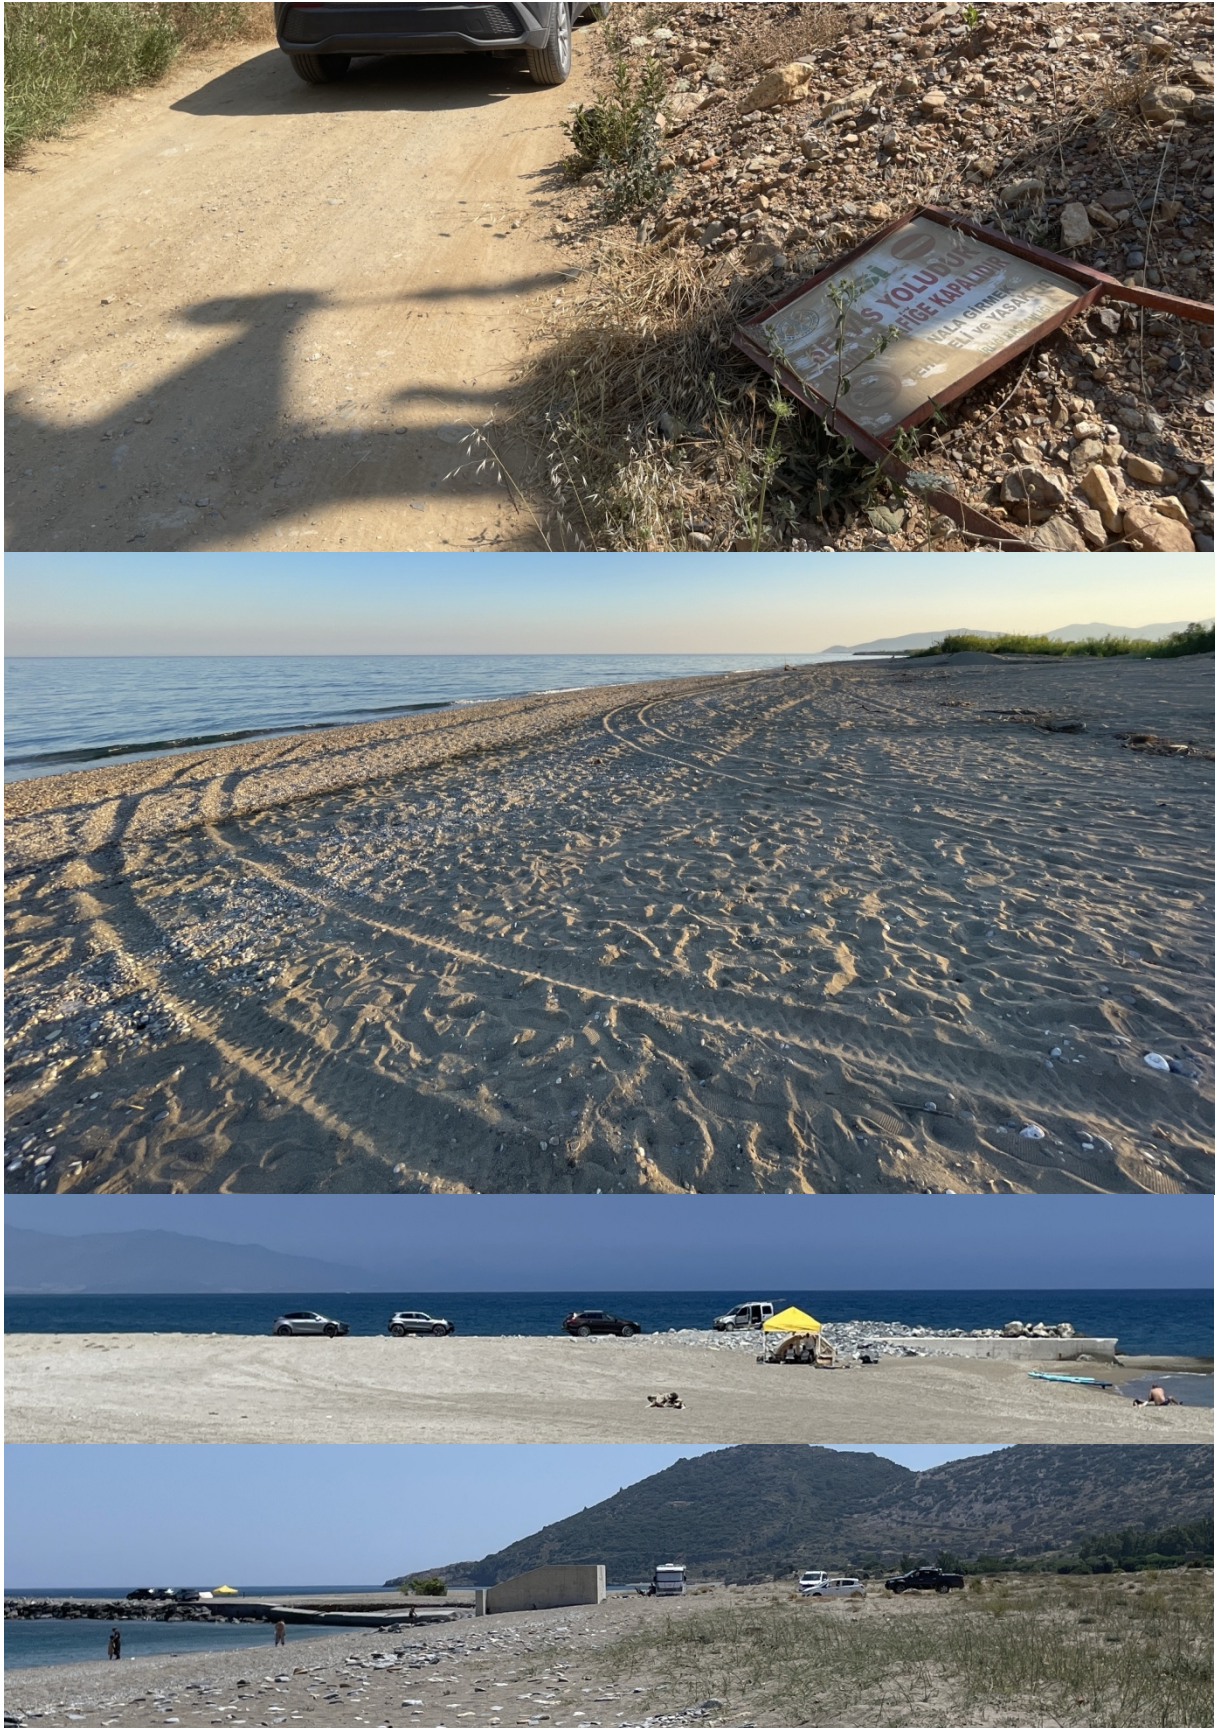
however, despite these preventative measures, motor vehicle tracks were still detected on the beach. Furthermore, uncontrolled vehicle entry was observed to persist on the western wing of the beach.

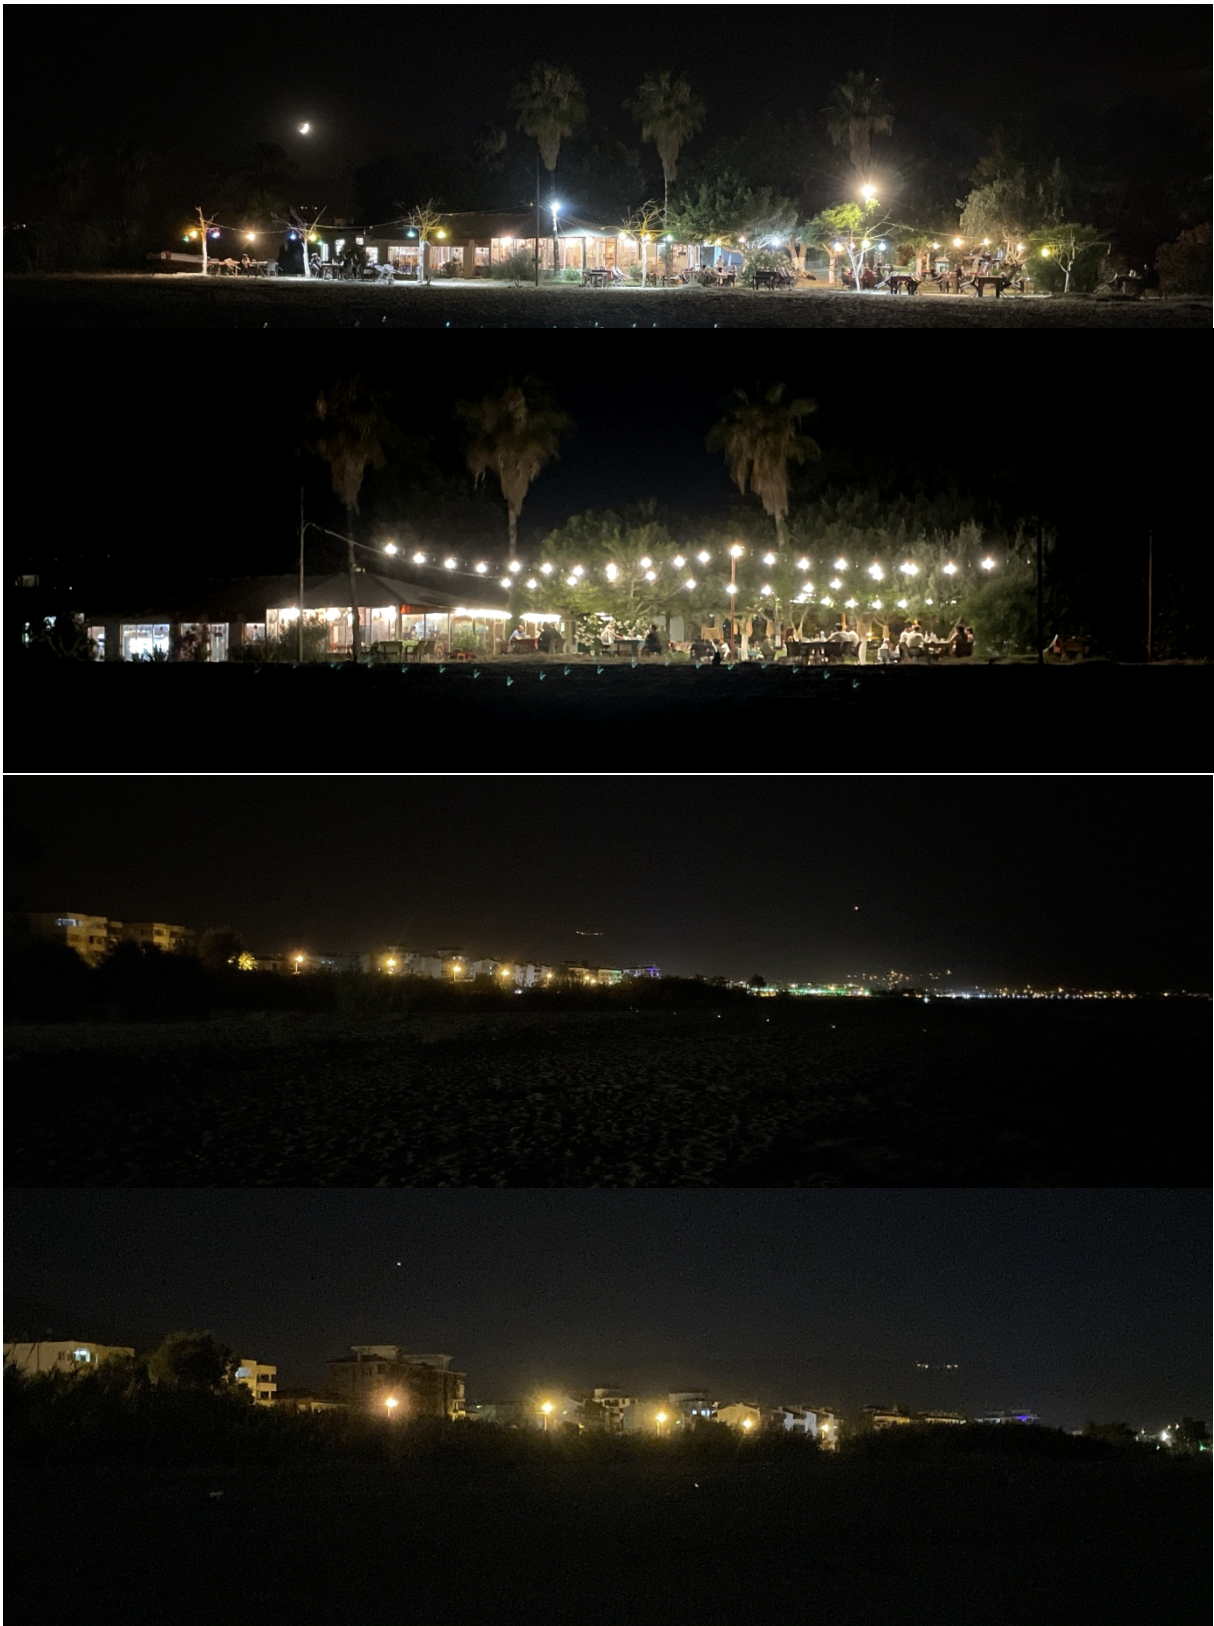
**Figure 5. Light pollution**

To more clearly visualize the change over the course of a year, a photo from 2025 is placed on top and a photo from 2026 is placed on the bottom.

The road lighting is the right color, but it's facing the wrong direction. Their status is the same.

Light pollution resulting from newly constructed parks, street lighting, and private businesses operating on the beach has reached critical levels (Recommendation Point 1). It has been determined that no mitigation measures against light pollution have been implemented across a wide spectrum, ranging from streetlamps and parks to restaurants and entertainment venues. While only a single business in Karaağaç was observed to have transitioned to conservation-oriented red-light usage, the high-intensity lighting used for wedding events at the adjacent bungalow business was found to counteract this positive measure. Particularly, the green, white, and blue-toned lights utilized in Devlet Bahçeli Park exert a direct negative impact on the orientation behavior of sea turtles. On the newly commissioned Anamur Pier (active for maritime passenger transport), streetlamps, and the newly installed spotlights of Rauf Denktaş Park, no shielding or directional lighting modifications have been made; instead, some lights were merely turned off. However, evaluations indicate that this partial shutdown is highly insufficient due to the light spill visible from various angles. Although removing spotlights entirely may not be feasible due to security concerns at the military camp and certain other facilities, the light sources in these areas must urgently be replaced with amber-toned spectrums. Furthermore, the exterior facade lighting of numerous newly constructed residential projects must be decommissioned immediately. (Figure 5 Light pollution)

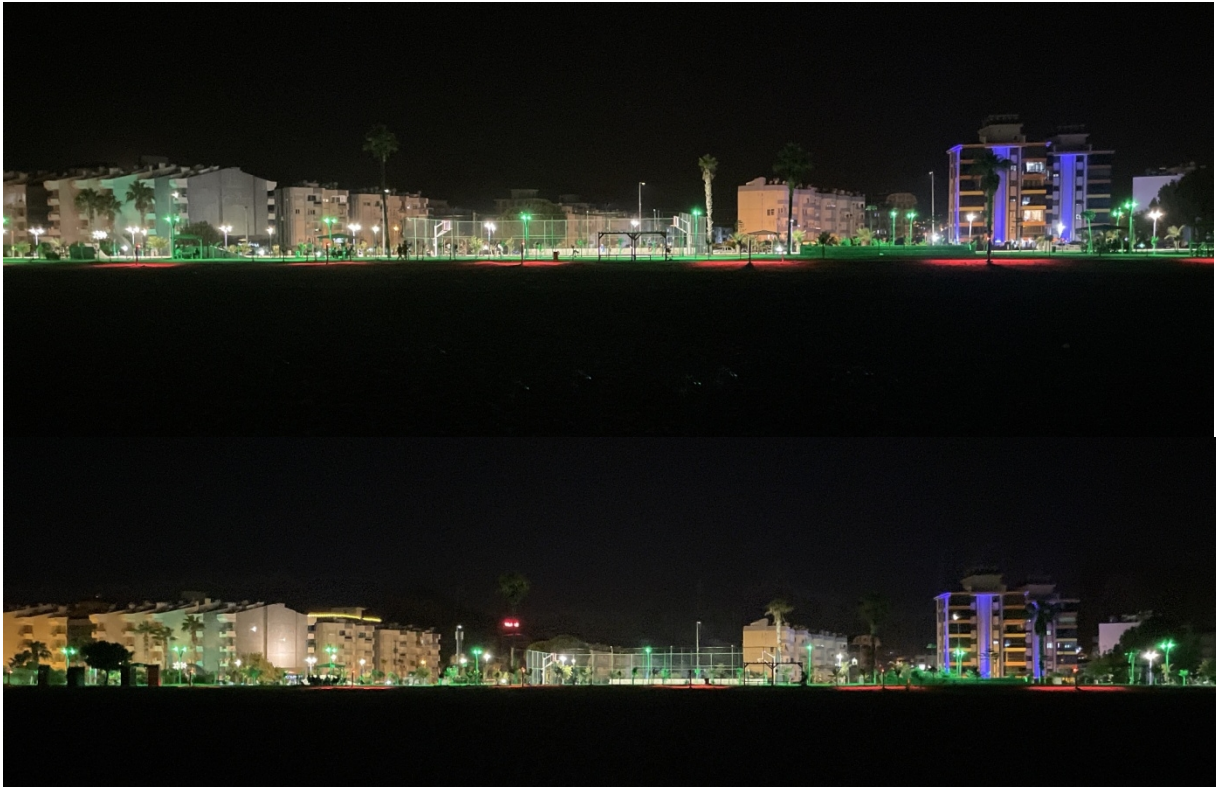
The lighting is part of the beach renovation project. The highlights in the middle were turned off for the basketball court, as were the lights facing the beach.

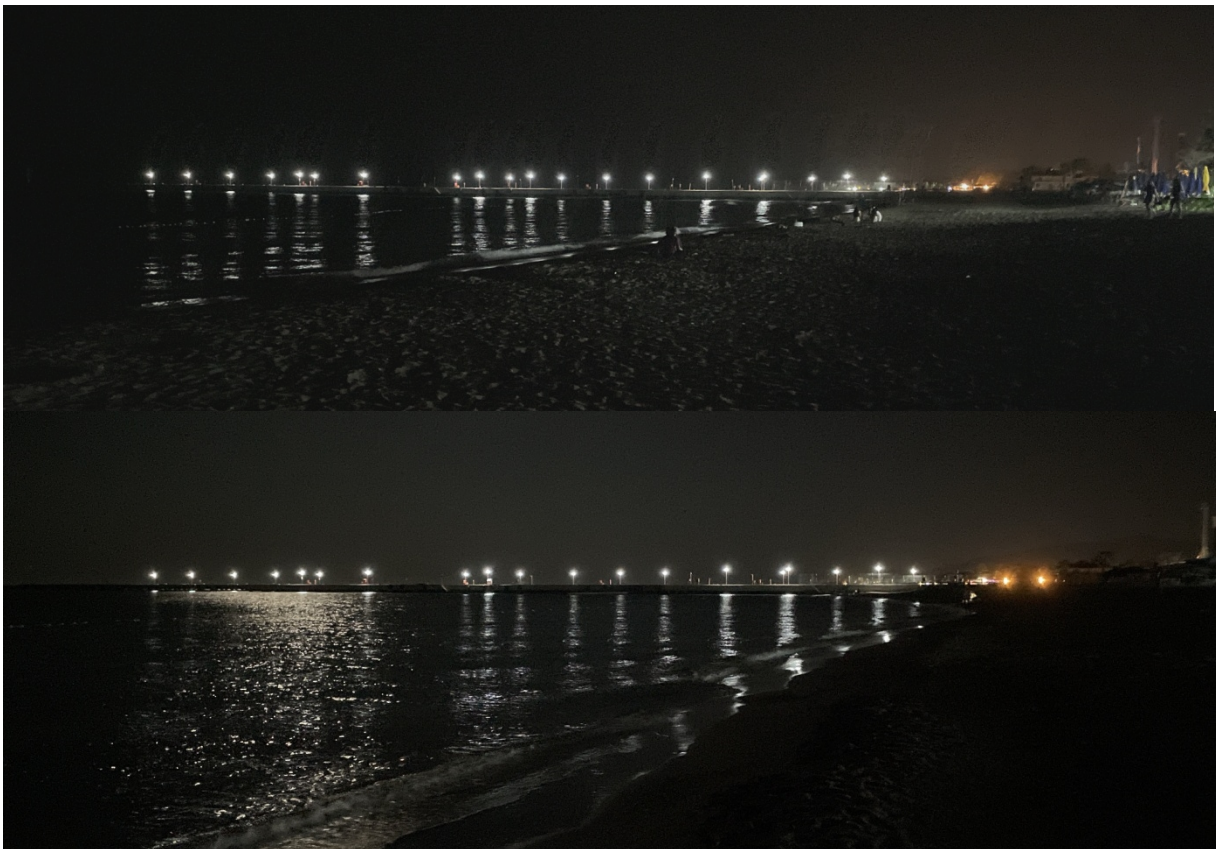
Port illumination and beach restaurant lighting casting artificial glare directly onto the nesting beach, contributing to localized light pollution.

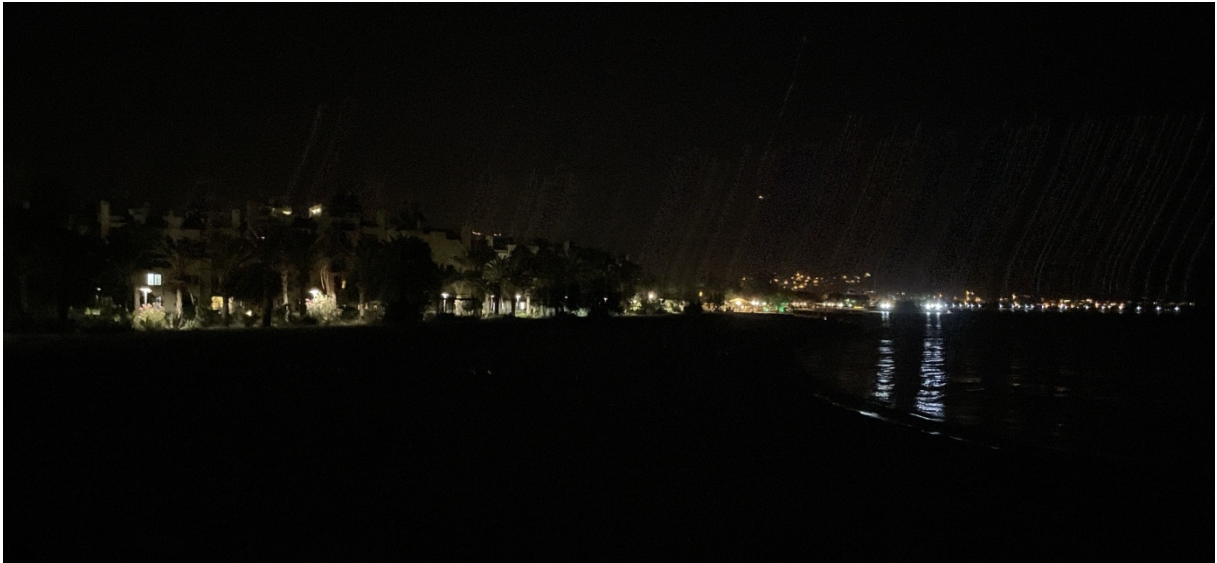
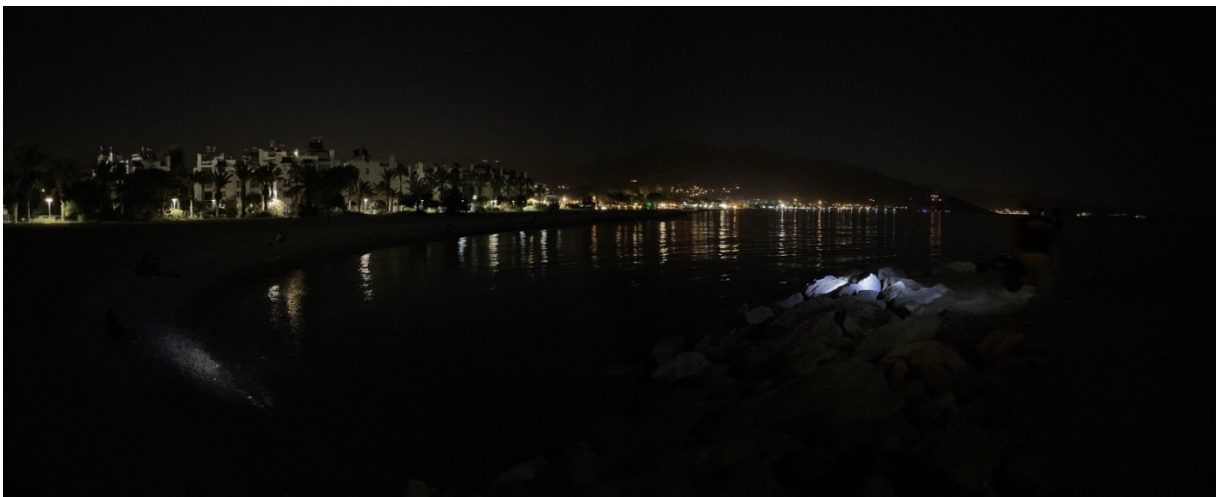
Although the illumination from the summer houses was partially shielded by the vegetation, the newly installed security lighting at the marina was found to be inactive. However, white light emissions from visitors on the beach remain highly conspicuous.

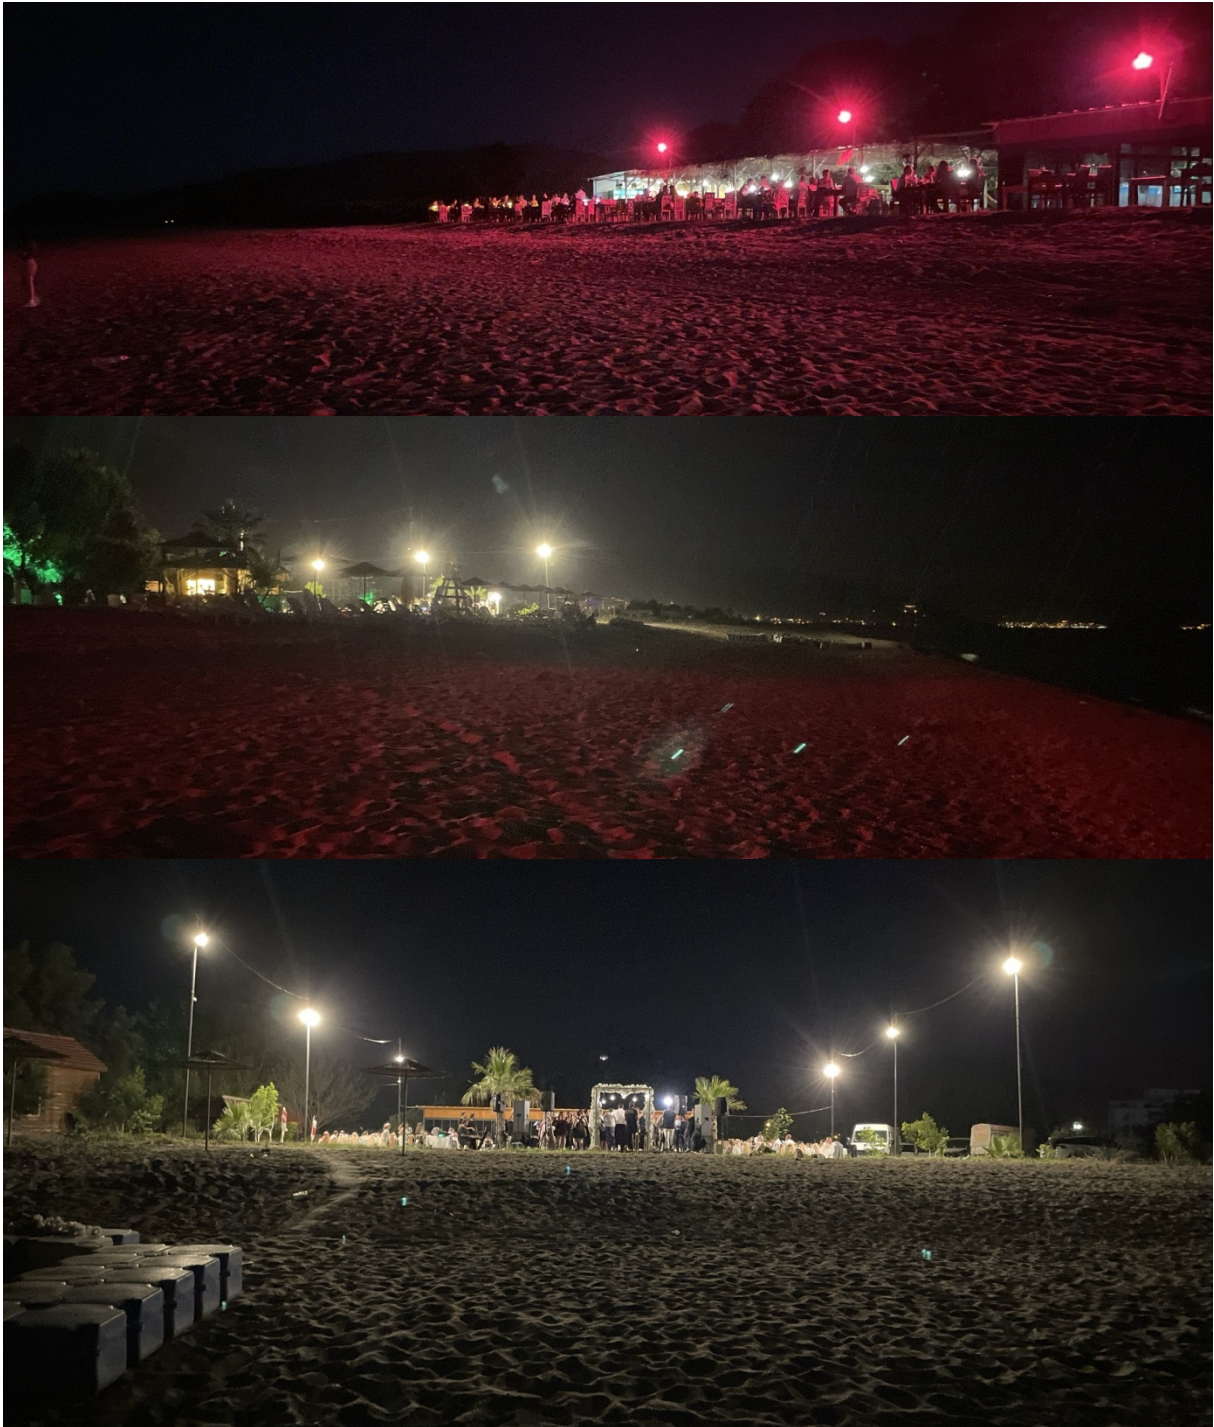
A business operating in Karaağaç implementing turtle-friendly red light lighting; however, the highly intense white illumination utilized by the adjacent bungalow enterprise mitigates and negates this positive environmental action.

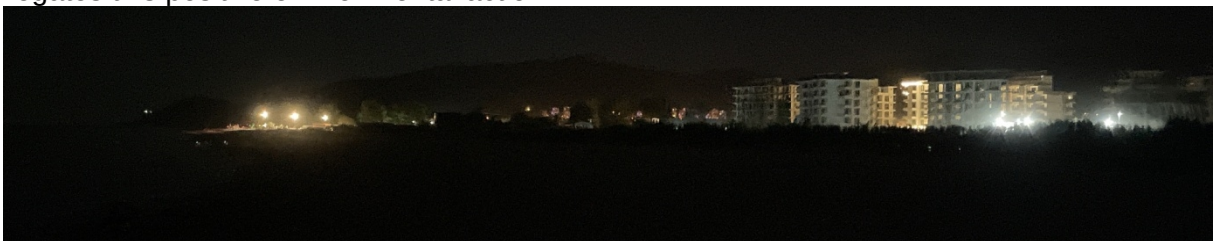
Newly installed exterior facade lighting and high-intensity light emissions from the wedding/event venue, directly impacting the beach front.

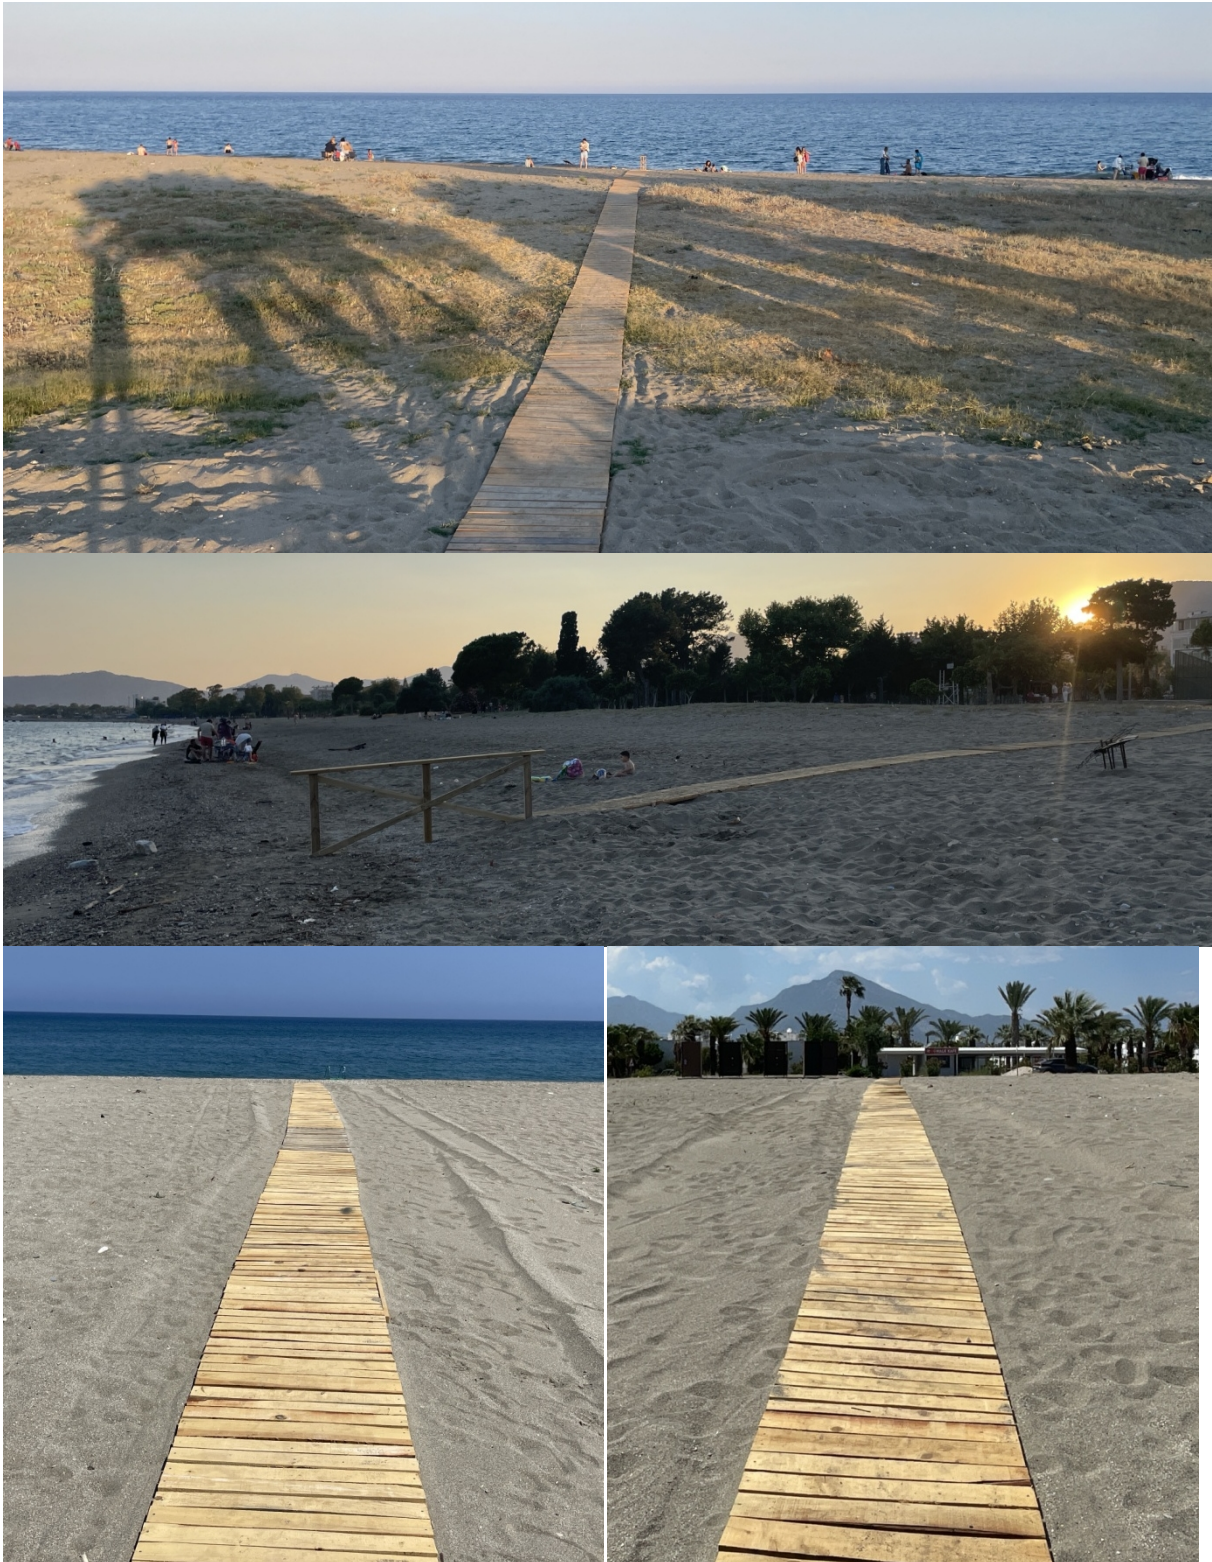
**Figure 6. Expanding businesses on the nesting beach**

The wooden boardwalk added in front of the newly constructed fish restaurant in Dragon Park, representing a direct physical intervention on the natural dune structure of the beach.

Evidence of beach fires was detected in multiple sections of the shore. In camping zones and newly designed park areas, non-native plant species that damage the natural dune ecosystem have been planted, and artificial vegetation changes have been induced through periodic irrigation. This practice is projected to cause a progressive narrowing of the beach width in the coming years. (*Figure 6. Expanding businesses on the nesting beach*)

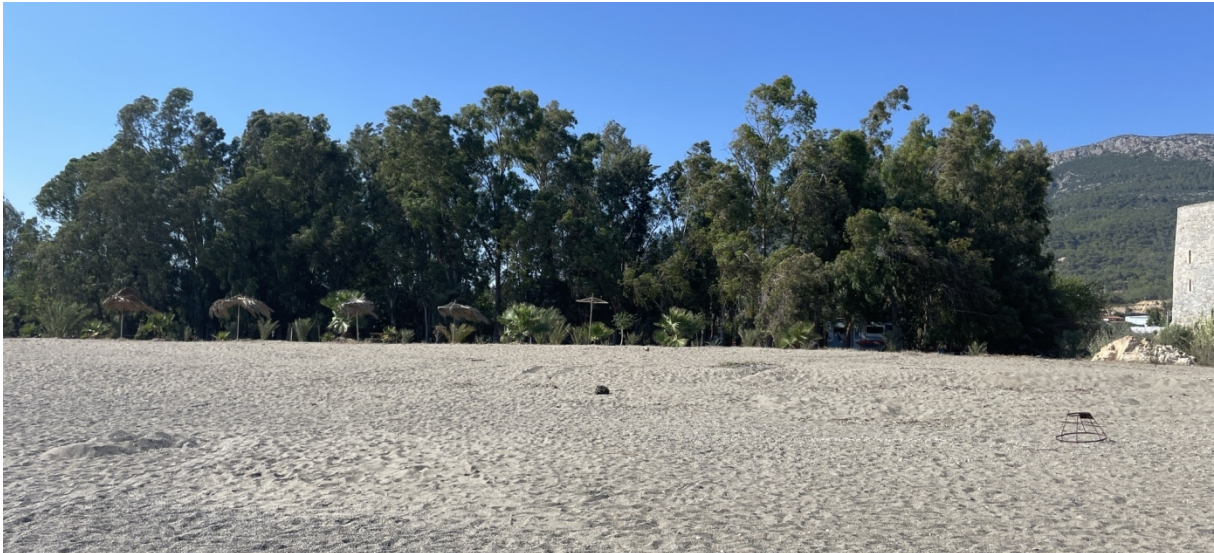
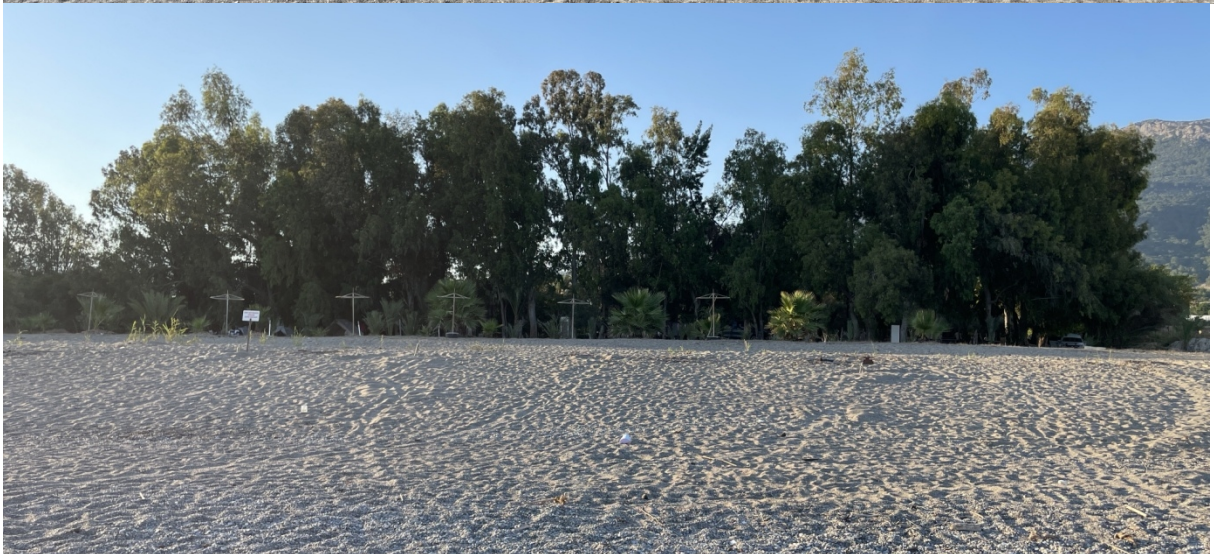
No different from last year Camping areas near Mamure Castle

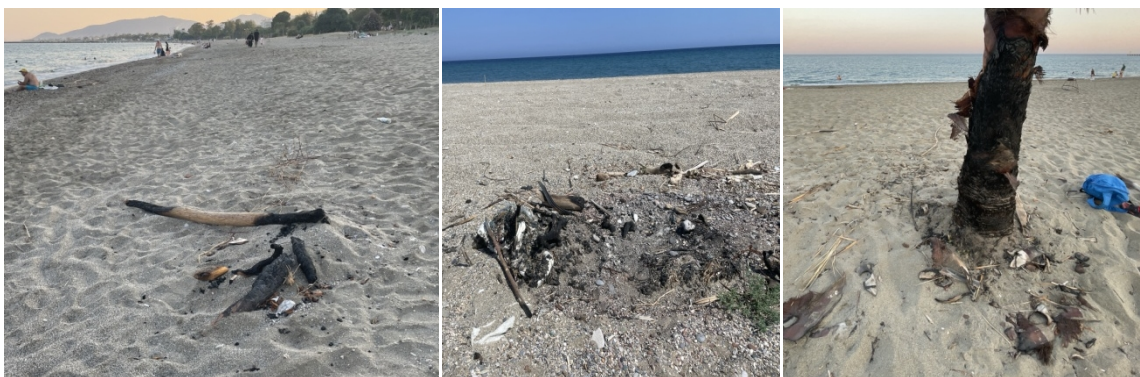
There has been an increase in fire indicators and litter on beaches.

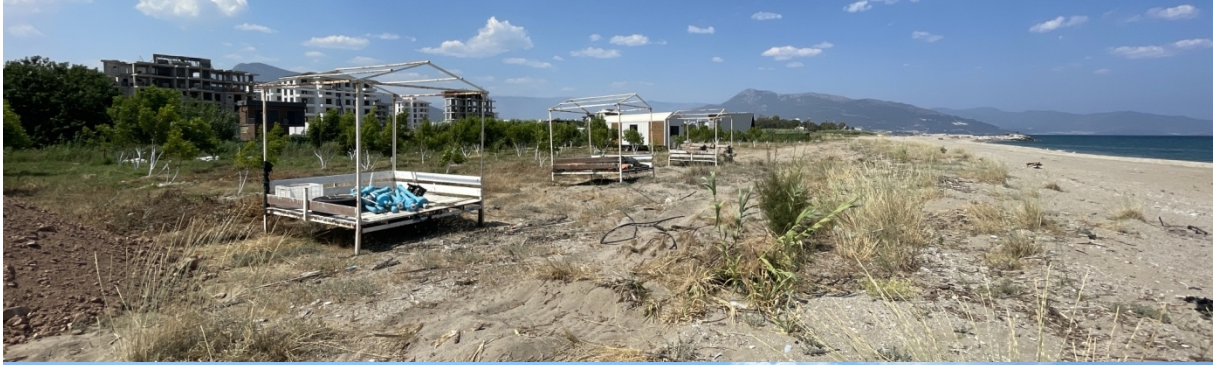
The construction of a new restaurant building and ongoing installation works of new pavilions on Karaağaç Beach by the local bungalow enterprise.

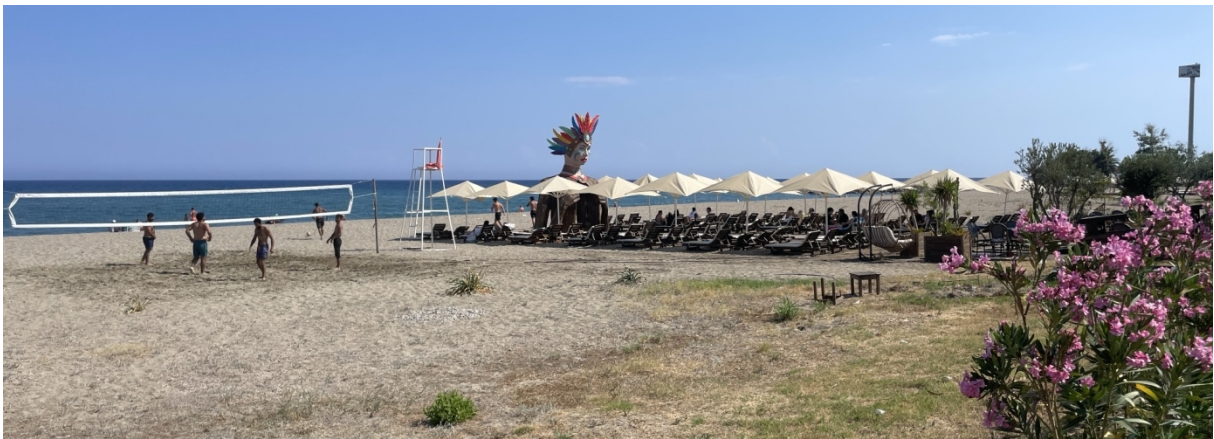
Observation of sunbeds and umbrellas occupying a vast area of the beach within Devlet Bahçeli Park, alongside the addition of beach furniture and the installation of a volleyball court, increasing recreational pressure on the coastal habitat.

Beach furniture are deployed on the shore by local businesses in an alarming rate. These furniture are not removed at night and are positioned in a manner that obstructs the critical nesting zone of the beach. Although some facilities in the area between Dragon Creek and Anamur Pier have been removed, a wooden boardwalk has been installed in front of the newly opened municipal business, and umbrellas and sunbeds belonging to private establishments still remain on the beach. Furthermore, it was observed that the sunbeds and umbrellas belonging to the businesses within Devlet Bahçeli Park cover a vast area, with new beach furniture being actively introduced.

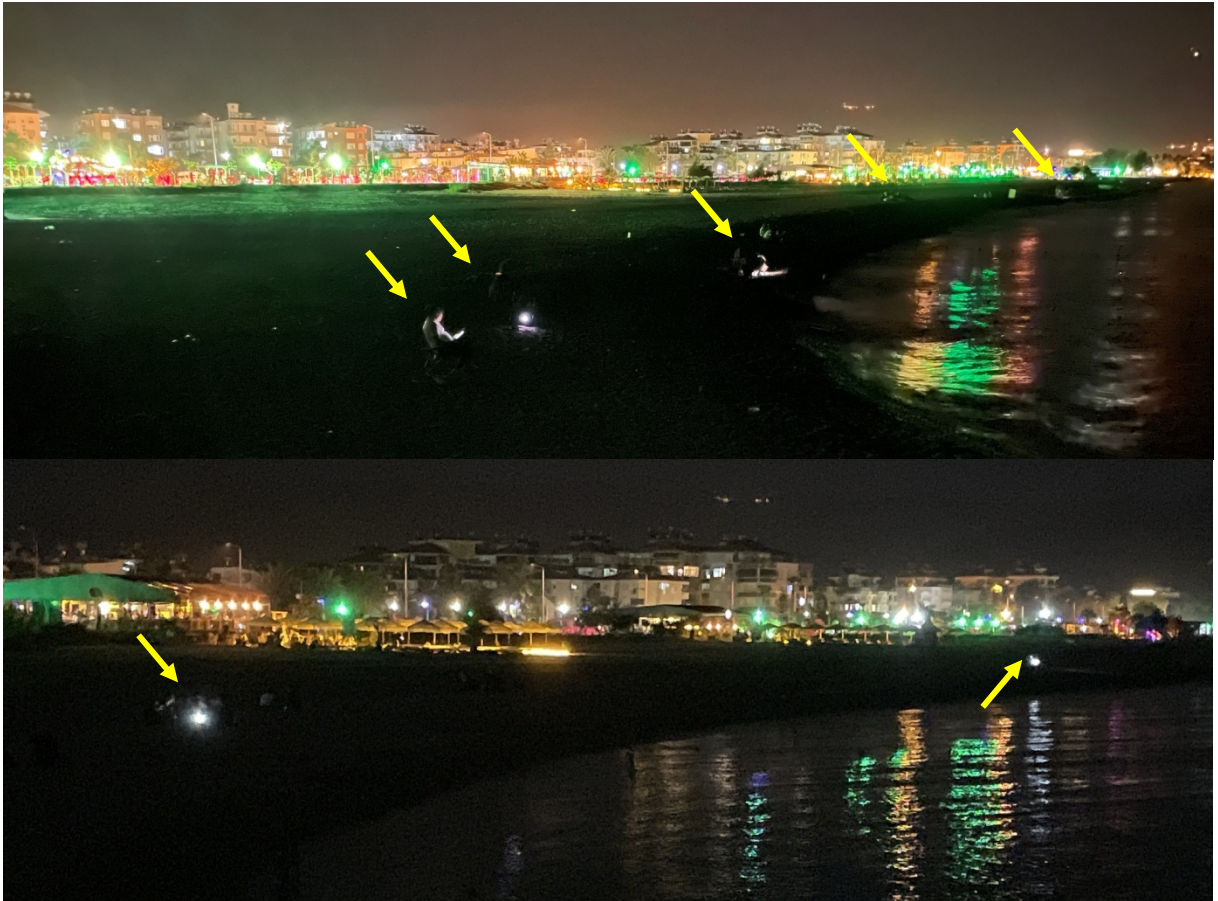
As in the previous year, visitors continue to use the beach actively at night within the areas illuminated by the parks constructed along the coastline (yellow arrows).

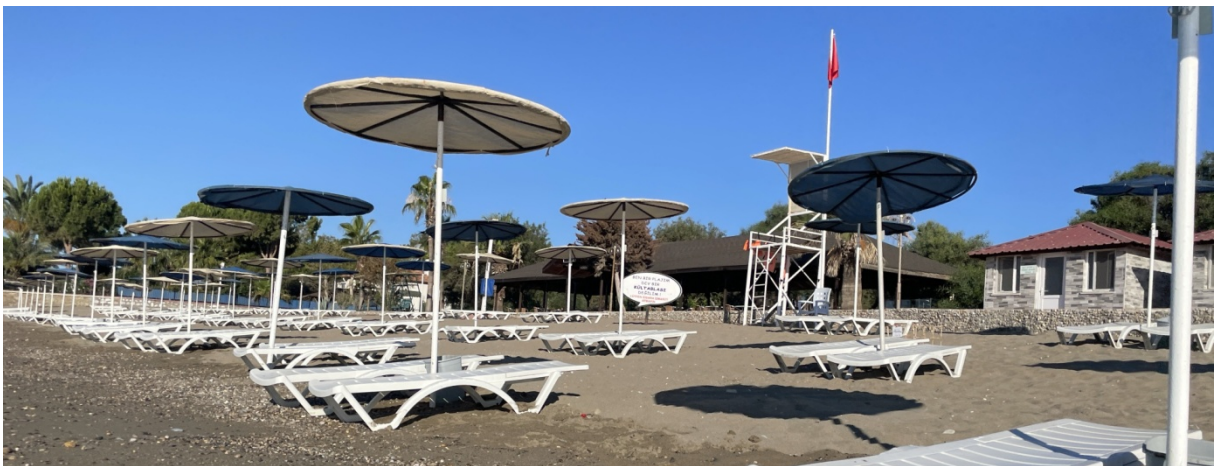
Beach furniture still covers the entire beach in some places.

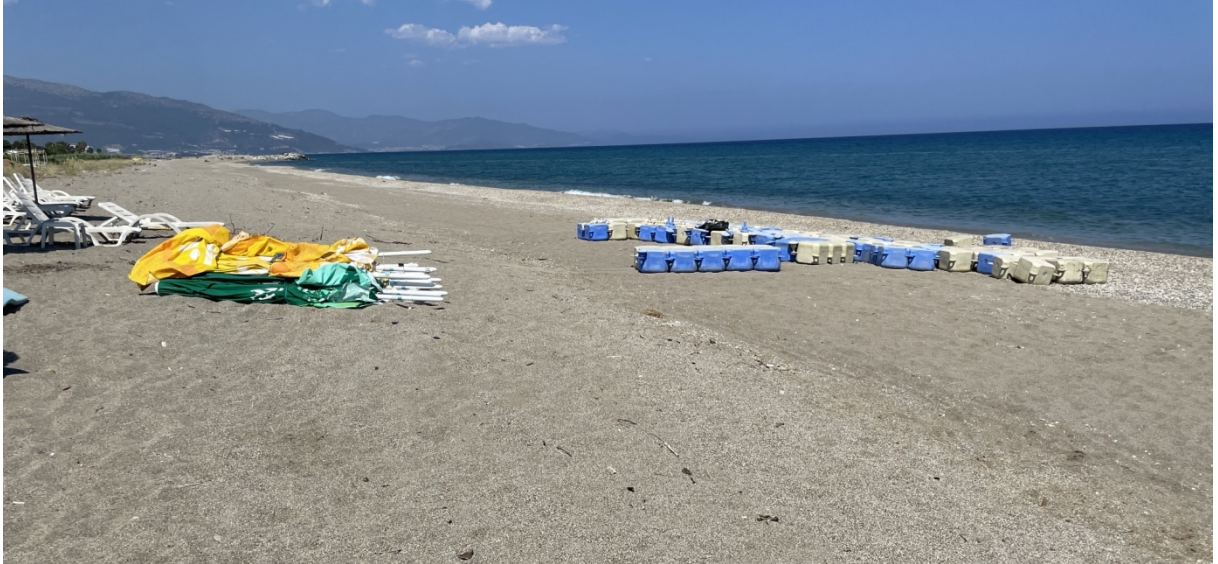
The designated area for the planned floating pier/jetty on Karaağaç Beach, alongside new umbrellas brought to the site to be installed on the beach.

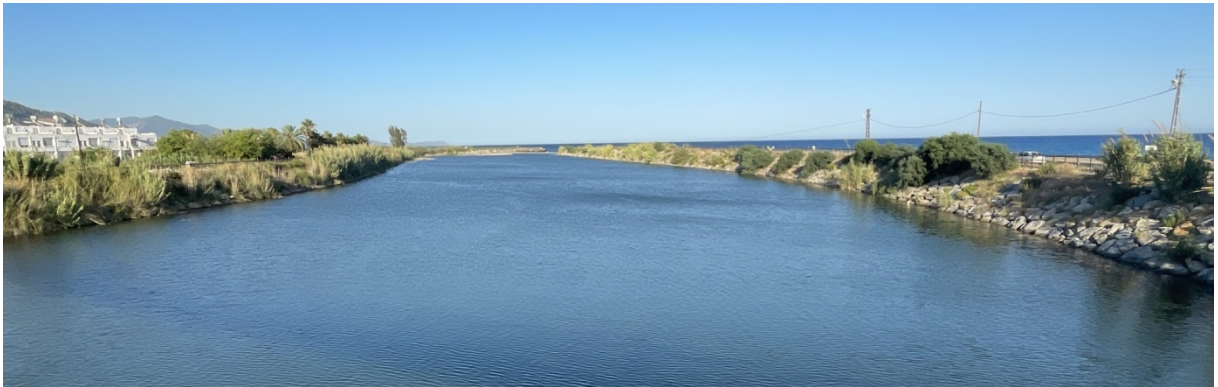
**Figure 7. Stone wall built alongside the Dragon River and the African Softshell Turtle**

Mouth of Dragon River in 2025

The riverbed restoration works conducted in Dragon Creek through the construction of stone retaining walls have completely destroyed the habitat of the African Softshell Turtle (Trionyx triunguis). Specifically, these stone walls built along the river channel have covered the sand dunes, completely eliminating the nesting zone of this species. During the on-site monitoring activities, no African Softshell Turtles were observed, contrasting sharply with data from previous years. (*Figure 7. Stone wall built alongside the Dragon River*) (*Figure 8 New problems still same*)

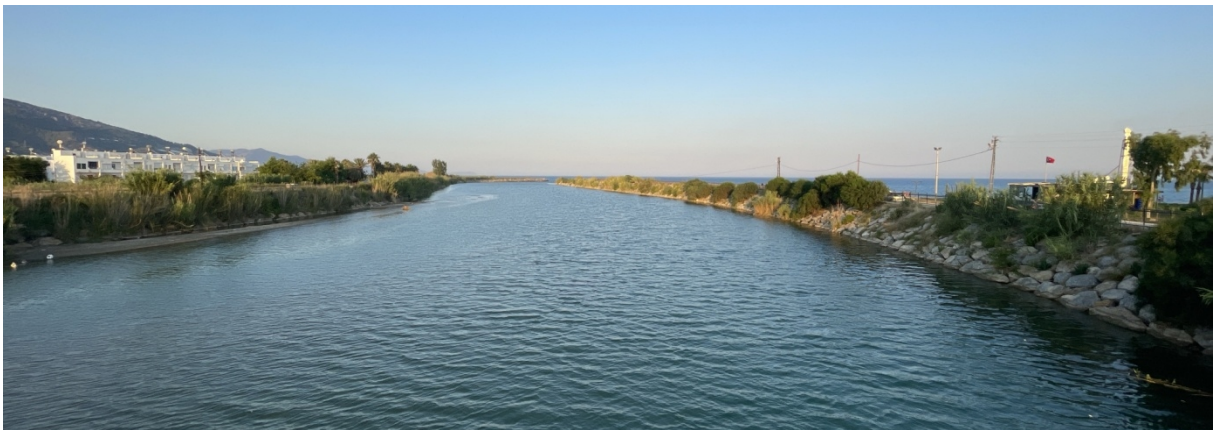
Mouth of Dragon River in 2026 with more vegetation

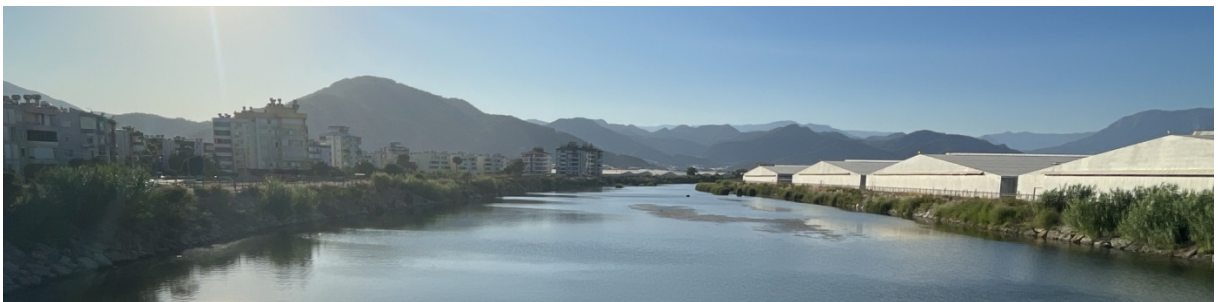
Land side of the river covered by stone wall in 2025

7. Rehabilitate the stone walls alongside of the Dragon River, Sultan Creek and Sarısu Creek that cause irreversible damage to the living environment and seriously affect the nesting activities and habitats of African soft shell turtles,

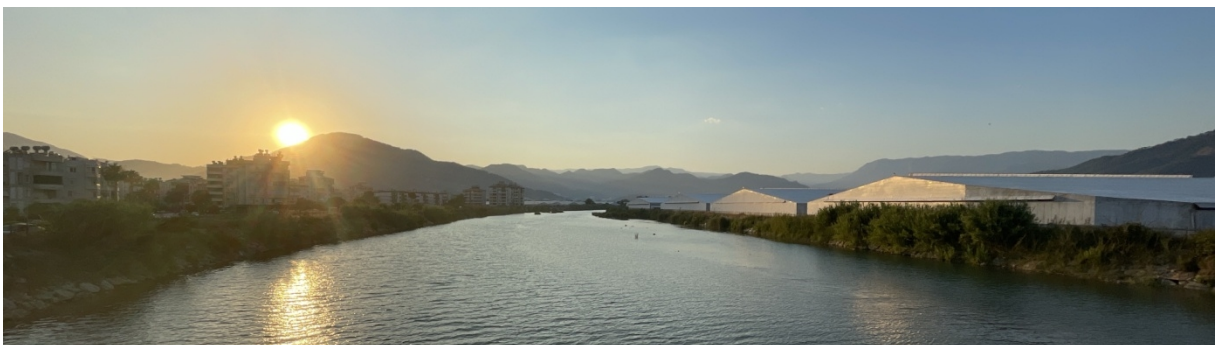
Land side of the river covered by stone wall in 2026 with more vegetation

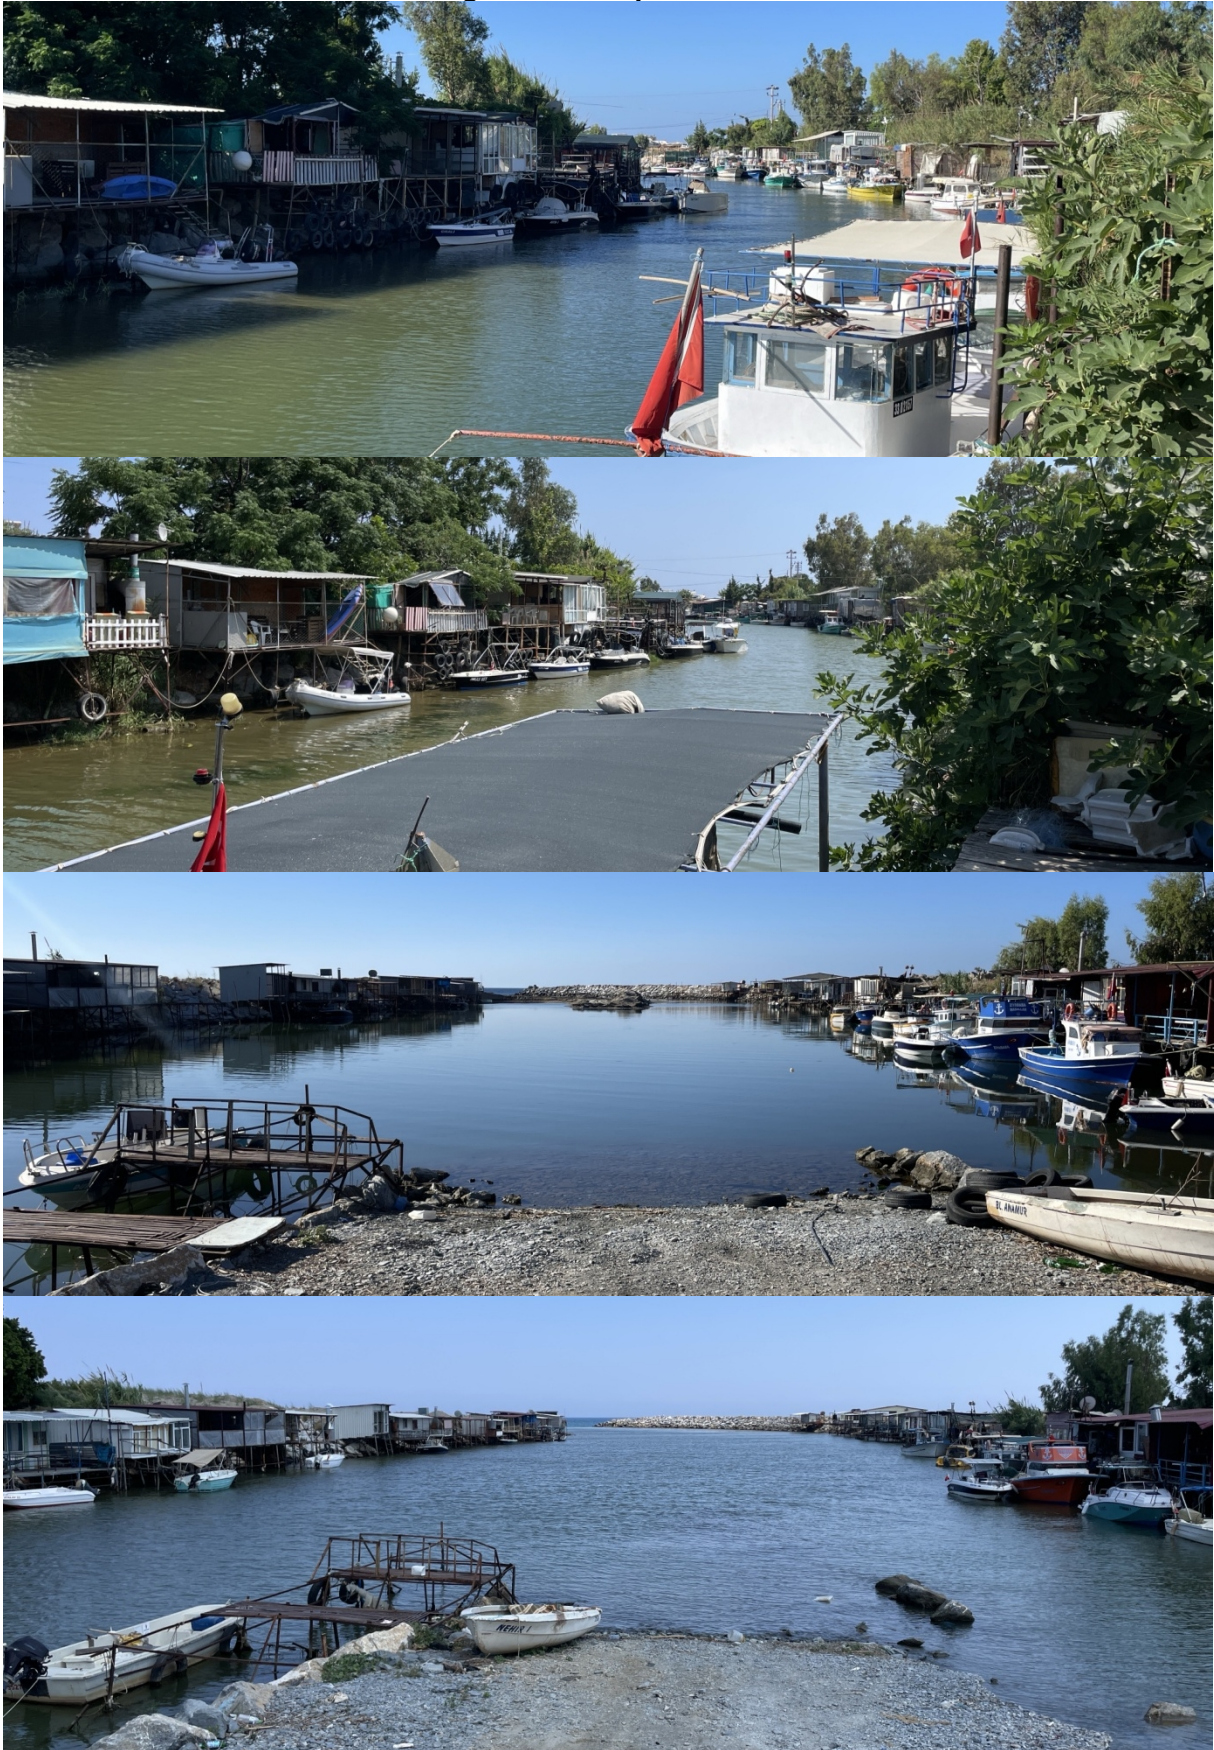
**Figure 8. New problems**

Barracks built on the Sultan Stream 2026
