**Habitat destruction in Mersin Anamur Beach (Türkiye)**

**-COMPLAINANT REPORT-**

#### **LOGGERHEAD SEA TURTLE (*CARETTA CARETTA*), GREEN TURTLE (*CHELONIA MYDAS*) & AFRICAN SOFT SHELL TURTLE (*TRIONYX TRIUNGUIS*) CONSERVATION MONITORING IN ANAMUR, MERSIN, TÜRKİYE**

### **DETAILED REPORT OF 2026 FOR ANAMUR SPA, TURKEY**

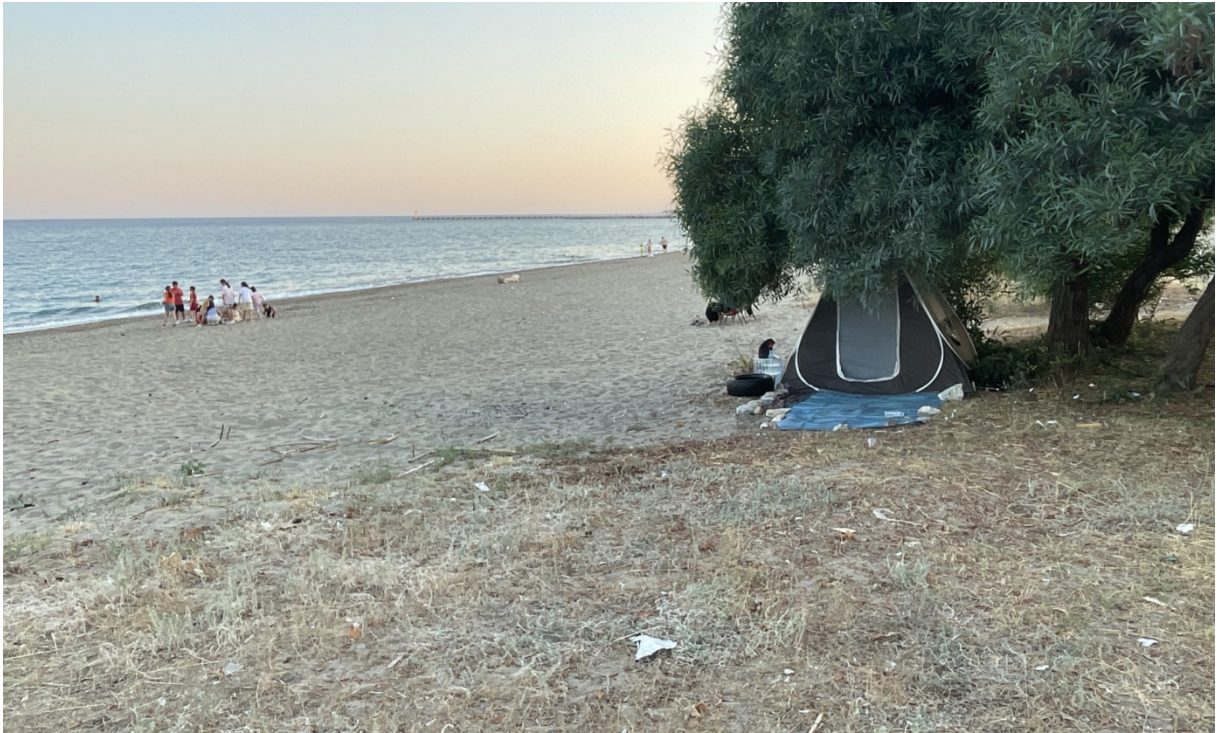
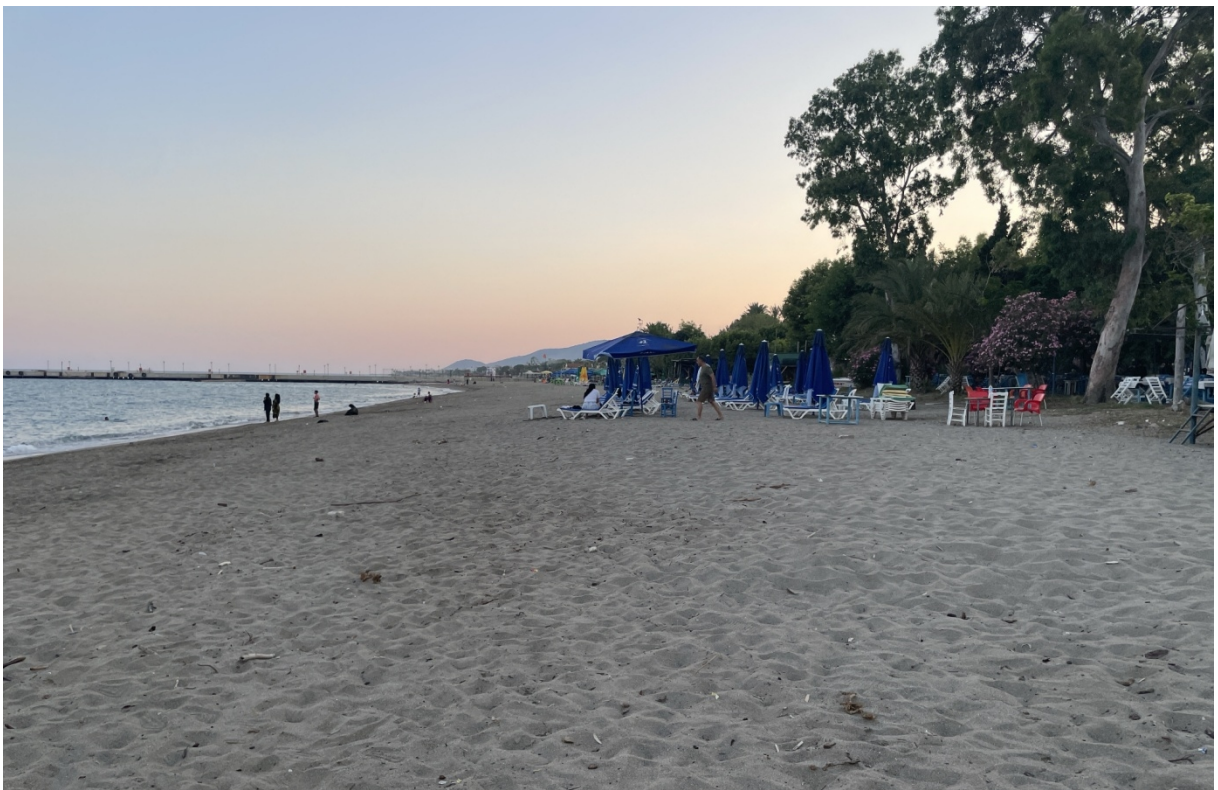
Observation of uncontrolled tent camping activities initiating on the beach, alongside certain businesses—, which had previously cleared their setups—expanding their sunbed and umbrella layouts once again.
