**Habitat destruction in Mersin Anamur Beach
(Türkiye)**

- REPORT BY THE COMPLAINANT -

LOGGERHEAD SEA TURTLE (*CARETTA CARETTA*), GREEN TURTLE (*CHELONIA MYDAS*) & AFRICAN SOFT SHELL TURTLE (*TRIONYX TRIUNGUIS*) CONSERVATION MONITORING IN ANAMUR, MERSIN, TÜRKİYE

4 November 2024

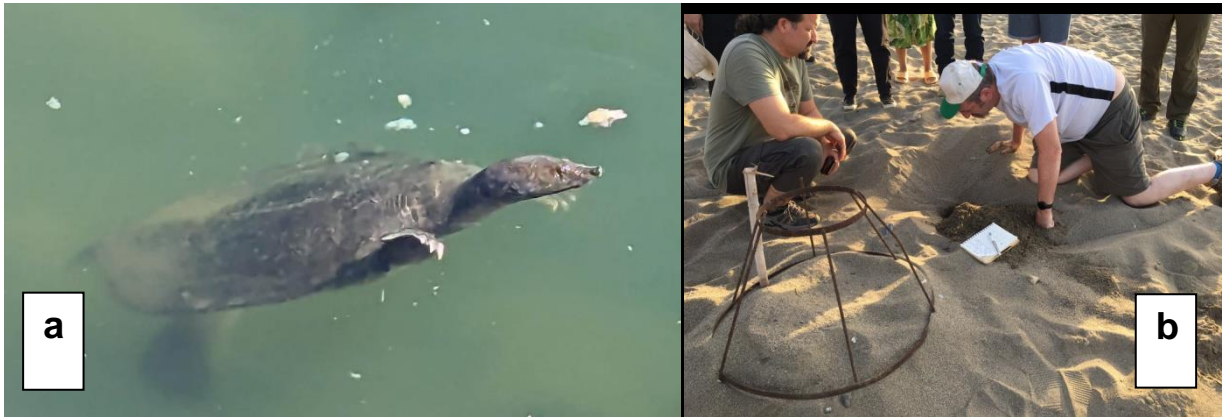
Fig. 1a) African soft shell turtle (*Trionyx triunguis*) welcomes the BCOSA team in the Dragon River.

Fig. 1b) Checking if the nest area is submerged or not, since the nest is close to the sea

- A *Trionyx triunguis* turtle was observed in the Dragon River. (Ref: Annex 4 - Figure 1a) We were informed that this species is not in the Ministry's National Biological Diversity Inventory, and therefore it is not monitored (no data collected) due to lack of personnel. It was stated that it is difficult to locate the *Trionyx triunguis* nests, since it requires special training. The Ministry's National Biological Diversity Inventory must be updated to collect and include data on the *Trionyx triunguis* turtle! Nile turtle individual was seen around Rolly Hotel beach [R18].

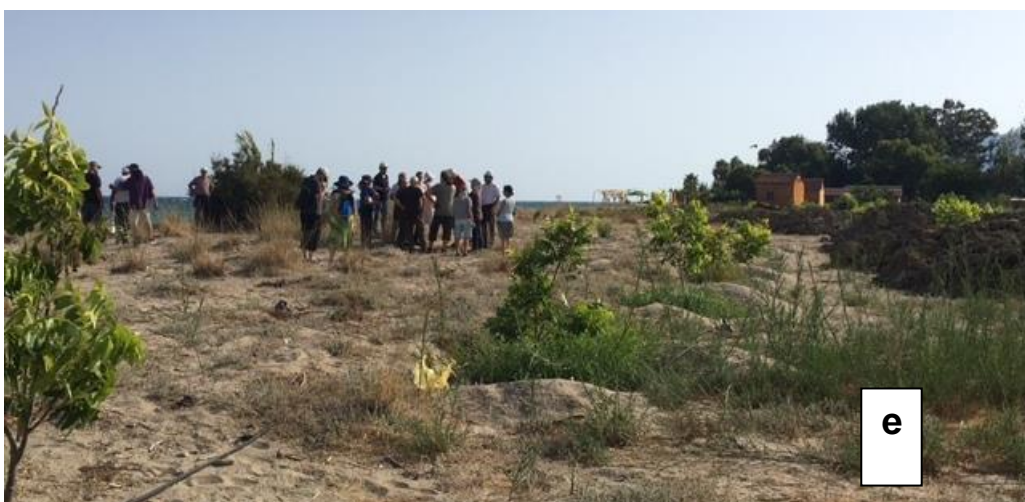
e

Fig. 1e) The BCOSA team is evaluating the business that has constructed bungalow houses and established a walnut garden by pouring soil over sand at the Karaagac beach.

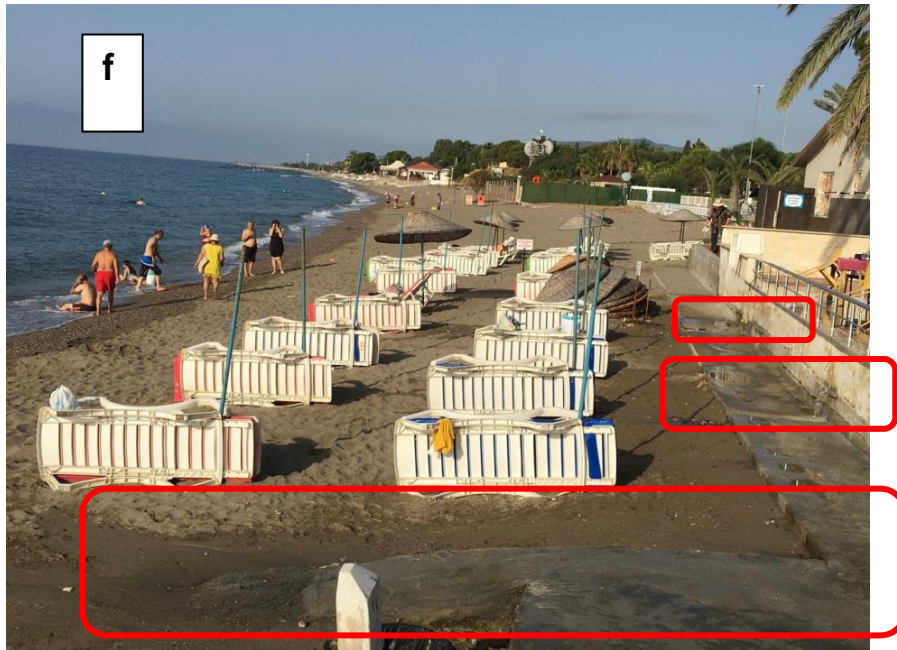
Fig. 1f) The area in front of the Teacher's Guest House. The concrete wall and the sun loungers in front of the building narrowed the beach. This poses the risk of some of the nests right in front of the sun loungers being submerged. Additionally, during the field inspection, it was observed that a large amount of water was flowing onto the beach due to the concrete floor being washed. Red marked areas depict the flowing water.

15. Fix the showers in Beach Arrangement Project (Devlet Bahçeli Park) to prevent water flows to the beach,
16. Remove the concrete floor in front of the Teacher's Guest House that narrows beach and causes nests to be submerged, (Ref: Annex 4 - Fig. 1f)

- A very high percentage of unmarked / uncaged nests were seen.
- It was observed that the concrete wall built in the Teacher's Guest House narrowed the beach very much, therefore most of the sea turtle nests were at risk of being submerged, and there was also a very intense water flow to the beach during the washing of the concrete stage. (Ref: Annex 4 - Figure 1f)

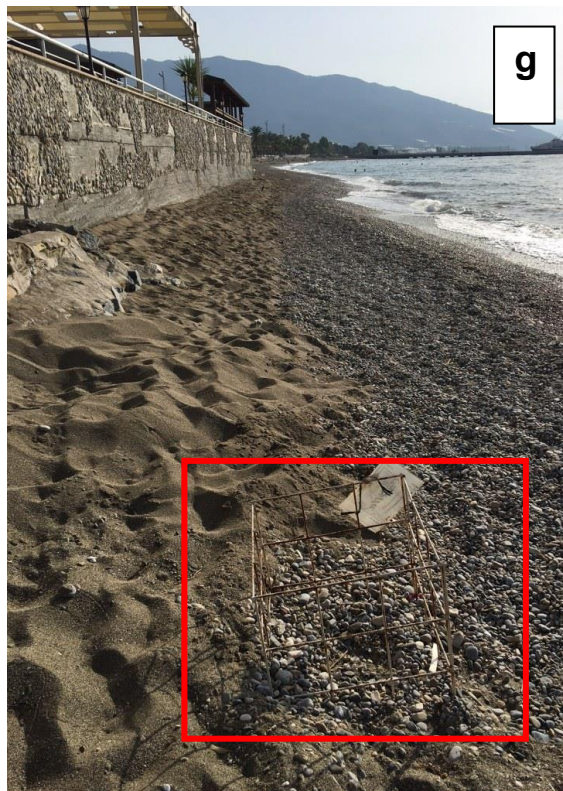
Fig. 1g) The area in front of the Military grounds. The concrete wall narrowed the beach. This poses the risk of some of the nests right in front of the wall being submerged. Red area marks the nest cage.

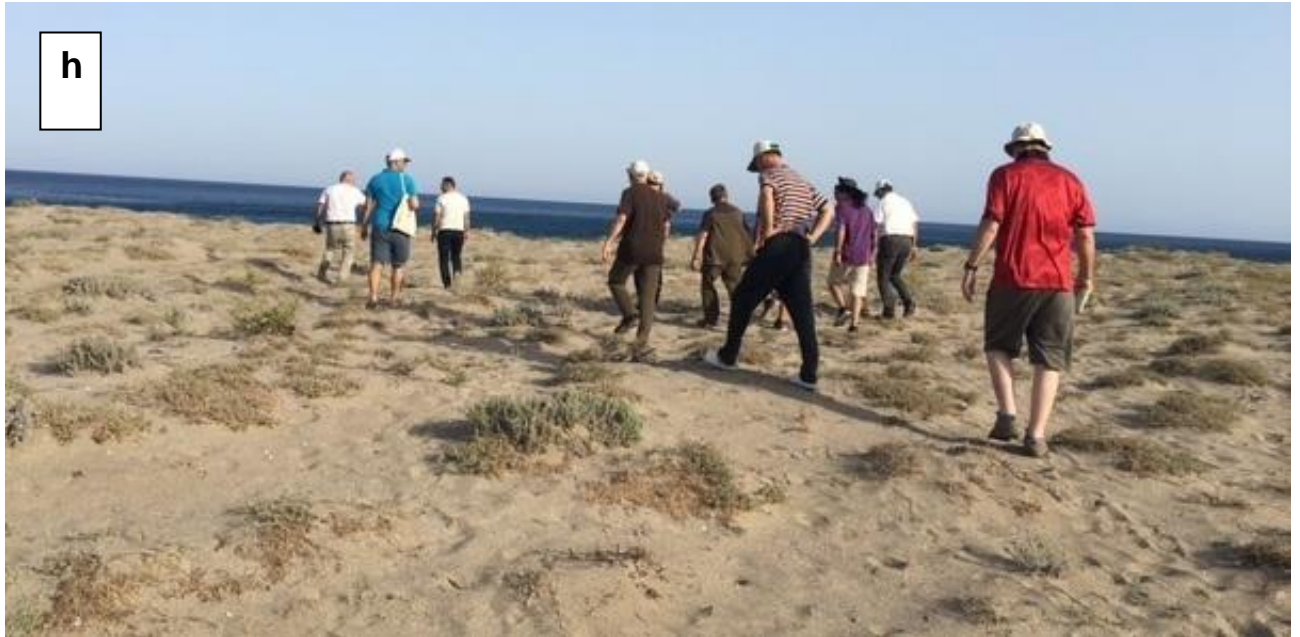
Fig. 1h) The BCOSA team at Anemurium region. Endemic sand plants are visible, whereas there is none left in front of the Beach Development Park. Also no cage is observed as an outcome of monitoring activity

- In Dragon and Karaağaç regions, there are many spots where you can drive to the beach without any barriers. (Ref: Annex 2 - Figure 5)
- In Anemurium (Ören), it was observed that there was a healthier ecosystem in terms of sand and vegetation richness in places where there is less or almost no human intervention. However no cage or marking is observed although foot prints of sea turtles are observed. (Ref: Annex 4 - Figure 1h)

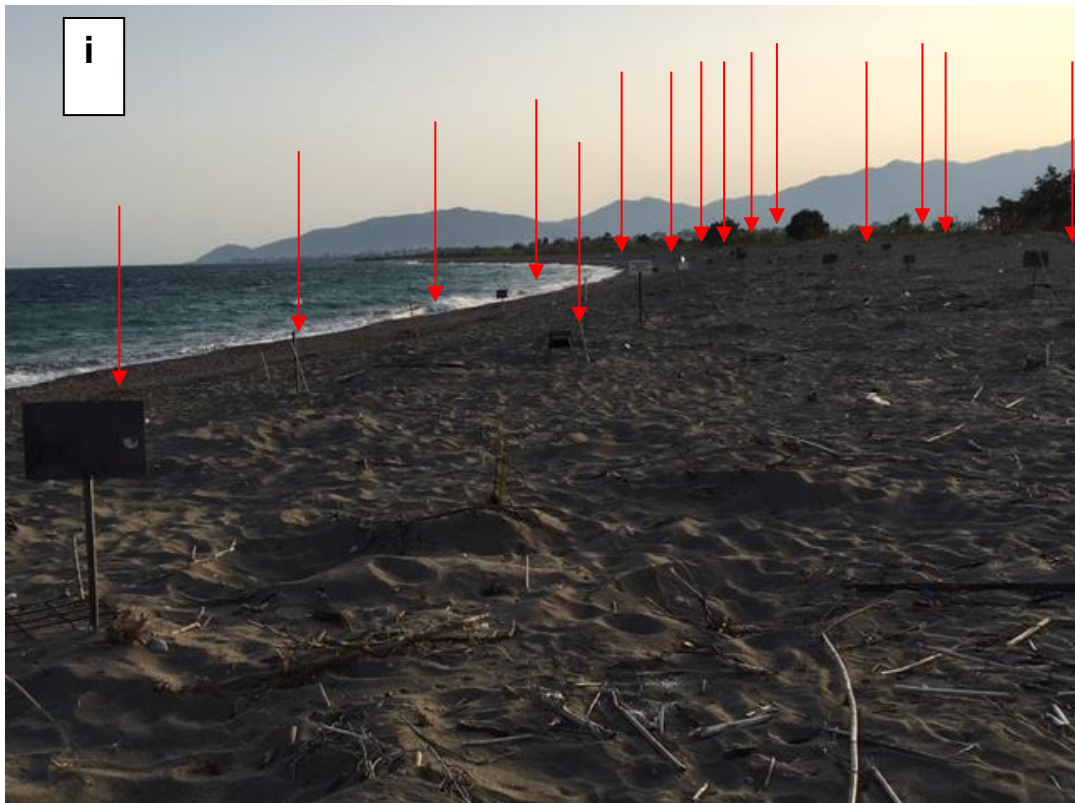
Fig. 1i) Nests in the Maure Castle region. Almost 16 nests are visible at this picture. However, uncaged sea turtle nests are observed too.

- A very dense nest presence was observed in the Mamure Castle area. Many nests were not caged. (Ref: Annex 4 - Figure 1i)

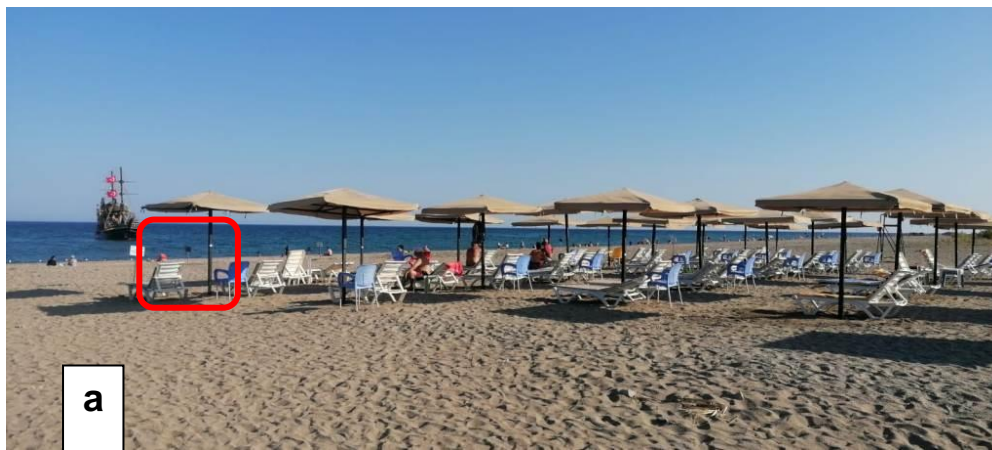
Fig. 2a) The businesses moved beach furniture closer to a distance of 15-20 meters from the shore after the BCOSA team left Anamur. (© MERÇED 8 July 2024) The sea turtle nest in front of the sun lounge is marked in red.

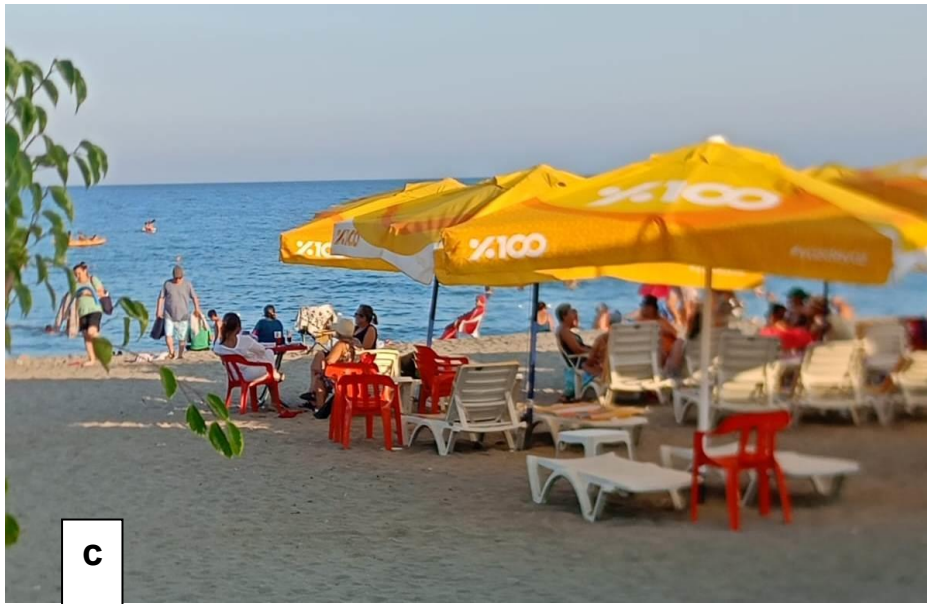
Fig. 2c) Another facility in front of the beach development park. Beach furniture moved close to the sea after the BCOSA team left Anamur. (© MERÇED 14 July 2024)

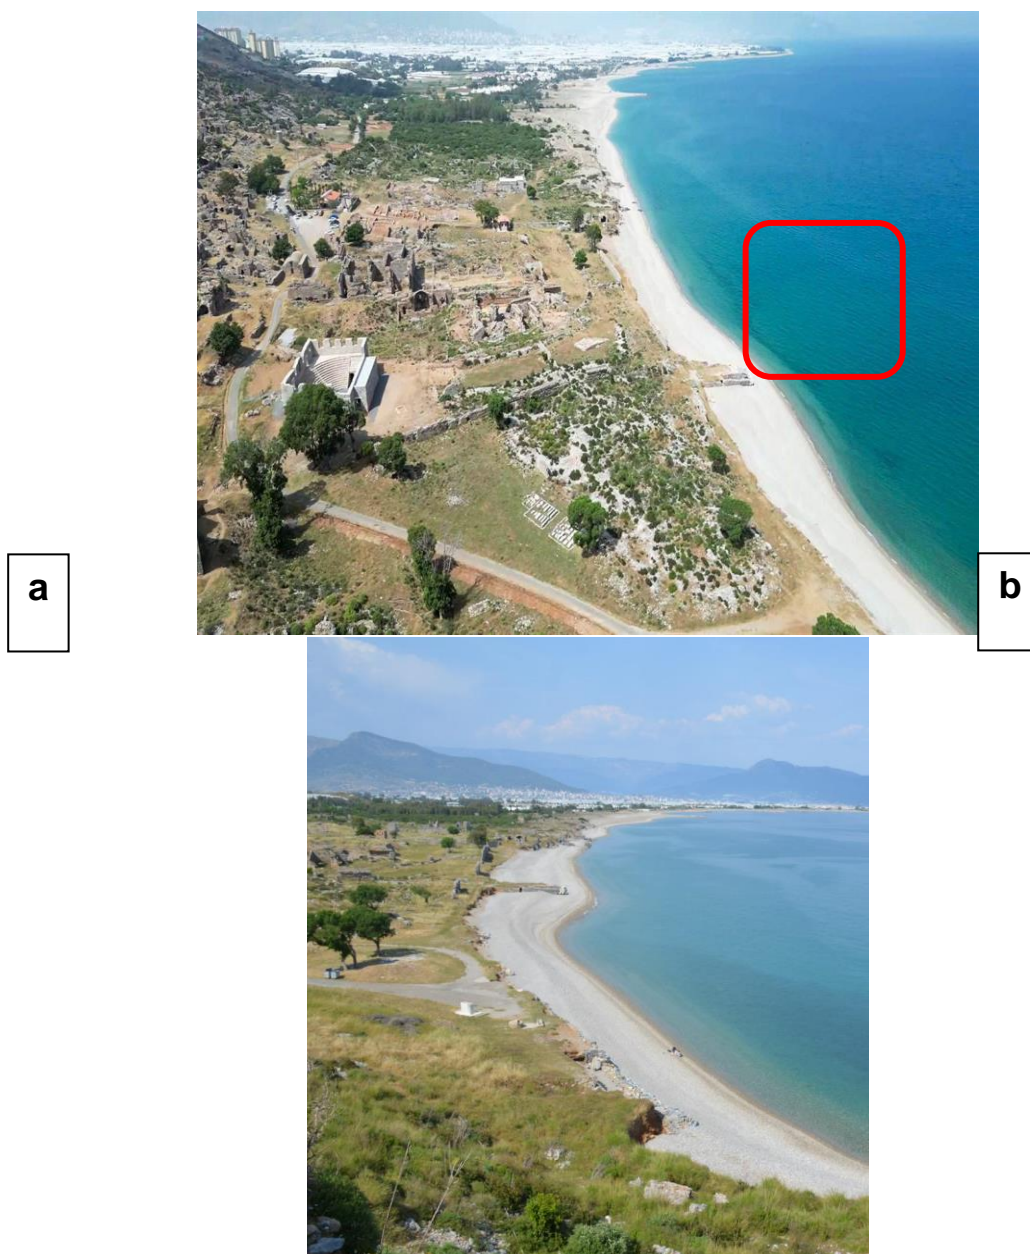
Fig 3a, b) Ancient City before construction starts - Red area in Fig 3b depicts construction area (underneath the two trees) There is a historical stonewall between the nesting beach and the construction area.

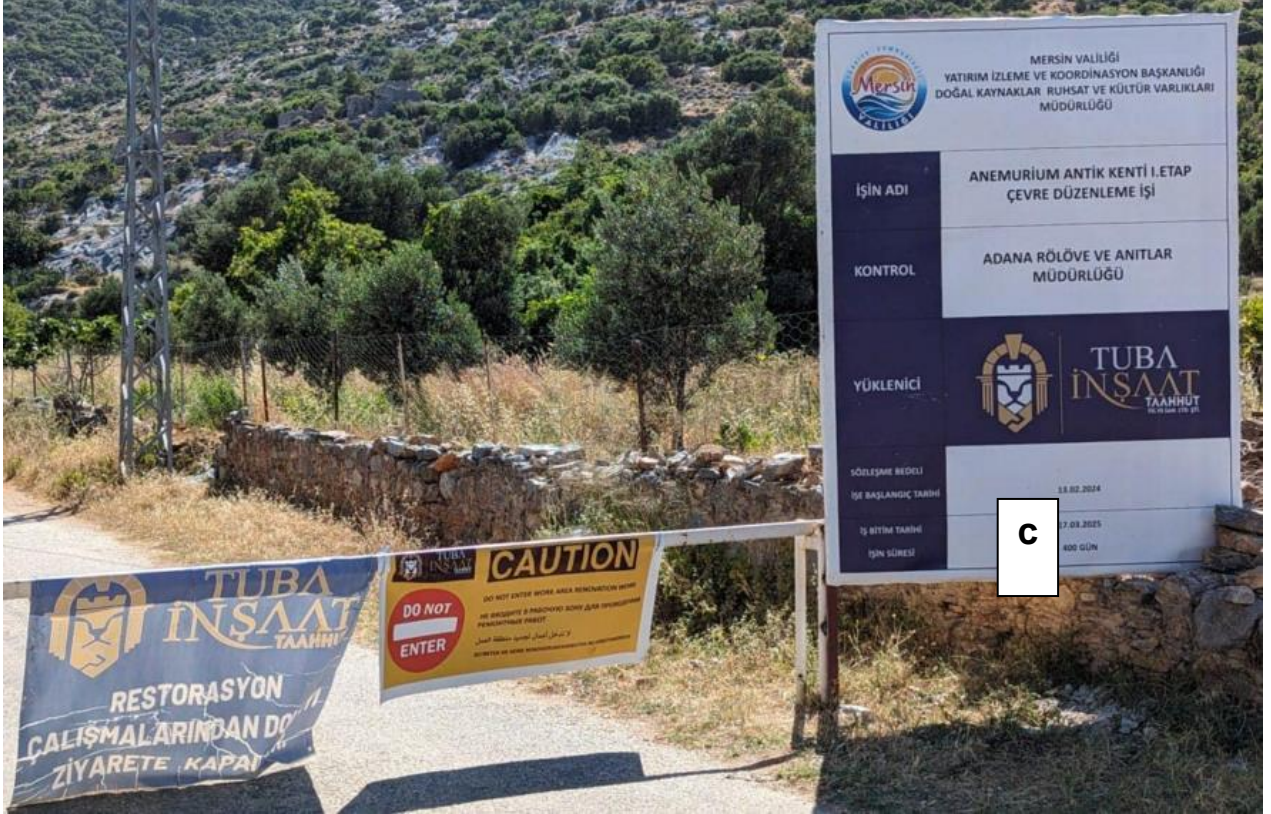
Fig 3c) Construction Information Sign: According to the sign, "Mersin Governorship awarded the "Anemurium Ancient City 1st Stage Landscaping Work" to a company called Tuba Construction to be completed between February 13, 2004 and March 17, 2025. "Entrance not allowed due to the restoration works."

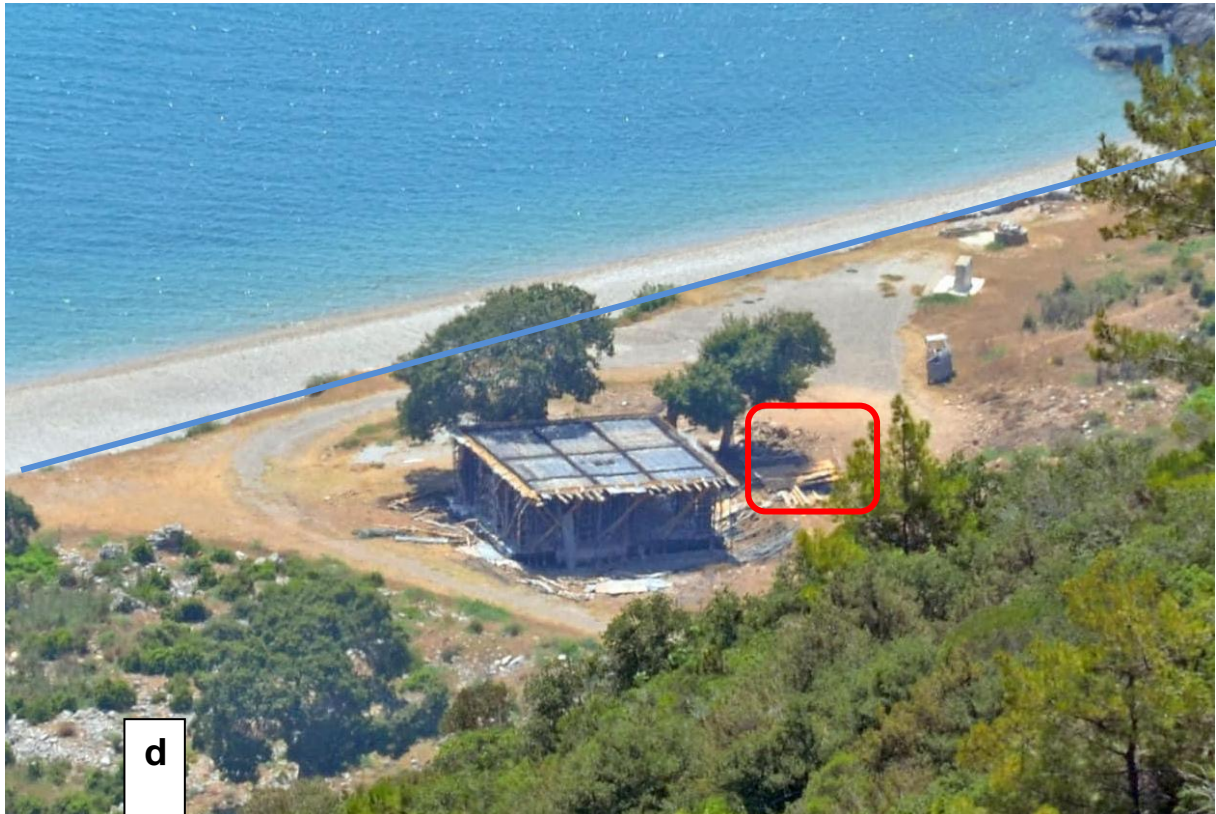
Fig 3d) Ancient City illegal construction - Red area depicts the septic (toilet) area which was dug 2-3 meters deep. The blue line depicts a historical stone wall between the nesting beach and the construction area.

The company that won the construction tender, as can be seen from the referenced video (Ref : Annex 5 - [R13]) shot about a month ago, excavated using heavy machines in an area approximately 25-30 meters away from the beach, where there are archaeological ruins, as well. They built a raft foundation which is contrary to the decision of the Adana Cultural and Natural Heritage Preservation Board. They started a reinforced concrete construction and dug a 3-4 m deep septic tank to be built on the western side of the building. Now the septic tank is covered with plywood to hide. (Ref : Annex 4 - Figure 3d)

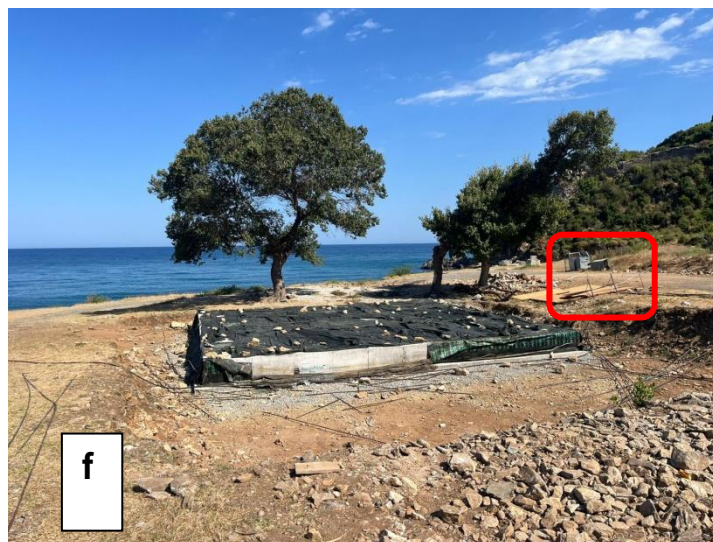
Fig 3f) The upper flat of the building was demolished as a result of public complaints. But the basement and the toilet still exist. The building should be removed totally. The red area depicts the septic (toilet) area which is covered by plywood to hide.

Following the reactions and objections to the concrete construction, the illegal building's upper flat is removed, but the cement foundation and the septic tank were left behind. It is highly likely that the construction will continue in accordance with the board's decision. The coastline of the Anemurium ancient settlement had also been declared a natural protected area in accordance with the decision of the Presidency of the Republic of Turkey. In other words, archaeological and natural protected areas overlap. This coast is also protected by the Circular # B.18.0.DMP.0.01.03, about the protection of the sea turtles. The coast line just beyond the construction site goes all the way to the Sultan Stream. The area hosts sand lilies and other dune plants and sand dunes on the beach. Since this area has been well protected for hundreds of years, it has remained preserved until today. Opening this special area to construction activities under the name of serving and promoting tourism is against the rules of domestic law and the international regulations (Bern and Lahey Convention).

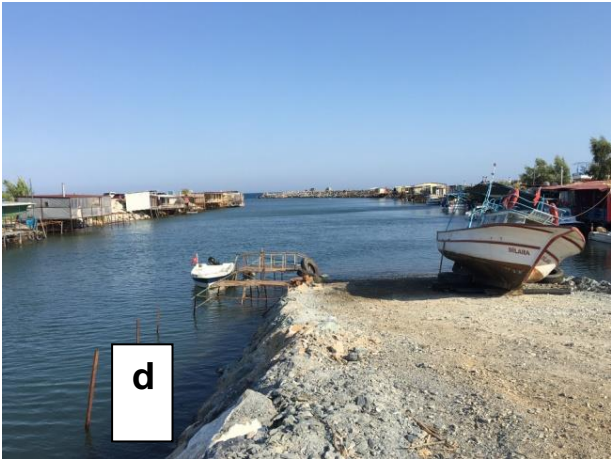
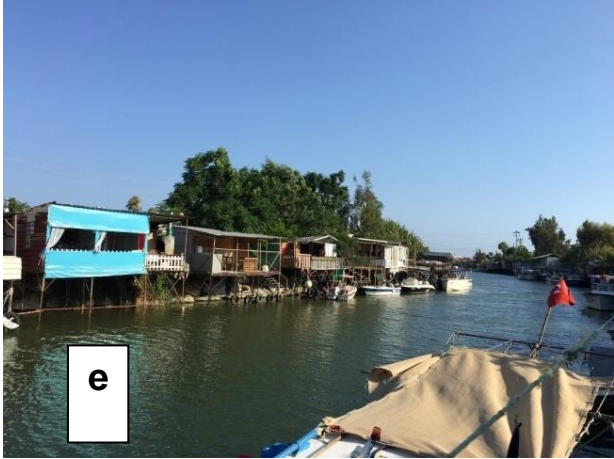
Fig. 4d-4e) The stone wall and illegal huts built alongside the Sultan Stream © MERCED - 1 July 2024

- The condition of the stone walls and huts in the Sultan Stream area was observed. This area is one of the four places where *Trionyx triunguis* turtles nest. (Ref: Annex 5 - [R1]) The illegal hunts and barracks had been removed from Dragon River, a few years ago. It is observed that those illegal constructions are located at the Sultan Stream (Ref: Annex 4 - Figure 4d-4e)

- to update the government's National Biodiversity Inventory records based on the academic publications, (Ref: Annex 5 – [R1])
- asses an urgent appraisal to collect latest status for this year,
- include African soft shelled turtles in the regular data collection process,
- increase man-power and provide training to collect data for African soft shelled turtles,
- Assess the stone walls built alongside the Dragon River, Sultan Stream, Sarisu Creek and make appropriate changes on the construction to let the sea turtles climb and make nest, (If necessary, get consultancy regarding the conditions that the wall must meet to let the turtles climb up)
- Remove the barracks built on the Sultan Stream.

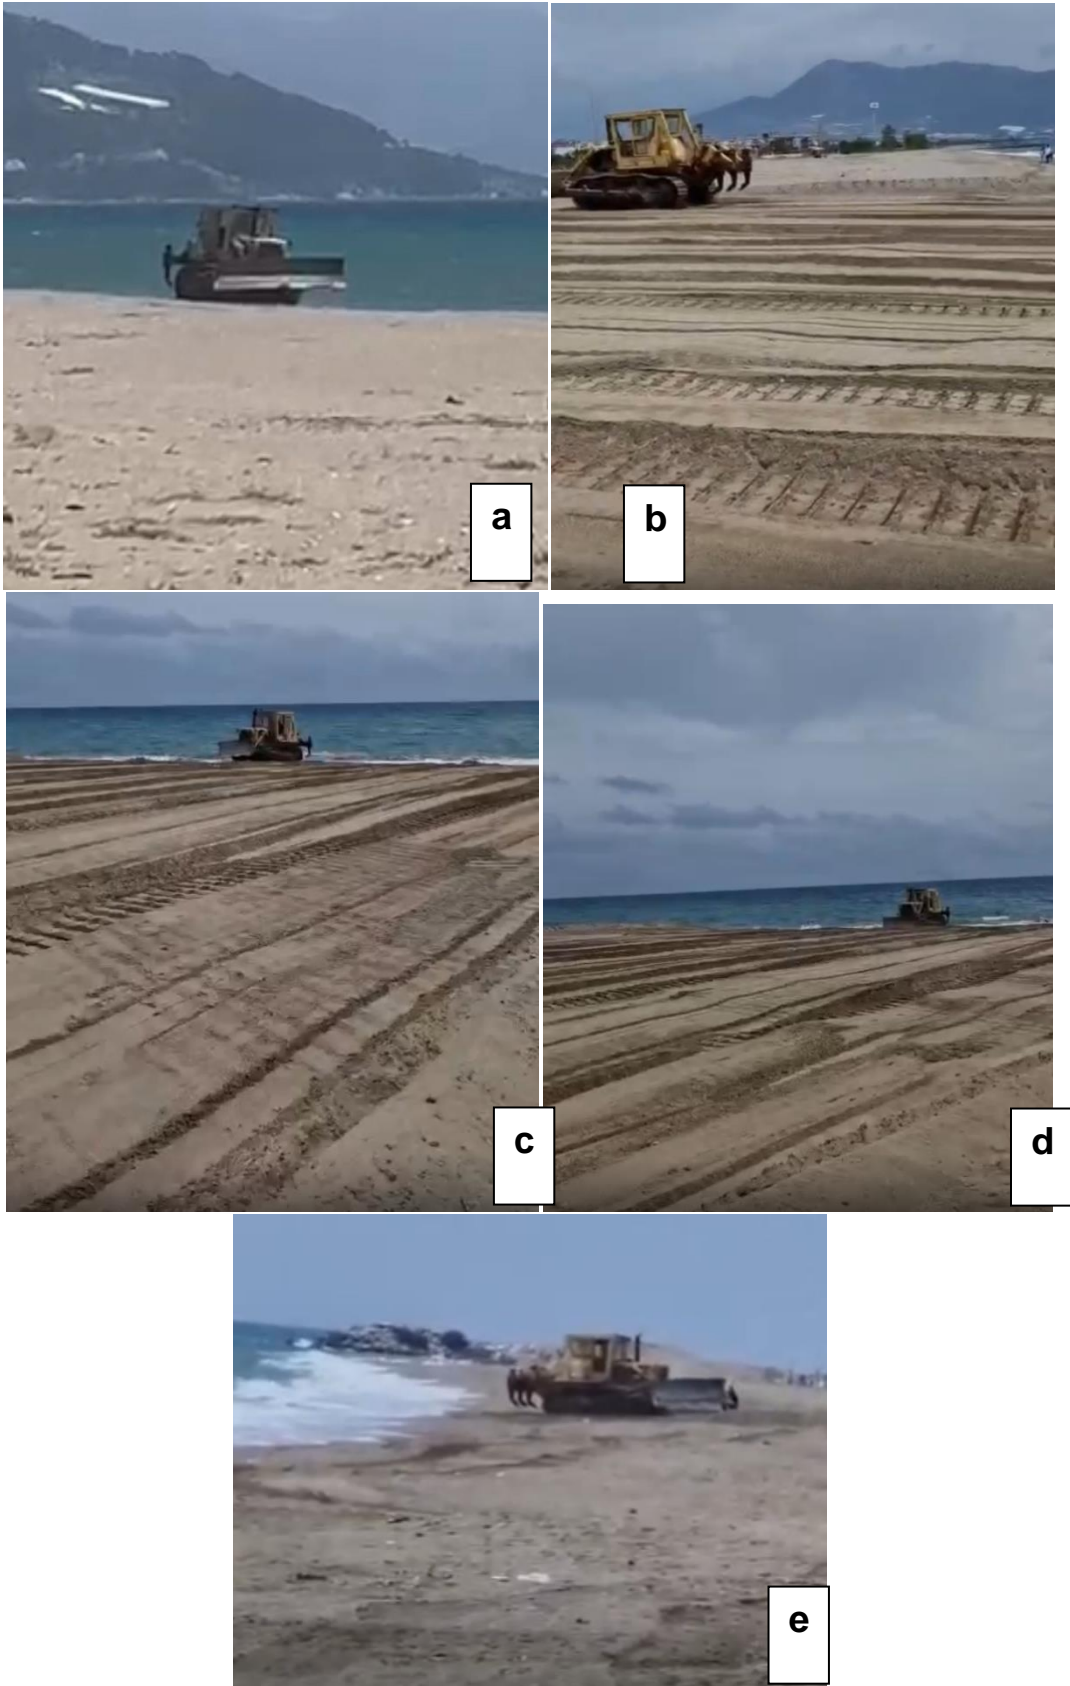
Figure 5 a-e - Plowing of the nesting beach with construction equipment - 20.04.2024

Fig 5 a-e) The nesting beach is plowed by construction machines resulting in habitat destruction (© MERÇED 20 April 2024)

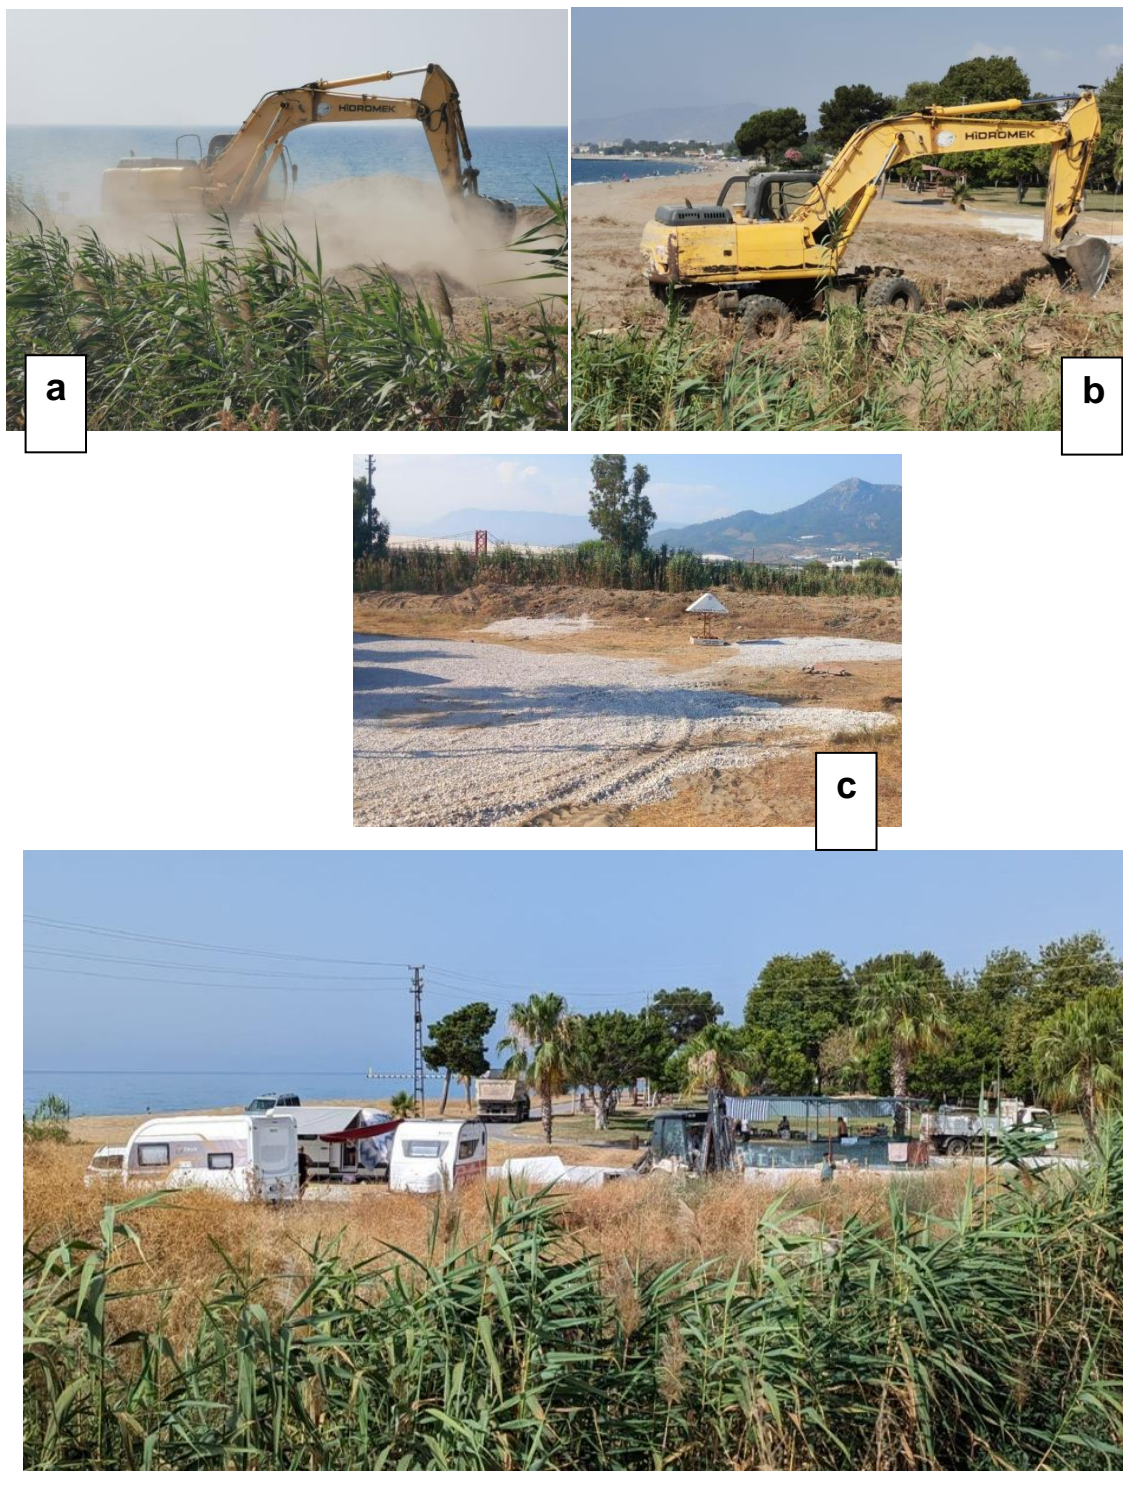
Figure 6 a-d - Caravan Camping Area Construction at the Dragon Beach- 25 - 30 June 2024

Fig.6a, 6b) In the Dragon beach region, during the nesting season the Municipality construction machines entered to the beach. They flattened the dune surface and they cut the reeds. 25.06.2024

Fig. 6c) They poured white pebbles on the surface. 27.06.2024

Fig. 6d) Caravans are observed in the same area after a few days. However during the BCOSA, there were no caravan. They were all removed from this area to prevent their photographs taken during the BCOSA.

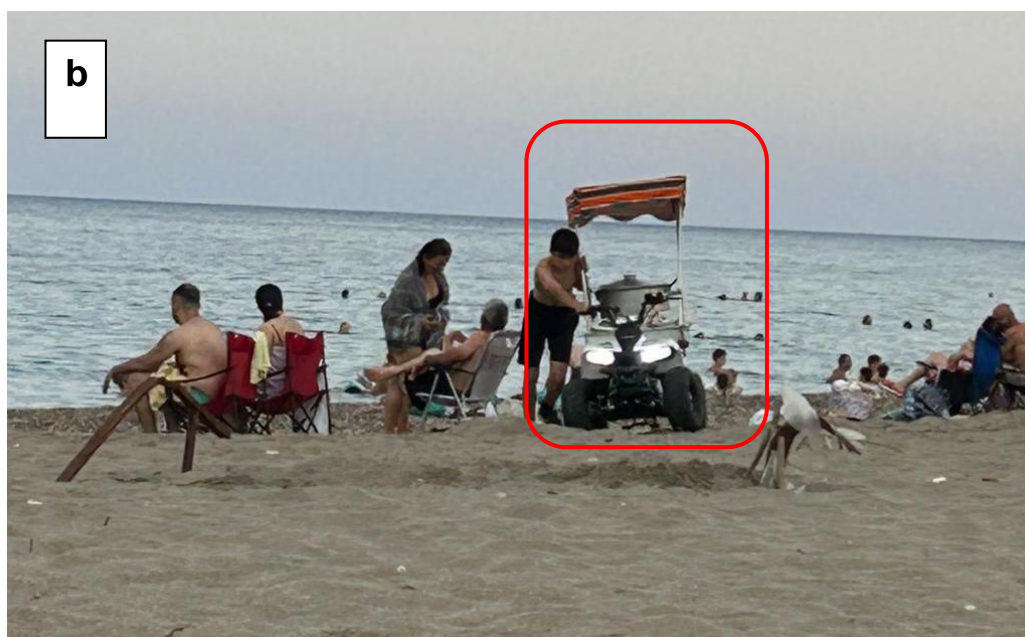
Fig. 7b) Corn sellers' vehicle at the beach

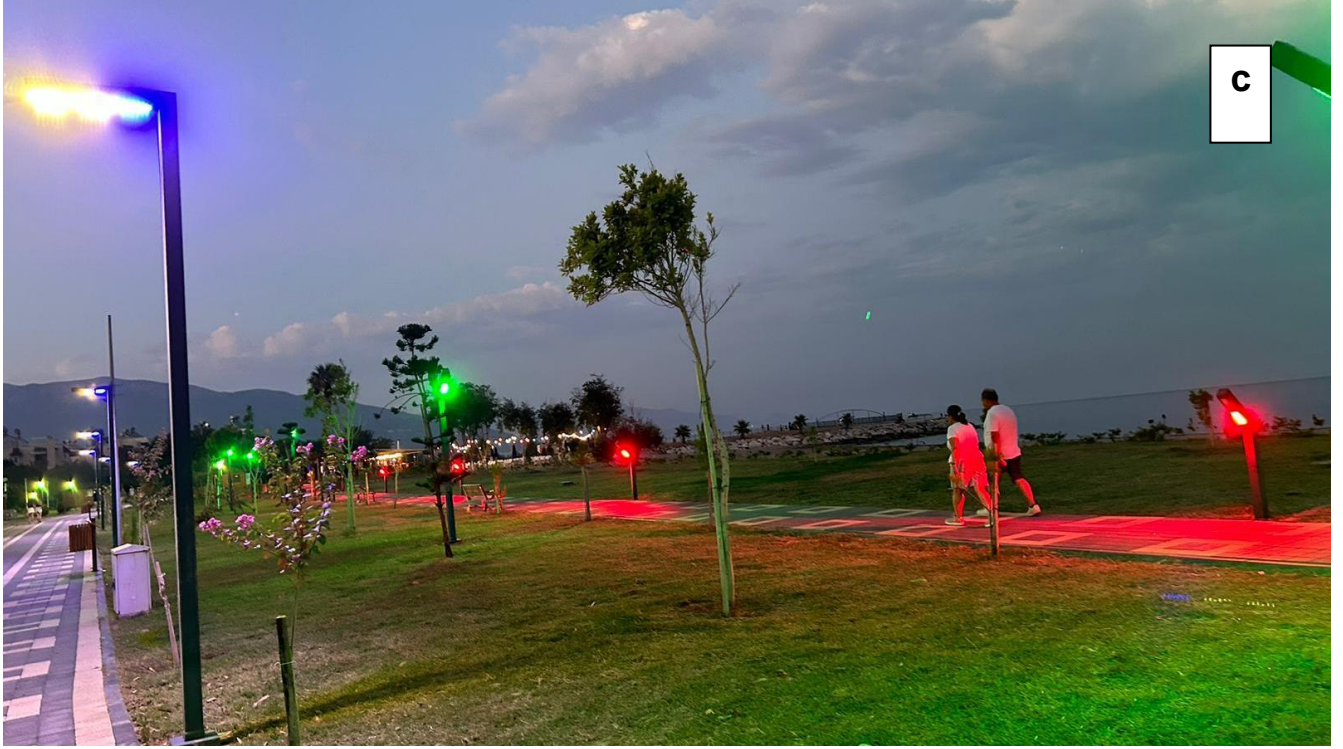
Fig. 7c) White, green and red lamps are used in the Beach Development Park (Devlet Bahçeli Parkı)

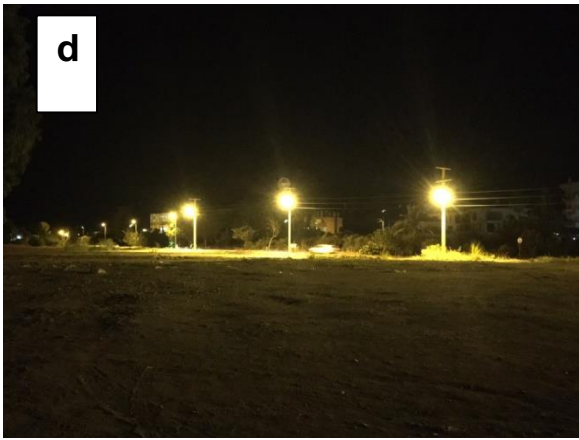
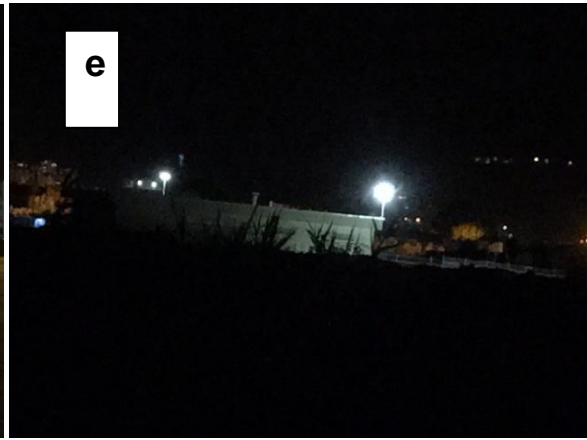
Fig. 7d) Street lamps facing to the sea in Cerenler region. 7e) Lights of the MESKİ (Water and Sewerage Office of Mersin Metropolitan Municipality) Pump station building - June 2024

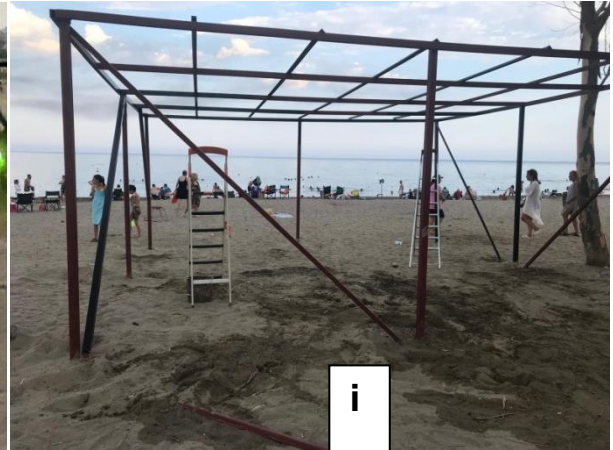
Fig. 7h- 7i) Iron profiles installed at the Anamur beach. It is learned that it will be a jet ski facility. And Nature Conservation and National Parks officials promised that the building will be removed. MERCED will monitor the status of the building.

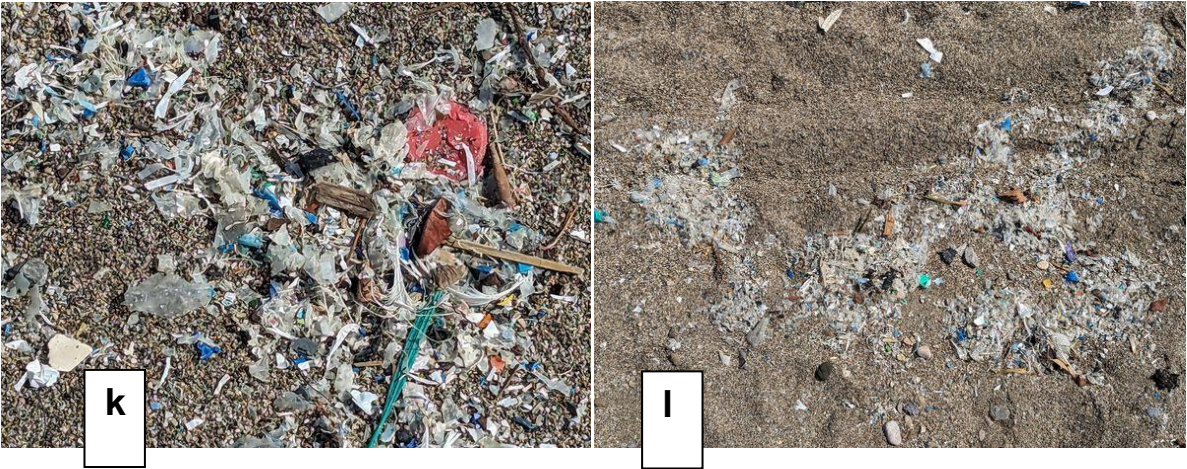
Fig. 7k, 7l) Plastic pollution at the beach. They are getting close to become micro plastics. They are approaching microplastic. They are candidates to be washed into the sea and swallowed by sea turtles.

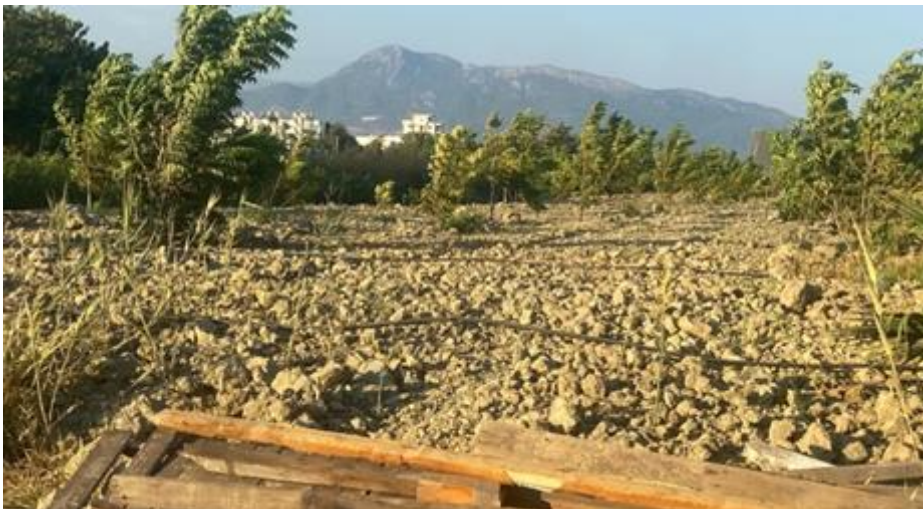
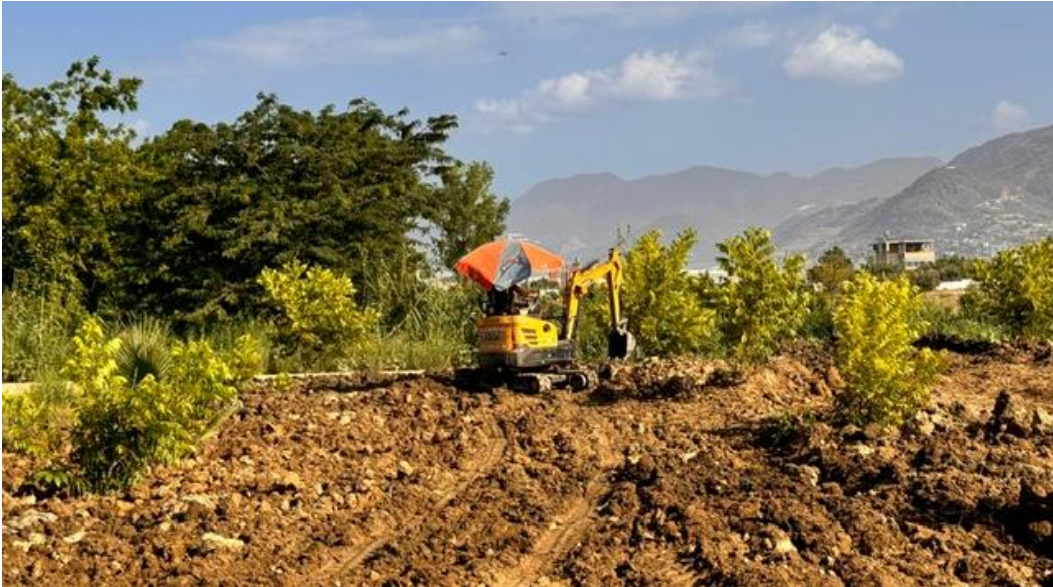
Fig. 8b) This area is within the 1st protection zone of the nesting beach. This soil and trees did not exist a few years ago - Karaagac Beach July 2024

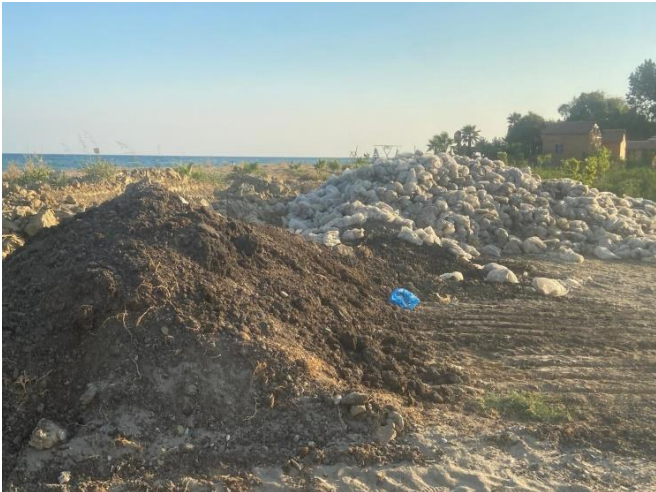
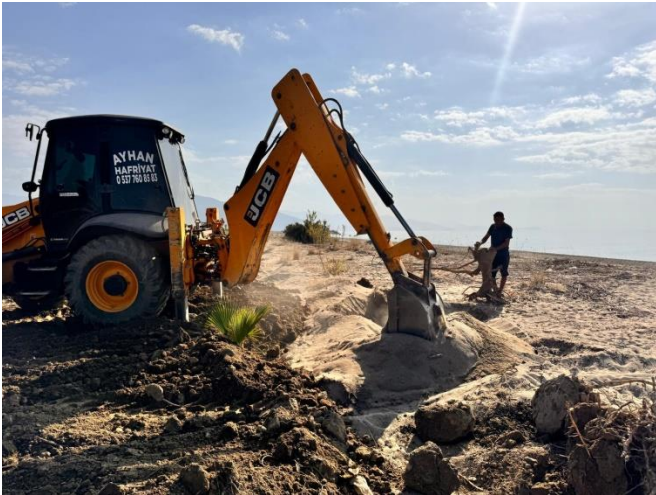
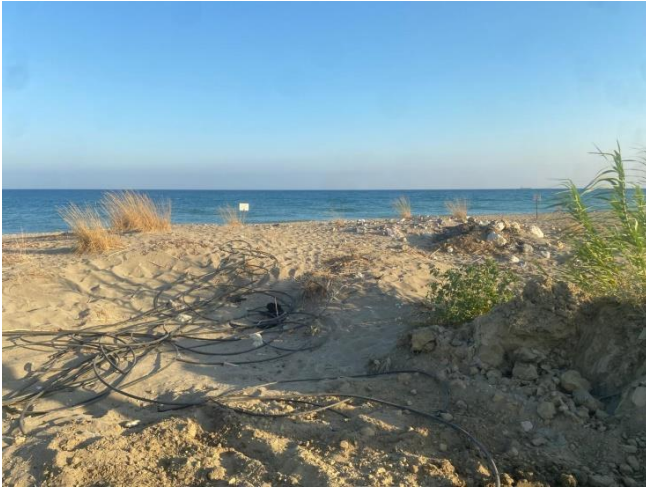
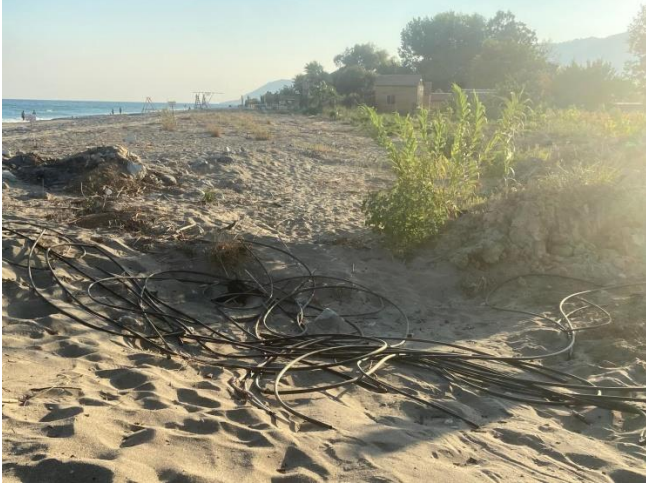
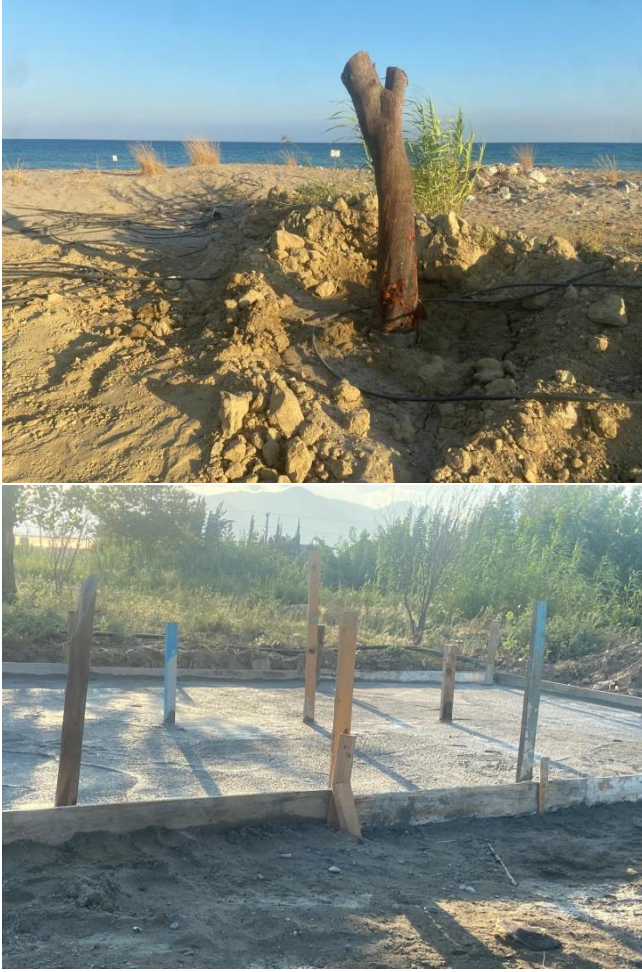
Figure 9 “Karaagac Beach & Restaurant”- Garden Construction and Concrete Floor - August 2024

Fig. 9) Excavation machines are regularly being operated during nesting season in the 1st protection zone of the beach. They mix soil and sand by the machines. They continue planting olive, walnut and fruit trees, and using fertilizers on the beach and continue agricultural activities, Plastic irrigation pipes resulting from antropojenic activities, Debris resulting from antropojenic activities, Habitat deformation of turtle nest beach as a result of interventions in the coastal zone with scoops in Karaagac. Also they built a concrete floor in the 1st protection zone - August 2024

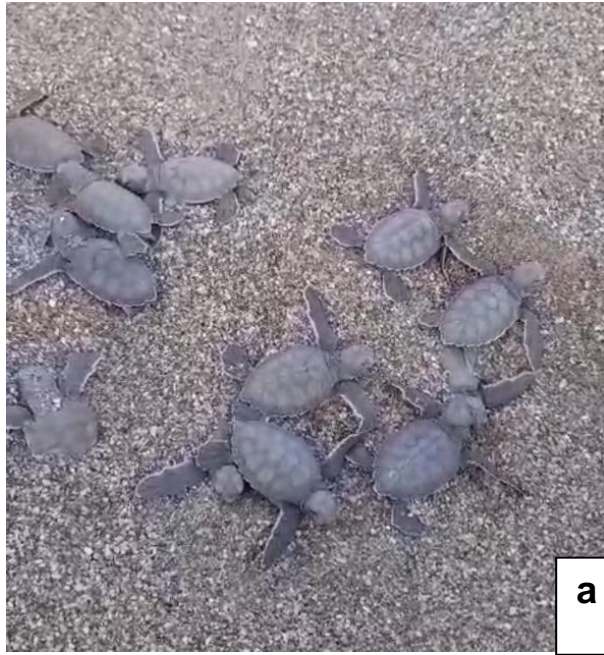
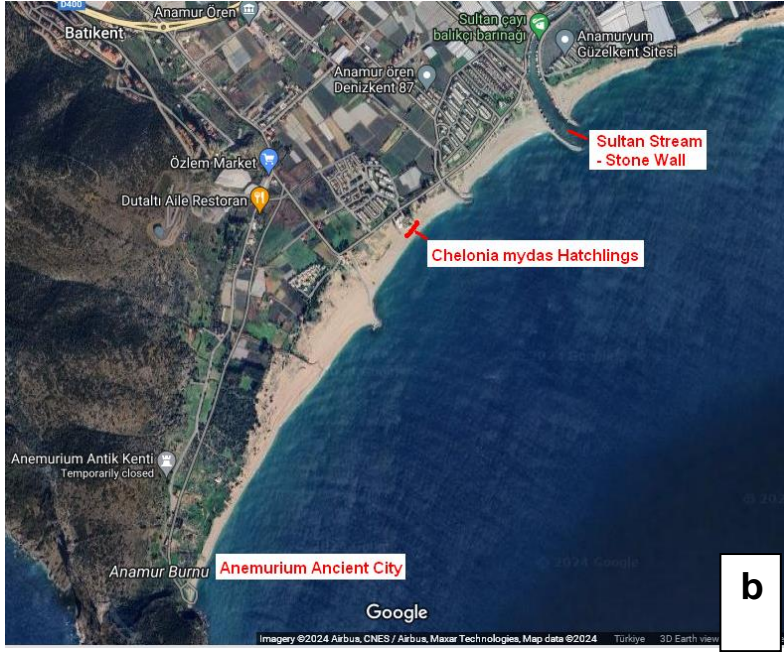
Figure 10 Green sea turtle (*Chelonia mydas*) Hatchlings in Ören - 26 July 2024

Fig. 10a) Green sea turtle (*Chelonia mydas*) Hatchlings in Ören region - Screenshot of videos shared at Annex 5 – [R16].

Fig. 10b) Map of the hatchling region (west of the Anamur nesting beach)

During the BCOSA, Green sea turtle (*Chelonia mydas*) nests were observed in the Dragon beach. After the OSA, people living at the Oren region recorded Green sea turtle hatchlings videos on 27.07.2024. (Full video reference is in Annex 5 - [R16]) Screenshot of the video and map of the location are available at Annex 4 - Figure 10.
