**Habitat destruction in Mersin Anamur Beach
(Türkiye)**

- REPORT BY THE COMPLAINANT -

LOGGERHEAD SEA TURTLE (*CARETTA CARETTA*), GREEN TURTLE (*CHELONIA MYDAS*) & AFRICAN SOFT SHELL TURTLE (*TRIONYX TRIUNGUIS*) CONSERVATION MONITORING IN ANAMUR, MERSIN, TÜRKİYE

4 November 2024

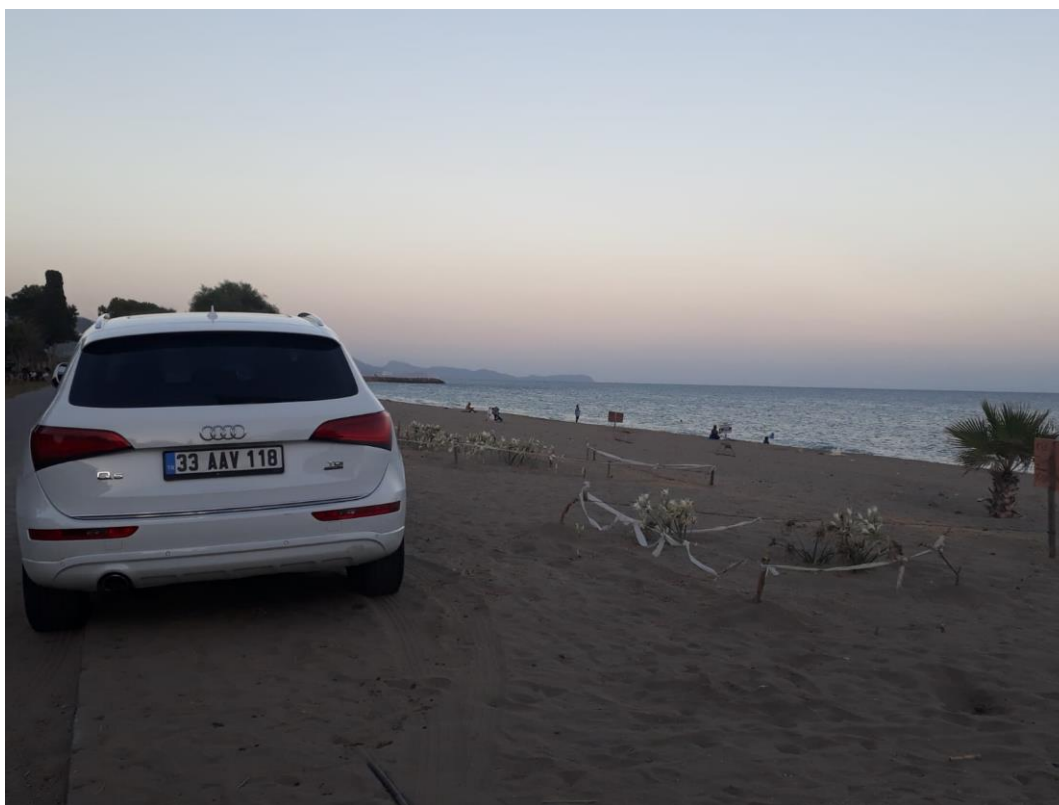
Figure 11 Illegal Car Entry to the Beach - August 2024

Fig. 11) A car parked near sand lilies (*Pancratium maritimum*), an endemic plant- August 2024

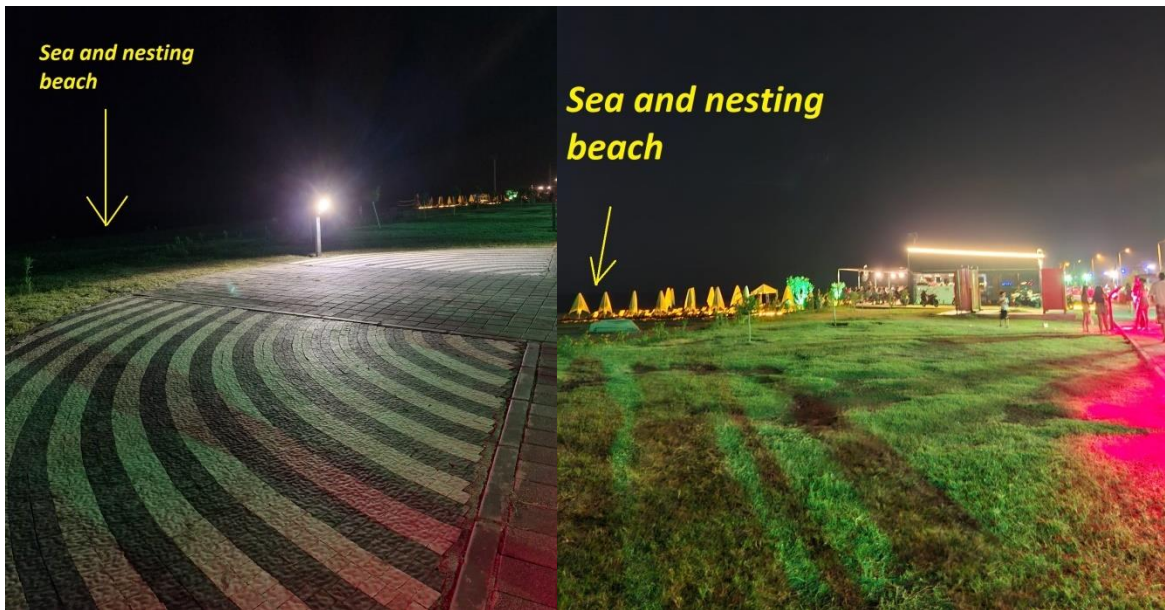
Figure 13 Light Pollution - September 2024

Fig. 13) Lighting poles at the bottom of the beach area where sea and turtle nests are located in Devlet Bahçeli Park. September 2024

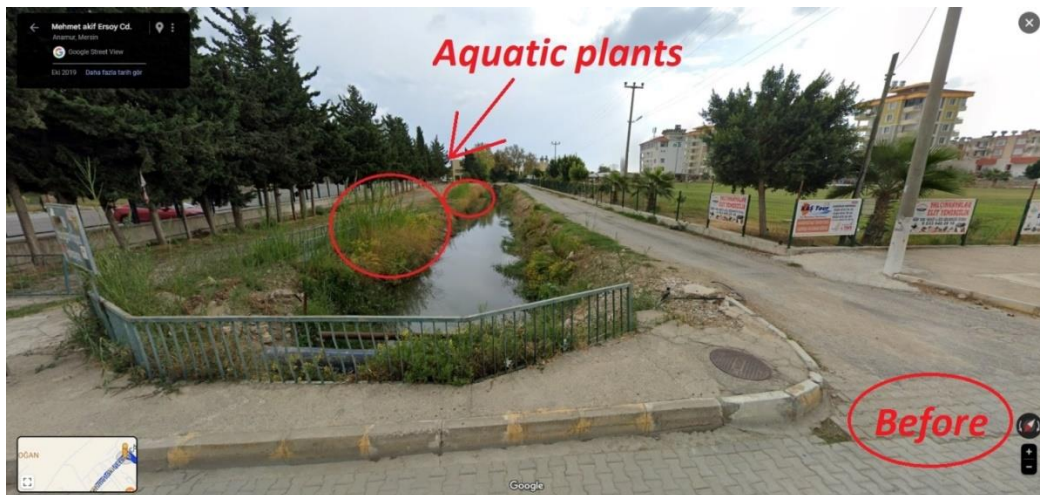
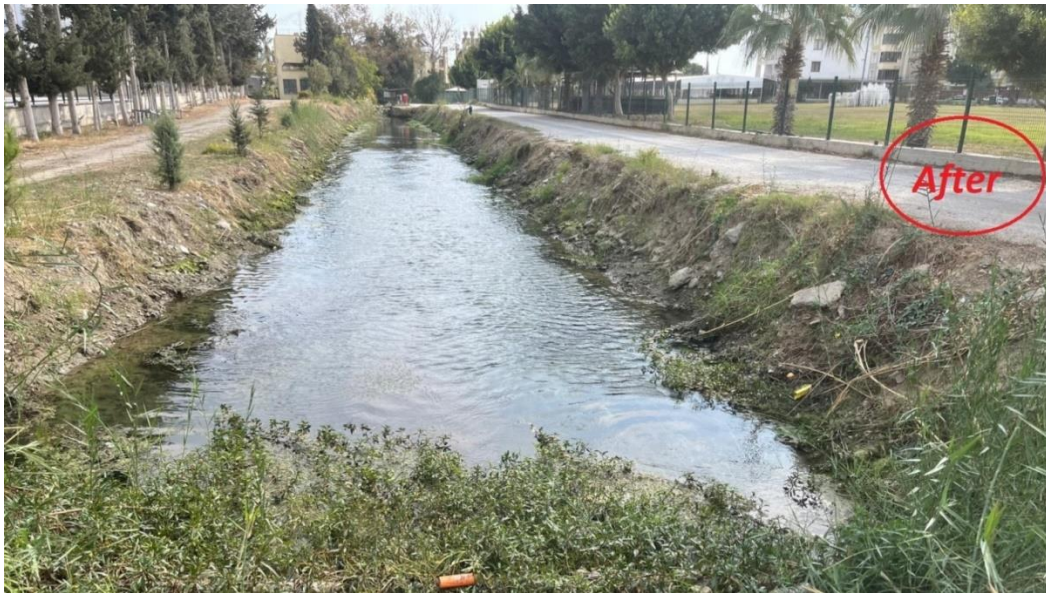
Fig. 14a, b) Destruction of aquatic plants in the stream next to Anamur 82 facilities

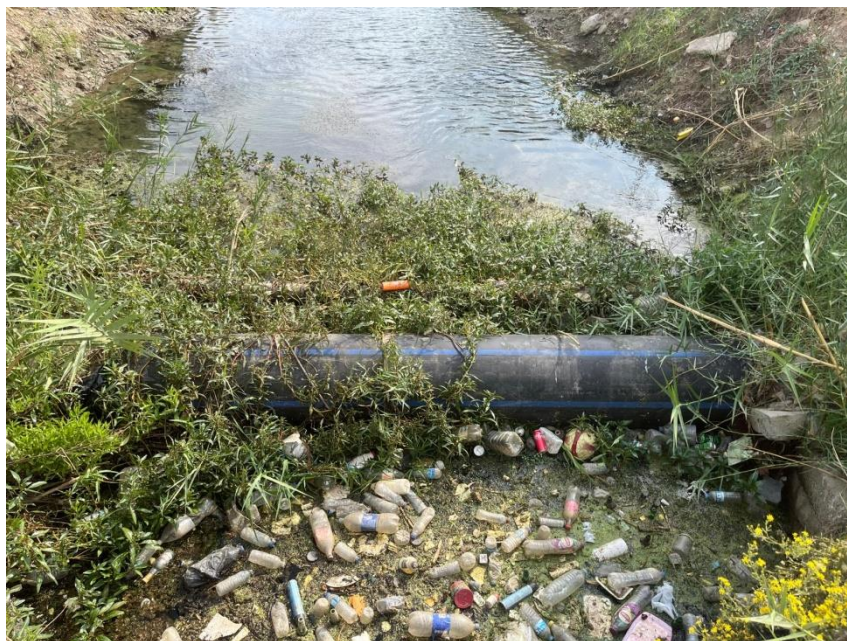
Fig. 14 c) Pollution in the stream next to Anamur 82 facilities

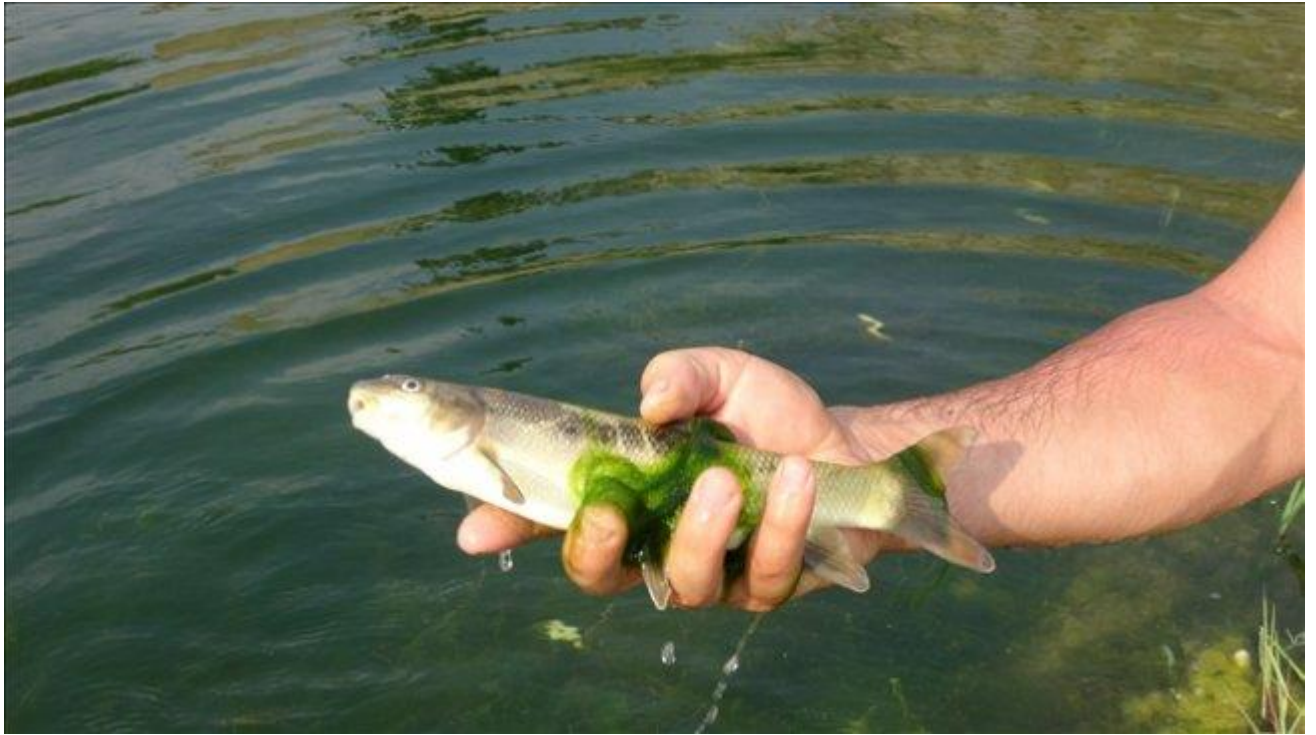
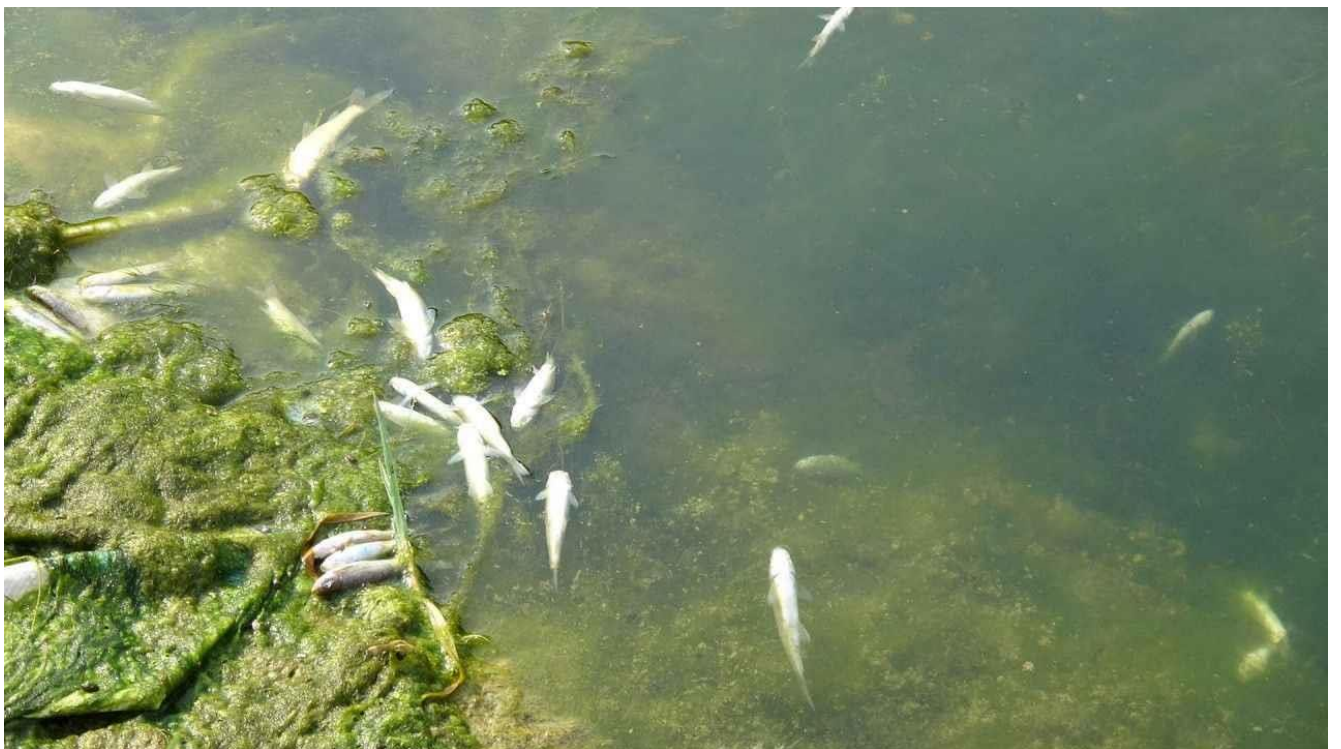
Figure 15 Mass Fish Deaths in the Streams

Fig. 15 a, b) Mass fish deaths in various streams in Anamur. Videos are available at Ref [R17]

The damage to the streams from existing and possible mines quarries in the region is unknown. Additionally, agricultural pollutants in the environment need to be investigated. Mass fish deaths occur at various times in these streams, which are home to Nile turtles. Again, the municipality's stream improvement and cleaning efforts are likely to have negative effects on the aquatic life in the streams. (References [R16-R17] includes videos)

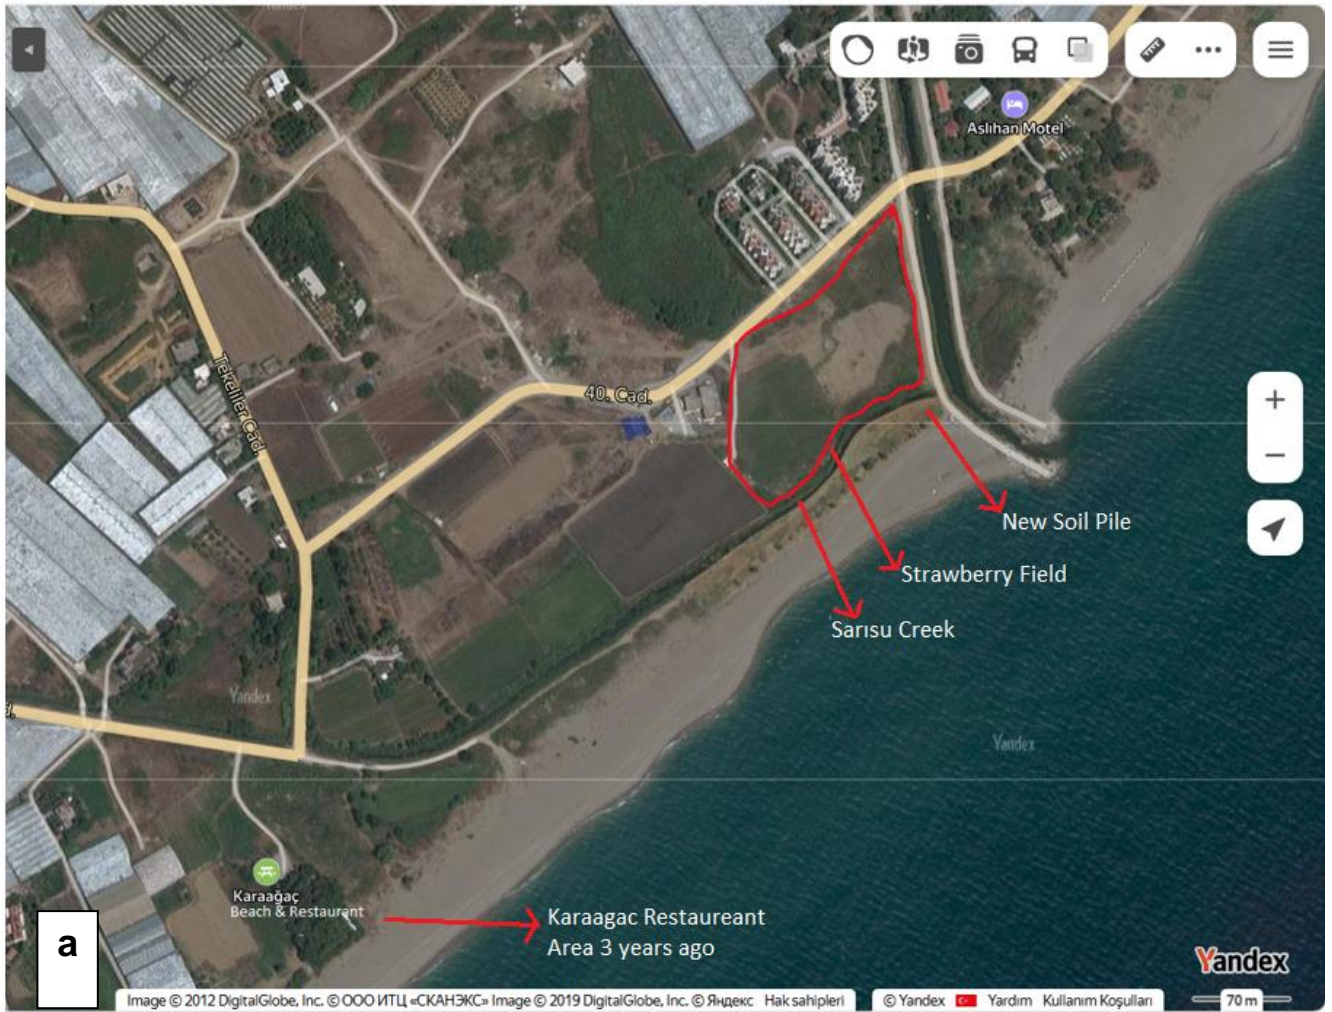
Figure 16 Soil Pile at the Karaagac Picnic Area – October 2024

Fig. 16a) Map of Karagac Beach November 2024 @Yandex Maps.

This map shows, new soil pile at the east of the beach (between Sarisu Creek and the sea). Also it displays the Karaagac Beach & Restaurant before they start invading the beach. No bungalows, no walnut garden, no concrete floor, no beach furniture.

22. The soil brought to the Karaagaç Picnic Area should be removed (Ref: Annex 4 - Fig. 16)

Related map and the photographs are presented at Annex 4-Figure 16.

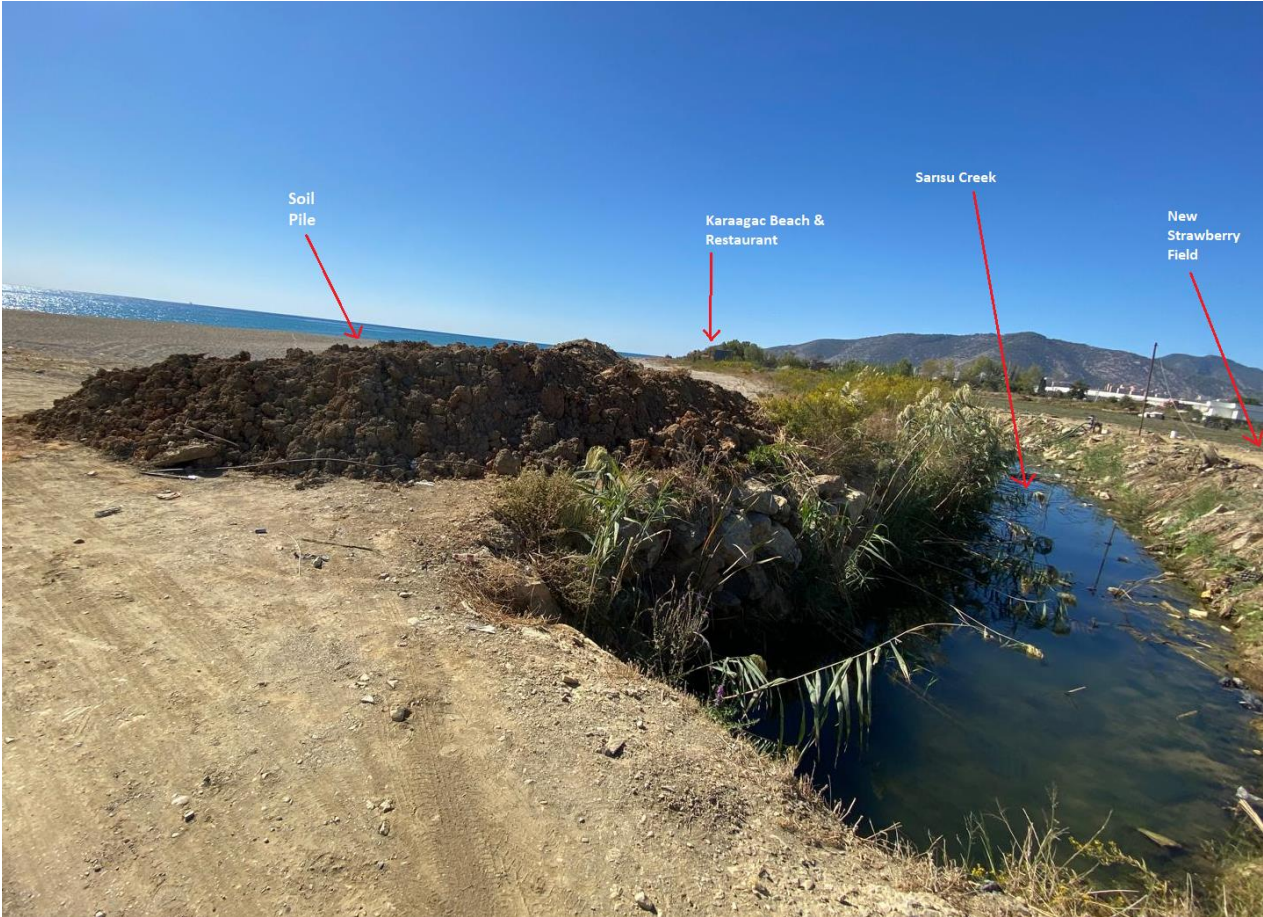
Fig. 16b) New soil pile is put on the beach. Reeds of the Sarsu Creek are cut during strawberry field works – Karaagac Beach – November 2024

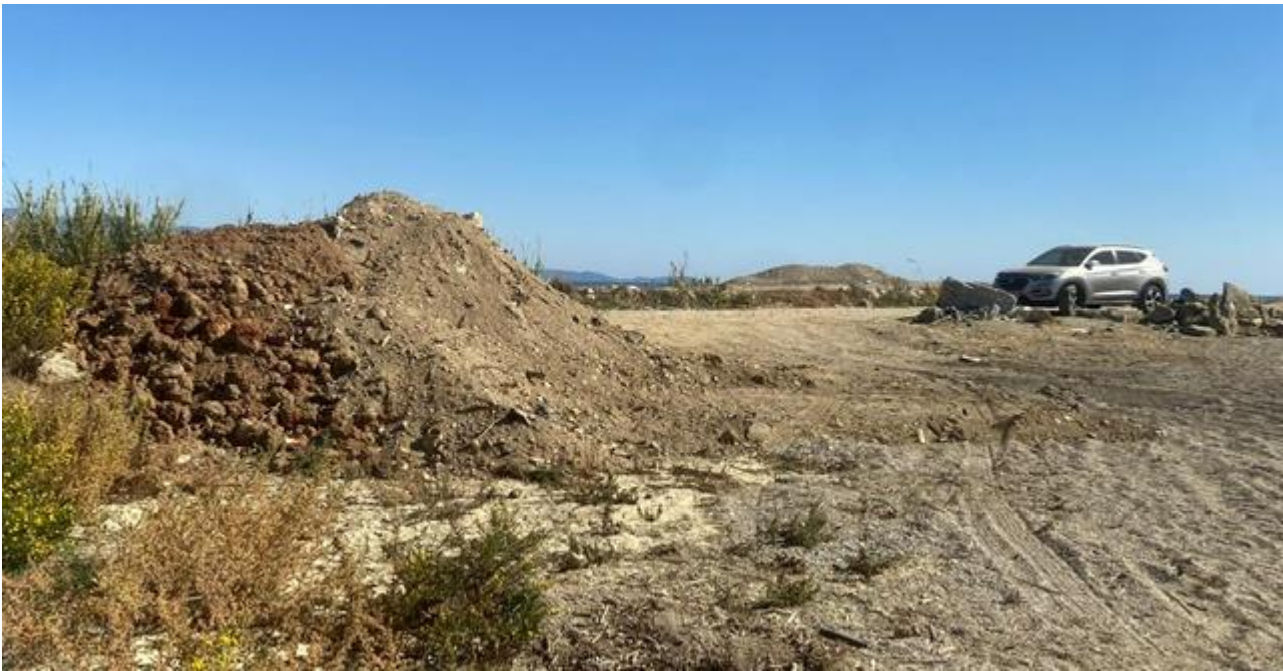
Fig. 16c) Soil pile on the beach. Since there is no barrier to entrance of the beach it is easy to bring soil or extract sand from the beach – Karaagac Beach – November 2024

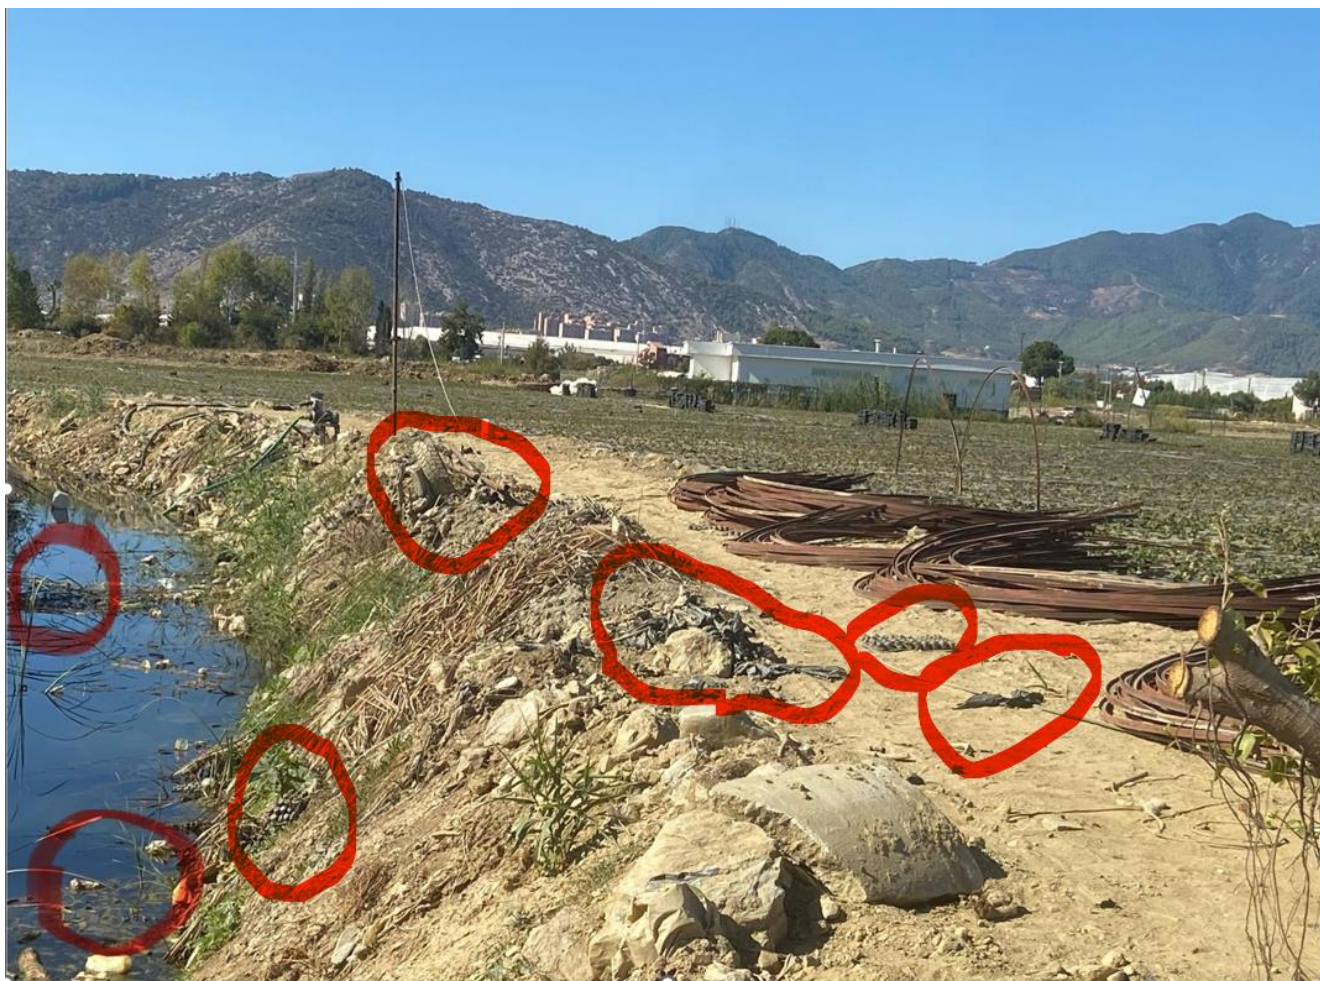
Fig. 16c) Plastic pollution caused by the strawberry field established on the north side of Sarisu Creek. In addition, reeds that had previously reached a height of 2 meters were cut on the banks of the Sarisu Creek – Karaagac Beach – November 2024

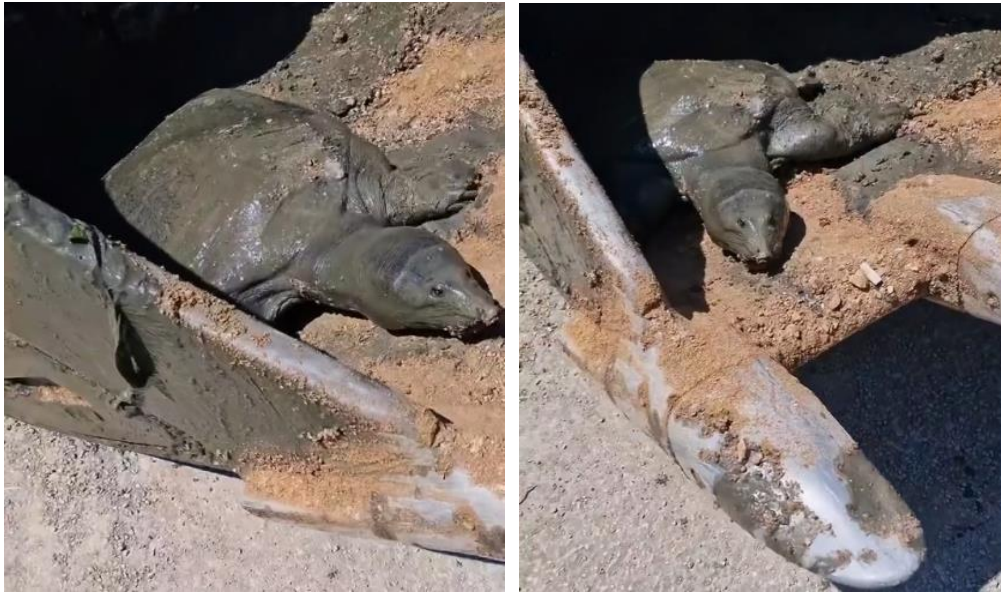
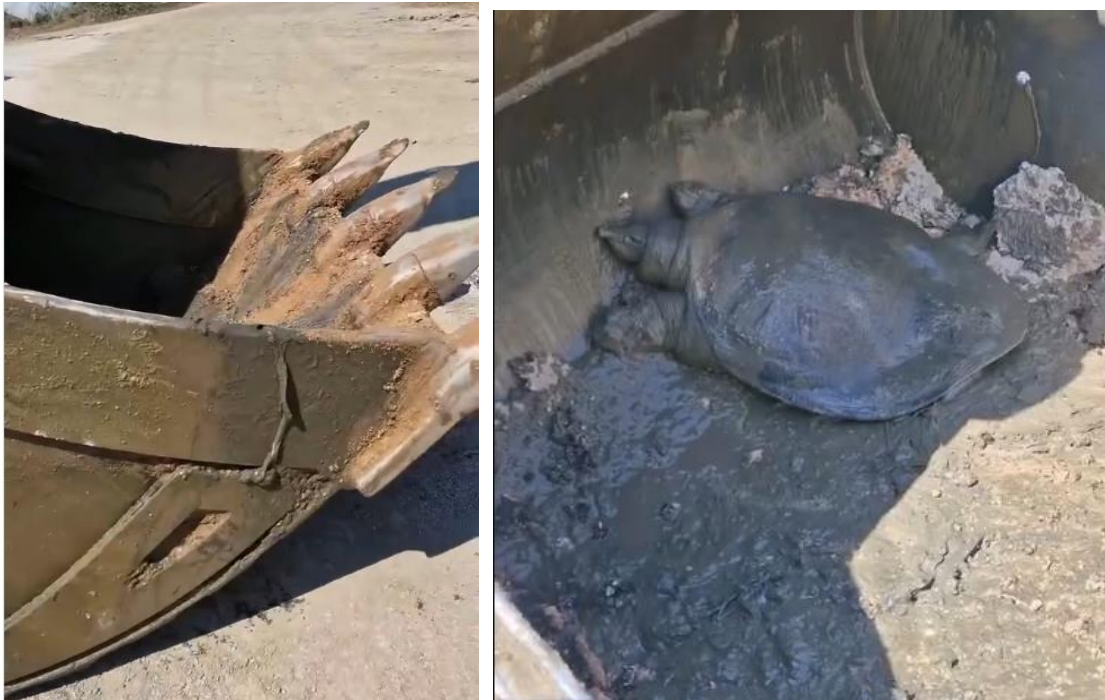
Figure 17 Soil Pile at the Karaagac Picnic Area – October 2024

Fig. 16c) A Nile turtle (*Trionyx triunguis*) individual caught during channel cleaning activity in the Akdeniz Neighborhood – Akdeniz Mahallesi (Neighbourhood) – November 2024 – Screenshot of video given in Annex 5 - [R18] – Copyright “anamurun_sesi” instagram account.

Related photographs are presented at Annex 4-Figure 17 and video link is available in Annex 5 - [R18].

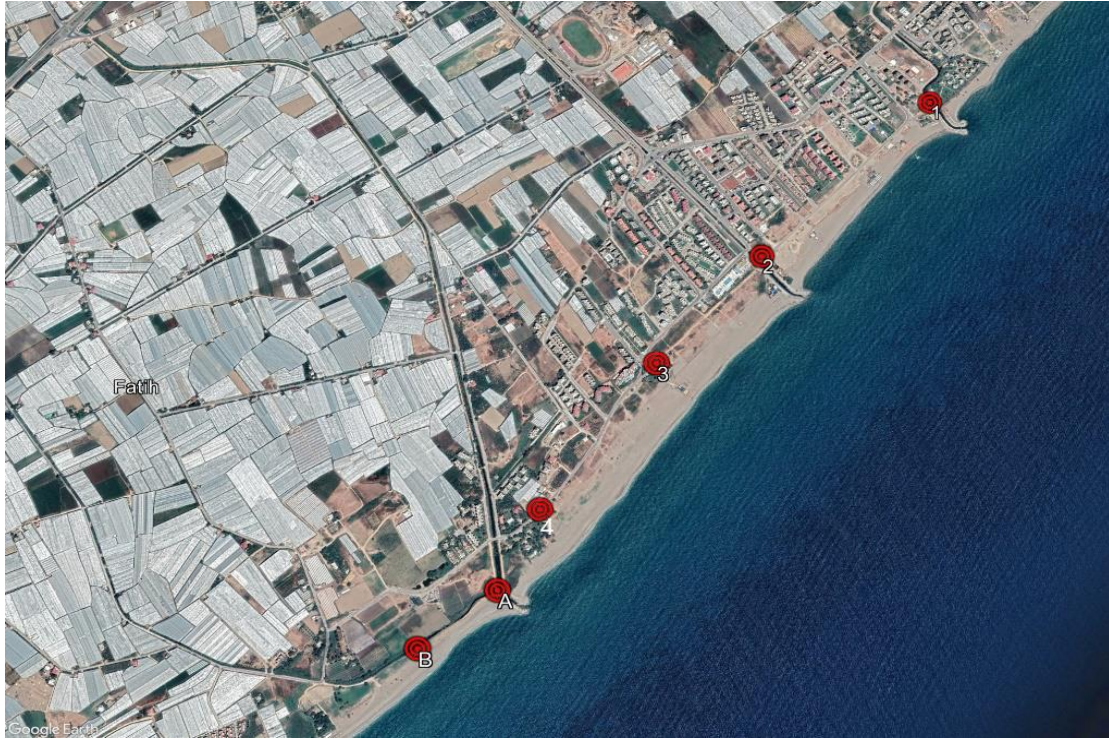
Map 2) Map displaying the allocated to the Anamur Municipality for Beach Development Phase. Area between 1 and 3 is completed so far - © MERÇED 8 August 2023

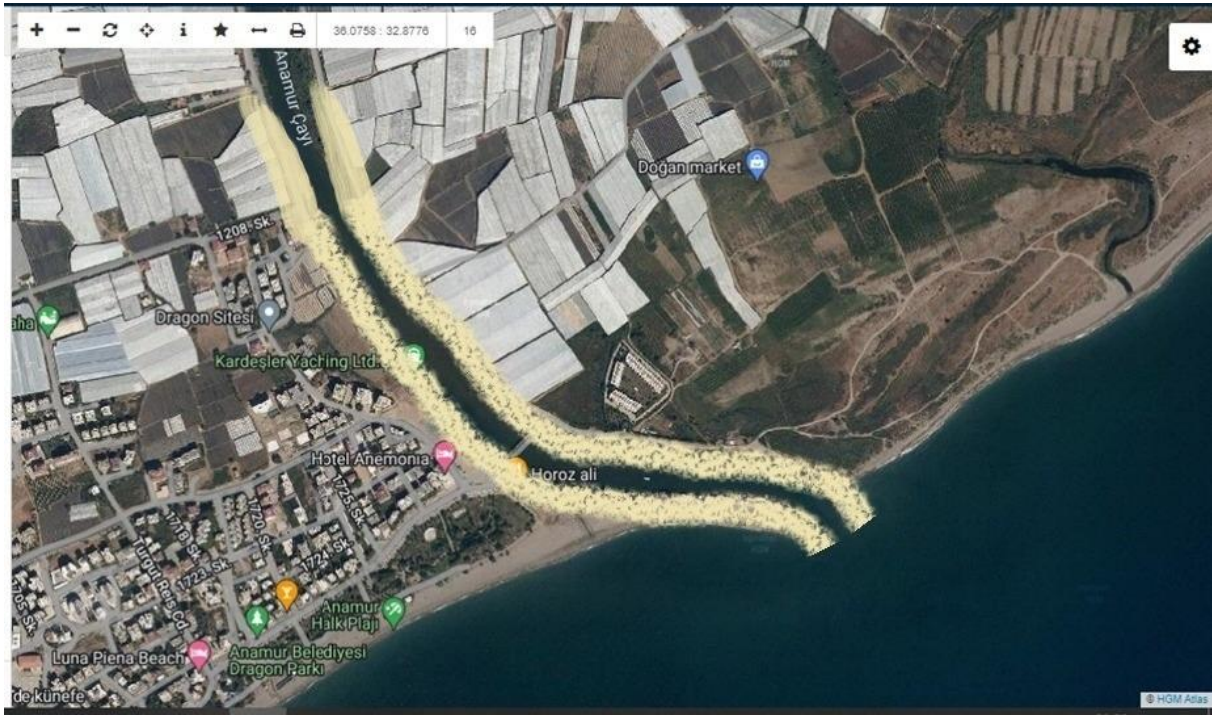
Map 3) Stone wall built alongside the Dragon River where African (Nile) Softshell Turtle (*Trionyx triunguis*) lives - © MERÇED February 2024

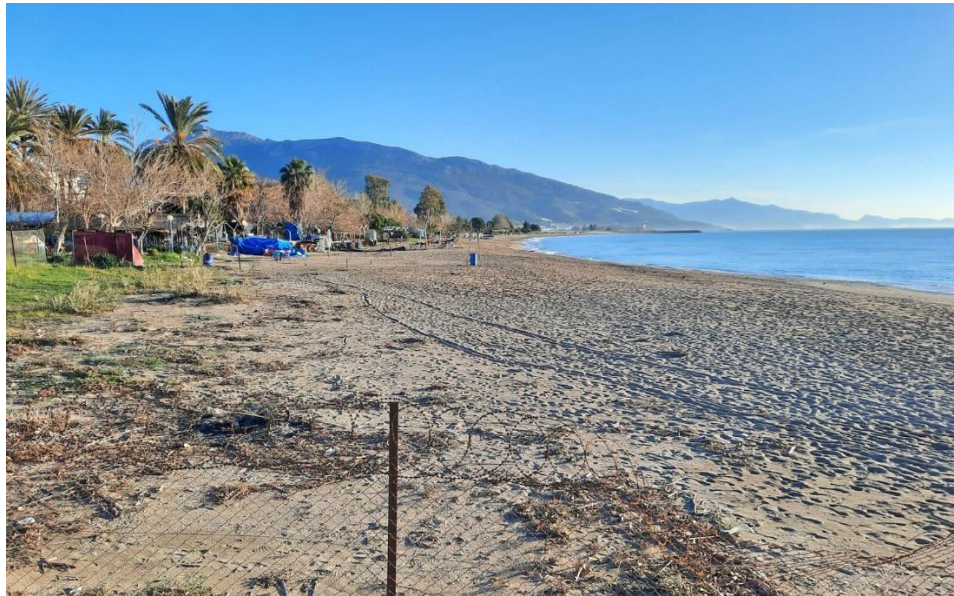
Figure 1 Vehicle entrance to the beach

(Fig. 1) Car tire tracks on the beach

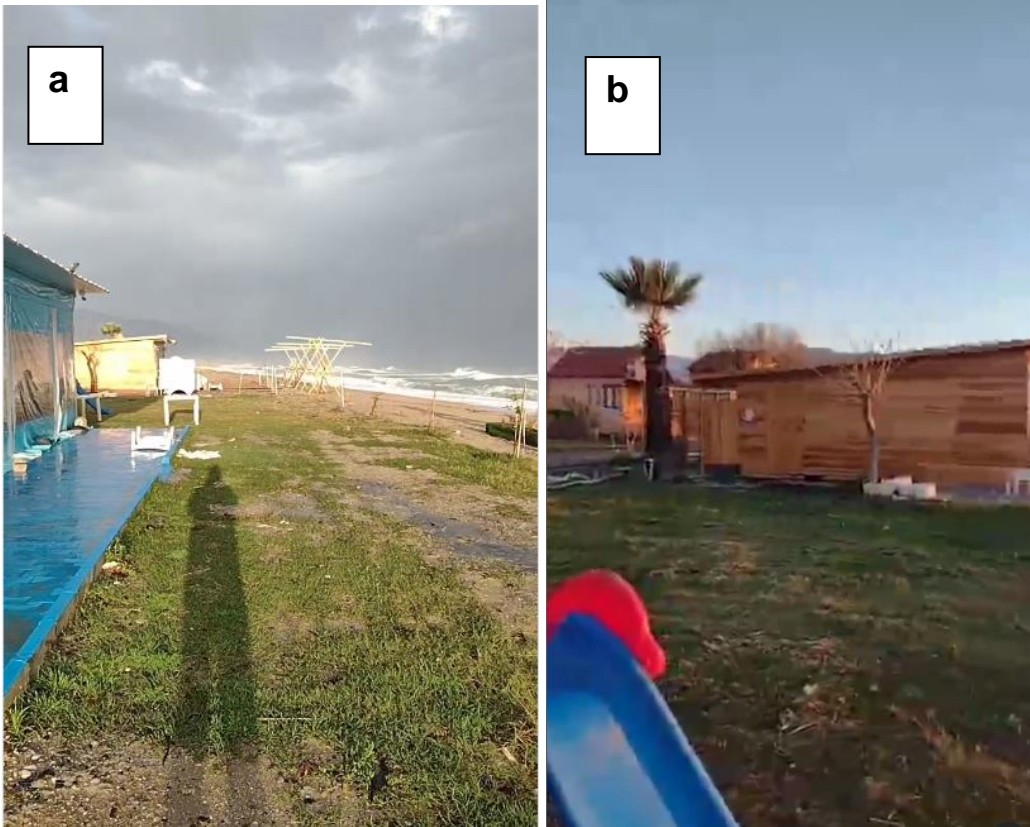
(Fig. 2a) Karaağaç Beach & Restaurant occupy beach. Ref6: Instagram account of Karaağaç Restaurant: <https://www.instagram.com/reel/C1KEjYfIXGW/> - January 2024

(Fig. 2b) Bungalows of the Karaağaç Beach & Restaurant. Ref7: Instagram account of Karaağaç Restaurant: <https://www.instagram.com/reel/C1OUqduIr8B/> - January 2024

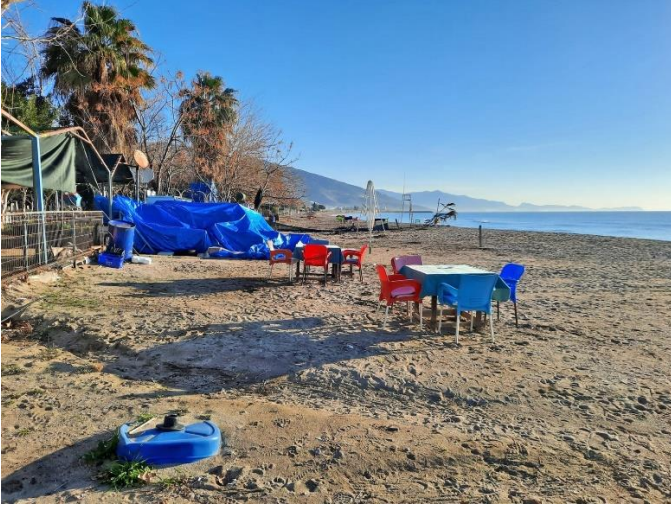
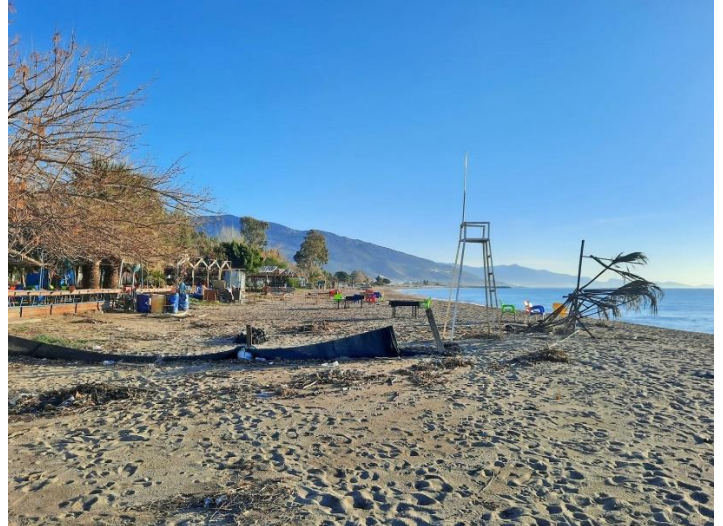
(Fig. 2c-2f) Businesses in the İskele Region – © MERÇED 6 February 2024

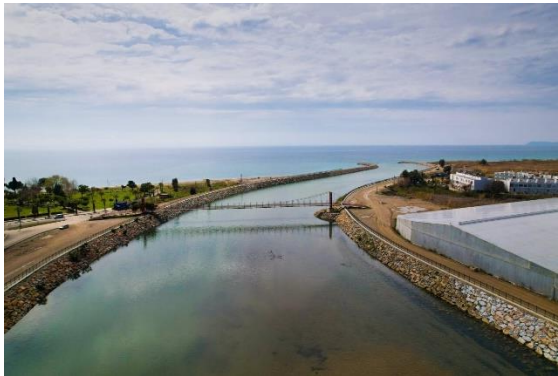
Figure 3 (a-d). Stone wall built alongside the Dragon Rivulet

(Fig. 3a-3d) Stone wall built alongside the Dragon Rivulet – Ref8: Website of the State Hydraulic Works (DSI) institution <https://www.dsi.gov.tr/Galeri/ResimgaleriDetay/4488> - © State Hydraulic Works (DSI) institution - 2023
