**Habitat destruction in Mersin Anamur Beach  
(Türkiye)**

**- REPORT BY THE COMPLAINANT -**

**LOGGERHEAD SEA TURTLE (*CARETTA CARETTA*),  
GREEN TURTLE (*CHELONIA MYDAS*) &  
AFRICAN SOFT SHELL TURTLE (*TRIONYX TRIUNGUIS*)  
CONSERVATION MONITORING IN ANAMUR, MERSIN, TÜRKİYE**

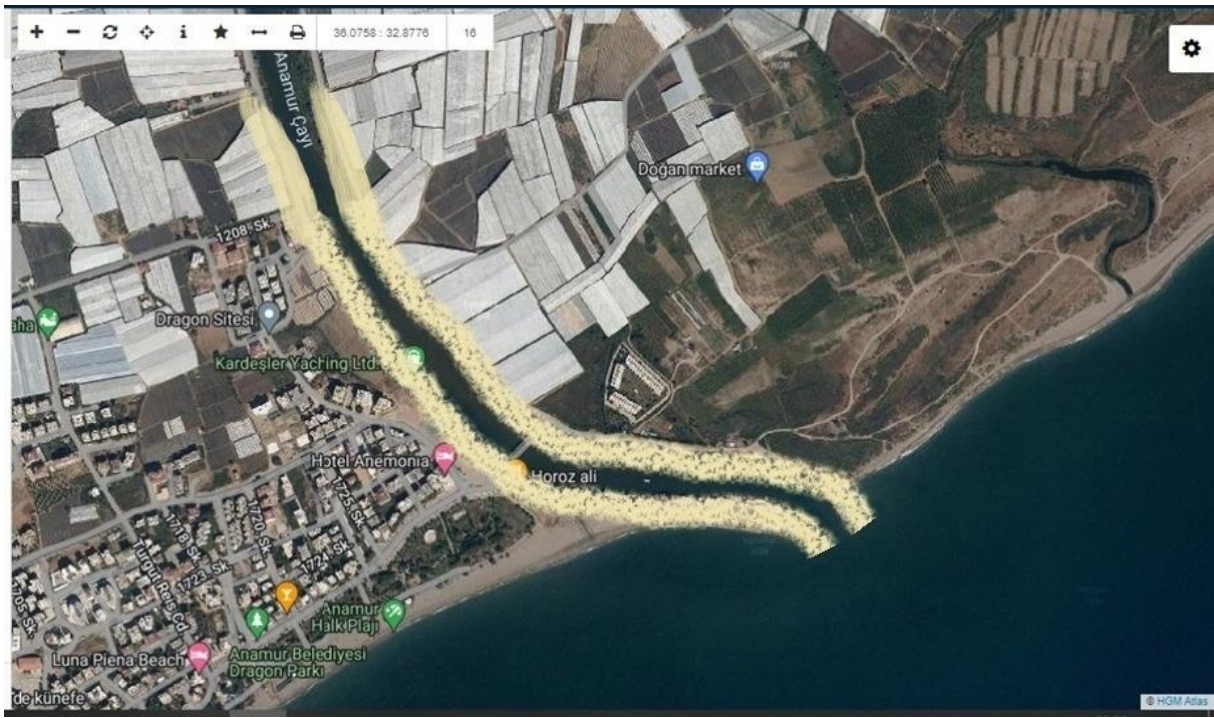
**Map 3)** Stone wall built alongside the Dragon River where African (Nile) Softshell Turtle (*Trionyx triunguis*) lives - © MERÇED February 2024

As stated in previous reports Dragon River is home to the African (Nile) Softshell Turtle (*Trionyx triunguis*). Last year, a 1.400 m stone wall built alongside the left and right of the Dragon River. The wall slope is steep, the stones pieces are too big and there are gaps in between the stones. This situation causes no turtle species to be able to climb up for nesting.

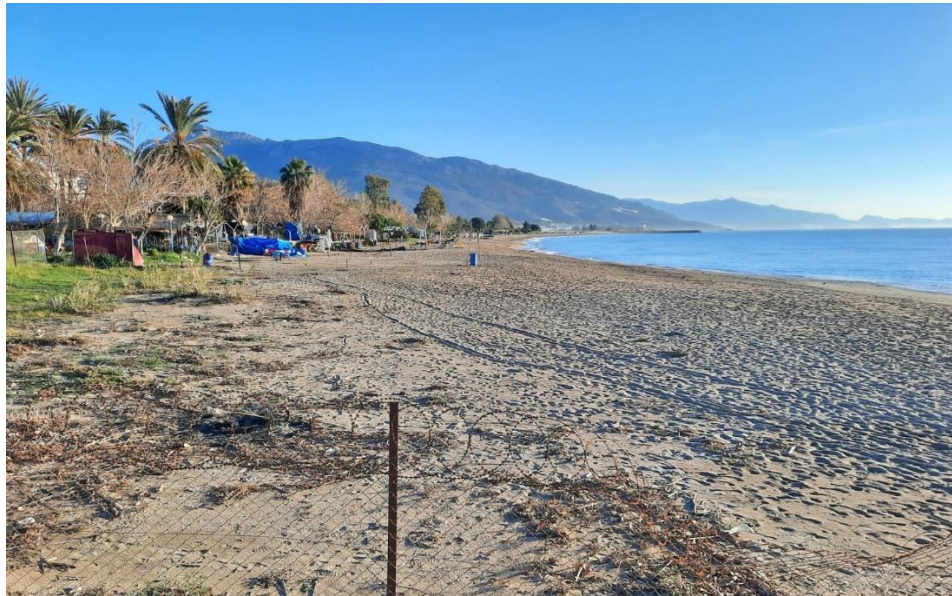
**Figure 1 Vehicle entrance to the beach**

(Fig. 1) Car tire tracks on the beach

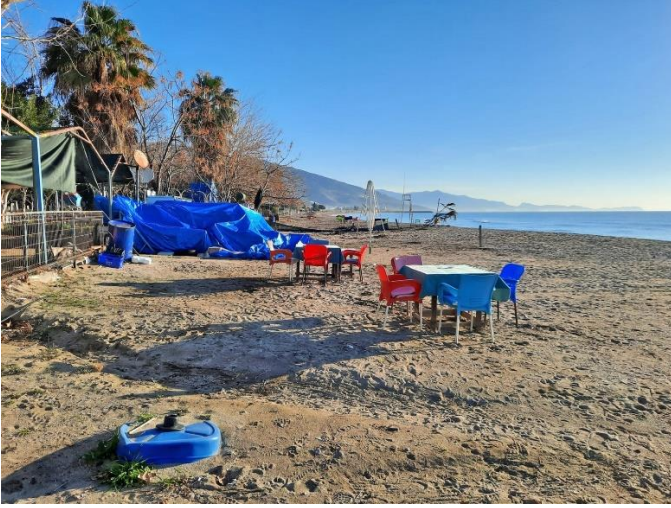
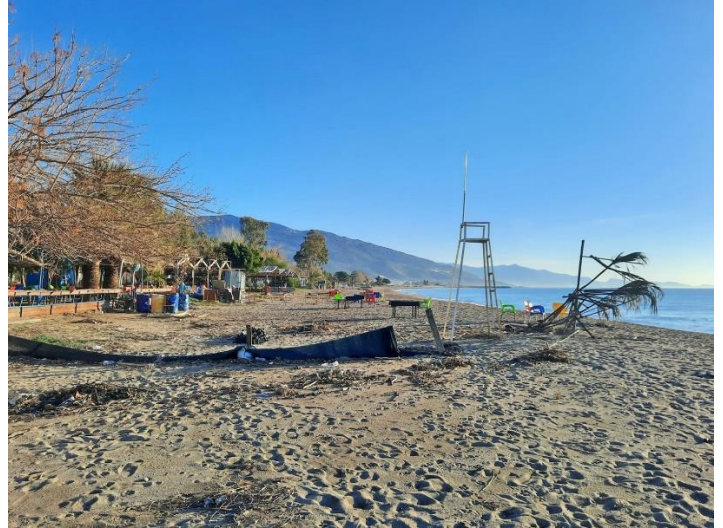
(Fig. 2c-2f) Businesses in the İskele Region – © MERÇED 6 February 2024

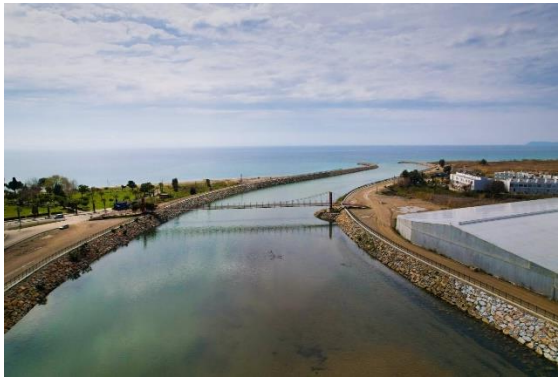
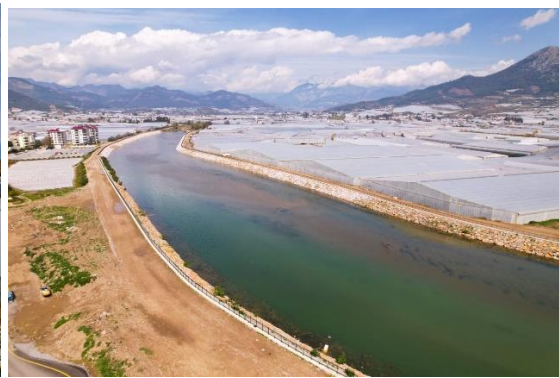
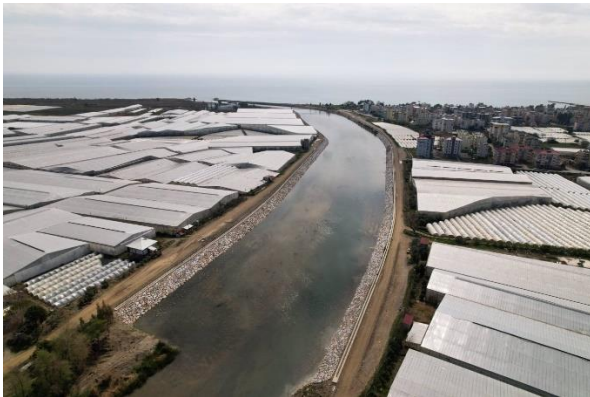
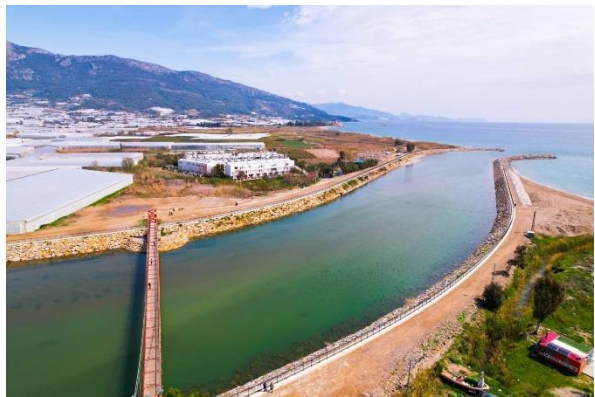
**Figure 3 (a-d). Stone wall built alongside the Dragon Rivulet**

(Fig. 3a-3d) Stone wall built alongside the Dragon Rivulet – Ref8: Website of the State Hydraulic Works (DSI) institution <https://www.dsi.gov.tr/Galeri/ResimgaleriDetay/4488> - © State Hydraulic Works (DSI) institution - 2023

- Collaborate and communicate with the local NGOs for ongoing and future changes.
- Prevent further stonewall construction along the Dragon River that results in irreversible damage to the habitat and severely impacts the nesting activity and habitat of the *Trionyx triunguis* turtles.
