**Habitat destruction in Mersin Anamur Beach (Türkiye)**  
**- REPORT BY THE COMPLAINANT -**

**UPDATE REPORT BY THE NGO****Marine Turtle Conservation in the Mediterranean****LOGGERHEAD SEA TURTLE (*CARETTA CARETTA*) &  
SOFT SHELL NILE TURTLE (*TRIONYX TRIUNGUIS*)  
CONSERVATION MONITORING IN ANAMUR, MERSIN, TÜRKİYE****8 February 2024**

*Document prepared by*  
**MERÇED - Mersin Environment and Nature Association Deputy**  
*& presented by*  
**MEDASSET - the Mediterranean Association to Save the Sea Turtles**

## **ANNEX 1: DETAILED UPDATE REPORT OF 2024 FOR ANAMUR SPA, TURKEY, MAPS & PHOTOGRAPHS**

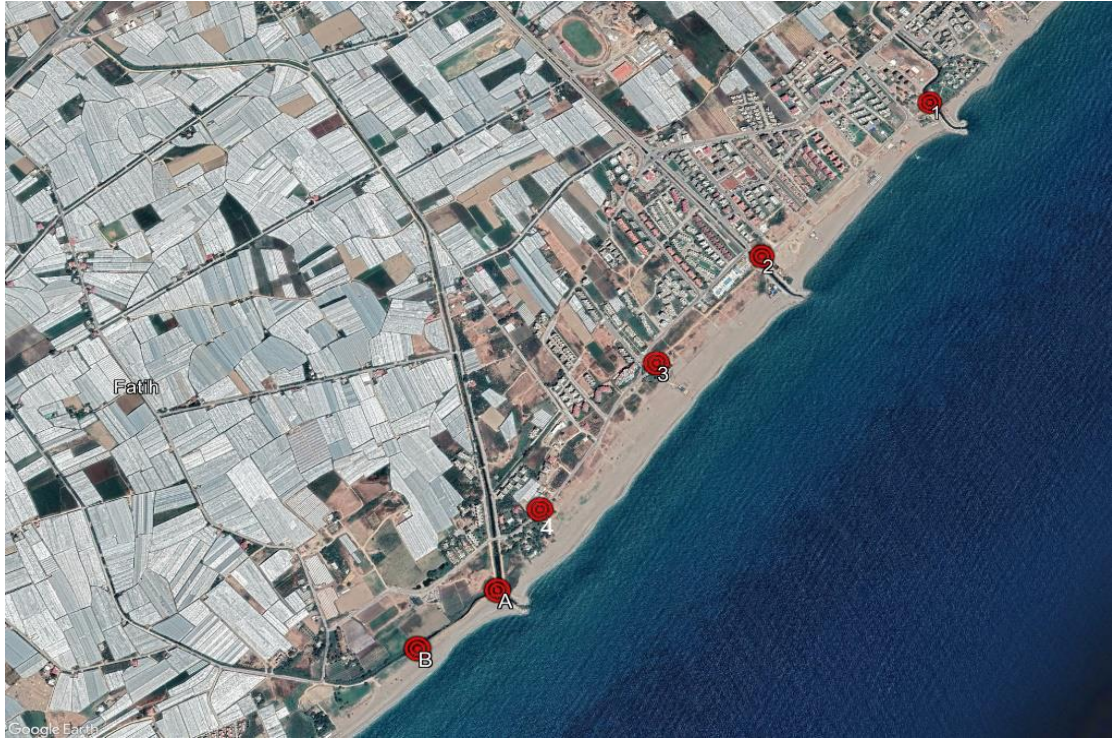
**Map 2)** Map displaying the allocated to the Anamur Municipality for Beach Development Phase. Area between 1 and 3 is completed so far - © MERÇED 8 August 2023

No additional construction took place yet this winter, although initially published project area plans describe a larger area than the area already completed. The reasons for this welcome delay are not known yet but may be due to the upcoming elections that will occur this spring or due to financial reasons.

No rehabilitation of the existing violations caused by the previous two development phases and described below, has occurred. Tons of soil were poured into the beach and dune areas are filled with stones and concrete, creating artificial landscape areas. Trees were planted on the beach; they are irrigated and fertilized regularly. Excessive water flowed on to the beach. These illegal activities continued during the nesting season, and the authorities remained silent and did not fulfill their inspection duties.

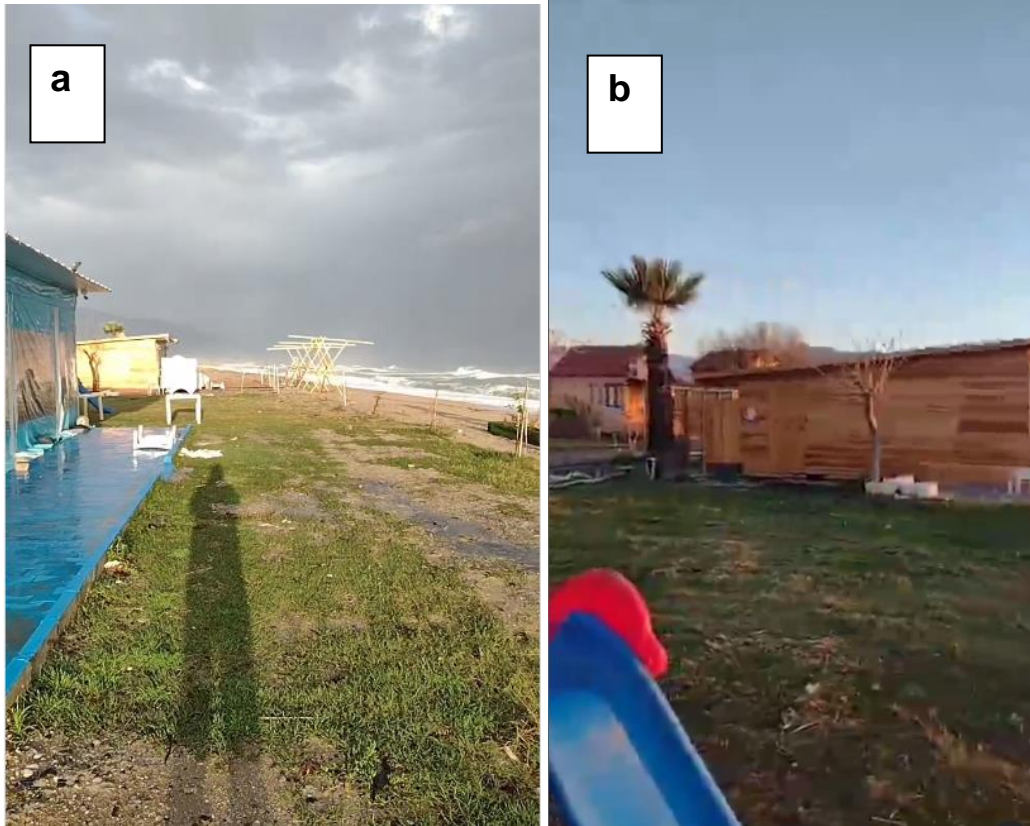
**Figure 2 (a-f). Expanding businesses on the nesting beach**

Karaağaç Beach & Restaurant in the Karaağaç region is one of these businesses. They continue to plant hundreds of trees, irrigate and fertilize plants, build bungalow houses, and place camellias, sun loungers, umbrellas, tables, etc. on the beach within 20-30 meters away from the shoreline. The authorities remain silent about the company's increasing number of bungalow houses, camellias, beach furniture and trees every year. The business area is within the 1st Degree Protection Zone. Photographs are provided in previous reports and company's Instagram account (Ref1: <https://www.instagram.com/karaagacbeach/> )

(Fig. 2a) Karaağaç Beach & Restaurant occupy beach. Ref6: Instagram account of Karaağaç Restaurant: <https://www.instagram.com/reel/C1KEjYfIXGW/> - January 2024

(Fig. 2b) Bungalows of the Karaağaç Beach & Restaurant. Ref7: Instagram account of Karaağaç Restaurant: <https://www.instagram.com/reel/C1OUqduIr8B/> - January 2024

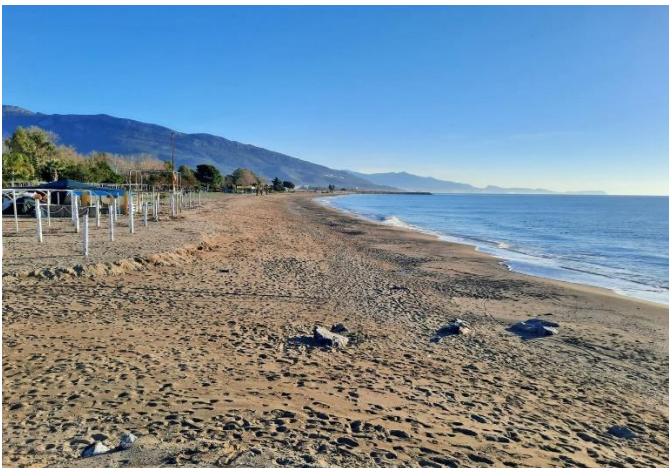
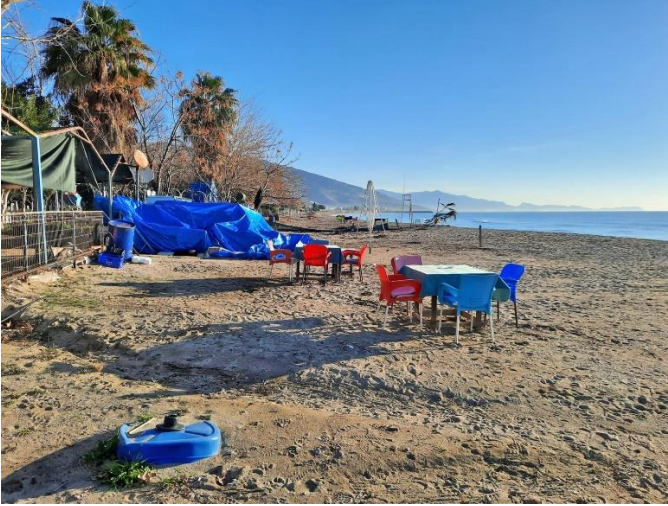
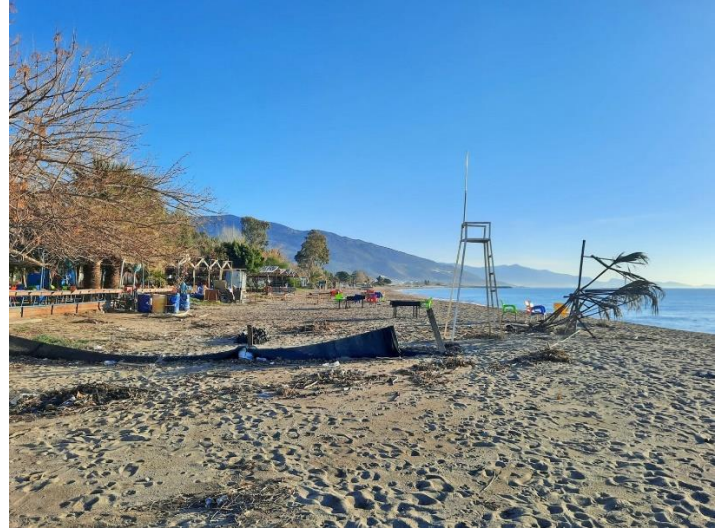
Also, there are many businesses in the Iskele region that occupy the beach. Some of the recent photographs of this region are given in Figure 2.

The beach furniture management of all these facilities does not comply with any rules. They keep beach furniture at the beach during the day and night. They all create huge amounts of noise and light pollution till late hours.

(Fig. 2c-2f) Businesses in the İskele Region – © MERÇED 6 February 2024
