New complaint: 2022/05

**Fence Construction on the Polish-Belarusian Border
(Poland)**

- REPORT OF THE GOVERNMENT -

*Document prepared by
the General Director of Environmental Protection of Poland*

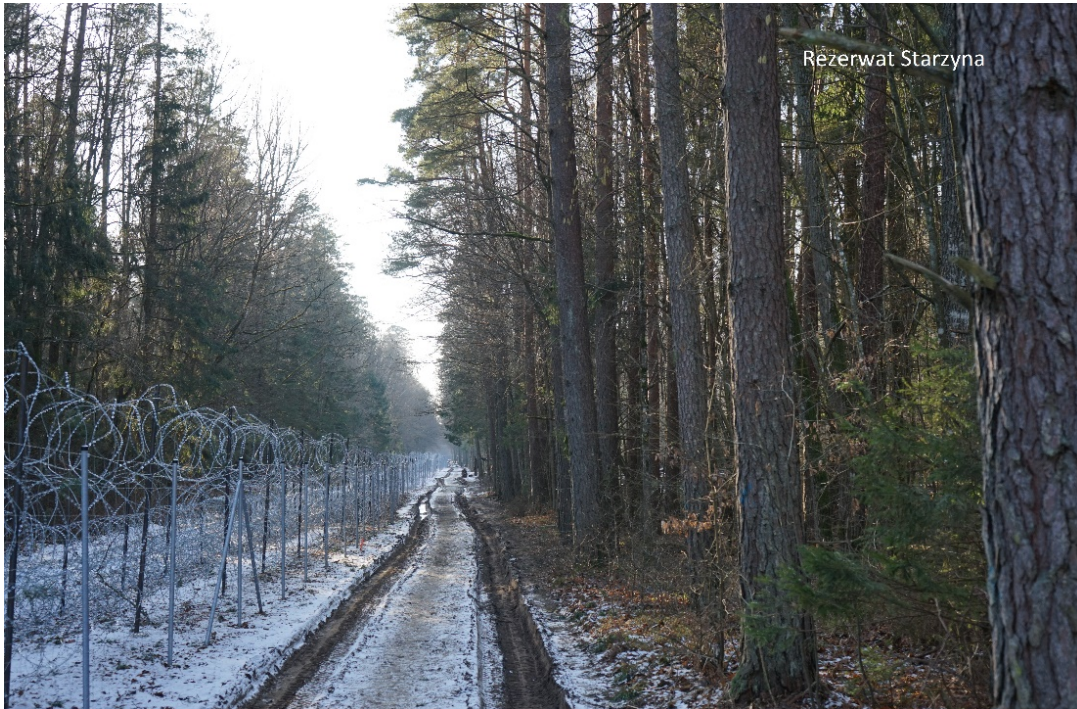
Photo 1. The appearance of the border strip before starting the construction of the barrier and securing the razor wire with a net on the Polish side of the border.

In order to increase the security of the state border, a barrier in form of a spiral fence consisting of poles and vertically placed concertina-type wire entanglements was laid along the border road on selected sections of the eastern border of Poland. The fence was secured with a net to avoid direct exposure of animals to possible negative effects of the wire (Photo 1). It should be emphasized that this security was only temporary.

Regarding the matter of logging, I would like to inform you that the vast majority of the border strip section did not require tree cutting, because on a significant length of its length the border road has been a cleared road for years (Photo 1), although in accordance with the law, such as mentioned above it could be a 15-meter strip. Necessary, very little interference in the stand (removal of individual trees on small fragments in the fringes of the habitats) took place along the border road running through the Białowieża National Park. The removed trees and deadwood were moved to an adjacent stand, where they will undergo a process of natural decomposition.

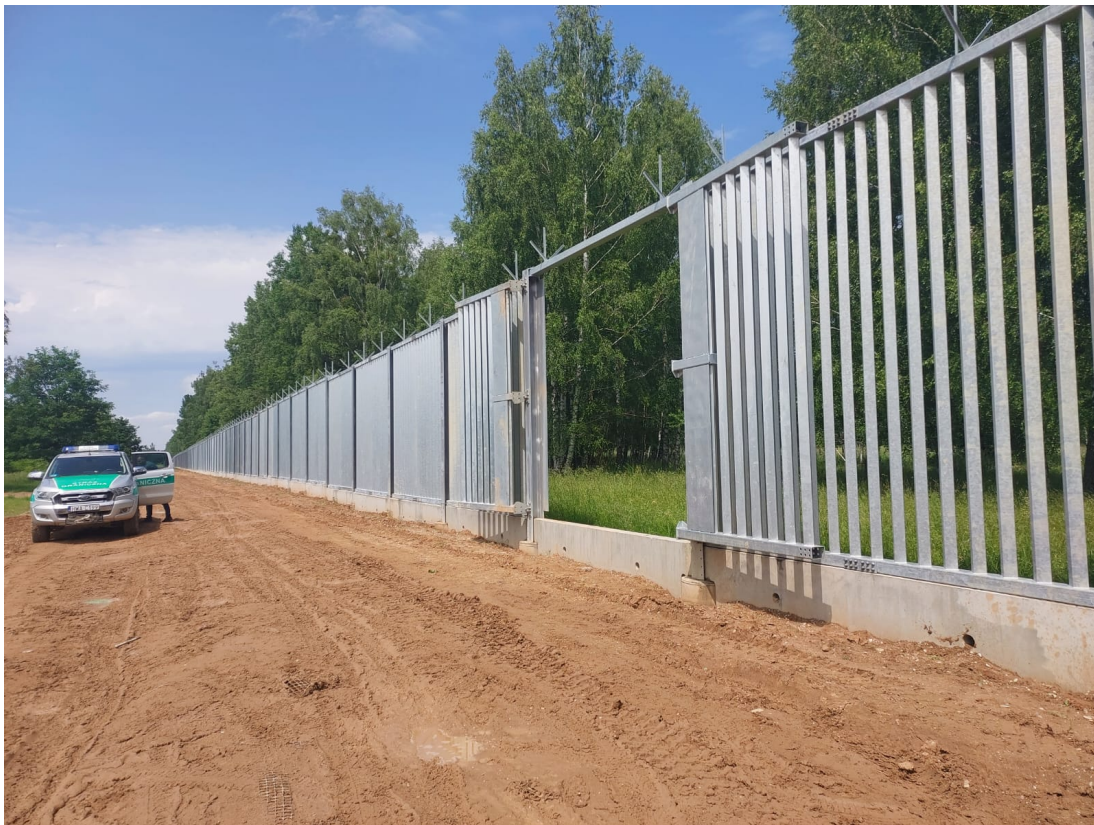
Photo 2. The appearance of the dam on the Polish side of the border with a crossing for large animals and culverts for small animals.

Referring to the allegations regarding the interruption of animal migration corridors, it should be emphasized that the chosen form of physical protection of the state border is the solution least interfering with the natural environment. It should also be emphasized that, unlike various temporary safeguards, the barrier does not pose a threat to the health and life of animals. The openwork nature of the barrier as well as the used passages and culverts ensure the possibility of animal migration. The barrier in Poland has over 70 thousand culverts for small mammals, amphibians and reptiles (two in each span) and 24 passages for large animals. The width of each passage is 5 m and the height is 4.5 m - these are sufficient parameters for the representatives of the largest species, such as European bison, elk, deer, wolf or lynx (Photo 2). The locations of the passages were determined on the basis of migration analyzes of large mammals - mainly bison and lynx (Fig. 1, 3-5). A comparative analysis with the results of telemetry studies of European bison and lynx showed that the passages were located correctly and optimally arranged. In addition, there are 100 additional 1.5x1.5 m passages that can be used by animals as needed.

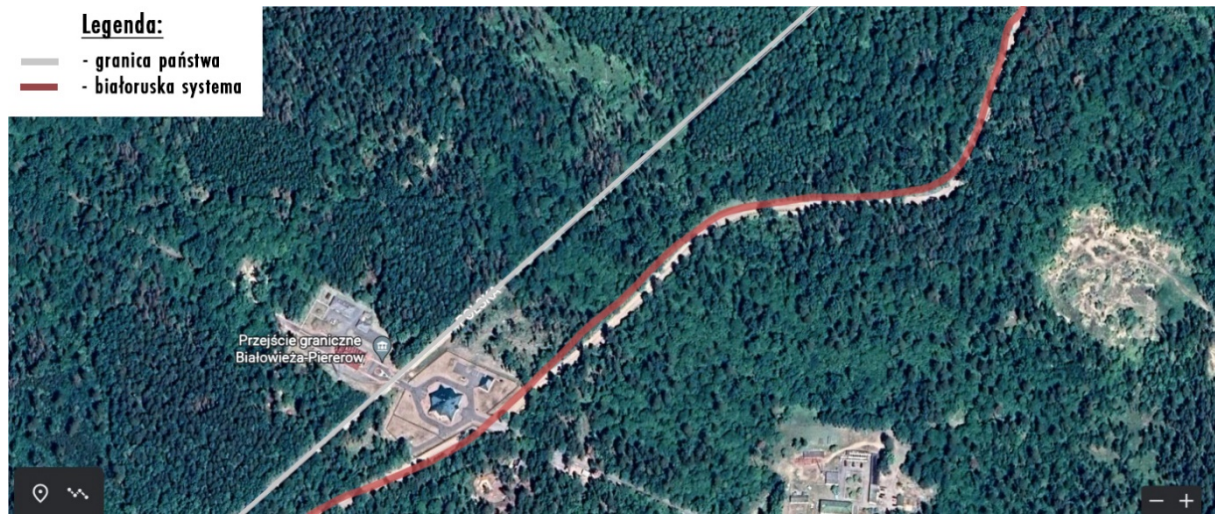
Photo 3. Systema in the vicinity of the border crossing Białowieża - Piererow,
source: <https://earth.google.com>

In addition, the migration of animals on the Polish side will be possible through rivers (on this section of the border these are: Leśna Prawa, Przewłoka and Narew) and water reservoirs where no dam has been built. Other protection systems will be used on these border sections, which will allow wild animals to freely cross the border. Therefore, the barrier on the Polish side of the border will not constitute a significant barrier on the migration routes of animals of pan-European importance. Poland does not fence rivers, which does not change the fact that the animals, after crossing the border rivers, encounter systemia on the Belarusian side, an obstacle that cannot be crossed (Photo 3).

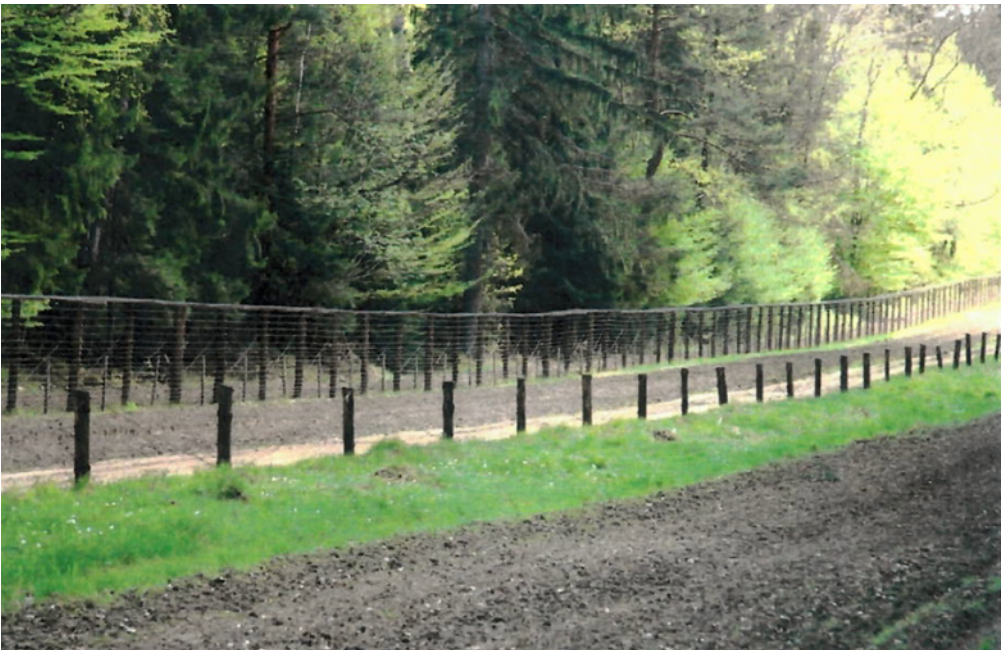
Photo 6. The appearance of the system consisting of several fences in the section of the Białowieża Primeval Forest in the immediate vicinity of the Polish-Belarusian border.

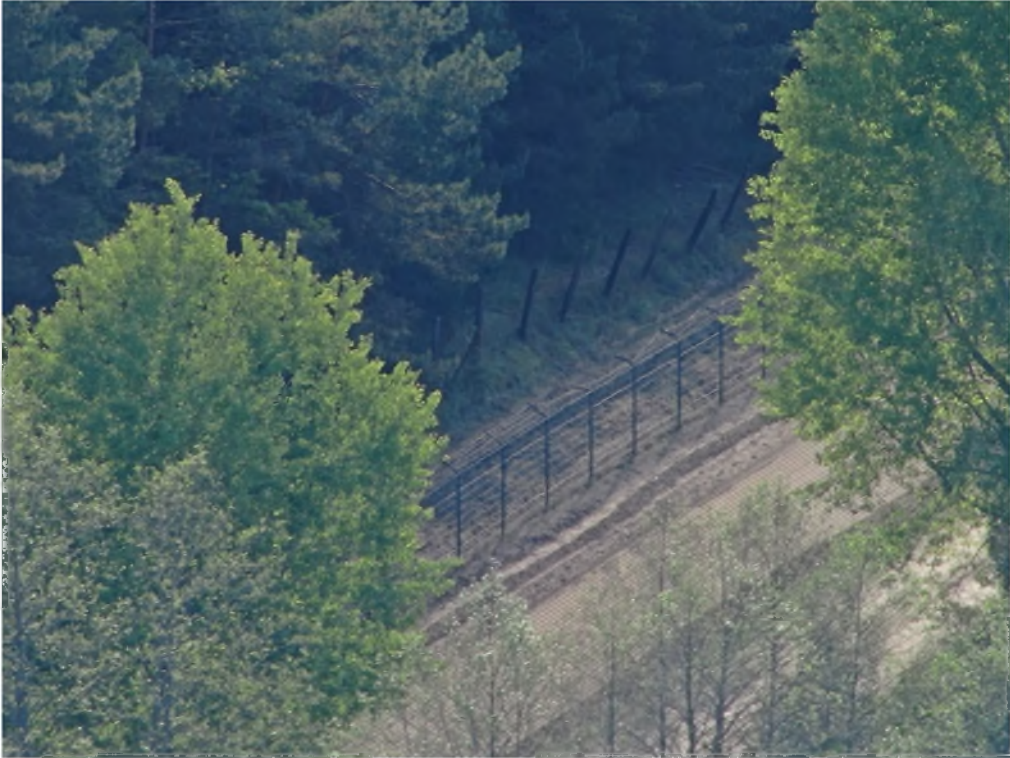
Photo 7. The appearance of the system consisting of several fences.

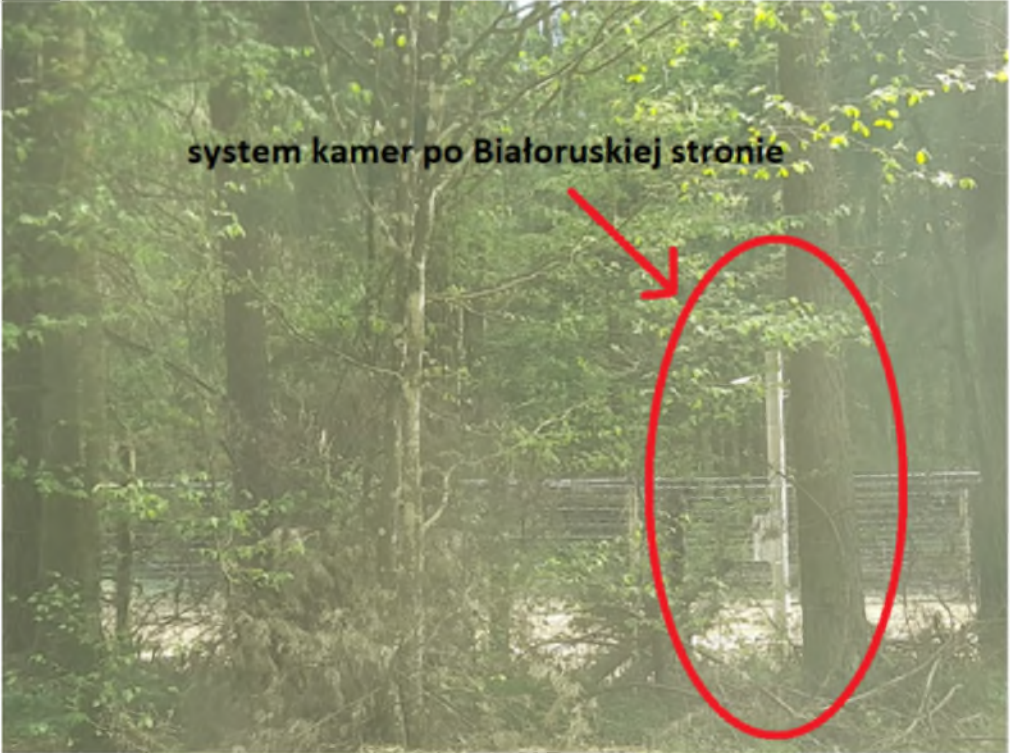
Photo 8. Camera system on the Belarusian side.

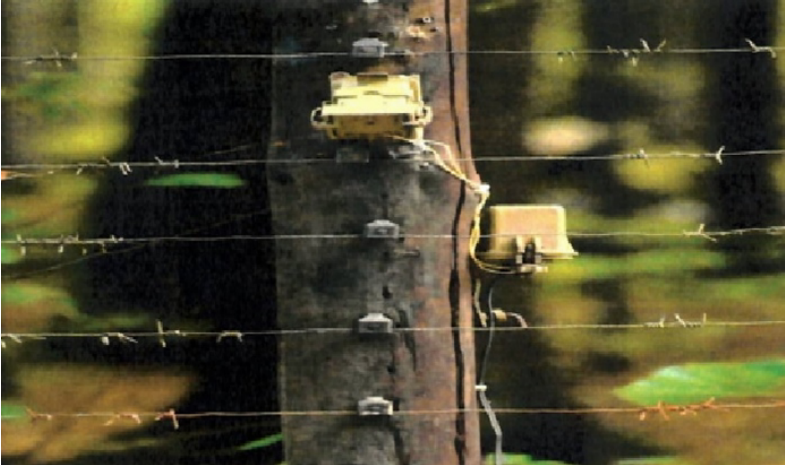
Photo 9. Sensor system on the Belarusian side.

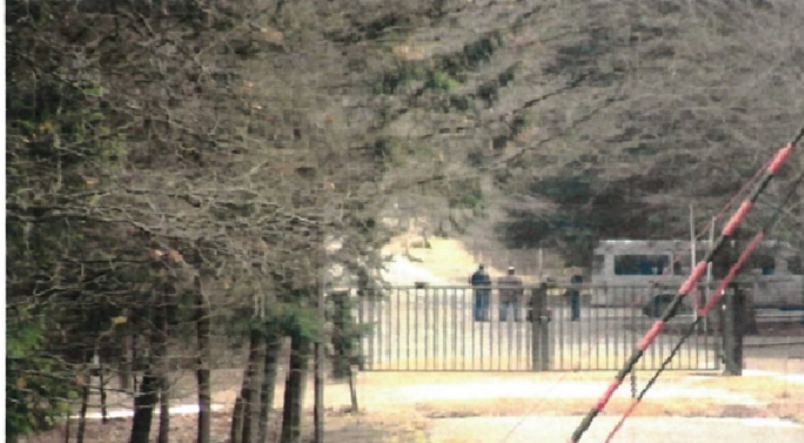
Photo 10. The gate in the system for border services.

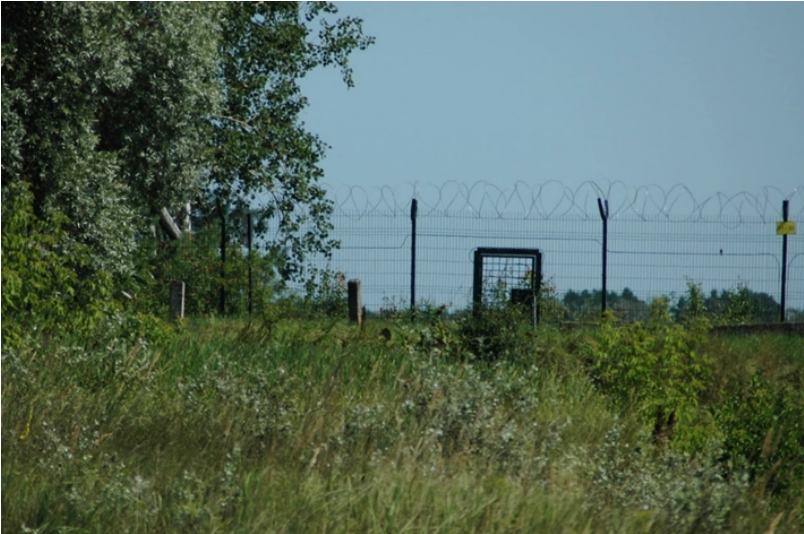
Photo 11. Wicket in the modernized fence used by border services, near Włodawa.

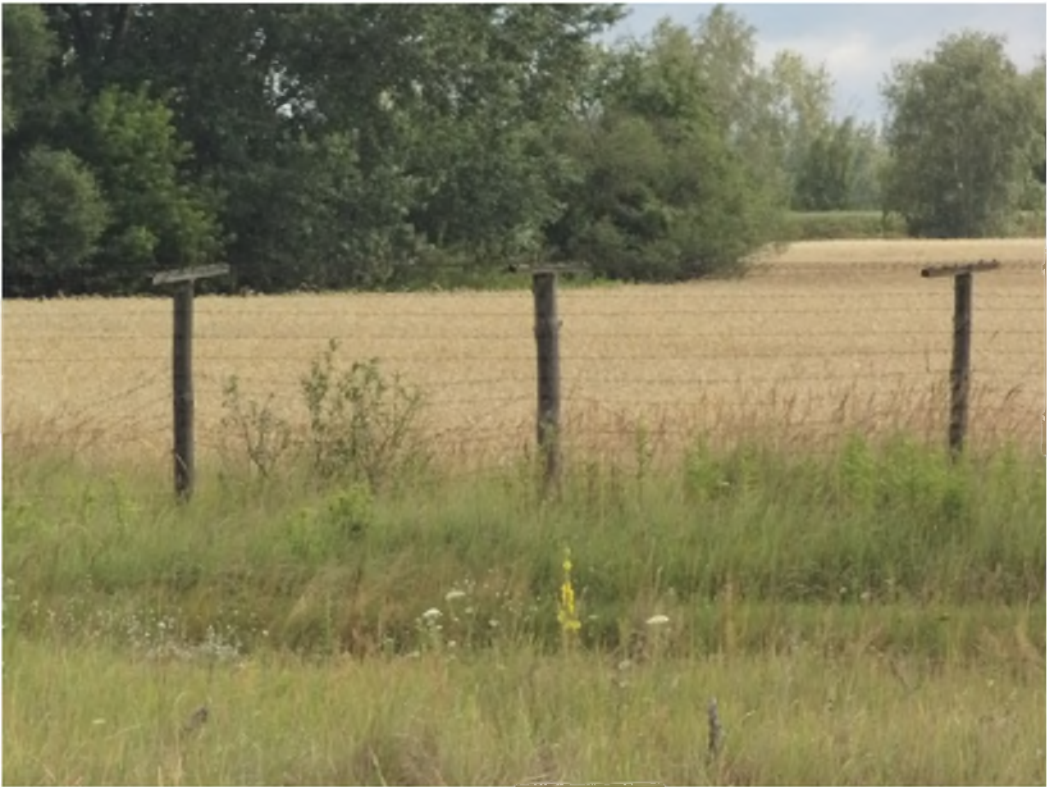
Photo 12. The characteristic shape of a wooden fence in the systema (letter T), near Terespol.

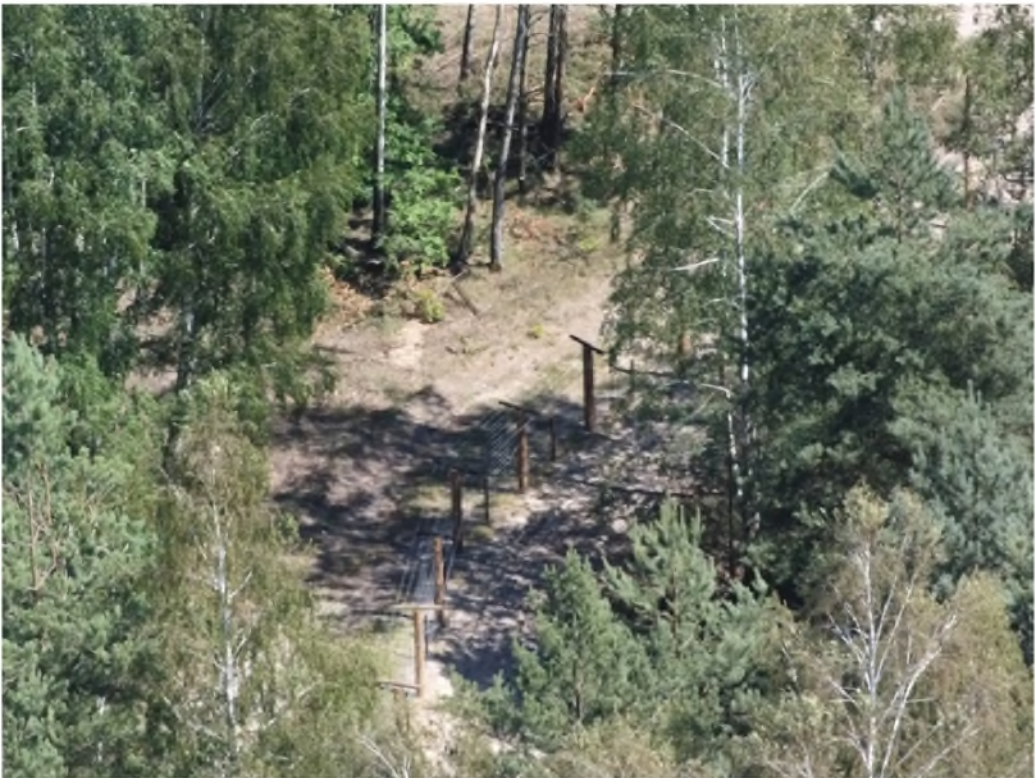
Photo 13. Visible horizontal protection of the fence with barbed wire lines, near Terespol.

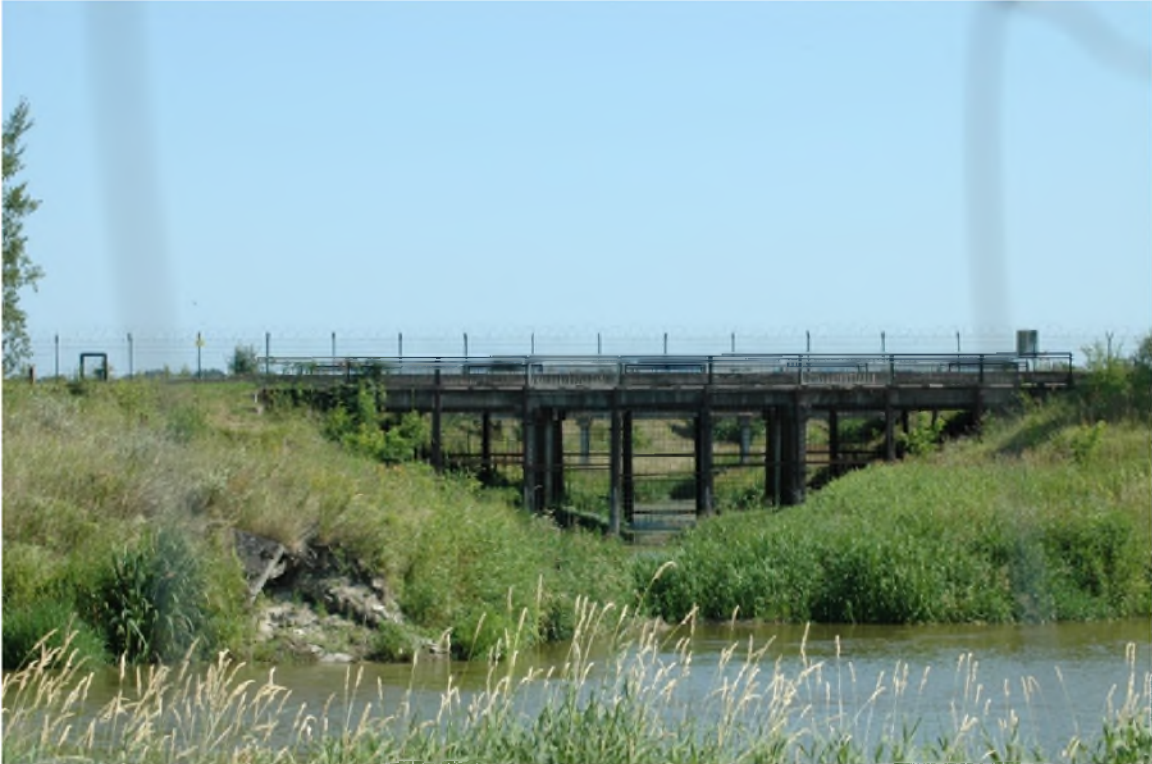
Photo 14. A tight dam on the river, near Włodawa.

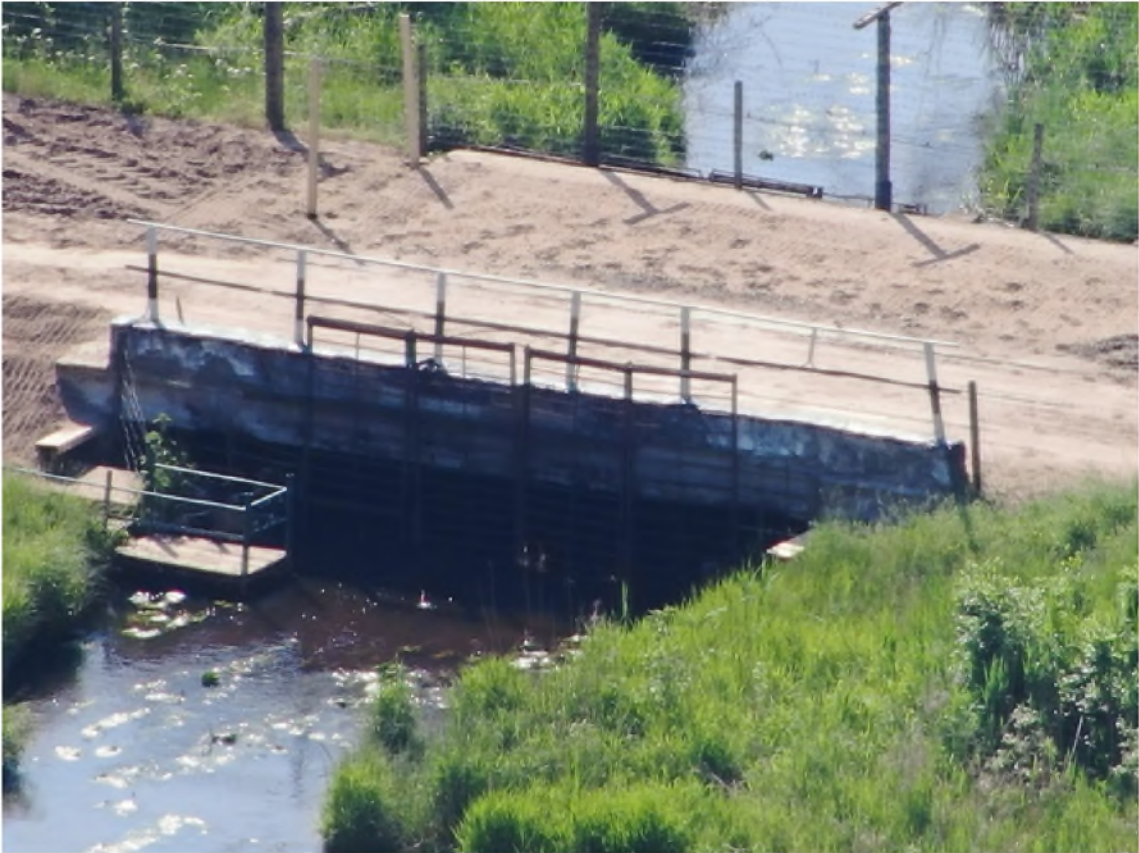
Photo 15. A tight dam on the river, near Włodawa.

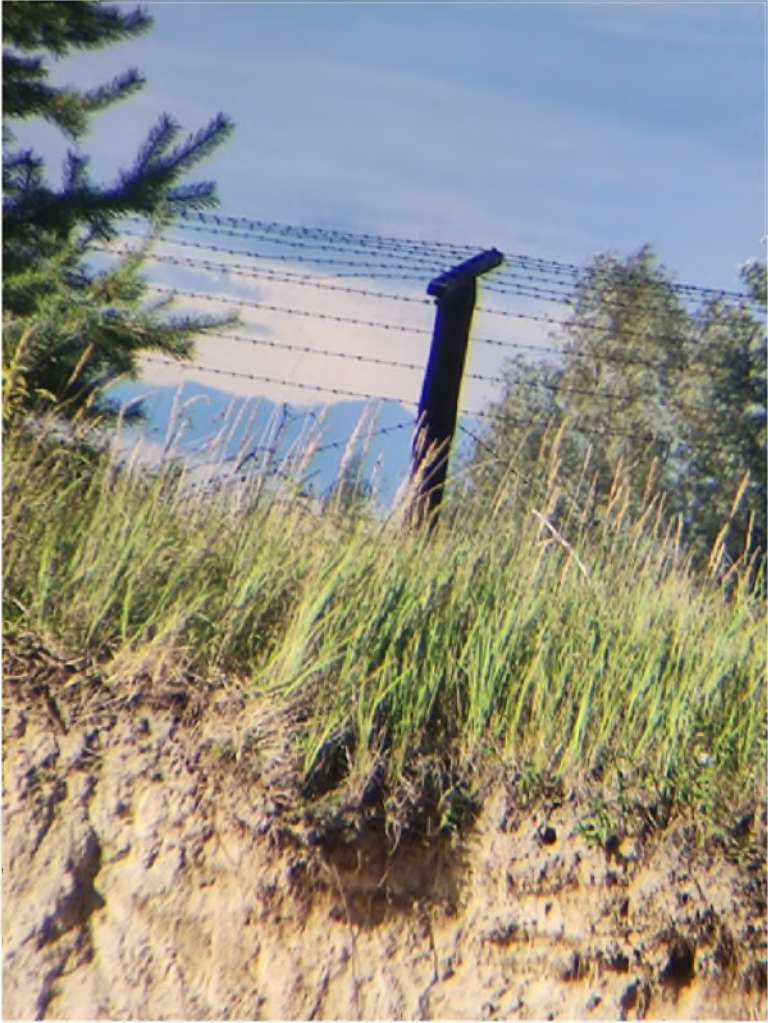
Photo 16. A fence built along the river.

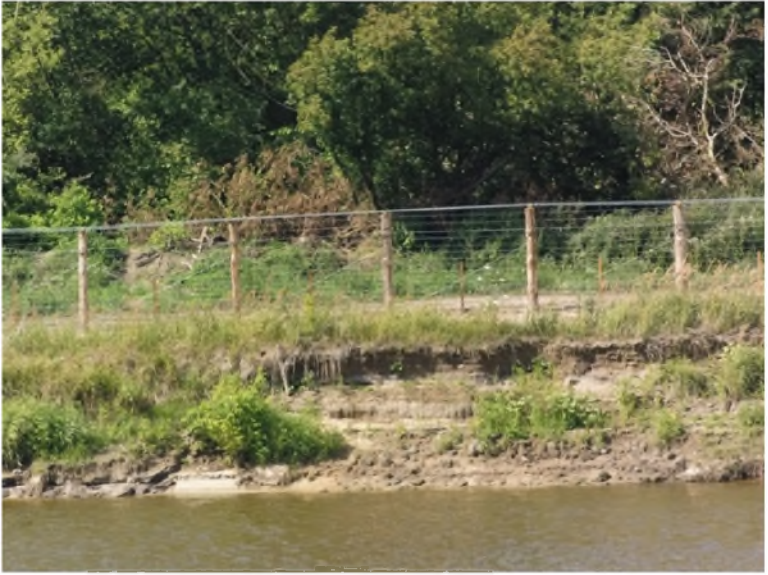
Photo 17. A fence built along the river.

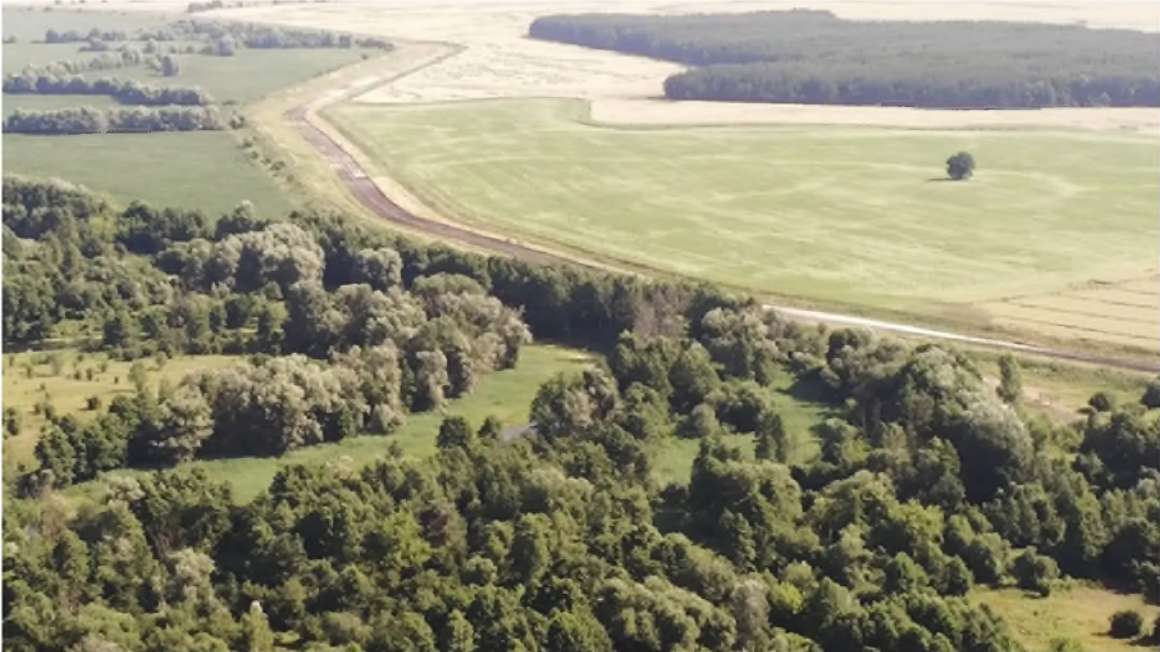
Photo 18. The fence is built along the flood embankment, near Włodawa.

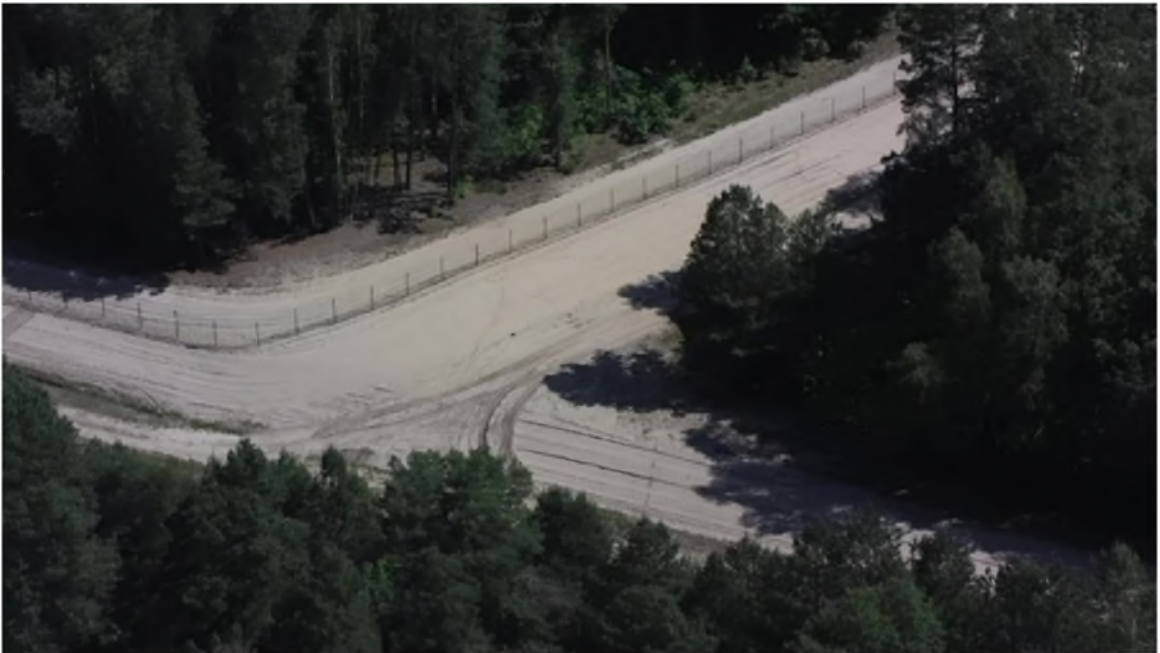
Photo 19. Ploughed wide stripes along the systema, near Włodawa.

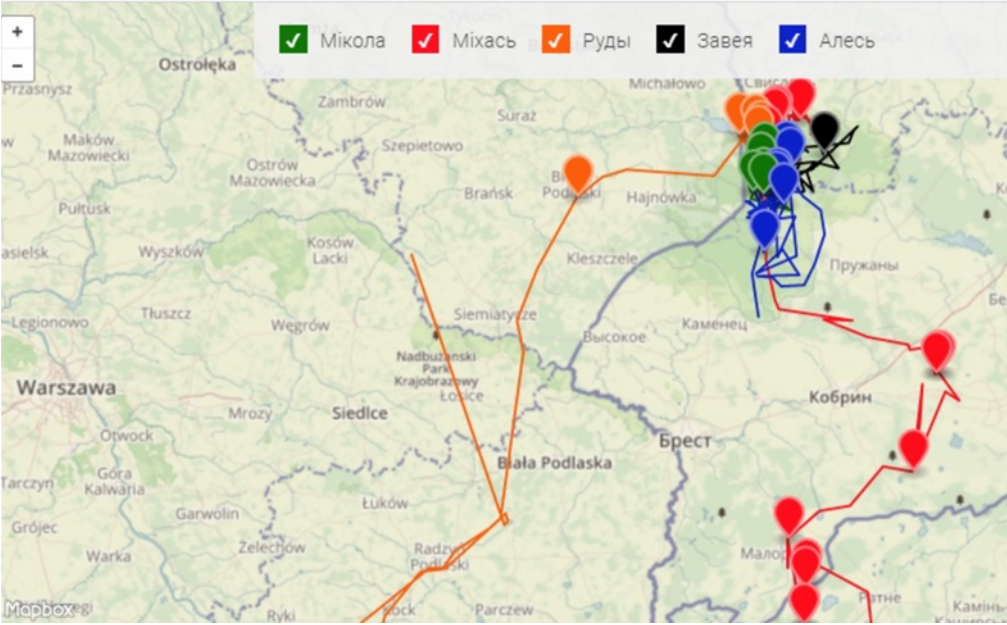
Fig. 6. Wolf's locations in the Białowieża Primeval Forest on the territory of Belarus based on research conducted since 2013 (<https://naviny.belsat.eu/pl/news/bialoruskie-wilki-z-gps-zwiedzaja-polske-mapal/>)
