**Recommendation No. 95 (2002) on the
conservation of marine turtles in Kazanlı Beach
(Turkey)**

- REPORT BY THE NGO -

FOLLOW-UP OF RECOMMENDATION NO. 95 (2002) ON THE CONSERVATION OF MARINE TURTLES IN KAZANLI BEACH (TURKEY)

15 August 2021

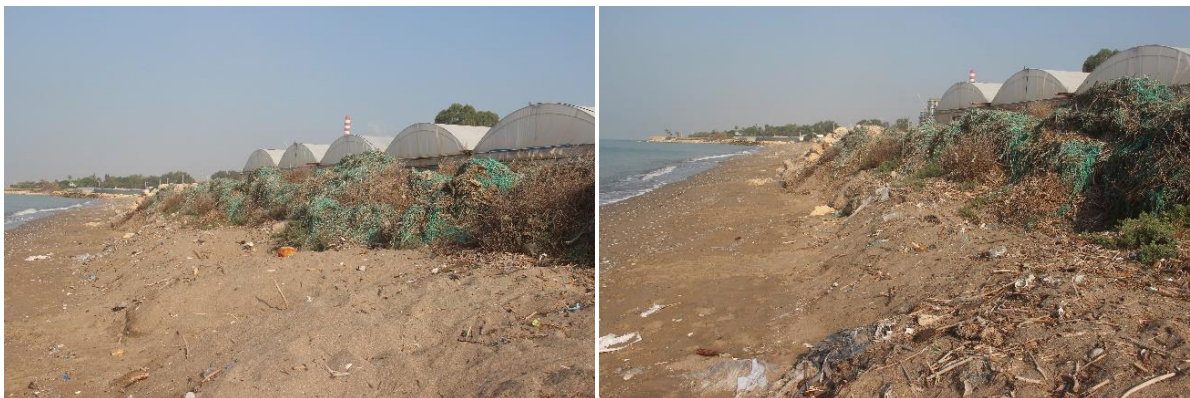
Fig. 4. Kazanlı. Section K3. July 2021. Greenhouses on the nesting beach, with heavy litter in front of them. Note that some sand has accumulated in front of the boulders.

Greenhouses in beach section K3 remain in place and most of them are actively used (Fig. 4). Continuing coastal erosion has exposed the mixture of gravel, stone and cement under the sand (Fig. 5). Tall reeds border the sea-facing sides of greenhouses, and artificial slopes made with boulders and large pieces of rubble can be seen in front of the reeds (Fig. 6). Despite the very little sandy area suitable for sea turtle nesting, tracks and nests can still be seen in the section (Fig. 7). When compared to 2017 images, some sand has accumulated in front of the boulder sets (Fig. 3, 5, 6). For further restoration, it may be necessary to remove the dirt road at the section's northern end (Fig. 8), as it passes too close to the beach and the nests located here, with hatchlings crawling towards the road due to the disorienting effect of Soda-Chromium factory's lights (Fig. 9). It is also advised to remove the small drainage pipe at the section's northern end as any discharge from it directly flows onto the nesting beach (Fig. 10). No information could be obtained about the purpose of a hedged area filled with different construction materials towards the north of section K3, which was also observed in 2019 (Fig. 11). An update is needed in relation to the legal steps for the "renewal of cadastral work" and the transfer "to public property" of "lands beyond the shore edge line" as per the 2019 Government report.

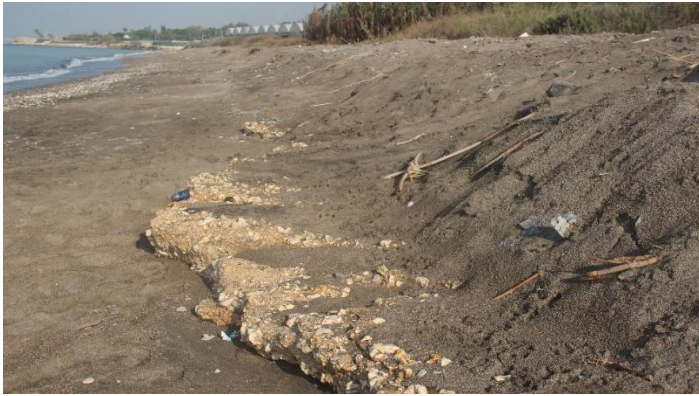
Fig. 5. Kazanlı. Section K3. July 2021. Exposed stone and cement mixture under the sand.

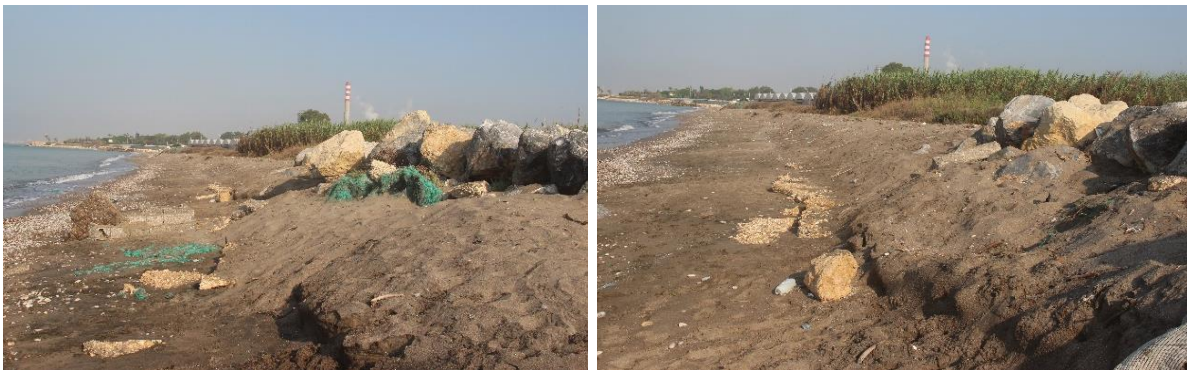
Fig.6. Kazanlı. Section K3. July 2021. Reeds and artificial slopes made out of boulders in front of the greenhouses. Note plastic nets from the greenhouses and other litter on the nesting beach.

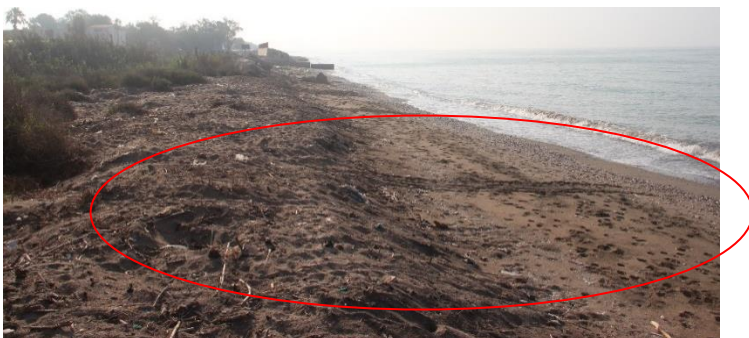
Fig. 7. Kazanlı. Section K3. July 2021. Adult sea turtle tracks (red circle) on limited sandy area in front of the greenhouses.

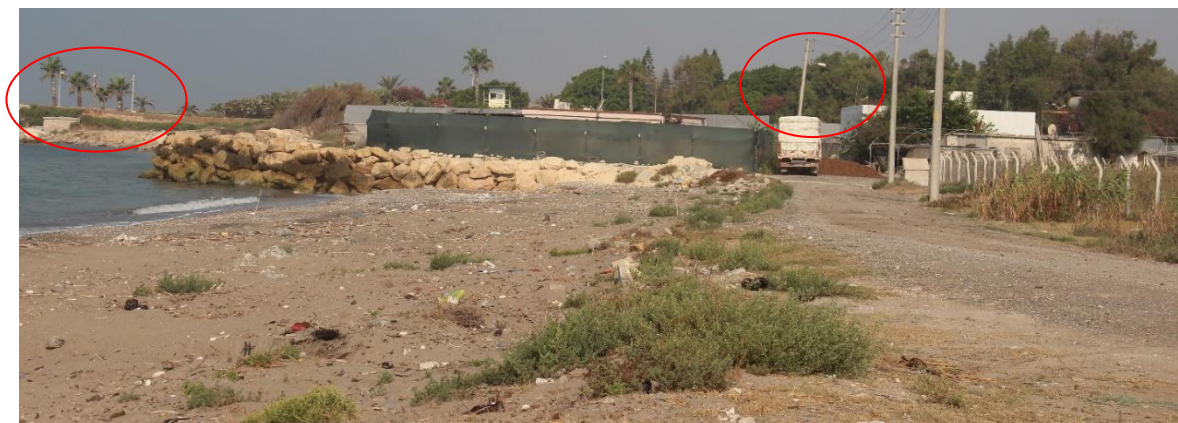
Fig. 8. Kazanlı. Section K3. July 2021. Dirt road at the section's northern end, too close to the sea. Note heavily littered shore. Street lights and Soda-Chrome factory's lights are shown in the red circles

In K1, lights from the summerhouse complex “Onur Sitesi” were intense around 23:00 (Fig. 21), although most of them were turned off after 00:30. The lights observed in 2019 at the wastewater pumping facility were turned off, and the small minibus parking place was removed. At the abandoned building in the eastern part of section K1, the first floor was occupied, emitting white lights at night (Fig. 22), though the streetlight next to the building has been removed. All other streetlights in the section are fitted with orange bulbs. In K2, “Sahil Balık” Restaurant was using somewhat dimmed lights (though still causing light pollution), and bright lights from “Denizkızı Restaurant”, “Cemre Café” and the recreational area illuminated the beach until midnight (Fig. 23, 13). Though not observed during the survey, “Cemre Café” hosts weddings that are likely to take place in the evening (Fig. 24). Parked vehicles also caused intense light pollution (see point 2). The football court and the wedding hall were both closed during the survey (Fig. 25-26). Lights from the Soda-Chromium Factory cause severe light pollution, strongly affecting both K4 and K3, causing hatchlings disorientation (Fig. 27, 9). The Factory’s lights are visible from all sections, including from neighbouring beaches beyond K1 and K4. The dirt road in K3 passes very close to the sea, leading to light pollution from cars passing by and parking near the shore (Fig.8).

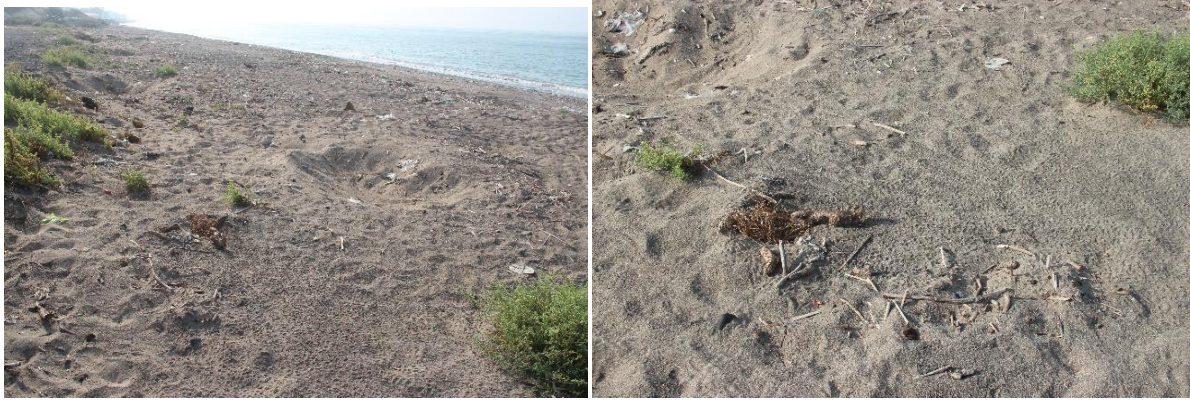
Fig. 9. Kazanlı. Section K3. July 2021. Hatchling tracks disoriented to the right, towards the artificial sources.

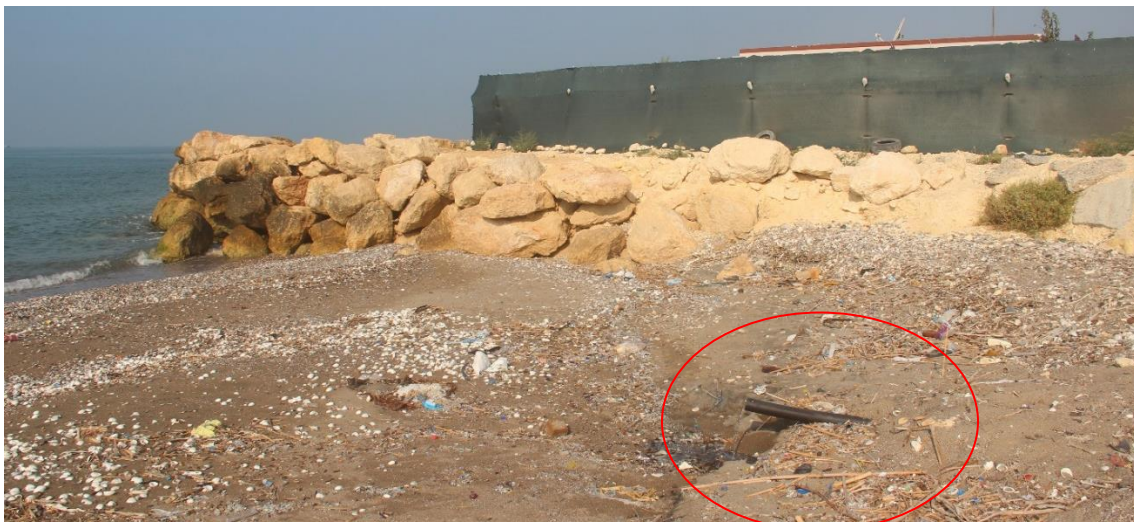
Fig. 10. Kazanlı. Section K3. July 2021. Small drainage pipe at the section's northern end.

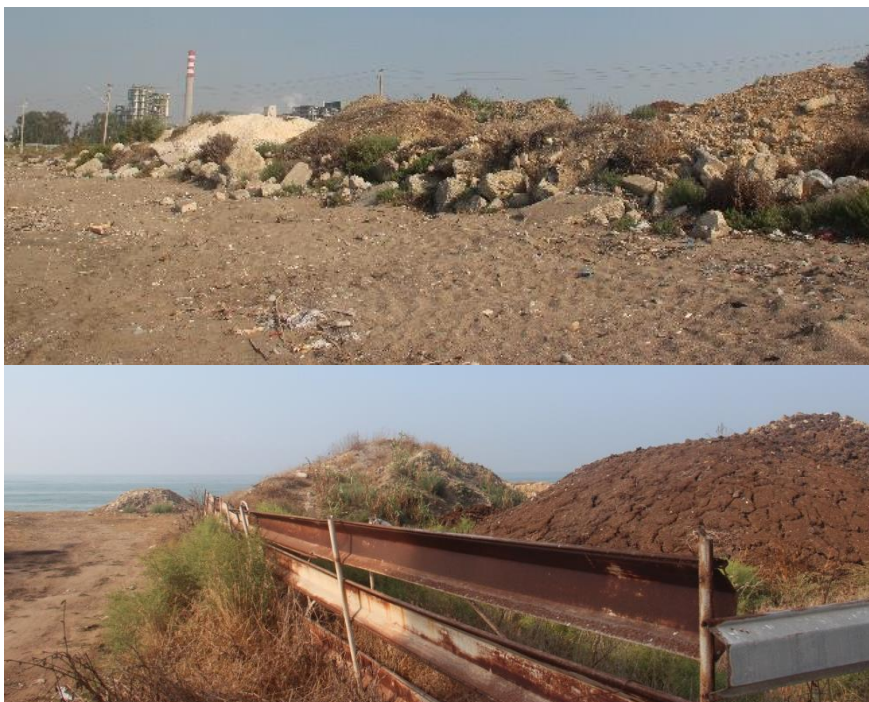
Fig. 11. Kazanlı. Section K3. July 2021. Construction materials piled near the beach.

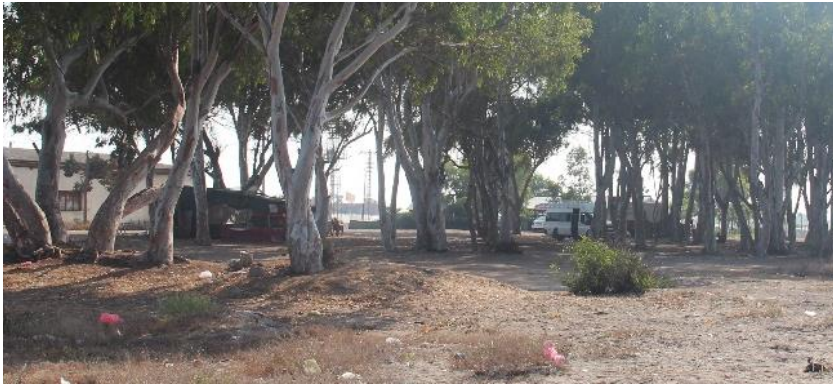
Fig. 12. Kazanlı. Section K2. July 2021. Vehicles parked behind the trees in front of the wedding hall, in view of the beach

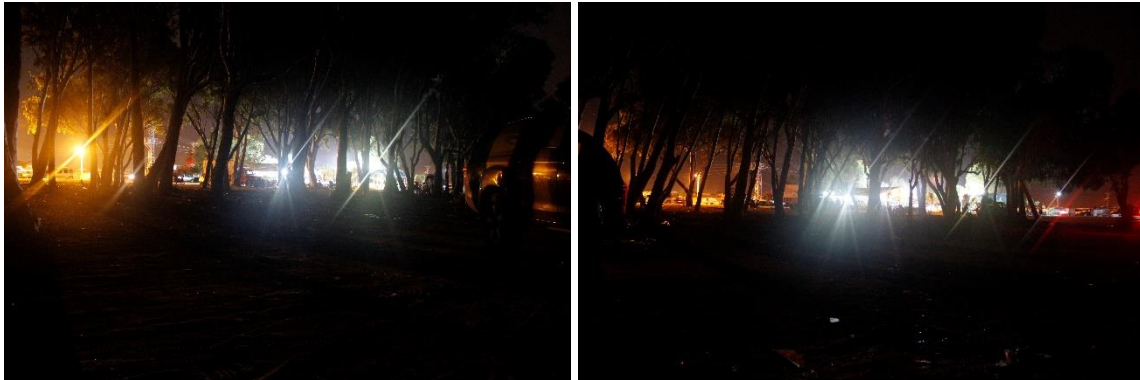
Fig. 13. Kazanlı. Section K2. July 2021. Light pollution from the vehicles, restaurants and cafés.

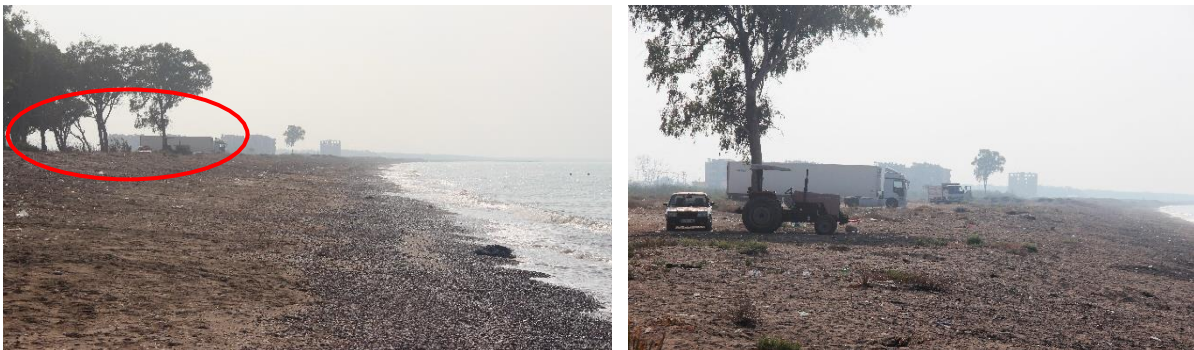
Fig. 14. Kazanlı. Section K1. July 2021. Several vehicles parked at the empty plot between the restaurants and the summerhouse complex.

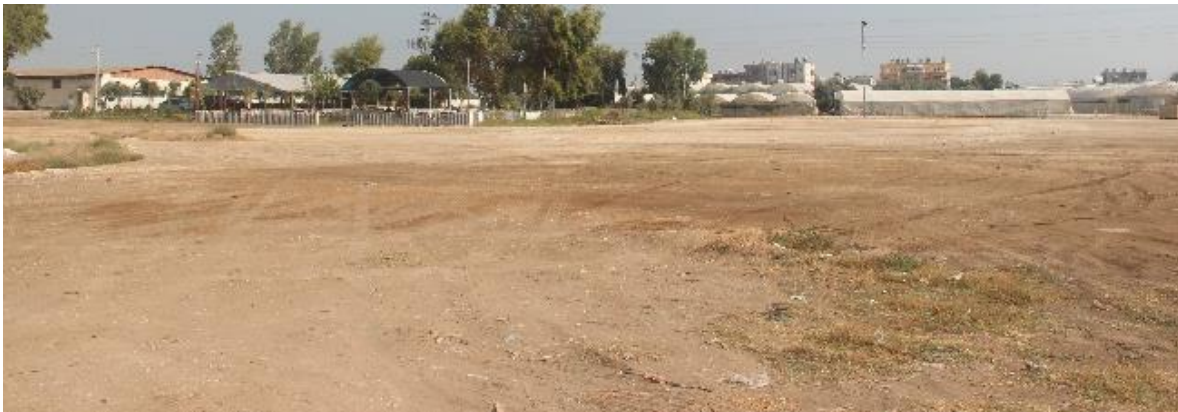
Fig. 15. Kazanlı. Section K1. July 2021. Vehicle tracks on the beach.

There is no designated taxi parking area near the beach in any of the sections. However, vehicles park directly behind and on the nesting beach in several sections in K1 and K2, causing light pollution and disturbances due to loud music and human presence (near the restaurants in K2, near the trees in front of the wedding hall between K2 and K1, and in an empty plot towards the summerhouse complex in K1) (Fig. 12-14). Vehicle tracks were observed on the nesting beach as several uncontrolled vehicle entry points exist in all sections (Fig. 15-16).

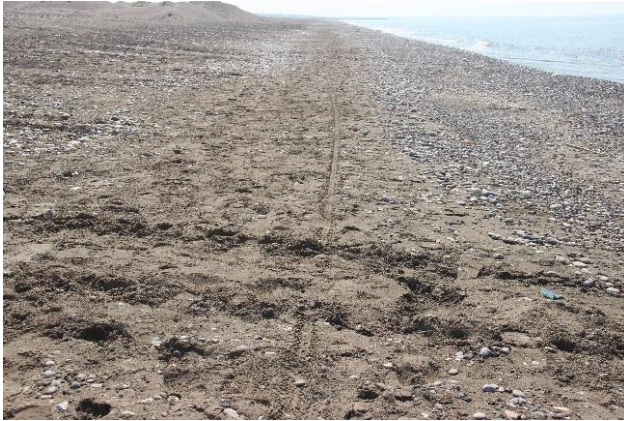
Fig. 16. Kazanlı. Section K1. July 2021. Vehicle tracks on the beach.

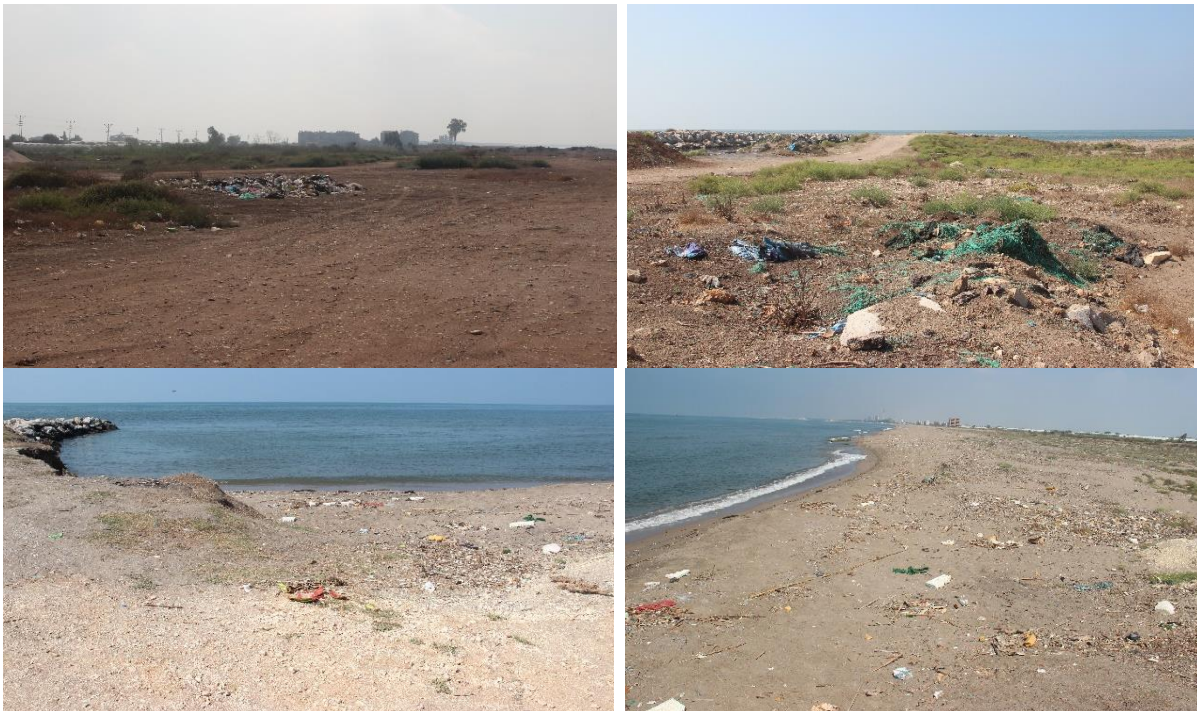
Fig. 17. Kazanlı. Section K1. July 2021. Plastic debris and other litter at the rear (top) and on the beach (bottom).

empty bottles) was observed on all beach sections with varying density. Sections K1 and K2 were heavily littered at the rear of the beach and less directly on the beach (Fig. 17-19). K3 and K4 were considerably more littered (Fig. 4, 6, 8, 10, 20). This indicates the need for more frequent debris removal and better waste management.

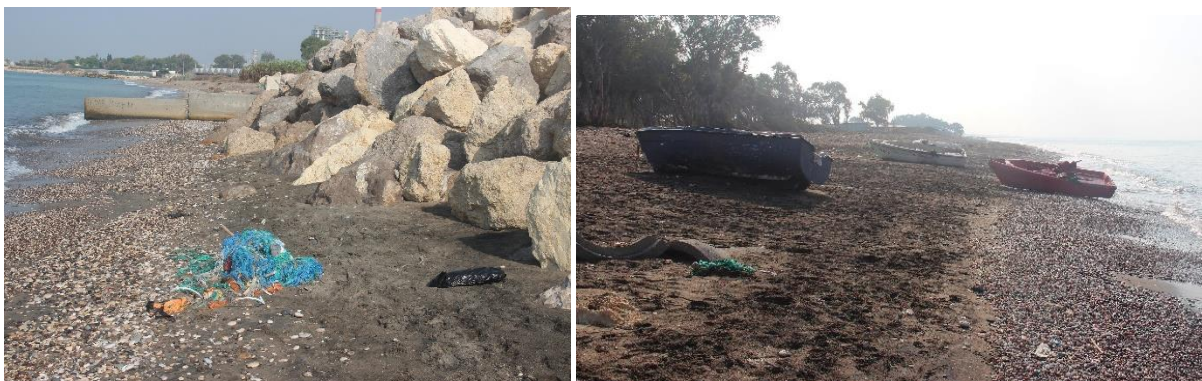
Fig. 18. Kazanlı, Section K2. July 2021. Plastic debris and other litter on the nesting beach. Note the boats in the nesting zone.

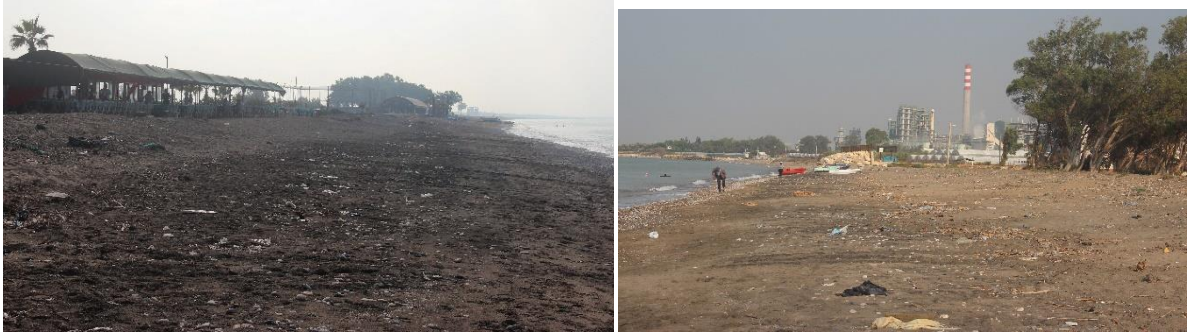
Fig. 19. Kazanlı, Section K2. July 2021. Plastic debris and other litter on the nesting beach. Note the boats in the nesting zone.

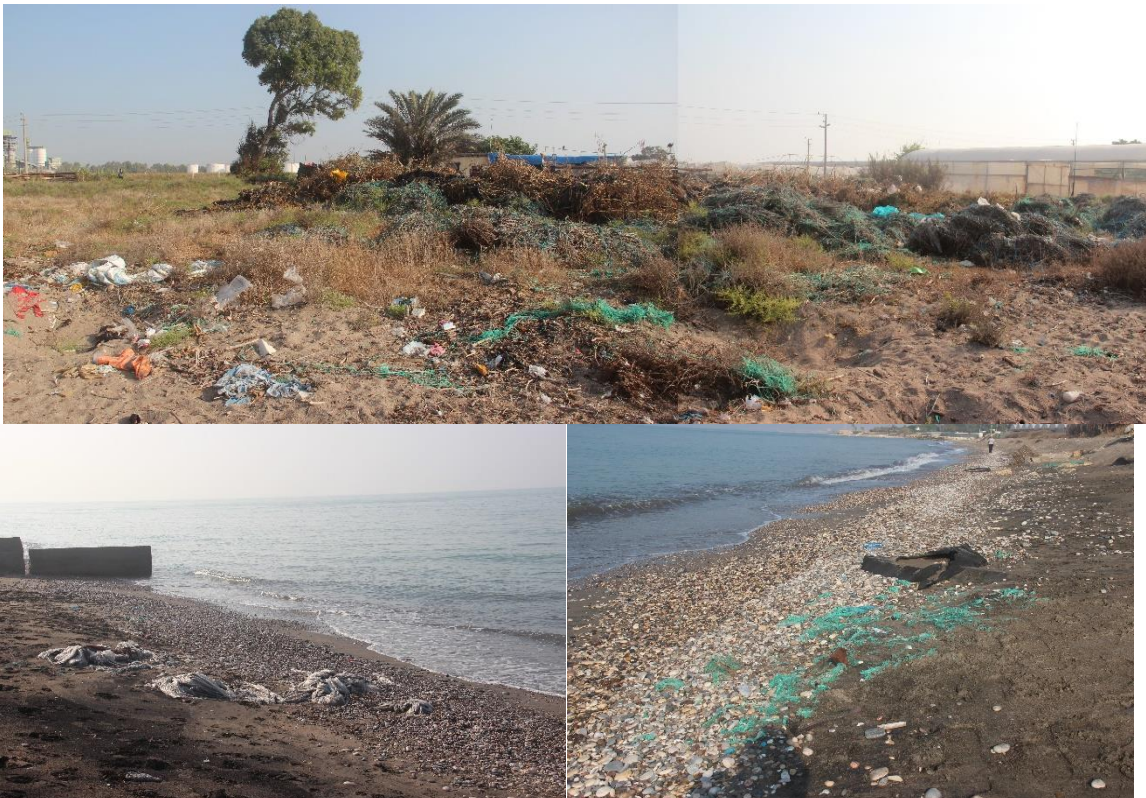
Fig. 20. Kazanlı, Section K3. July 2021. Plastic debris on beach: a) piles of greenhouse nets in the beach dunes (Coordinates 36.8120264654455, 34.74549461110521) b) plastics and other litter; c) nylon covering material; d) greenhouse nets and tires.

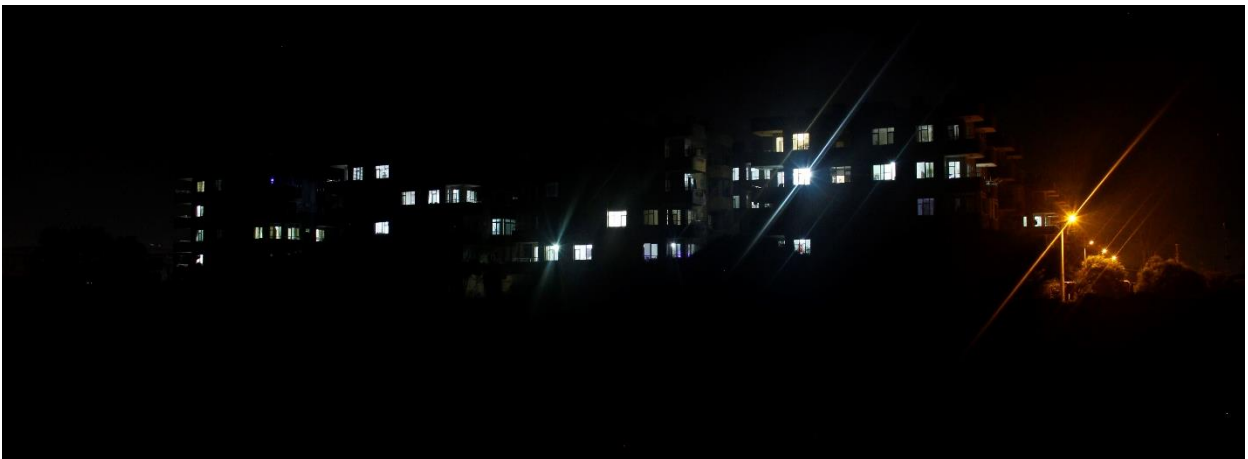
Fig. 21. Kazanlı, Section K1. July 2021. Lights from summerhouse complex "Onur Sitesi".

The huge summer house complex “Onur Sitesi” remains on the dunes in section K1 (Fig. 44) and is a source of light pollution after 00:30 (Fig. 21). Authorities should collaborate with experts and ensure that owners adopt appropriate landscaping and lighting. In disregard of the Recommendation, on 21/10/2020 (Decision No. 223159) the complex was included in the “Sustainable Development and Controlled Usage Area”, despite the fact that the adjacent nesting beach area is included in the “Natural Site - Qualified Natural Conservation Area” (Fig 45).¹³

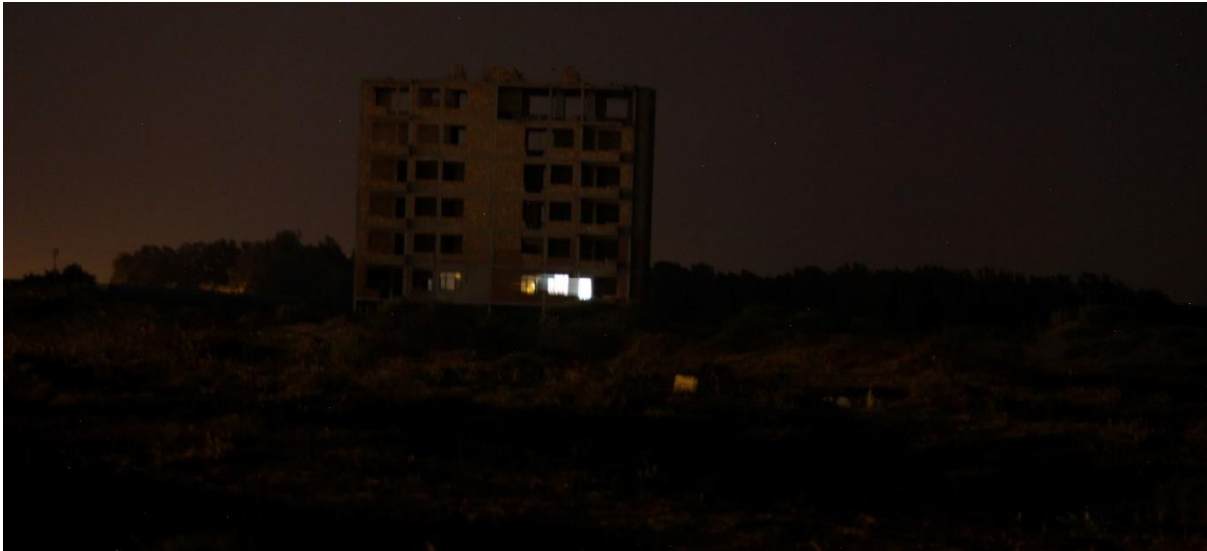
Fig. 22. Kazanlı. Section K1. July 2021. Lights from the occupied 1st floor of the abandoned building.

The illegal building in K1 has not been removed and its first floor is still occupied (Fig. 40) and lights can be seen at night (Fig. 22).

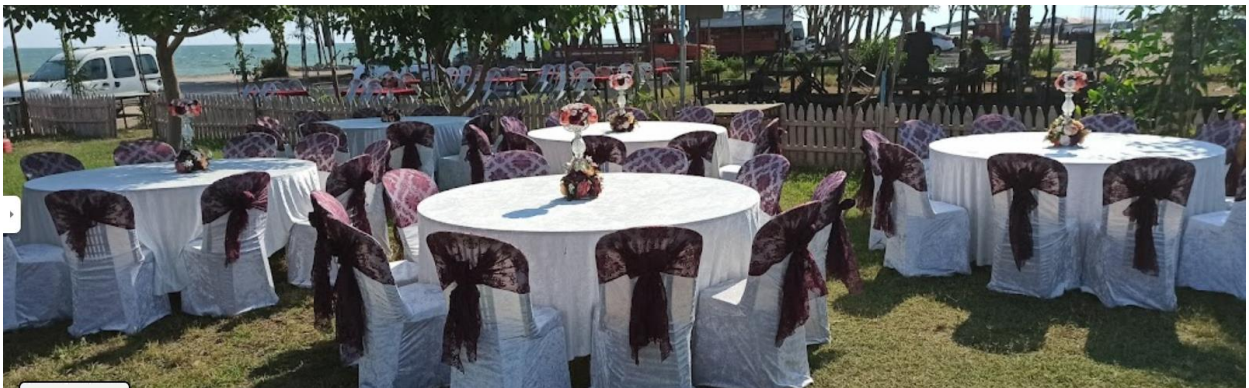
Fig. 24. Kazanlı. Section K2. June 2021. “Cemre Café” hosts weddings that are likely to take place in the evening Source: <https://goo.gl/maps/CZg6DvifDwKopUc5A>

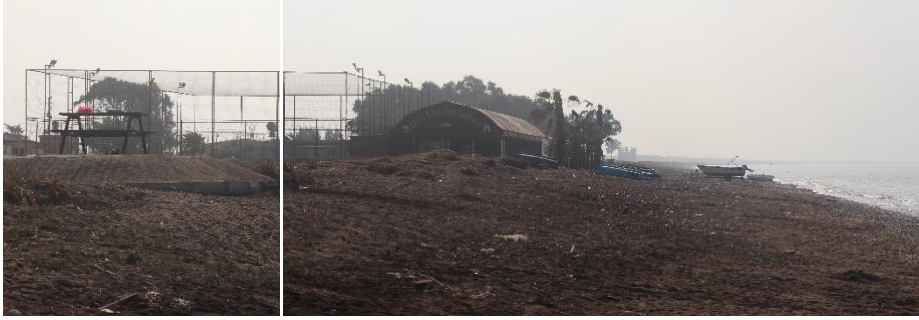
Fig. 25. Kazanlı. Section K2. July 2021. Football court closed at the time of the survey.

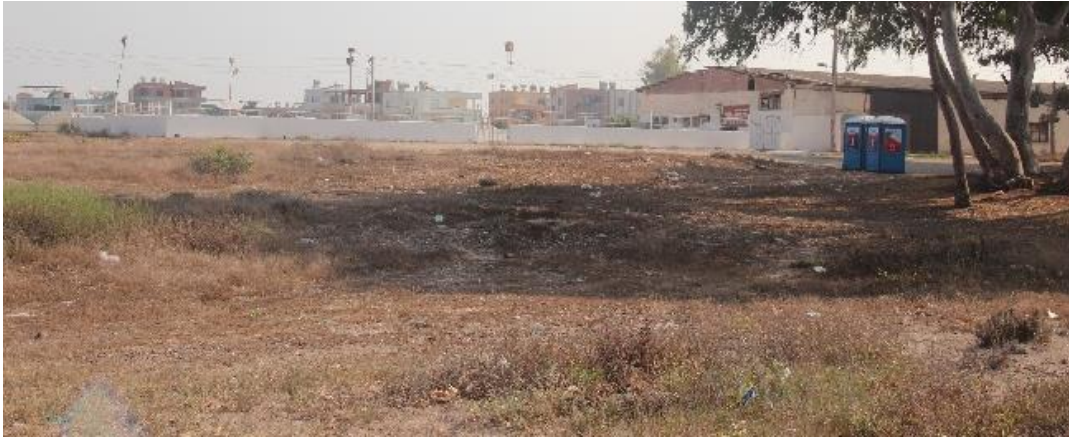
Fig. 26. Kazanlı. Section K2. July 2021. Wedding hall, closed at the time of the survey.

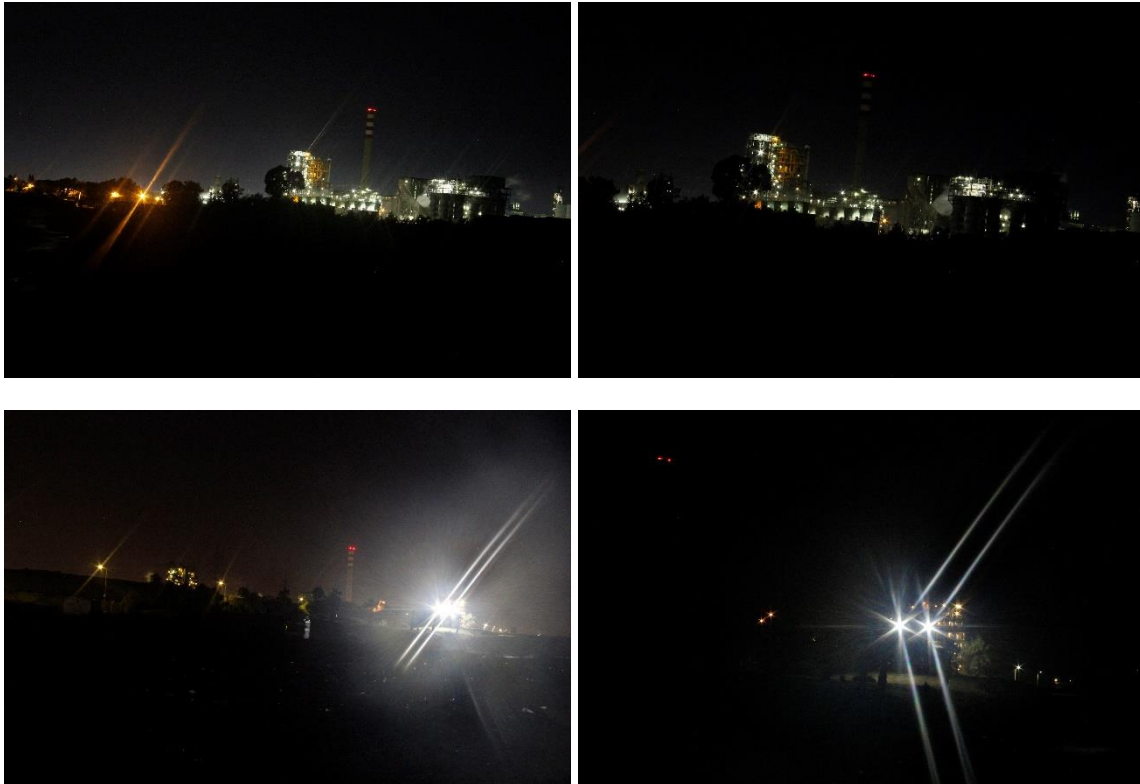
Fig. 27. Kazanlı. Section K4. July 2021. Light pollution from the Soda-Chromium factory.

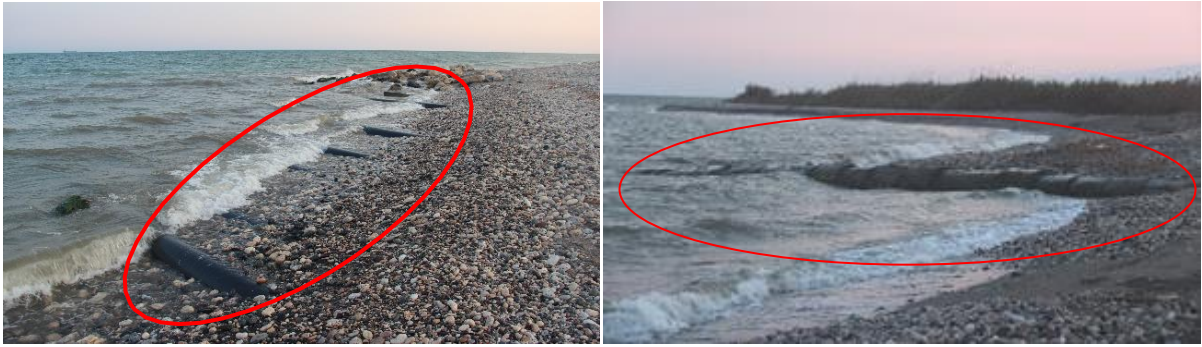
Fig. 28. Kazanlı. July 2021. Pipes extending into the sea beyond the northern border of K4: a) six small pipes, close to the factory's northern end; b) one large concrete pipe, further away from the factory.

According to the 2017 and 2019 Government Reports, chemical waste from the Soda-Chromium Factory is treated in two different industrial waste treatment facilities belonging to the Factory, and waste is analysed by an accredited laboratory, and “discharged chemical compound levels are below the limits”. The factory’s website also states the same, but the actual analysis results cannot be found on the Factory’s website or on any government websites. The screen in Kazanlı town, which used to show effluent analysis was entirely removed in 2021. The Factory’s discharge channel drains directly into the sea of section K4 (Fig. 3). Just beyond K4, there are at least seven pipes extending into the sea; it is unclear if these are draining chemical waste from the Factory or from elsewhere (Fig. 28).

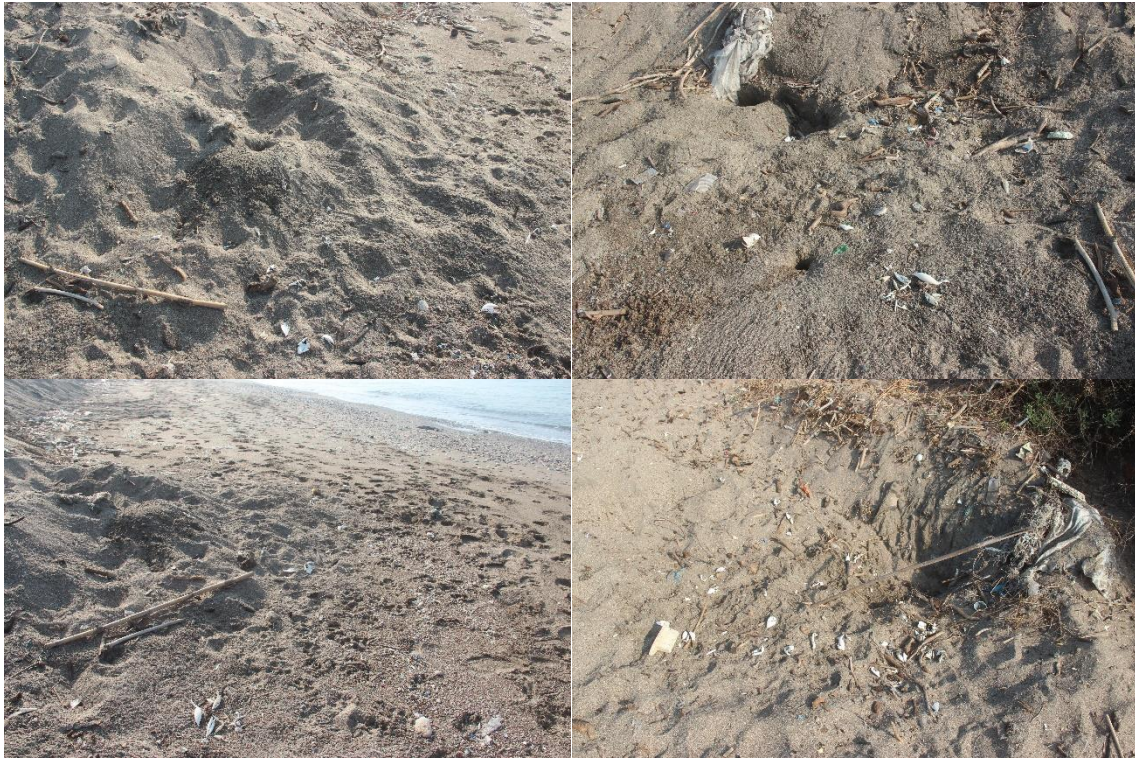
Fig. 30. Kazanlı. Section K1. July 2021. Gulls, one of the known predators of hatchlings.

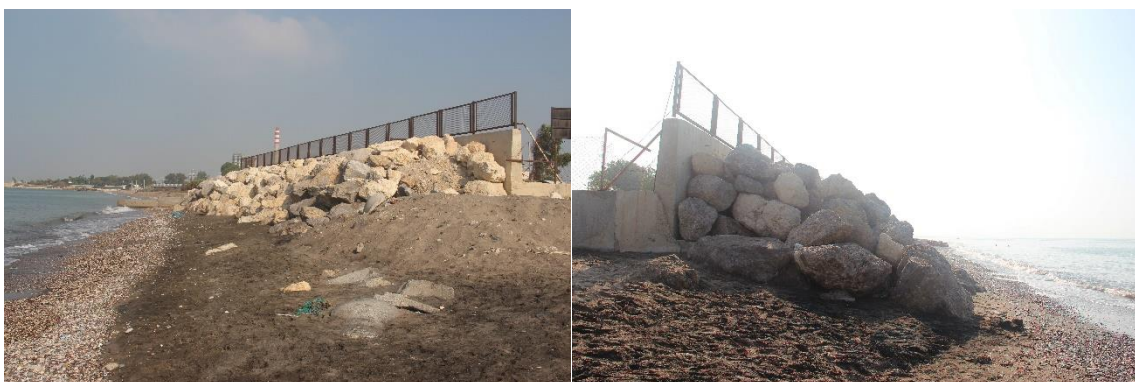
Fig. 33. Kazanlı. Section K2. July 2021. Arbitrary use of boulders in front of the local schoolyard.

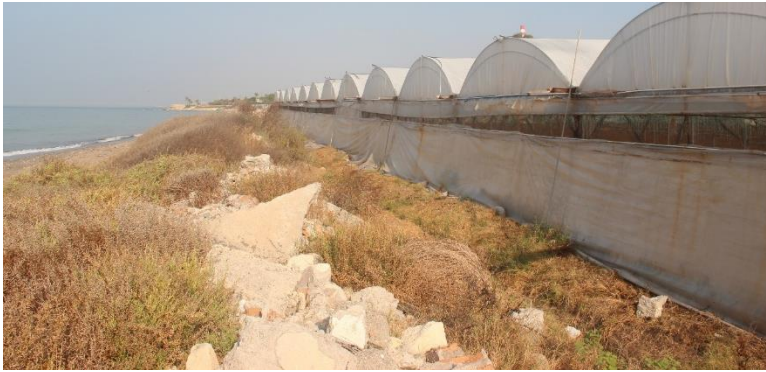
Fig. 34. Kazanlı. Section K3. July 2021. Use of rubble in front of the greenhouses.

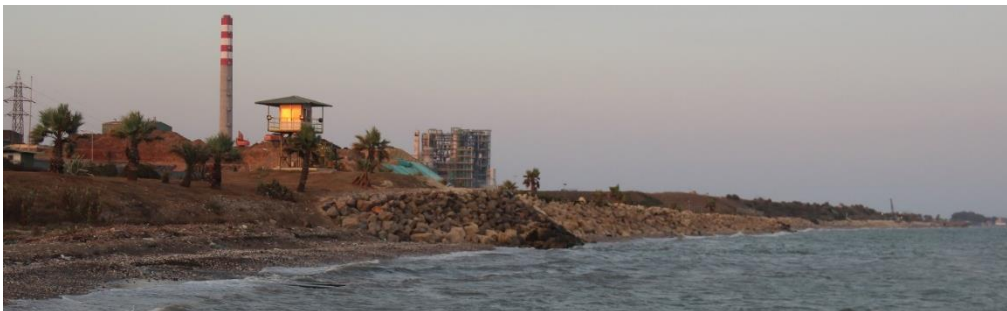
Fig. 35. Kazanlı. July 2021. Boulders entirely bordering the shore line in K4 and K3.

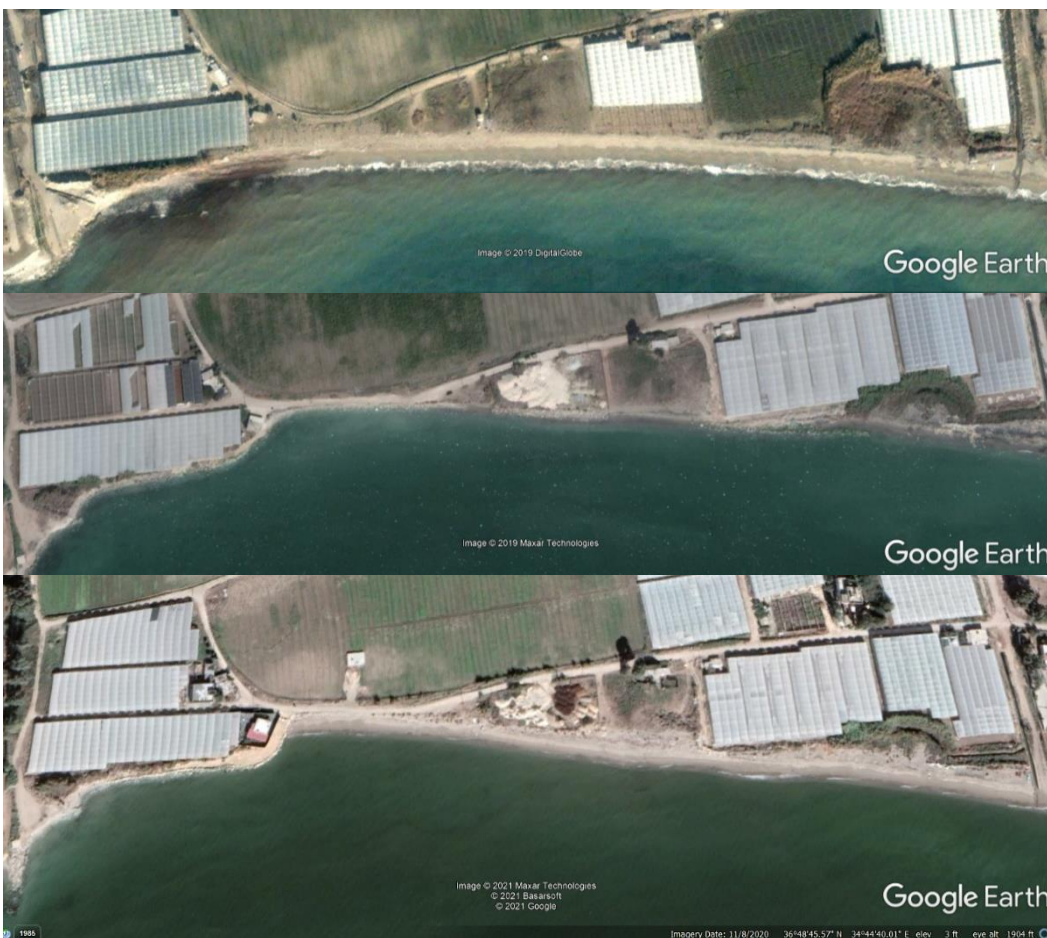
Fig. 36. Kazanlı. Section K3. July 2021. Satellite imagery showing coastal erosion progress. Top: 2007; middle: 2018; bottom: 2020 (Source: Google Earth).

There is no information regarding erosion monitoring on nesting beaches in Kazanlı. Several projects have been mentioned in the Government Reports submitted to the Bern Convention, but there has been no solid outcome. The only measure taken seems to be the arbitrary use of boulders and concrete/cement structures (Fig. 6, 8, 33-34). Erosion remains a critical problem, severely affecting sections K3 and K4 in particular (Fig. 4, 5-6, 19b), where the small beach is non almost non-existent and a large portion of the shore is entirely bordered by boulders (Fig. 8, 10, 35). Although gravely ineffective, it may be very slightly preventing further loss of sand (Fig. 36). Erosion seems to also be affecting section K2 (Fig. 37). Coastal engineering studies should be immediately launched to evaluate manmade structures that are further accelerating erosion.⁸ A setback zone in K3-K2 and maintenance of the setback zone in K1 (that is empty with the exception of two buildings - see point 9 & 14) can protect the nesting beaches from further erosion. We strongly advise against any coastal build-up in any of these zones in K1, 2, 3. The broadening of the road lining K2 indicates possible development, which is of great concern. Of concern, possible sand movement was observed in K1, forming high slopes in the dunes that form the nesting zone: though adults can crawl over, hatchlings cannot. Dunes in this area need to be under strict control, considering also the sea daffodils (*Pancretium maritimum*) that are present; including around the summerhouse complex, indicating it is built on top of the dune system (Fig. 44).

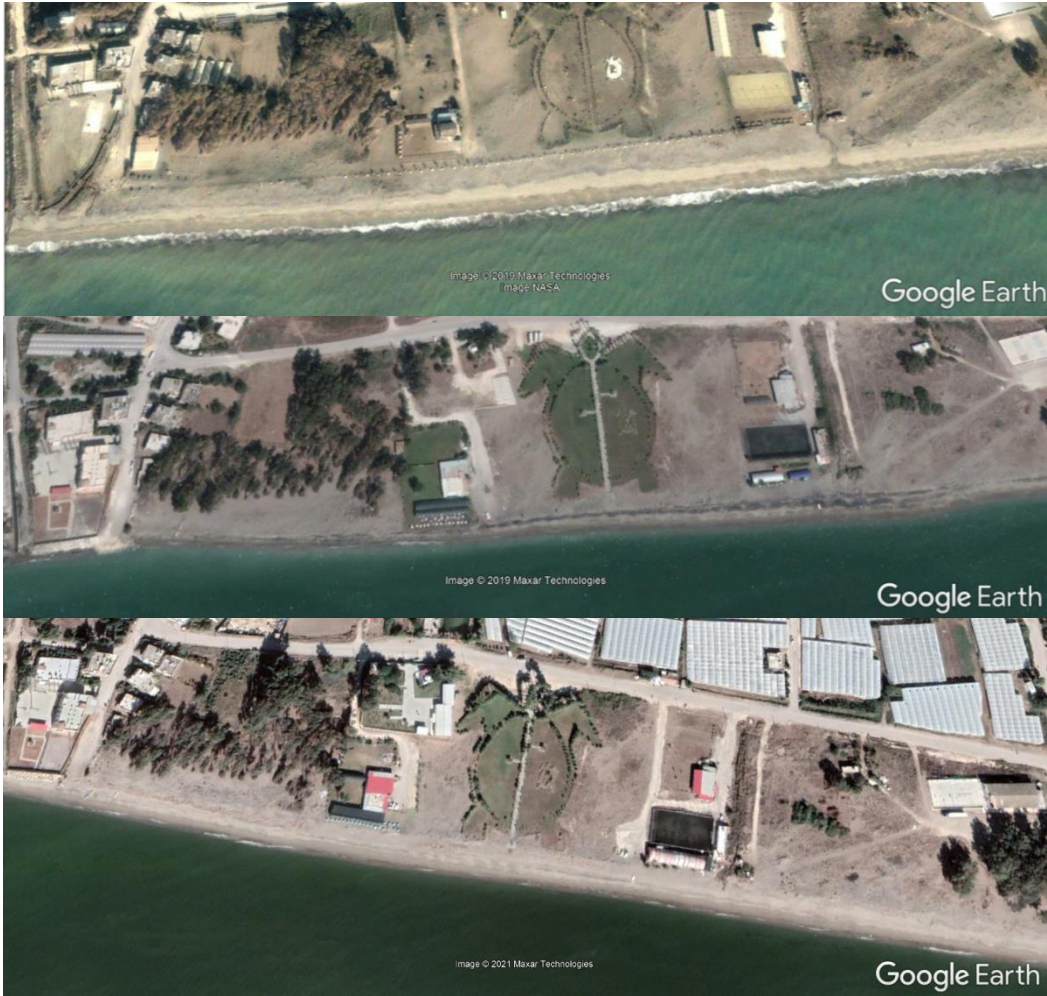
Fig. 37. Kazanlı, Section K2. July 2021. Satellite imagery showing coastal erosion progress. Top: 2007; middle: 2018; bottom: 2020 (Source: Google Earth).

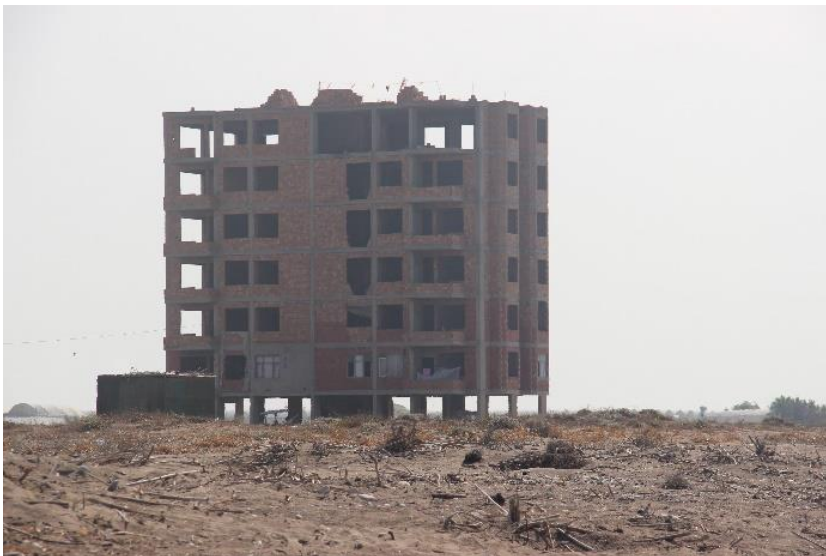
Fig. 40. Kazanlı, Section K1. July 2021. The illegal, abandoned building, still standing on the beach with its 1st floor occupied.

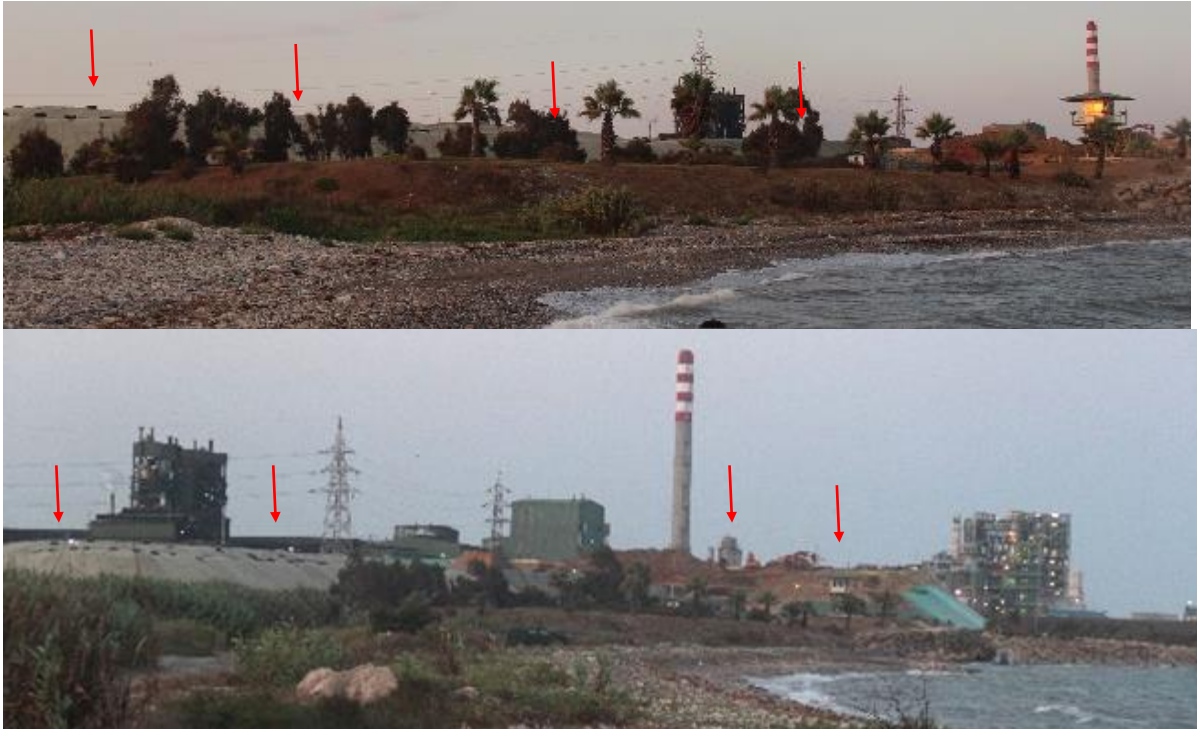
Fig. 41. Kazanlı, Section K4. July 2021. Toxic and neutralised inside the Soda-Chrome Factory complex, next to the beach and sea (red arrows).

Since the 1990s, 1.5 million tons of toxic waste, that has a high concentration of toxic chromium (Cr 3+/6+) compounds and is a by-product of the Soda-Chromium Factory activities, is deposited directly next beach section K4. The waste neutralization and landfilling started in 2010, but despite

Government commitments, it has yet to be completed. The 2019 Government Report stated that the waste are “neutralized, pressed, and then deposited in a temporary landfill which is surrounded by an impenetrable geomembrane covering”. However, 700.000 tons of the toxic waste still remained next to the Mediterranean Sea, despite commitment in 2009 that the removal would be completed by 2019. The “temporary” landfill area of the neutralised waste also continues to be too close to the beach and the sea, inside the Factory grounds (Fig. 41). In 2021, no significant change was observed in the sizes of waste deposit piles comparing to 2019 (Fig. 42-43). Information on progress is required and efforts need to be intensified. The situation poses a high risk threat to the environment and human health.

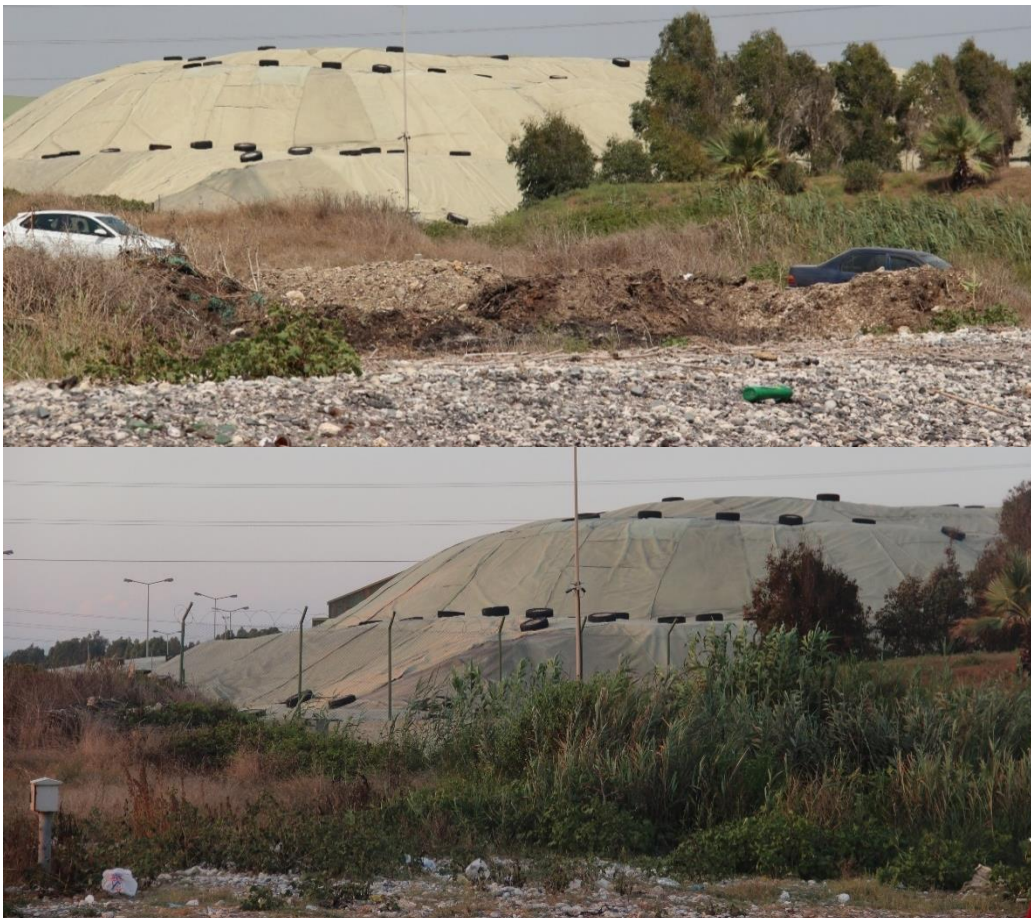
Fig. 42. Kazanlı, Section K4. Soda-Chrome Factory toxic waste deposit piles: top: 2019; bottom: 2021.

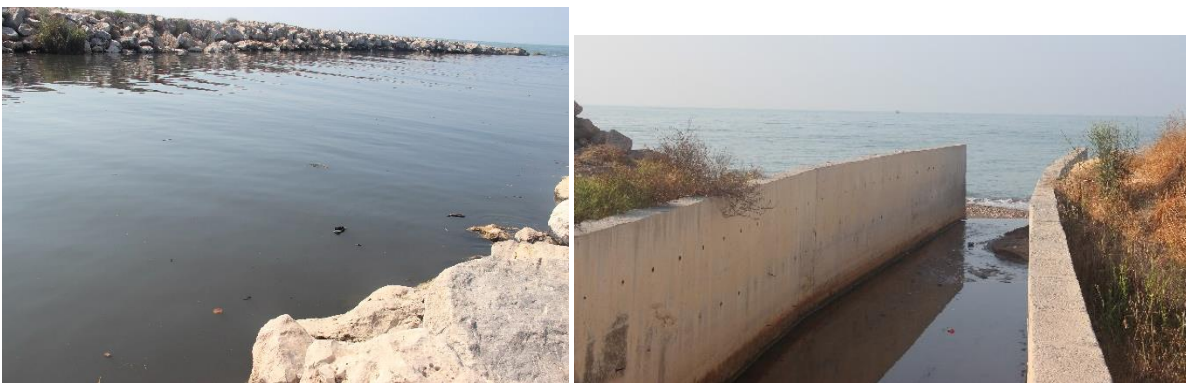
Fig. 46. Kazanlı. July 2021. Example of drainage channels reaching the sea Left: K1 southern end. Right: K2-K3 border.

Drainage channels reaching the sea (Fig. 46) are possible sources of agrochemical contamination, and analysis reports are required. Channels adjacent to the main road behind K2 and K1 were also observed to be quite polluted (Fig. 47). As noted in point 5 there are a few drainage channels reaching the sea in sections K4 and K3 though their source is unclear and information is required. Drainage pipes and new greenhouses beyond K1 and K4 should also be monitored as they directly affect sea water quality. Akdeniz Municipality strategic plan for 2020-2024 mentions several projects on promoting agricultural practices, including organic agriculture, and environmental recycling.¹⁴ The composted fertilizer production unit, at the back of the K1 beach (Fig. 48) may have been established within the scope of these projects. An update on the bio-farming attempts and the project “Integrated pest management in undercover vegetables and fruits” is required with details of practices.
