**Recommendation No. 95 (2002) on the
conservation of marine turtles in Kazanlı Beach
(Turkey)**

- REPORT BY THE NGO -

FOLLOW-UP OF RECOMMENDATION NO. 95 (2002) ON THE CONSERVATION OF MARINE TURTLES IN KAZANLI BEACH (TURKEY)

15 August 2021

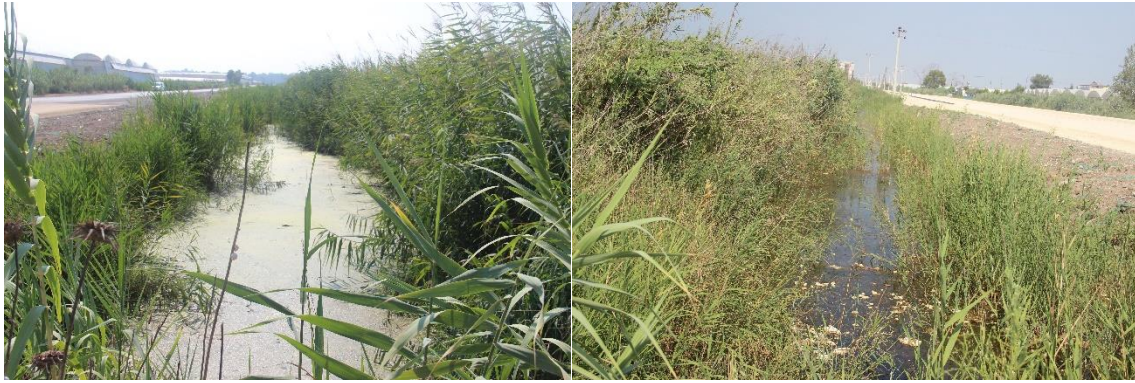
Fig. 47. Kazanlı. July 2021. Polluted drainage channels adjacent to the main road behind K2 and K1

Drainage channels reaching the sea (Fig. 46) are possible sources of agrochemical contamination, and analysis reports are required. Channels adjacent to the main road behind K2 and K1 were also observed to be quite polluted (Fig. 47). As noted in point 5 there are a few drainage channels reaching the sea in sections K4 and K3 though their source is unclear and information is required. Drainage pipes and new greenhouses beyond K1 and K4 should also be monitored as they directly affect sea water quality. Akdeniz Municipality strategic plan for 2020-2024 mentions several projects on promoting agricultural practices, including organic agriculture, and environmental recycling.¹⁴ The composted fertilizer production unit, at the back of the K1 beach (Fig. 48) may have been established within the scope of these projects. An update on the bio-farming attempts and the project “Integrated pest management in undercover vegetables and fruits” is required with details of practices.

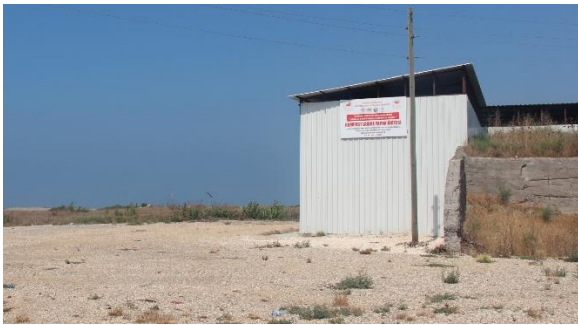
Fig. 48. Kazanlı, Section K1. July 2021. Composted fertilizer production unit at the back of the beach.
