Community-led Urban Strategies in Historic Towns (COMUS)

Goris Urban Streets Rehabilitation

Preliminary Technical Assessment

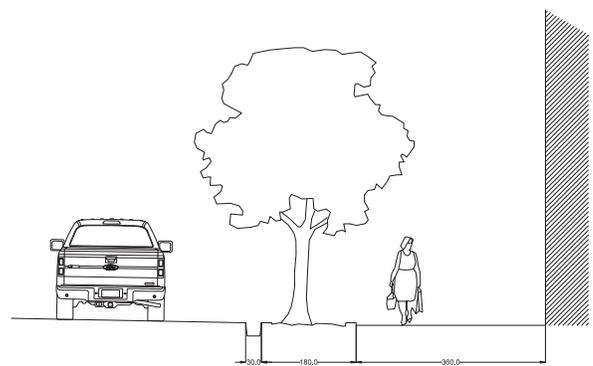
In the longitudinal streets situated to the west of the Syunik street there is a significant difference between the eastern and western pavement marks, the western sections of lateral streets have significant slopes, and stairs were made in the section of Bakhshyan, Sisyan and Khorenatsi streets, due to the big slope, due to which it is not drivable (see Picture 10).

Picture 10. Davit Bek Street, Section

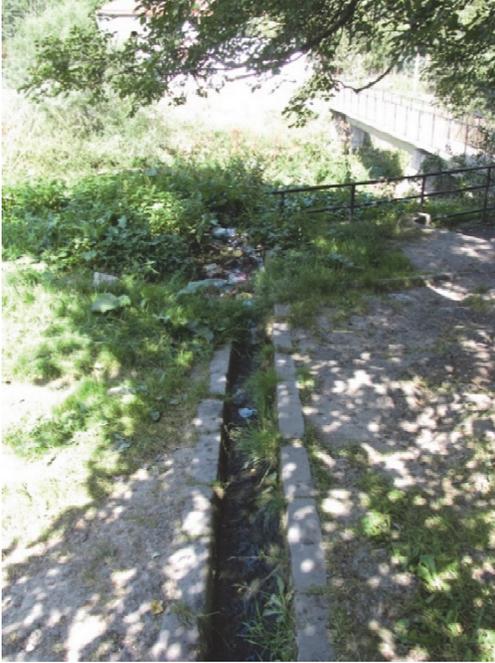
The surface drainage of the city is carried out by irrigation canals that flow into Vararak River through lateral streets. However, some of the sections of those canals are currently destructed and damaged, and very often is damped by household garbage, and the sections flowing into the river are bogged.

Picture 11. Water Channel, River Pouring Section

It is possible to carry out the surface drainage of the city through the channels passing parallel the pavements, for which it is necessary to reconstruct the whole system of those channels with the local basalt stone, restore the destructed and deteriorated sections, widen and deepen the channels passing through lateral streets if needed, construct the sections where those are pouring into the river, by ensuring an unhindered flow of these waters into the river, in order to avoid the bogging in these sections.

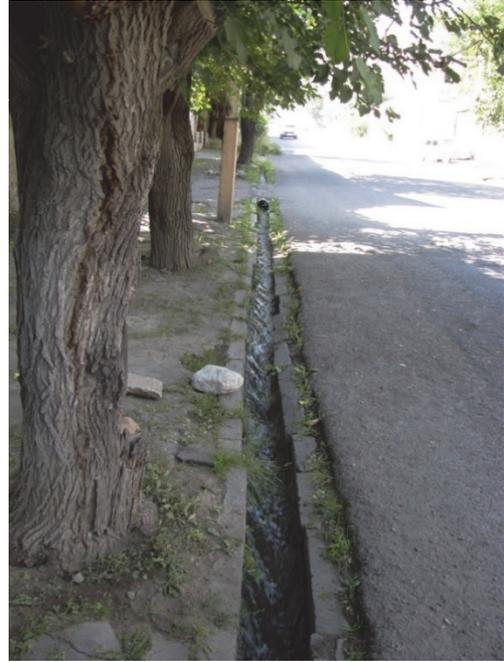
Picture 12. Water Channel

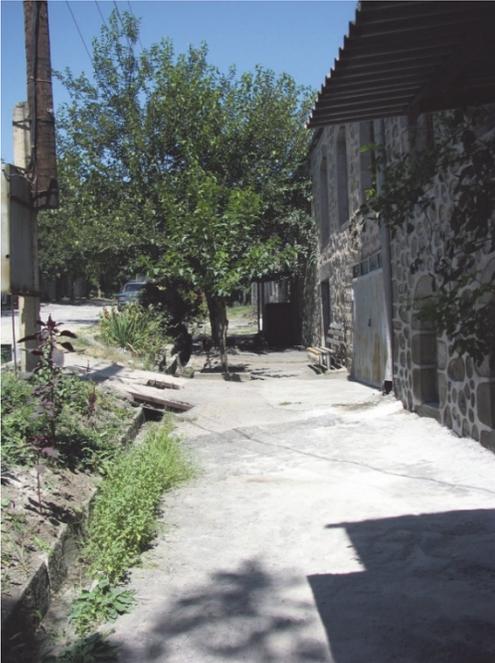
Previously the Goris streets were slabbed, while now those are asphalted. Boundary stones of the pavements are destructed and lacking sometimes. The water streams are not fully operational, some parts are completely closed.

Picture 13. A Street, Water Channel

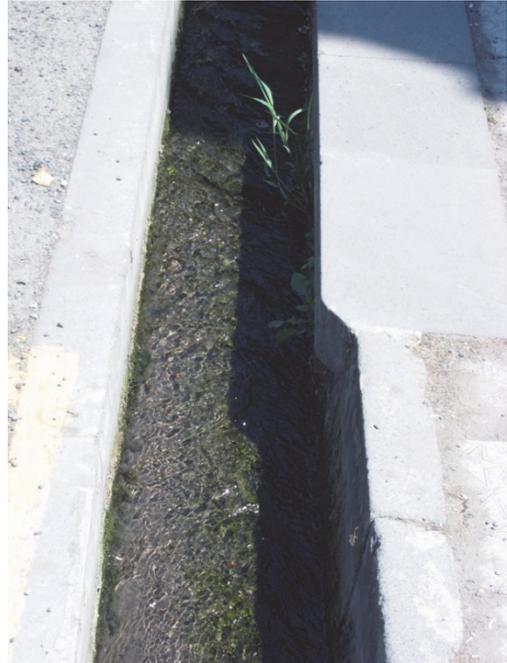
Picture 14. A Restored Water Channel

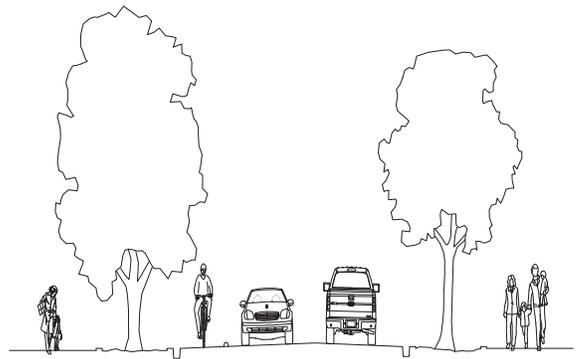
Picture 19. Recommendation to organize a bike route

The width of the main streets enables to separate bicycle routs on the adjacent pavements which can be both double-sided – adjacent to one side pavement, and one-sided – adjacent to two pavements of the street (see Picture 14).

bicycle routes in the longitudinal and latent streets located to the west of Syunik Street. It is recommended to reconstruct the Satyan Street leading to old Goris, by organizing a bicycle route (see Picture 13). Particular attention should be paid to Getapnya Street, which shall be reconstructed, getting it up to the stadium and organizing a special bicycle route, alleys and racetracks along the whole length of the street, in the area adjacent to the river.

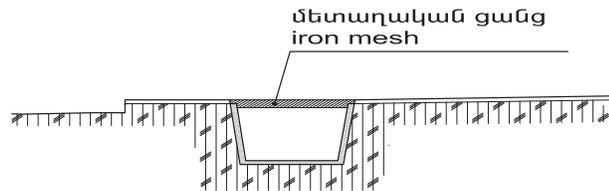
Picture 20. A water channel, a segment where it is covered by an iron mesh

The streets and pavements of the city are mainly divided from the traffic part by channels and the pavements are constructed on the same level as the streets. In case of preserving this solution, and if placing iron meshes on the channels, a single surface is formed, which will allow the disabled people in wheelchairs to cross the streets without any obstacles. Based on the above, the channels should be covered - if not at their entire length, then as a priority, at the pedestrian crossings and the sections leading to the garages and yards – with iron meshes (see Picture 16, 17).

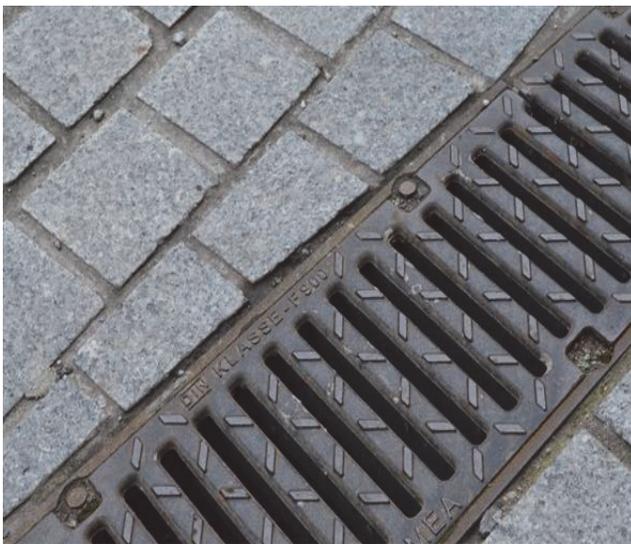
Picture 21. Sample of an iron mesh
<http://trenchdrainblog.trenchdrainsystems.com/2013/07/10/cork-city-of-trench-drains/>

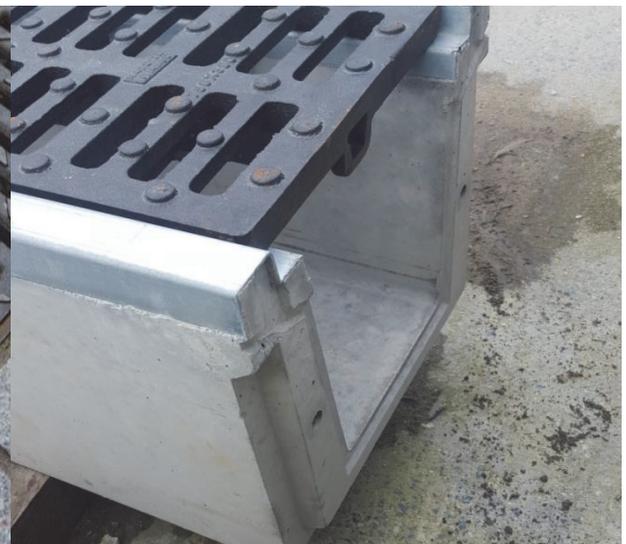
Picture 22. Sample of an iron mesh
<http://www.cbs-concreteproducts.co.uk/drainage-channels/>

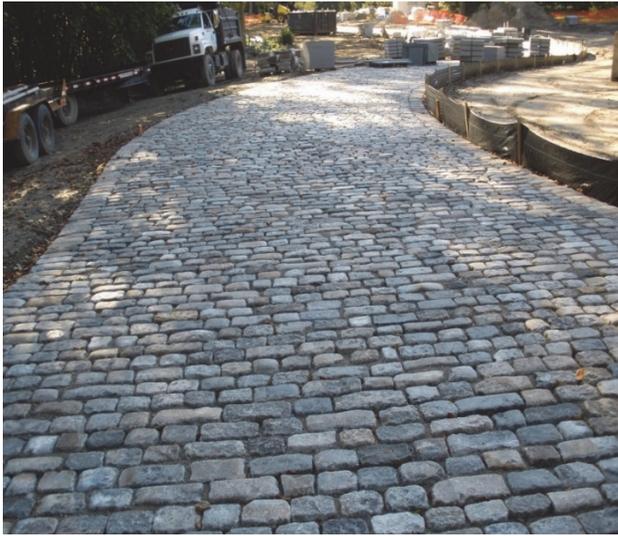
Picture 23. An example of a slabbed street
<http://www.hotelroomsearch.net/united-kingdom/cobblestones>

It is necessary to reconstruct the pavements, especially within the boundaries of the historical core, with local slabs, avoiding asphalt as much as possible and restoring the original appearance. It is desirable that on the territory of the historical core the streets are also slabbed with local stones, and outside of the territory of the preserve, only the pavements can be slabbed, leaving the streets asphalted (See Picture 18).

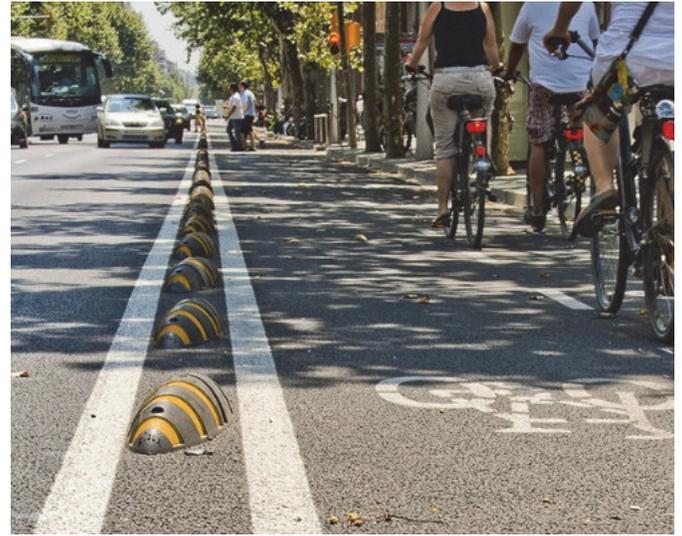
Picture24. An example of bike rout with rubber side stones
<http://inhabitat.com/armadillo-cool-recycled-plastic-bike-lane-dividers-keep-cyclists-safe-on-roads/the-armadillo-barcelona-spain-jpg/>

In the case of Goris, it is appropriate to separate those bicycle roots by stone or rubber side stones. It is desirable to give the preference to the local stones. Based on the situation, it is recommended to organize the
