Community-led Urban Strategies in Historic Towns (COMUS)

**Rehabilitation of Historic District
located within
Gorky-Abovyan-Rustaveli-Varpetats streets
in Gyumri**

Preliminary Technical Assessment

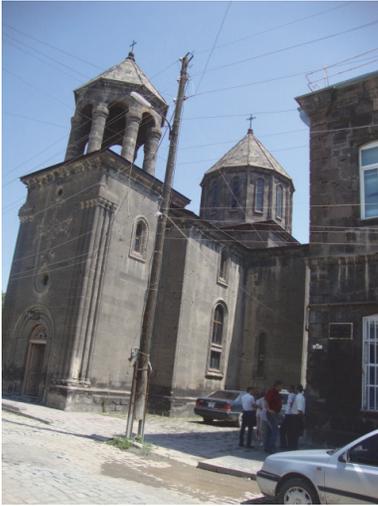
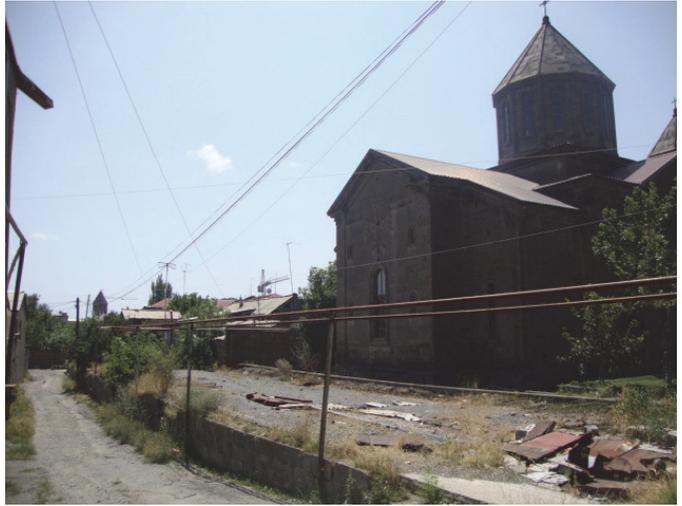
Picture 3. Saint Nshan Church

13. For the last time, Saint Nshan Church was repaired in 2000s and is in a good state.

13. Saint Nshan Church was restored in 2000s for the last time and is currently in a good condition. (Picture 3, 4)

13. Saint Nshan Church does not need a repair

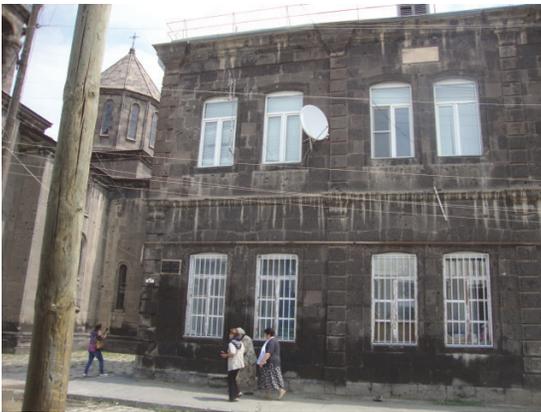
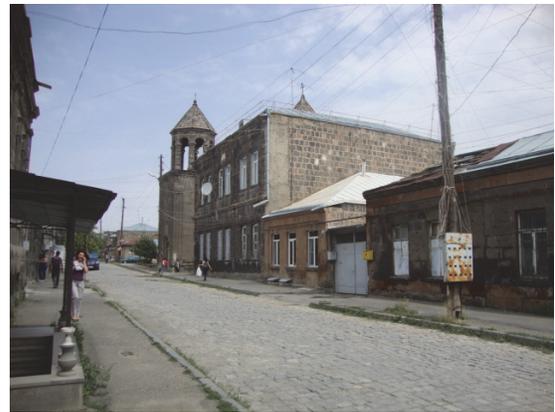
Picture 5. Building in Abovyan 41 address

14. The two-storied residential house in Abovyan 41 is in need of repair, there are cracks seen in the walls, the wooden balconies and the cellar are broken and eroded, and currently is it used only partially.

14. The two-storied residential house in Abovyan 41 (Picture 5, 6) is preserved, however is not used, in the result of which it has an untidy look. Due to the broken roof, both the walls and the core are damaged, the wooden constructions of the coverings between the floors are rotten, and in the result, the building faces a serious threat.

14. The need of repair for Abovyan 41 two-storied residential building is due to its high aesthetic, historical, cultural and architectural value. The monument has high priorities of restoration, repair and re-projection of the coverings between the floors, the construction system and its layout design, and improvement of the internal yard. In order to ensure the stable and safe exploitation of the building, and due to the circumstance of ensuring its safety in a seismologically 9 point risky zone based on the 12 point earthquake scale of Richter, it is necessary to:

- Strengthen the building foundations and eliminate the sediment phenomenon of the walls through drainage;
- Under a high pressure inject special liquid (lime) into the empty parts created in the core due to the decay of mortar;
- Restore the wooden constructions and balconies;
- Implement repairs in all the sections of the construction with the aim of further use;
- Improve the yard;
- Develop new operational solutions for the use of the structure, taking into account the regulation of functions of the two different institutions and the conditions for joint use and maintenance.

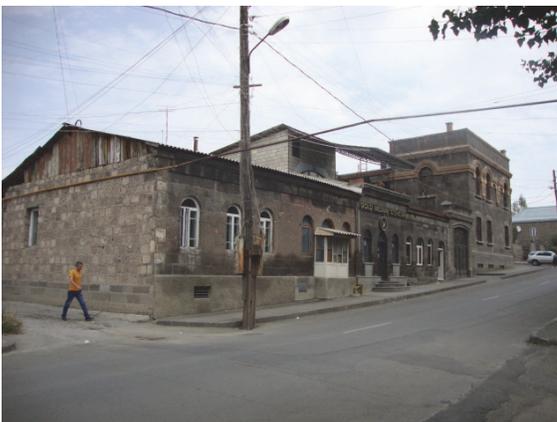
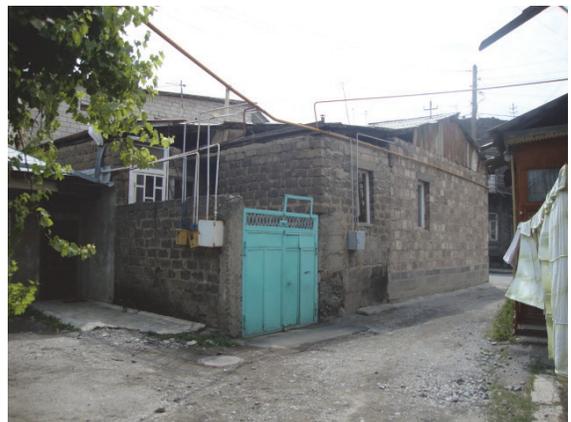
Picture 7. Residential house in Shiraz Street

22. Shiraz 41, 43 /old address/ residential house (Picture 7) is in a good condition due to regular renovations by the owner, the left part of the building is used as a trade point.

22. Building located in Shiraz 41, 43 is not in need of repair.

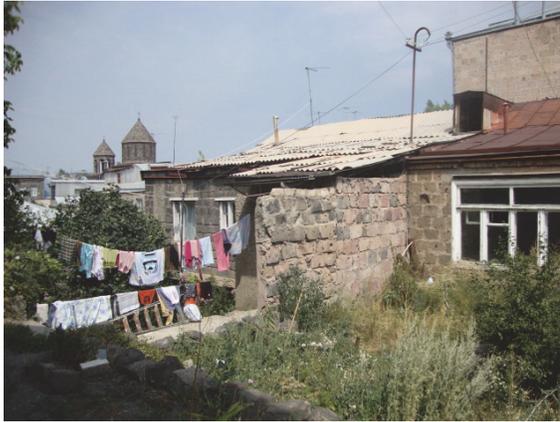
Picture 8. Residential house in Shiraz 90 address

22. Shiraz 90 /old address/ residential house (Picture 8) architecture is distorted by diverse additional constructions, and is in poor condition, however is inhabited.

22. Architecture of the Shiraz 90 /old address/ residential house is highly distorted due to additional structures. It is necessary to remove the newly built additions, restore the initial functional significance of the structure and implement reinforcement works.

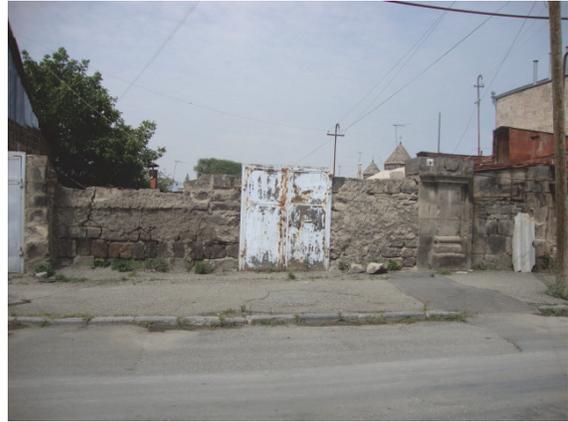
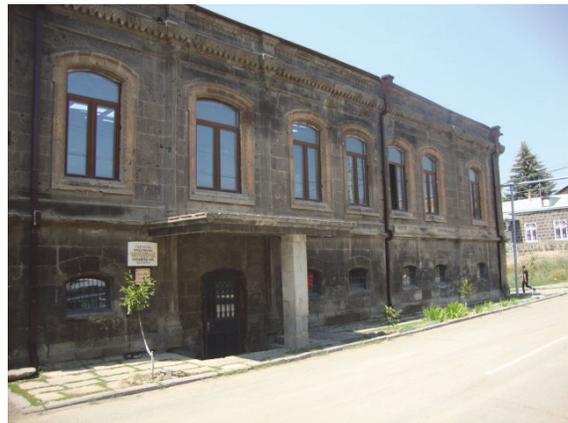
Picture 9. Yard of the Residential House in Varpetats Street

The overall look of Varpetats street monumental buildings (Picture 9, 11) is painfully distorted due to inappropriate interventions by the owners. Additional constructions are built, which are made by reinforced concrete walls, ignoring the traditional tufa stone, near the entrances of some buildings metal gates are installed, stone fences are made, the stones being alien to the traditional ones.

In order to restore the architectural and historical appearance of the Varpetats street residential monumental buildings in it necessary to dismantle the incompatible additions and additional structures,

restore their original appearance - the masonry of walls and traditionally hewed stones, forged gates, chimneys, water pipes and their funnels, window bars and wooden parts, restore the internal yards of the residential houses and all the Gyumri traditions connected with them.

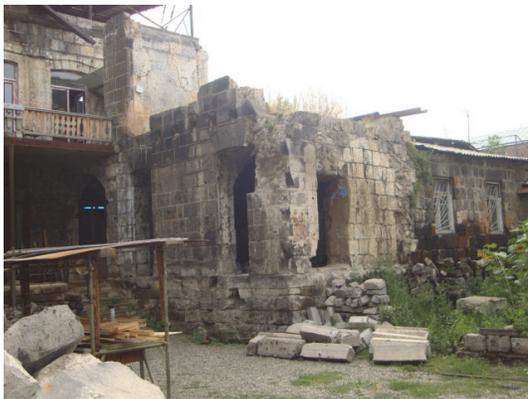
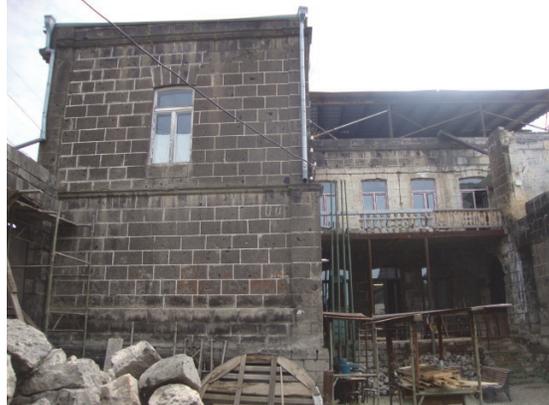
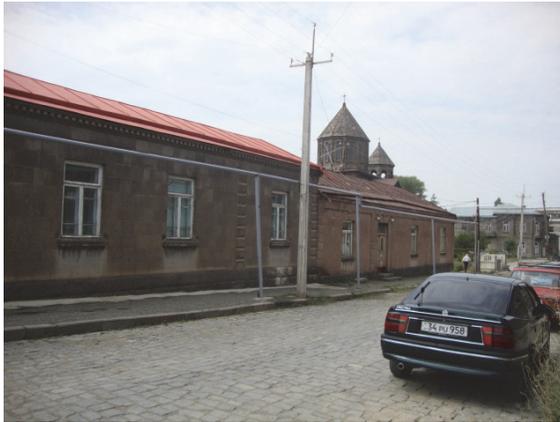
Picture 12. Residential house in Varpetats Street

10. Having a great cultural, historical and architectural value, the Rustaveli-Varpetats streets corner building (Picture 12, 13, 14) is currently in an emergency condition. The structure is a building built with the local tufa stone and a lime and sand binding material. It has a harmonious facade and layout structure against the diagonal axis of Varpetats and Rustaveli streets. The facades are divided by five pairs of pilasters decorated by vertical and semi-circular grooves, which are based on simple profiled anchors and crowned by graceful capitals. The monument also has a horizontal divide- between the semi-basement and the residential floor and between that floor and the roof base parapet, the first of which is simple profile and the second is a toothed and strongly expressed zone ornamented with complex vegetal motive. Lintels of wide windows opened on the facades are curved style - appropriate to Gyumri architecture, and are wrapped in a complex rim. Windows of the semi-basement floor are designed to be more modest. The facade near Rustaveli Street has an open balcony, which is also typical to Gyumri residential houses' architecture. The facade on Rustaveli street ends with a luxury decorated arched entrance leading to the courtyard, where the traditional wrought gate is missing. Covering of the structures floors is made by wooden logs; the roof is two-sloped, with a metal covering based on wooden truss. On the pavement near the building on Varpetats street, the traditional slabbed pavement has been preserved. The devastating earthquake of 1988 and the fact that a big part of the building is not inhabited have caused a big damage to the monument. In particular, the wooden coverings of the roof and between the floors have collapsed, and sedimentary cracks are conspicuous on the facade from Varpetats street.

10. The corner building of Rustaveli-Varpetats streets has high priorities of restoration, repair and re-projection of the roof, coverings between the floors, the construction system and its layout design, and improvement of the internal yard. In order to ensure the stable and safe exploitation of the building, and due to the fact, that is its needed to ensure its safety in a seismologically 9 point risky zone based on the 12 point earthquake scale of Richter, it is necessary to:

- Strengthen the building foundations and eliminate the sediment phenomenon of the walls through drainage;
- Under a high pressure inject special liquid (lime) into the empty parts created in the core due to the decay of mortar;
- Restore the wooden constructions and balconies;
- Implement repairs in all the sections of the construction with the aim of further use;
- Improve the yard;
- Develop new operational solutions for the use of the structure, taking into account the regulation of functions of the two different institutions situated in the monument and the joint conditions for use and maintenance.

In order to prevent the highly emergency of the Rustaveli-Varpetats streets corner building, urgent interventions are necessary, the total cost of which is 14 000 000 AMD (about 26 500 EUR).

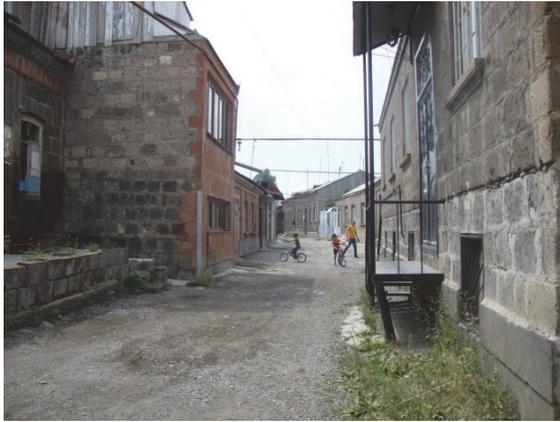
Picture 17. Construction on the territory adjacent to Saint Nshan church /not a monument/

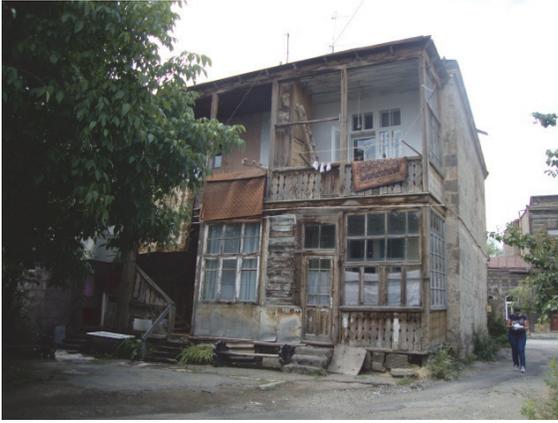
Picture 20. Abovyan Street, two-storied residential house

The corner building adjacent to Abovyan and Gorki streets, which is not included in the state inventory list of immobile monuments, has both architectural and historic value. It is a two-storied construction built by tufa stone, and the main facades are plastered with lime and sand. It has compound profile cornice which separates the floors from each other. The facade of the first floor is developed in horizontal grooves. From the side of the yard, the construction has wooden traditional balconies (Picture 19, 20).

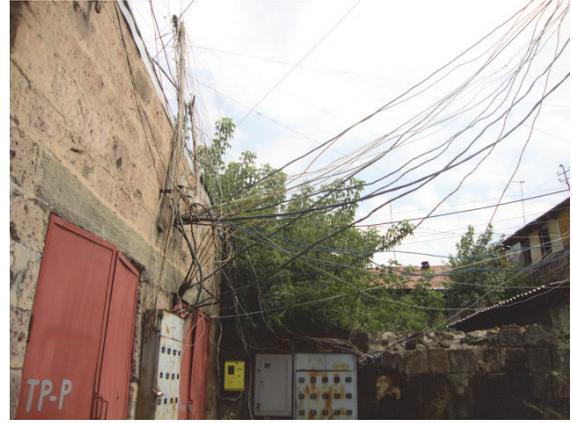
Picture 21. Abovyan Street, yard of a two-storied residential house
