Open File 2019/5

Habitat destruction in Mersin Anamur Beach (Türkiye)

REPORT OF THE ON-THE-SPOT APPRAISAL
2-4 JULY 2024

Prepared by ALan F. Rees, PhD, Consultant

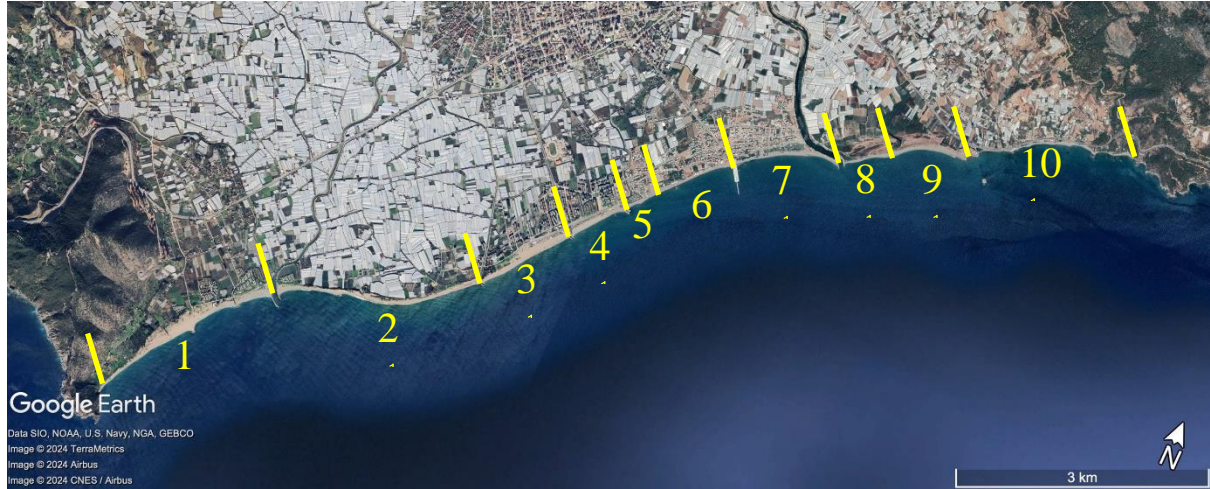
Figure 1. Anamur coast and assumed beach subdivisions used in nest monitoring. 1) ÖREN-S. SUYU / Anemurium – Sultan River. 2) S. SUYU-KARAAĞAÇ / Sultan River – Karaağaç. 3) KARAAĞAÇ-CERENLER / Karaağaç - Cerenler (Stage 2+). 4) CERENLER-TAŞLIK / Cerenler – Stony Area (Stage1). 5) TAŞLIK-ASKERİYE / Stony Area – Military. 6) ASKERİYE-İSKELE / Military – Port side. 7) İSKELE-DRAGON / Port Side – Dragon River. 8) DRAGON-DERE / Dragon River – Nameless River. 9) DERE-KALE / Nameless River – Mamure Castle. 10) KALE-PULLU / Mamure Castle – Pullu National Park

The turtle nesting beach is reported as 12.7 km long and is segmented by the presence of several small rivers some which are habitats used by the Nile soft shelled turtle (Uçar et al. 2012; Uçar and Ergene 2022). The beach is least developed at either end and has considerable urban and touristic infrastructure more centrally located (Fig. 1).

The coastal arrangement project that has been undertaken included ‘Stage 1’ at beach section 4 and ‘Stage 2’ at beach section 3 (see Figs 1 and 3). Stage 2 is reported as not completed with a further 400 m stretch of beach to be subject to coastal arrangement and this is covered in point 10. Development of the beach under the coastal arrangement project was subject to advice and guidelines from the national Sea Turtle Scientific Committee (Kaska Y, pers. comm. 2024). The coastal arrangement project has resulted in major changes to the beach and hind-beach/dune area along the developed stretches. These include concreted walkways, extensive lighting infrastructure, irrigated grass areas, new road, shower and changing facilities (Figs 3, 11, 16 and 17). Most tourist enterprises such as bars and restaurants have been relocated back away from the beach (conservation zone 1), though lighting issues remain. Both development stages are discussed individually next.

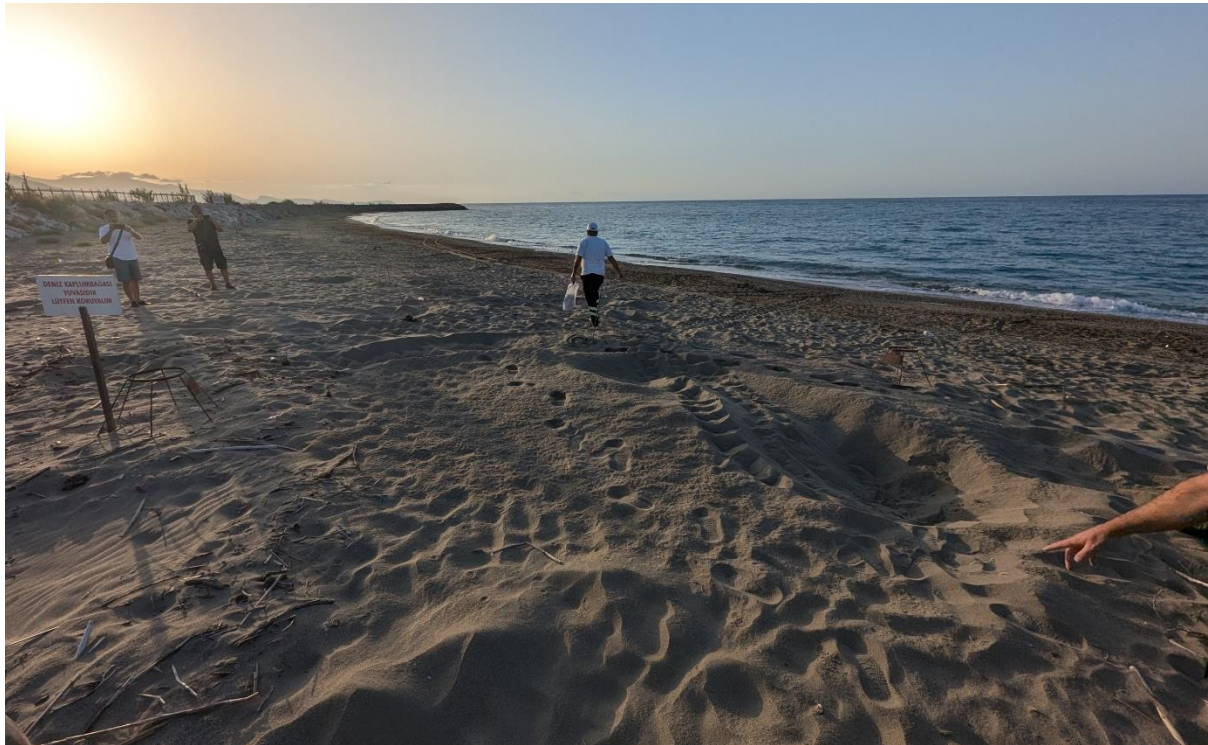
Figure 2. A fresh green turtle nest observed near Dragon River during the 3 July 2024 OSA. It was not clear that the person responsible for surveying the beach understood that it was not a nest made by the more common loggerhead turtle. This was the only green turtle nest observed and recorded so far in the 2024 nesting season.

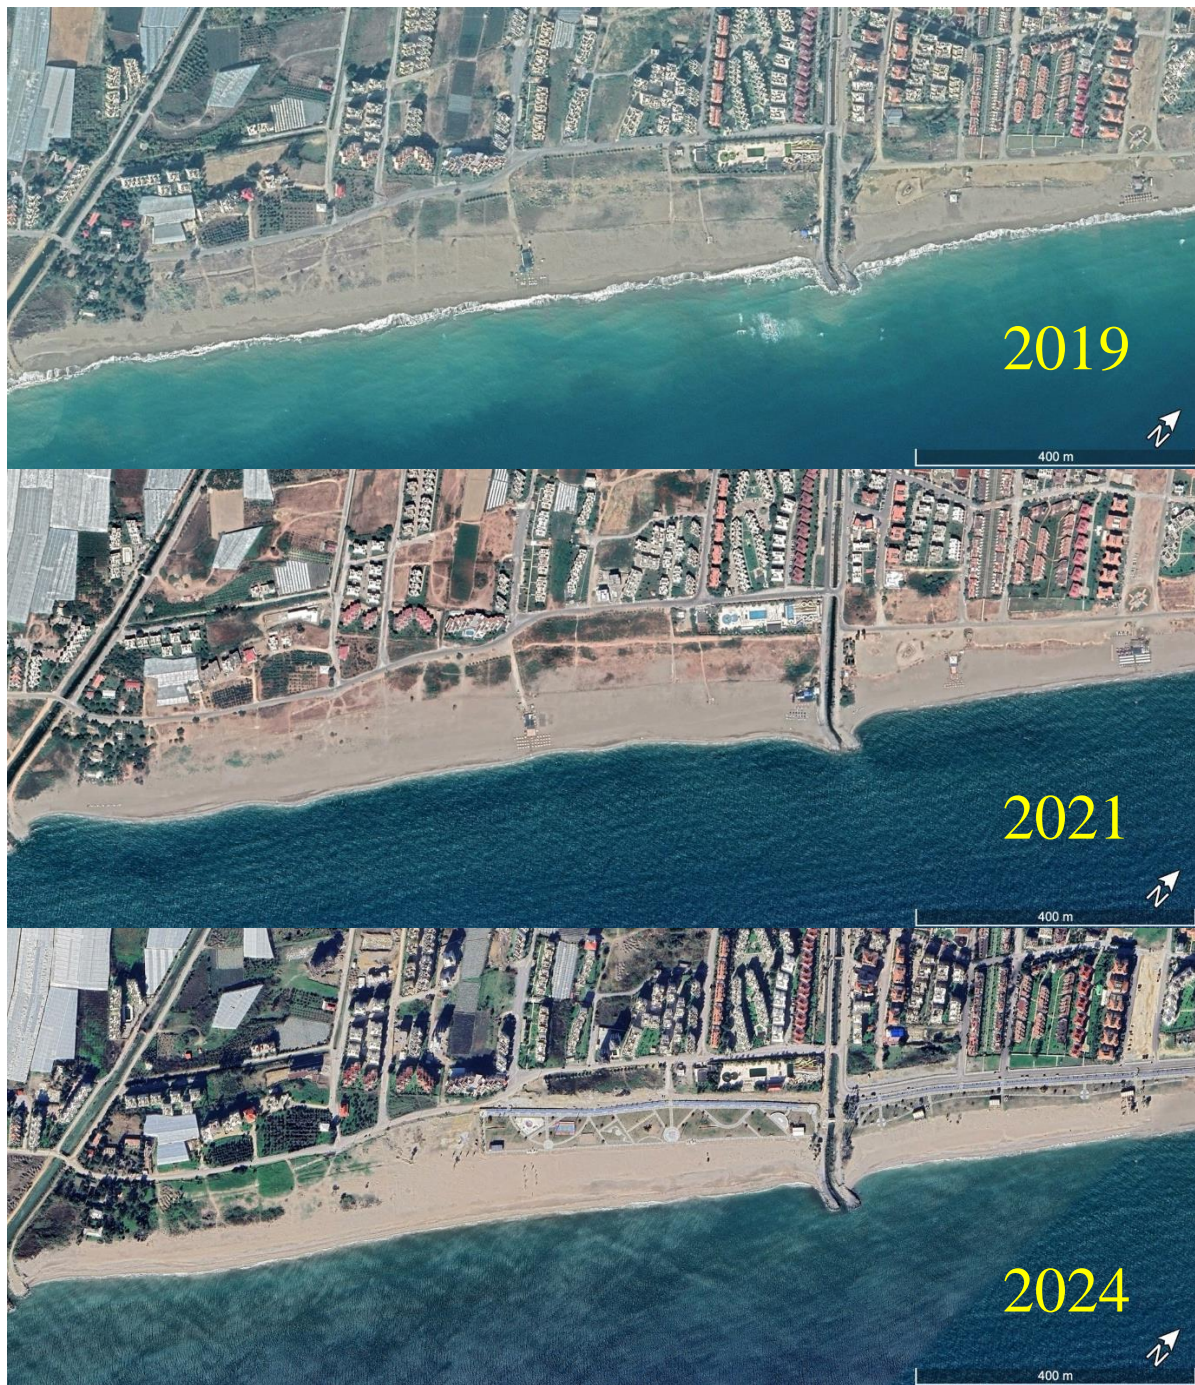
The alterations of Stage 1, the first completed on the coast, notably included the addition of a paved road behind the beach (Fig. 3), installation of multiple green and white walkway lights and other infrastructure (Fig. 16) and moving bars and restaurants back away from the turtle nesting zone. Clearing the turtle nesting zone of tourist structures is a positive result of this development, however walkway lighting design and light management are poor and did not follow the national Sea Turtle Scientific Committee advice.

Figure 3. Status changes over time for beach section 3 (left of the river [Stage 2]) and part of 4 (right of the river [Stage 1]) as shown using Google Earth Pro. Note the removal of most of the tourist infrastructure close to the shore and substantial landscaping of the foredune area between 2021 and 2024. For details of beach divisions see Fig. 1.

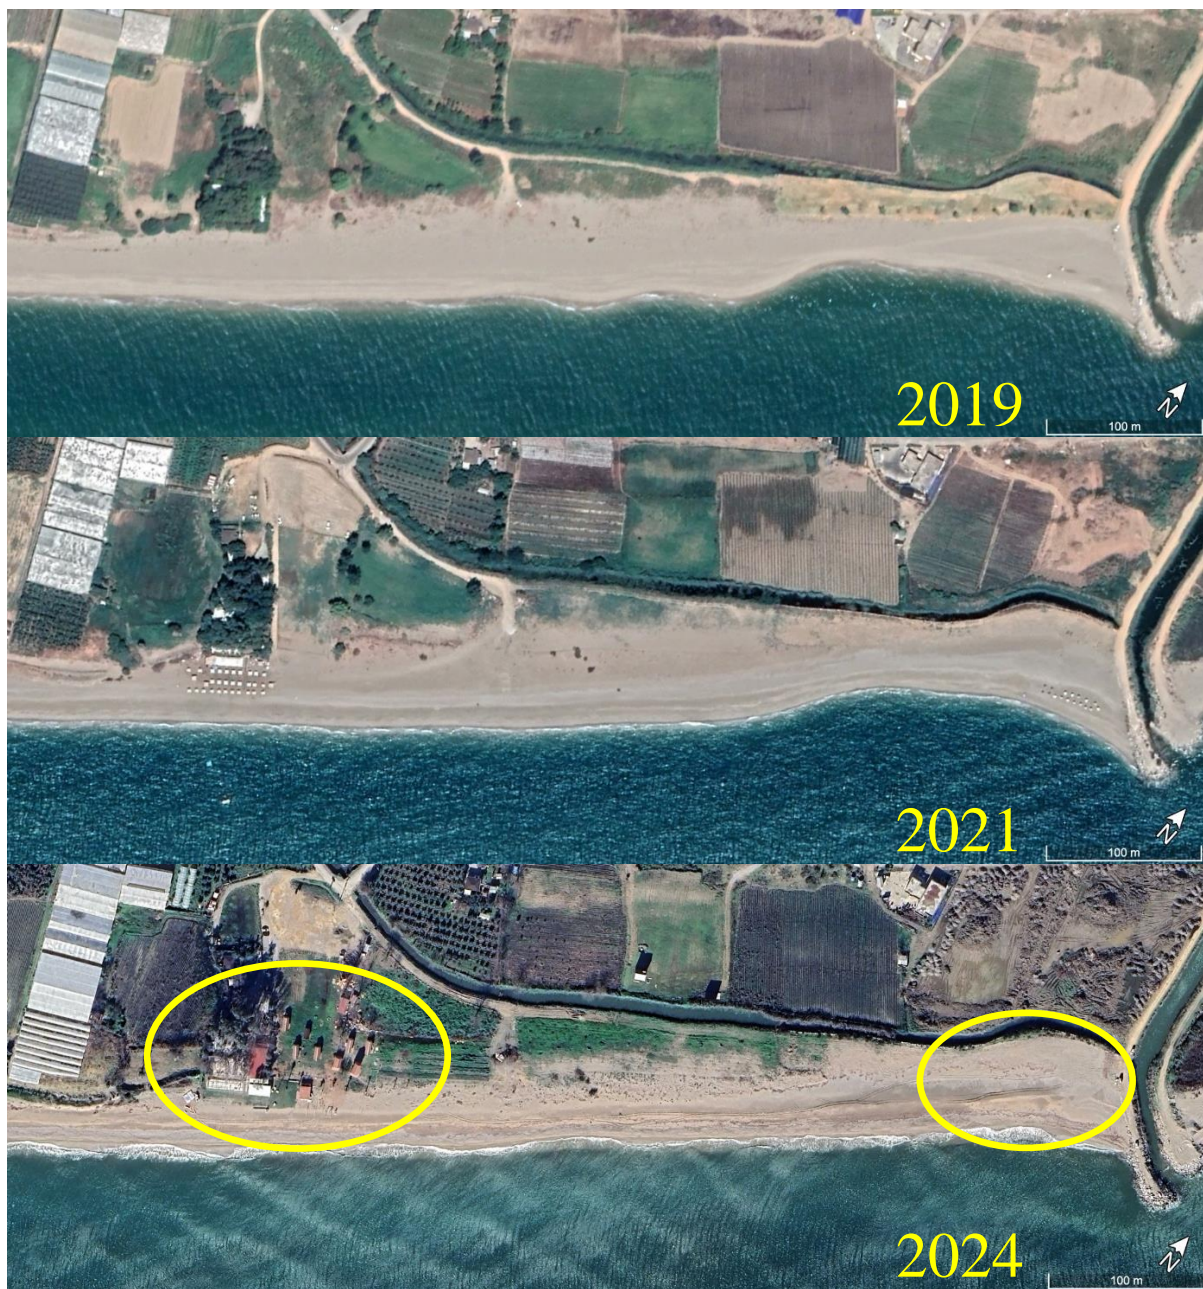
Development of touristic facilities on beach section 2 (see Fig. 4) was the most obvious example of small business expansion. According to discussion during the OSA, this area involves the potential private ownership of normally state land behind the beach, which complicates issues. However, the development: bungalows, cantina, irrigated lawn and trees, beach furniture etc. and storing of large amounts of soil on the beach and dune area (Fig. 12) are reducing the physical area available to the

Figure 4. Northern part of beach section 2 with development of touristic infrastructure on and near the beach (left oval) and a landscaped and remediated 'picnic area' (right oval). Both locations have been topics within the specific complaints raised against the insufficient governance of the turtle nesting beach. Note also the reduction of sand immediately to the left of the river between 2021 and 2024. For details of beach divisions see Fig. 1.

The main area of beach requiring restoration, that is not considered under specific report points was the area of touristic facilities on beach section 2. This area should physically be relatively simple to restore however legal complications of the process based on alleged private ownership of the land could hinder restorative actions. The local authorities indicated they were enthusiastic to do what they could under the established legal framework. Indeed, Anamur had recently undergone elections where a new party had been voted into power and during the OSA meetings they were keen to suggest they want to do all they can to protect the turtles and their habitats and correct any mistakes made by the previous administration. Details of such interventions are listed in the relevant report points.

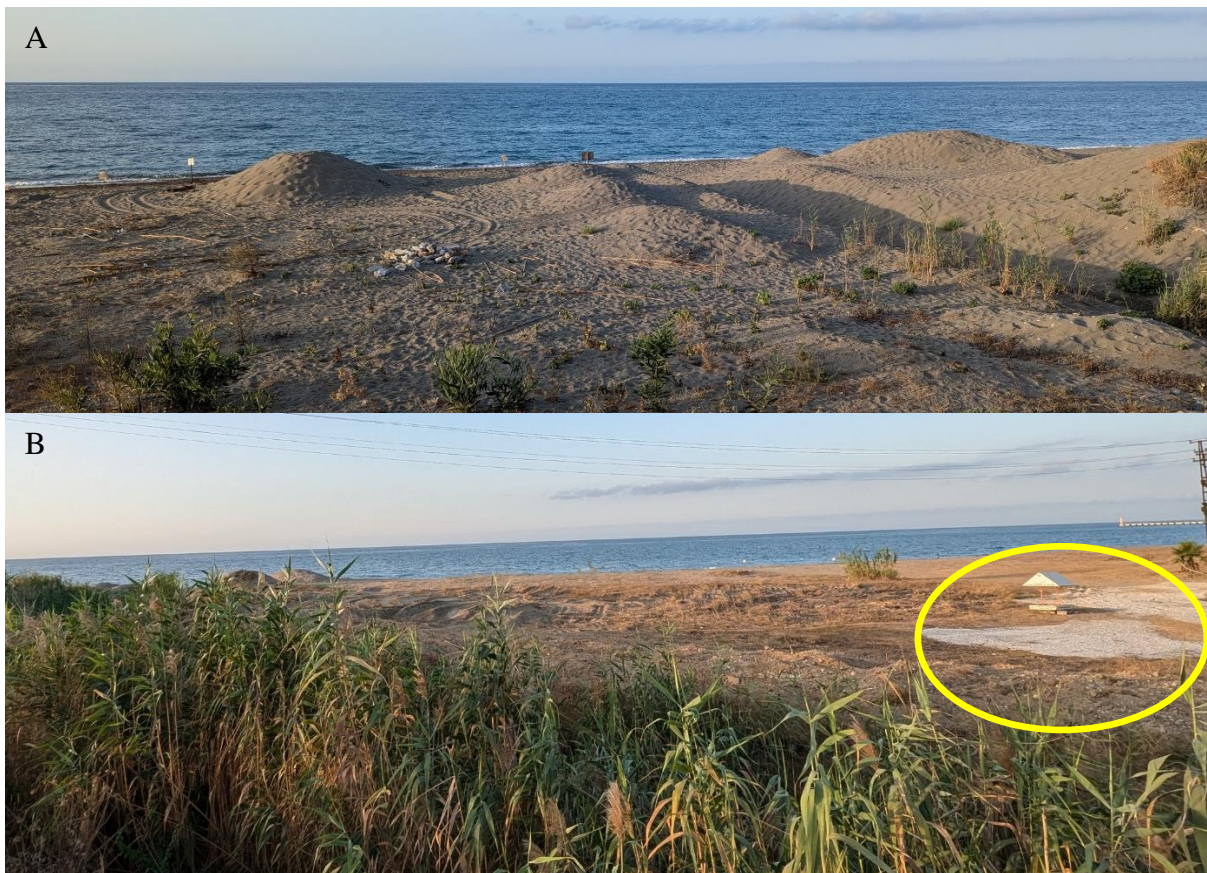
No recent evidence of sand extraction was witnessed during the site visits. However, evidence of movement of sand, through piling of sand, was observed near to Dragon River where the area had been cleared and partially covered in stones, which according to MERÇED Anamur were to “to establish a caravan camping area” (Fig. 5).

Figure 5. Evidence of movement (piling) of sand on the beach (A) and landscaping the dune area “to establish a caravan camping area” that includes laying of stones to stabilise the ground (B; yellow oval).

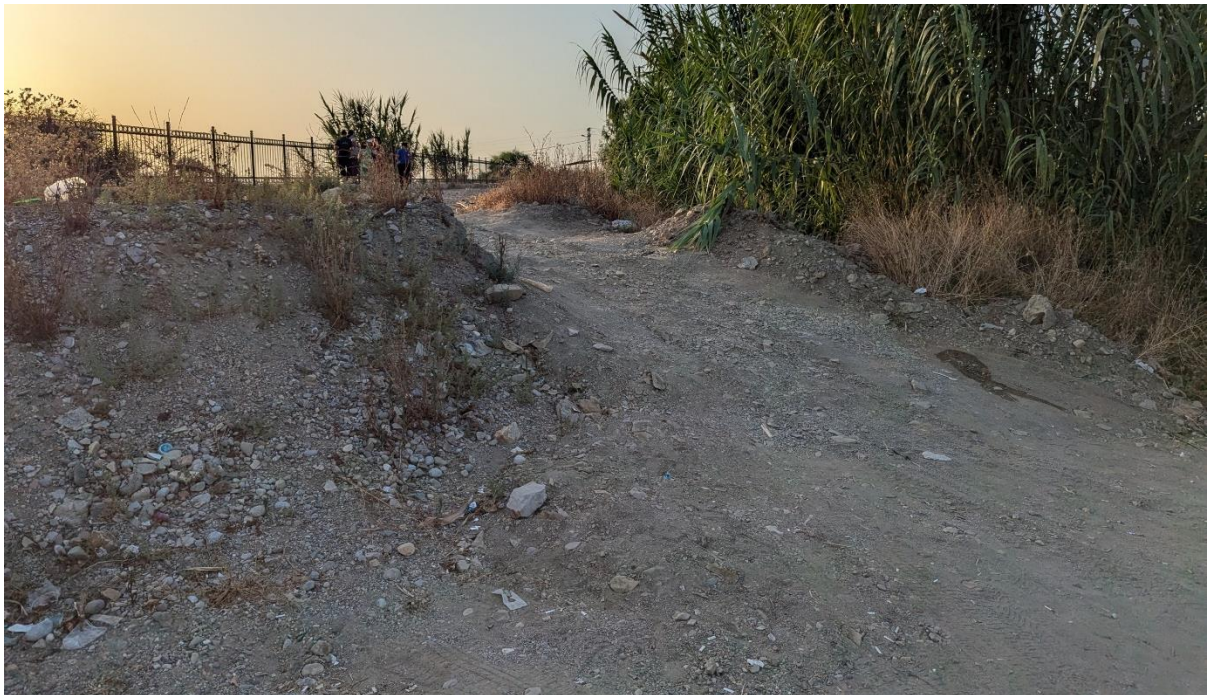
Intermittent vehicular access to the beach was observed to be possible for dedicated drivers where access prevention measures had been modified (e.g., Fig. 6). However, there was very little evidence of cars, 4WD vehicles or heavy machinery observed on the beach during the OSA. A small quad bike, used to sell maize, was observed on one stretch of the beach and tracks from the surveying officer's

Figure 6. The beach near Dragon River is made accessible by the smoothing of a dirt slope that was in place to prevent access.

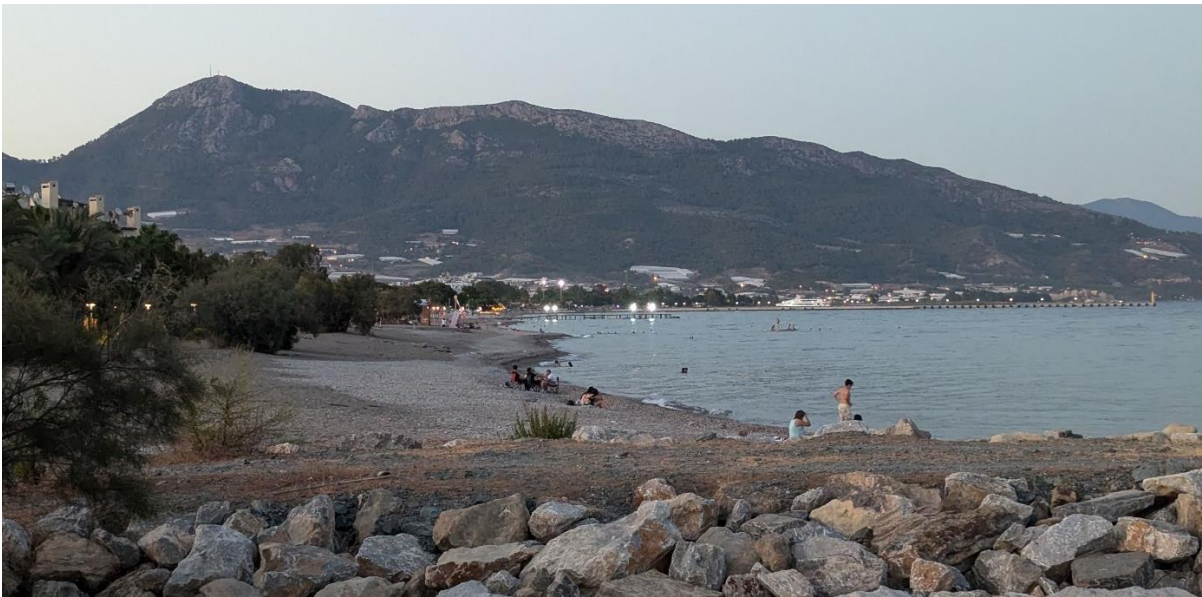
Bright lights were observed on the piers at beach section 6 (Fig. 8) which were confirmed to be causing hatchling misorientation (Fig. 9). Other sections of beach remain undeveloped with little to no light pollution, so focussed attention to the areas illuminated at nighttime are warranted.

Figure 8. Bright lights on the piers at beach section 6.

Design a hatchling management plan to be prepared for occurrences of hatchling disorientation caused by artificial lighting and respond promptly and strongly to adjust, revise or eliminate problematic lighting.

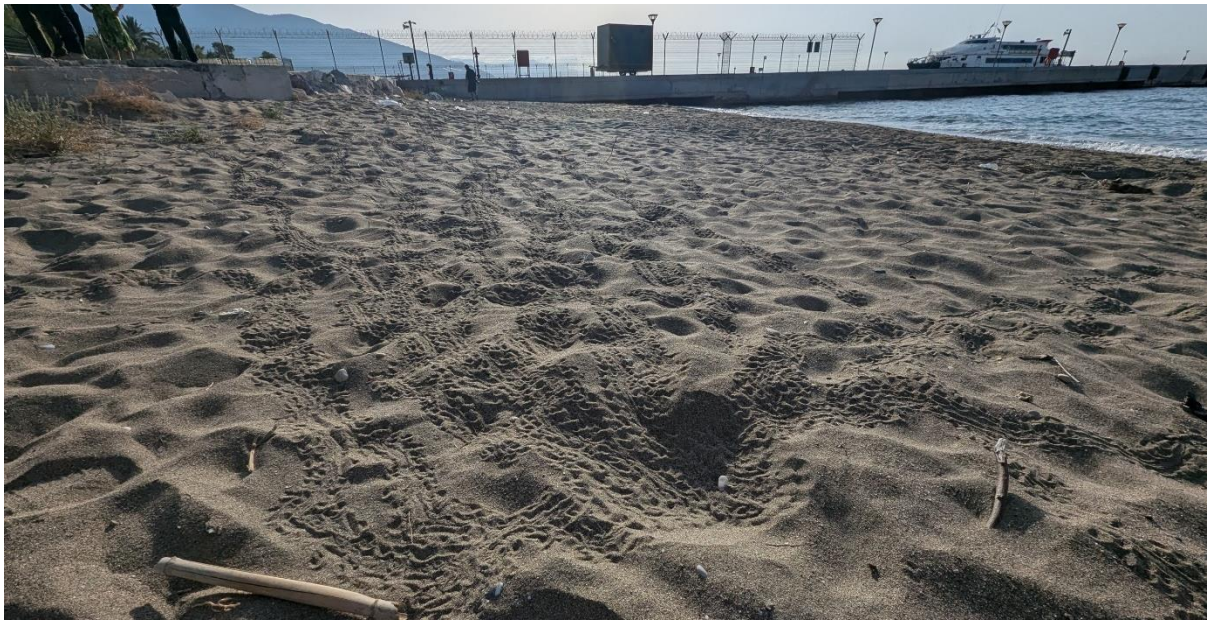
Figure 9. Evidence of hatchling misorientation (hatchling tracks running along the beach from the nest towards the pier, rather than towards the sea) from beach section 6.

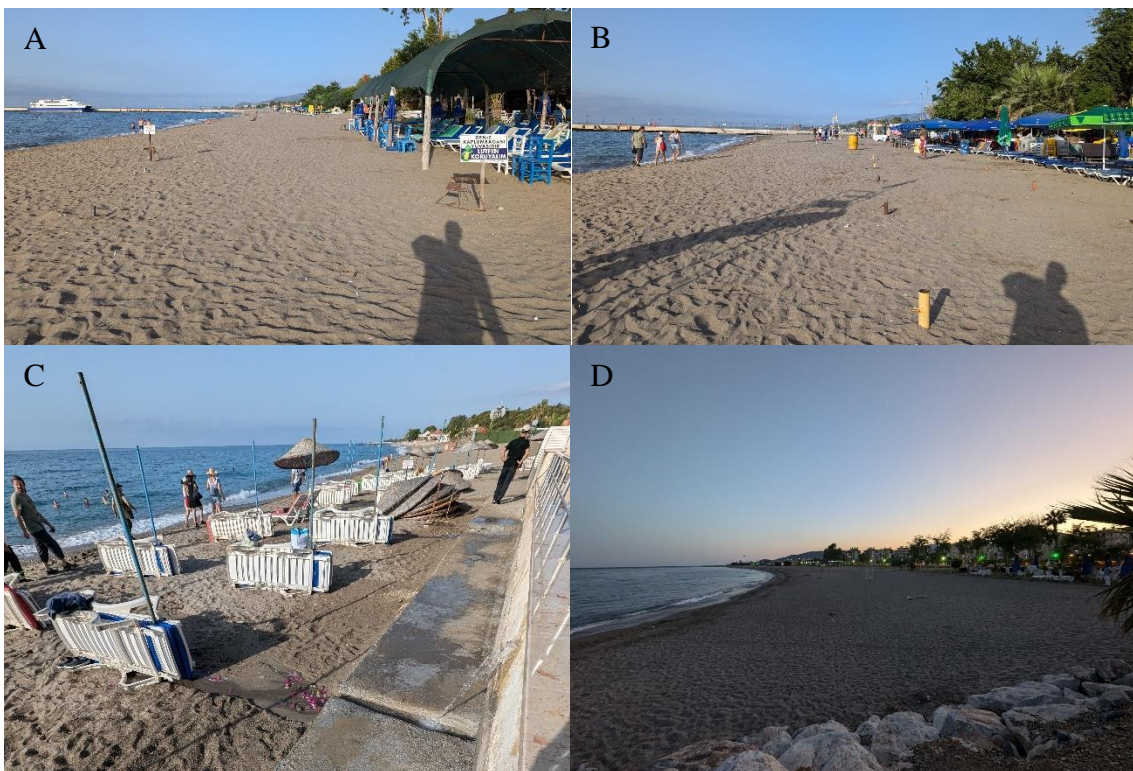
During the OSA locations that had potential to be overrun with beach furniture generally had very little beach furniture present, even during the day, with a notable exception in section 7 (Fig. 10). Consequently, the presence of furniture on the beach at night was not observed to be an important issue for turtle nesting during the OSA. However, the situation has the potential to change from one day to the next, given the presence of umbrella bases in the beach and numerous sun loungers placed along the top of the beach and monitoring and enforcement of regulations is warranted.

Figure 10. Touristic areas of beach and the presence of beach furniture and constructions.

A & B) Beach cafes etc. on beach section 7 displaying absence of furniture over the beach during the day. Bases for umbrella poles are evident on the beach and there were many sun loungers placed along the top of the beach, *suggesting that the absence of furniture may not be coincidental with the dates of the OSA.*

C) Upended sun loungers and umbrella poles on a narrow stretch of beach at the northern part of section 7. Note also the wastewater flooding onto the beach, at more than one point, from the stage floor of the construction behind the beach that was being hosed down beach.

D) The empty beach of the northern part of section 4.

3 removal of beach furniture at night	Good	Low	Only a few small areas where beach furniture in place and potentially removed at night, except for the development on Karaağaç beach. Furniture removal requires regular monitoring and enforcement.	Furniture removed from beaches at night to free up turtle nesting zone.	Monthly check (random dates); May to September.
4 collect of littering [sic]	Good	Low	The beaches observed were all relatively litter free.	Beaches regularly cleared of litter without using heavy machinery.	Monthly check (random dates); May to September.
5 treatment of wastewater	n/a	n/a	Wastewater from beach showers along 'Stage 2' of beach section 4 were assessed to not be impacting the nesting area. But recommended to not be increased in number.	No additional water-sources placed that drain directly onto beach.	Bi-monthly checks; January, March, May, July, September, November.

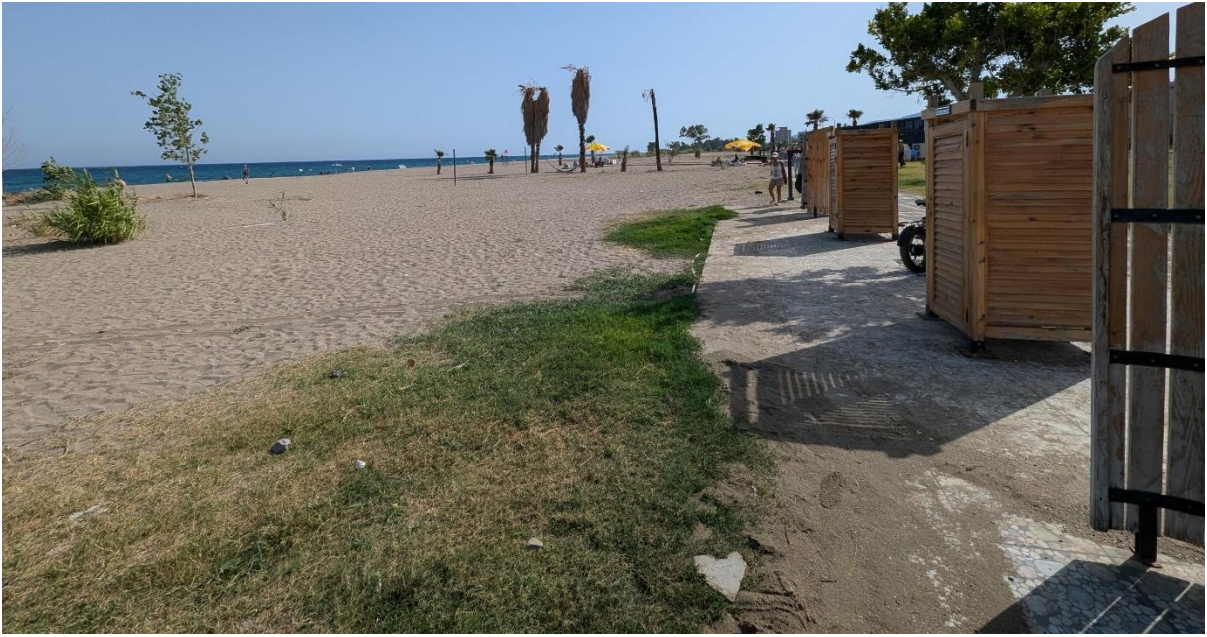
No problems of excessive littering, or litter removal were observed during the OSA. Neither were any problems with wastewater observed. Several showering stations with water that flowed into the sand were observed at the back of beach section 3 (Fig. 11). They were assessed to not be impacting the turtles due to the width of the beach and the distance of the shower effluent from the nesting zone.

Figure 11. One of several showering and changing stations along the rear of beach section 3. Note the grass growing where the shower water is running onto the beach/dune area, but due to the distance from the sea, the importance of this spillage and growth is negligible.

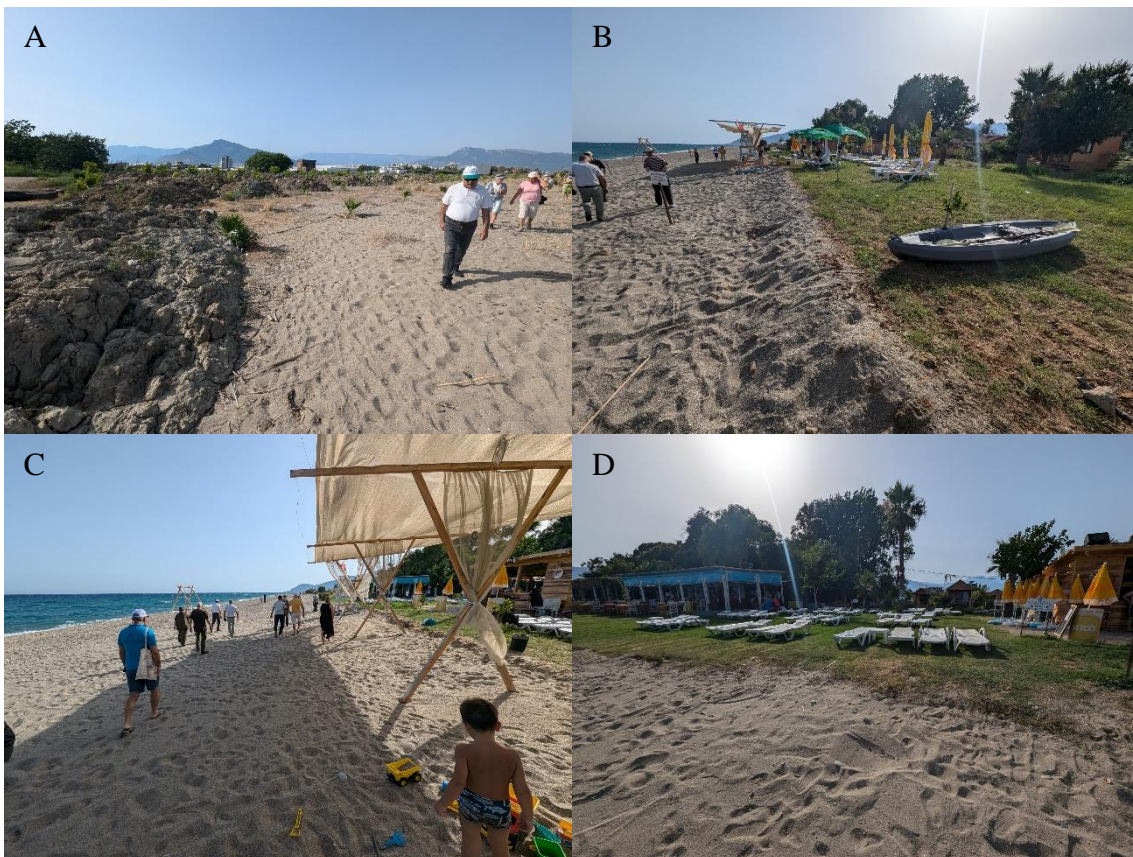
turtles for nesting and degrading the natural habitat which should be under protection under national legislation. This is especially concerning as the development occurs away from the main developed area and, if left unchecked, may act as a catalyst for other such developments.

Figure 12. Anthropogenic impacts on beach section 2 (Karaağaç beach).

A) Large amounts of soil dumped on the beach and dune area together with recently planted and irrigated trees.

B - D) grass lawn, buildings, bungalows and miscellaneous tourist infrastructure established on and behind the beach.

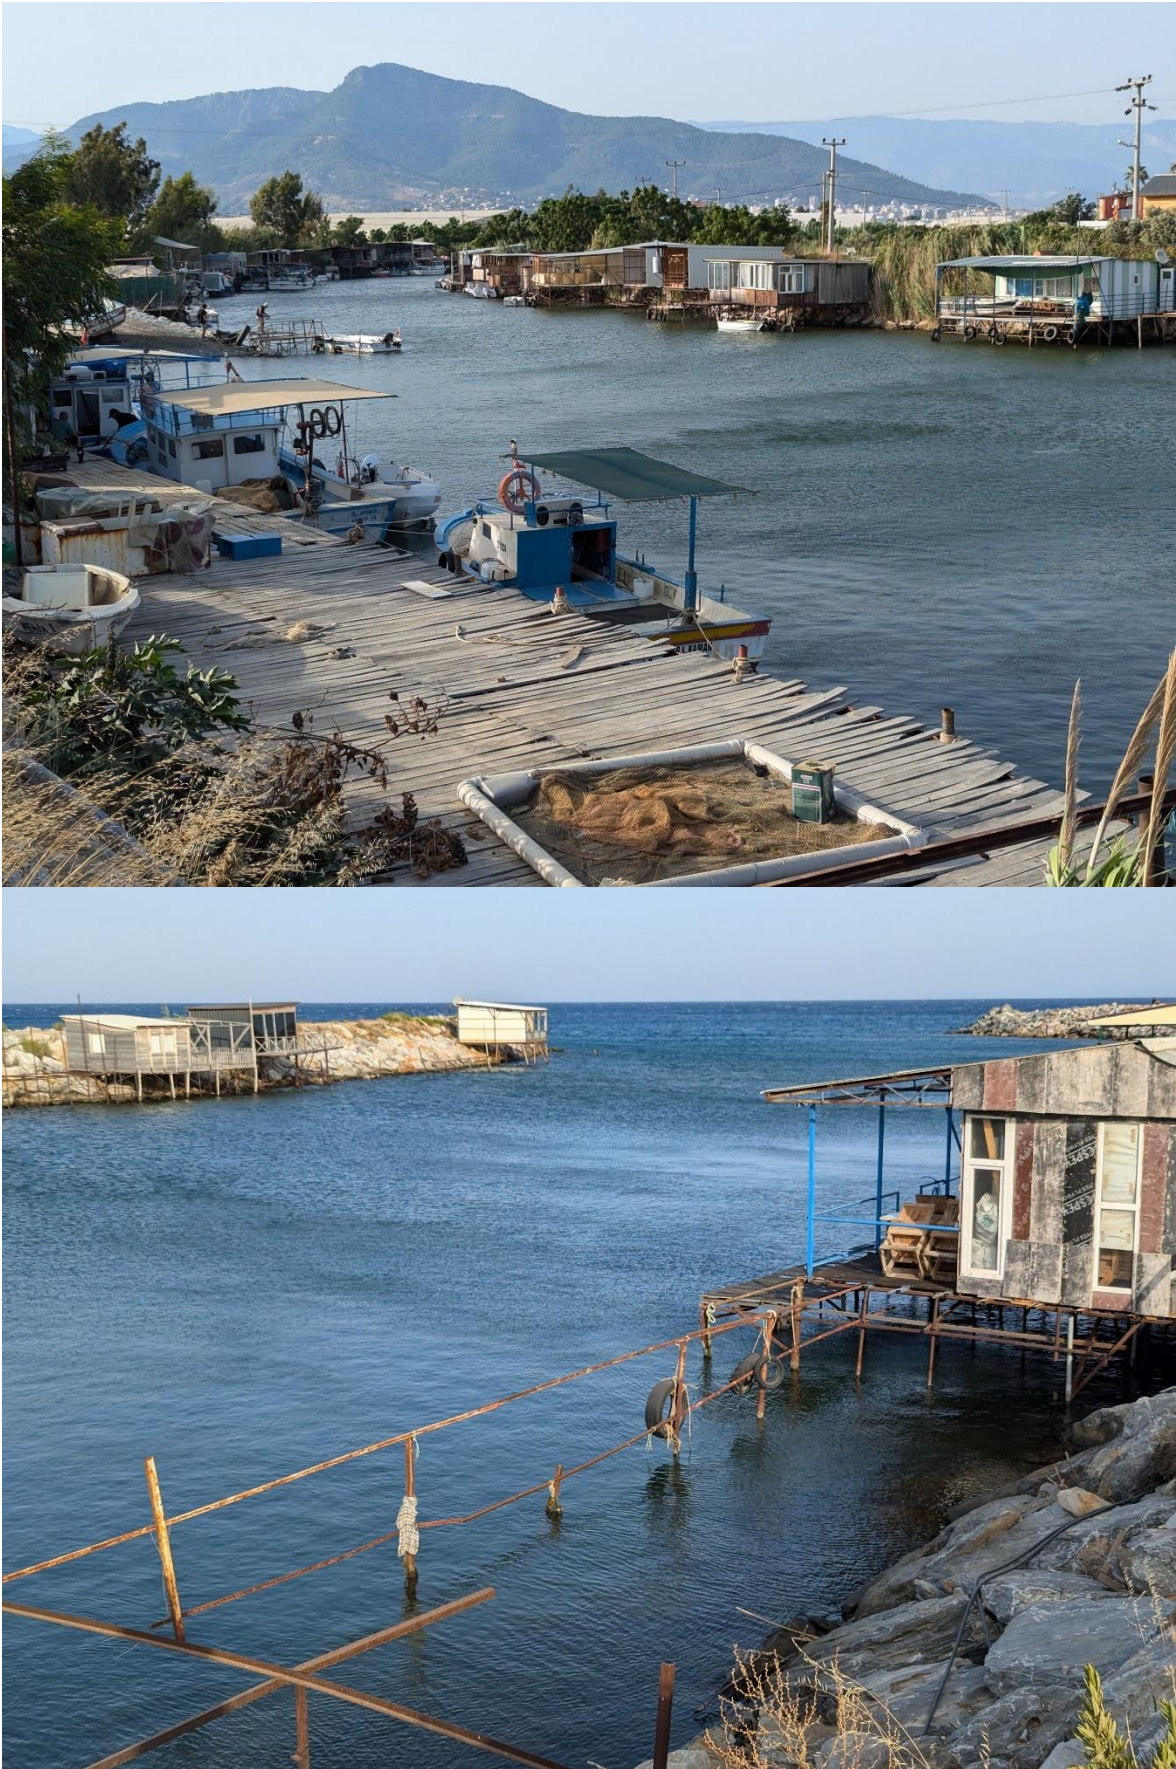
Impacts on Nile soft shelled turtle habitats. The presence of buildings along the river banks at Sultan River (boundary between beach sections 1 and 2; Fig. 13), that had been moved from Dragon River (boundary between beach sections 7 and 8) were reported as illegal, dumping raw sewage into the river. These buildings mainly impact Nile soft shelled turtle habitat. The Nile soft shelled turtle was reported as present at Sultan River (where the riverbanks have been covered in stone), the river next to the picnic area and Dragon River. The latter two location are dealt with under specific report points (8 and 11), but it should be noted there is a general lack of scientific data on the distribution and breeding of Nile soft shelled turtles in the area. Published data come from surveys in 2006 and 2007. It was reported that a biodiversity study carried out between 2016 and 2018 identified no nests from this species in the area and no information is available from a study undertaken in 2019. The surveyor employed to protect turtle nests on the beaches gave no indication that they had seen any Nile soft shelled turtle nests, nor that they made any specific efforts to identify them near river mouths.

Figure 13. Reportedly illegal buildings located along the walled banks of Sultan River.

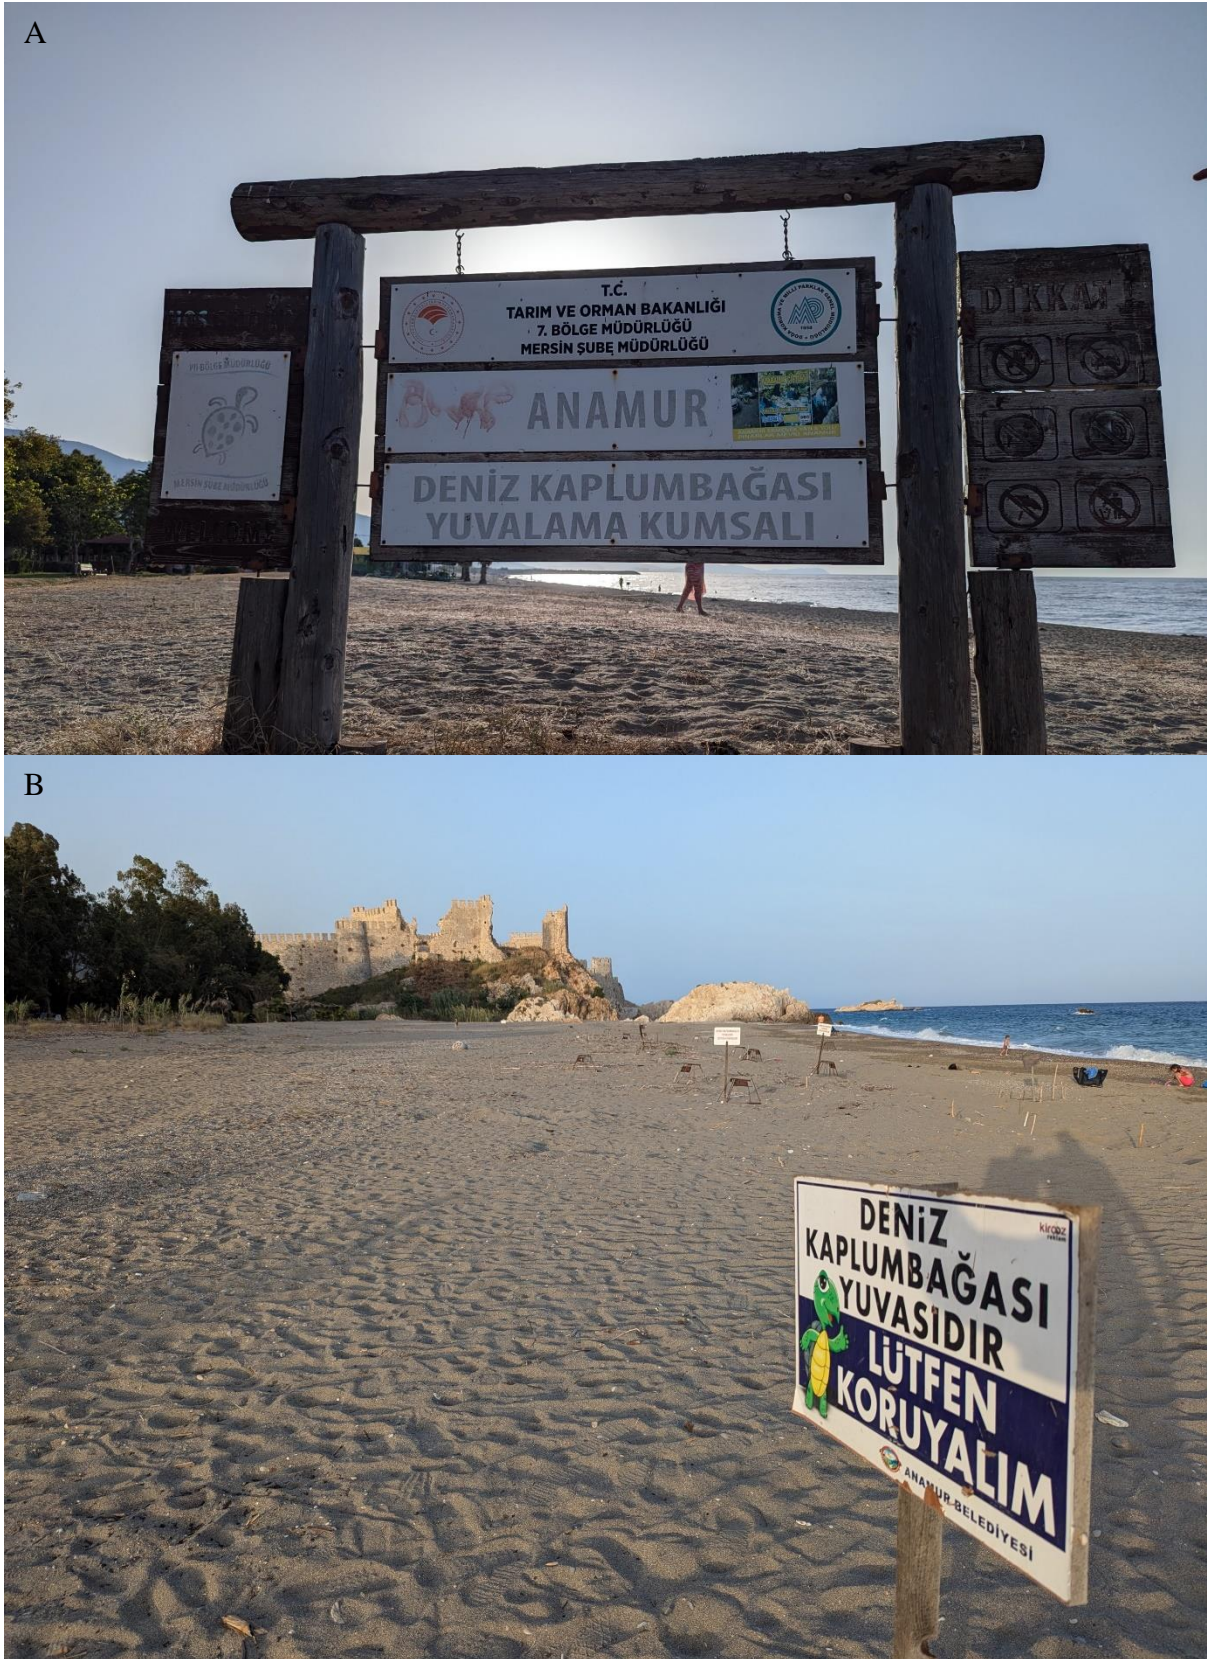
One large information sign including information about sea turtles was observed during the OSA field visit on the highly touristic beach section 6 (Fig. 14). A similar sign was reported as being in place at another point along the beach but was not observed. Considering the general open access to the beach in the area backed by Anamur town, this is a rather paltry amount of signage. Additional signs were present at different parts of the beach often placed next to nest protection cages. However, many such cages bore no information signs (Fig. 14).

Figure 14. Beach signage relating to sea turtle protection on Anamur Beach.

A) Large sign on beach section 7 in the developed area of Anamur Beach.

B) Sign on beach section 9. Note the numerous protective cages over the sea turtle nests in the background. Many such cages across the beach lack any signage to explain what their purpose is.

9 Information and warning signs about turtles in the beach entrance areas	Poor	Low	Only two signs reported present (one seen). Relatively simple to add more. Adding signage to each nest protection cage is recommended as priority and establishing at least one visitor information centre would be beneficial.	(a) Construct turtle visitor exhibit. (b) Prepare and place individual signs with/on all nest cages.	(a) *Check for progress; January, April, July, October. (b) Intermittent checks; *April (signs prepared?), June & August (signs in place?)
10 Assess the state of collaboration and communication between the authorities and civil society	Medium	Moderate	Communication prior to the OSA was poor, but the OSA acted as a catalyst. With new local government in place matters could improve, but this will require willingness from all sides.	Establish multi-stakeholder teams for beach status assessments and turtle monitoring.	Quarterly check for progress; January, April, July, October.

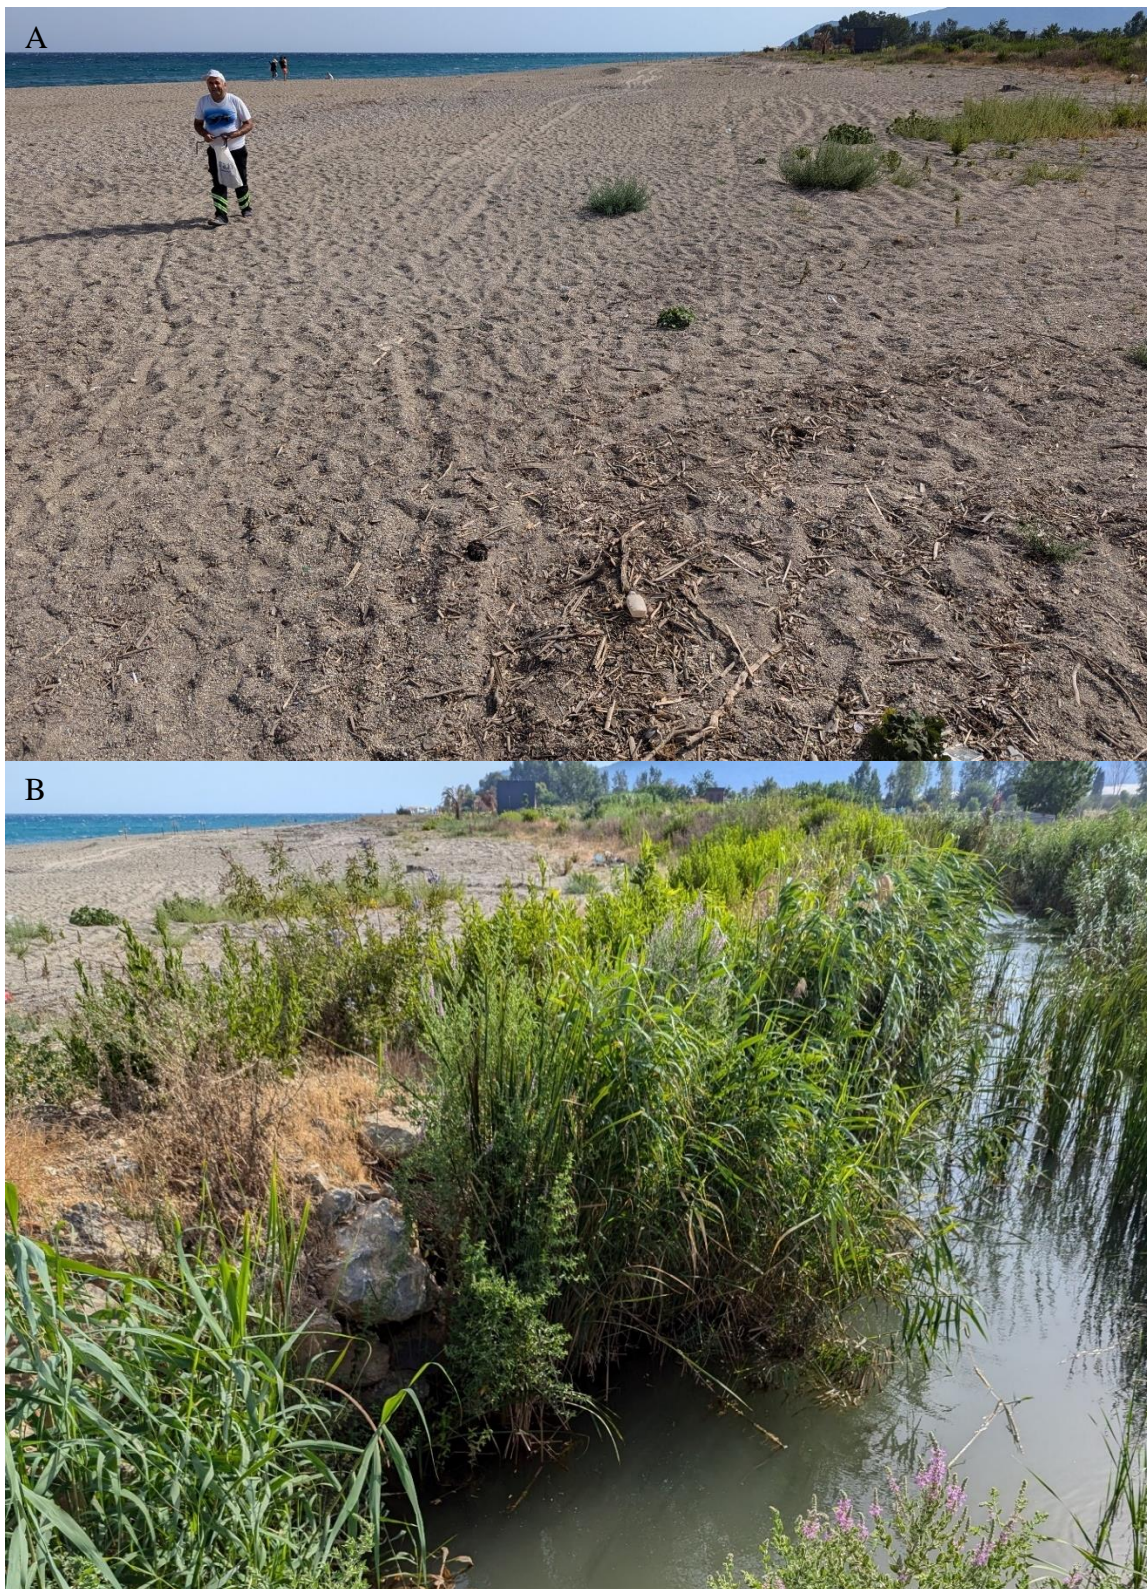
The portion of beach section 2, identified as the picnic area, was reported to be heavily impacted during its landscaping and development. However, following complaints the area was cleared and rehabilitated. The beach area, as observed during the OSA now looks to be in good, natural condition (Figs 4 and 15) except for some evidence of the extensive vehicular use of the beach that must have been required during the rehabilitation process (Fig. 7). The drainage channel to the rear of the beach retains stone walling that was said to be put in place during the creation of the picnic area (Fig. 15), which is suggested to affect the behaviour of Nile soft shelled turtles that may be present in the drainage channel. However, there is no solid recent evidence of that species being present in the channel.

Figure 15. The rehabilitated 'picnic area' of beach section 2.

A) Section of rehabilitated beach and foredune that appears to be in near natural condition.

B) Evidence that a stone wall remains in place along the seaward side of the drainage channel.

Potentially impacting behaviour of the Nile soft shelled turtle that has been reported to inhabit the waters in the past.

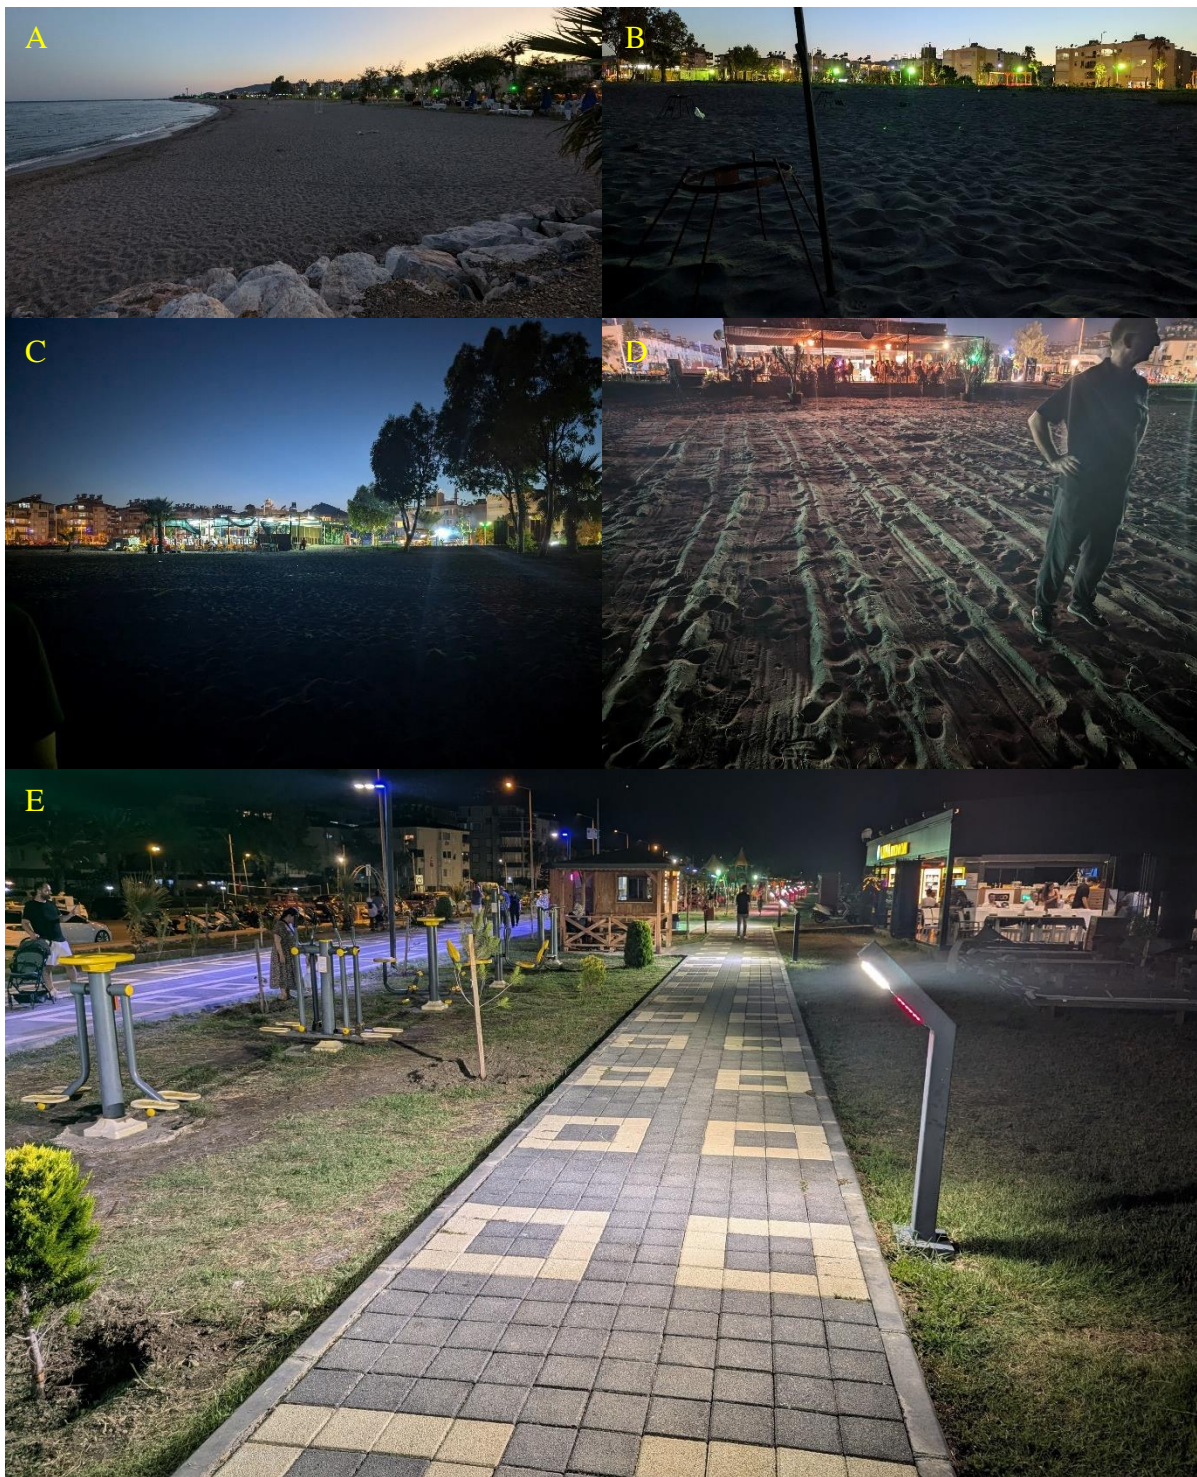
Figure 16. Condition of the beach along section 4, altered by the coastal arrangement project Stage 1, as observed during the 2024 OSA.

A) Looking along Stage 1 from the eastern end. Green walkway lighting very visible. Beach is mainly clear of development in zone 1 – water's edge to 65 m inland.

D) Bar set back from the coast with less disruptive lighting but extensive, possible beach cleaning, activity on the beach in front of it affecting at least the surface layer of the beach.

E) Detail of the illuminated, paved walkway with bar, rest huts, exercise equipment and planted vegetation. See also Fig. 3.
