Open File 2019/5

Habitat destruction in Mersin Anamur Beach (Türkiye)

REPORT OF THE ON-THE-SPOT APPRAISAL
2-4 JULY 2024

Prepared by ALan F. Rees, PhD, Consultant

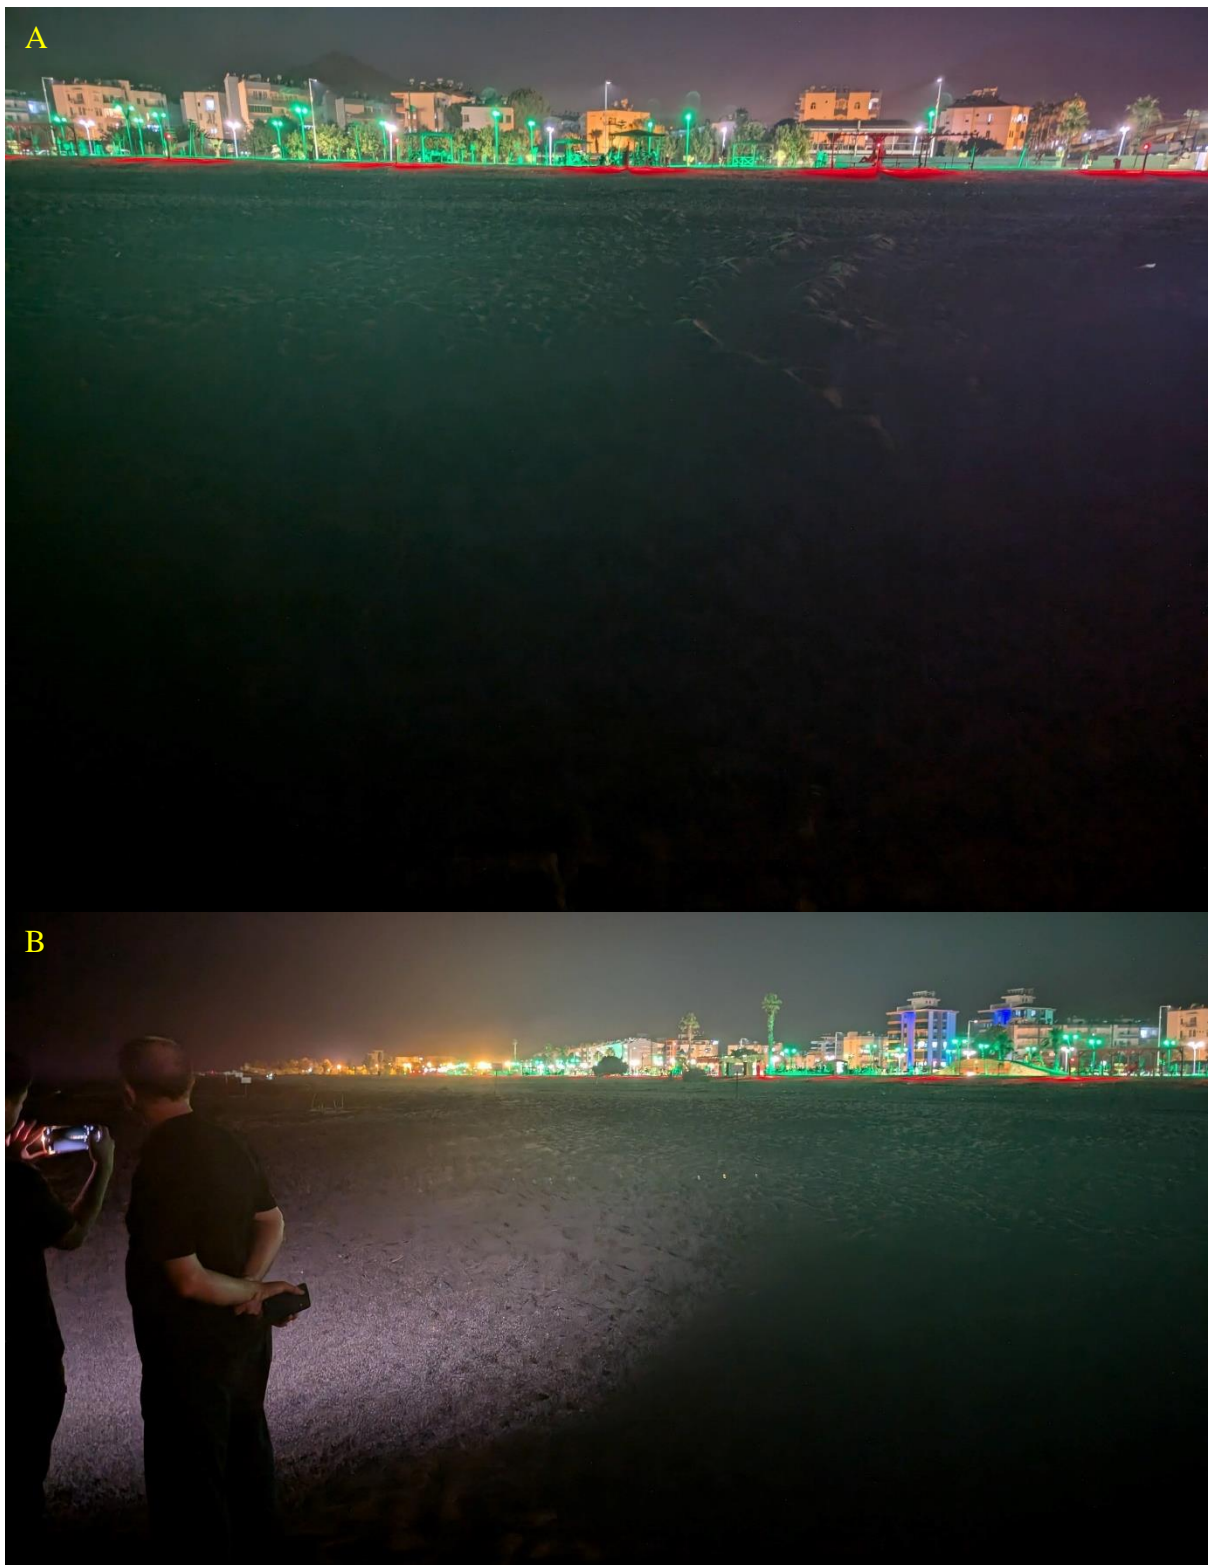
The alterations of Stage 2, so far completed, are similar to Stage 1 although no new road was constructed behind the beach. The new lighting arrangement (Fig. 17) is better than for Stage 1 but can be further improved through changing the colour and brightness of the luminaires used.

Figure 17. Condition of the beach along section 3, altered by the coastal arrangement project Stage 2, as observed during the 2024 OSA.

A) View from water's edge inland to the illuminated walkway.

B) View towards the western end of Stage 2 as currently completed. The left part of the image (lacking green lighting) is the remaining 400 m of Stage 2 that is yet to be developed. Note the mix of red and green and white lighting that predominates along the developed beach. See also Figs 3 and 11.

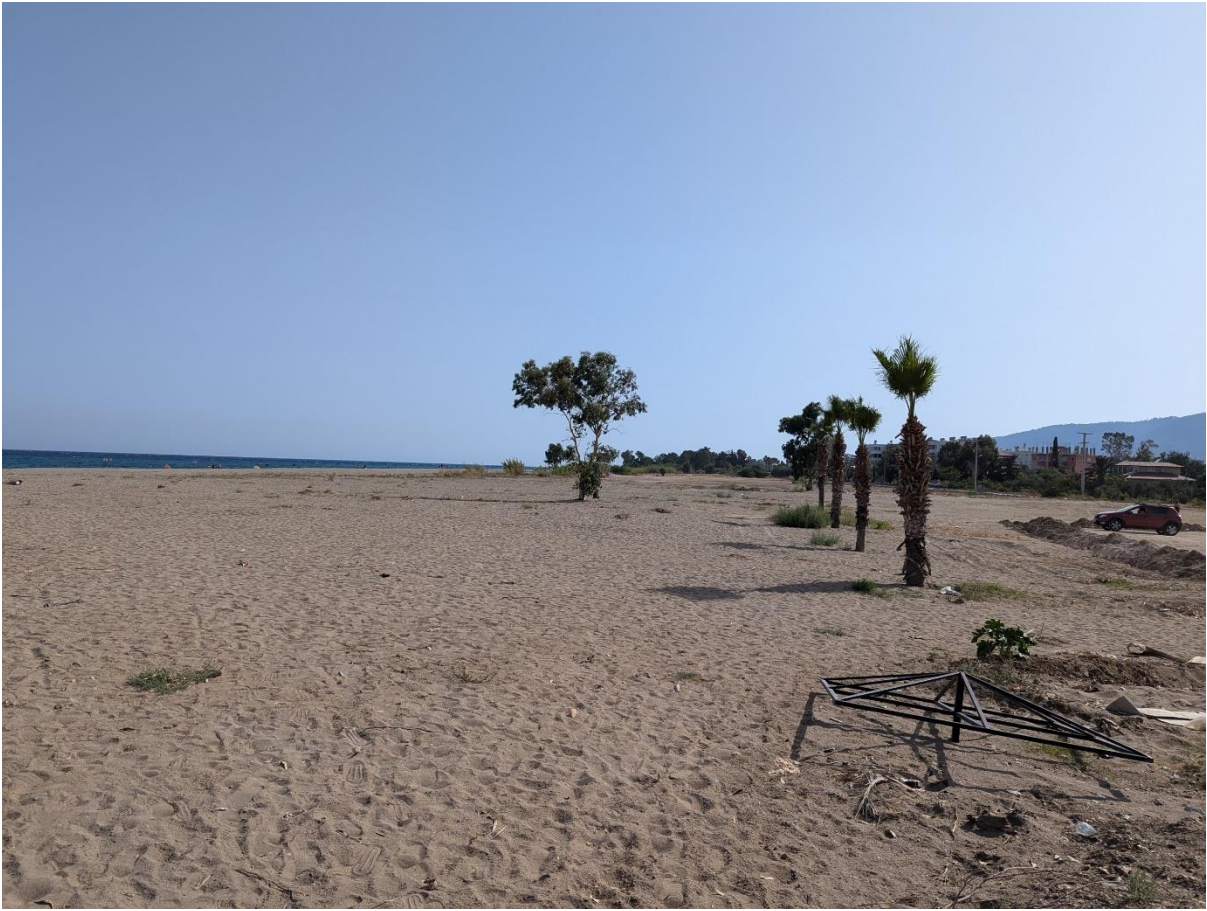
Figure 18. View of coastal area due to be developed as completion of Stage 2 of the coastal arrangement project. Note its undeveloped condition, barring several artificially planted palm trees.

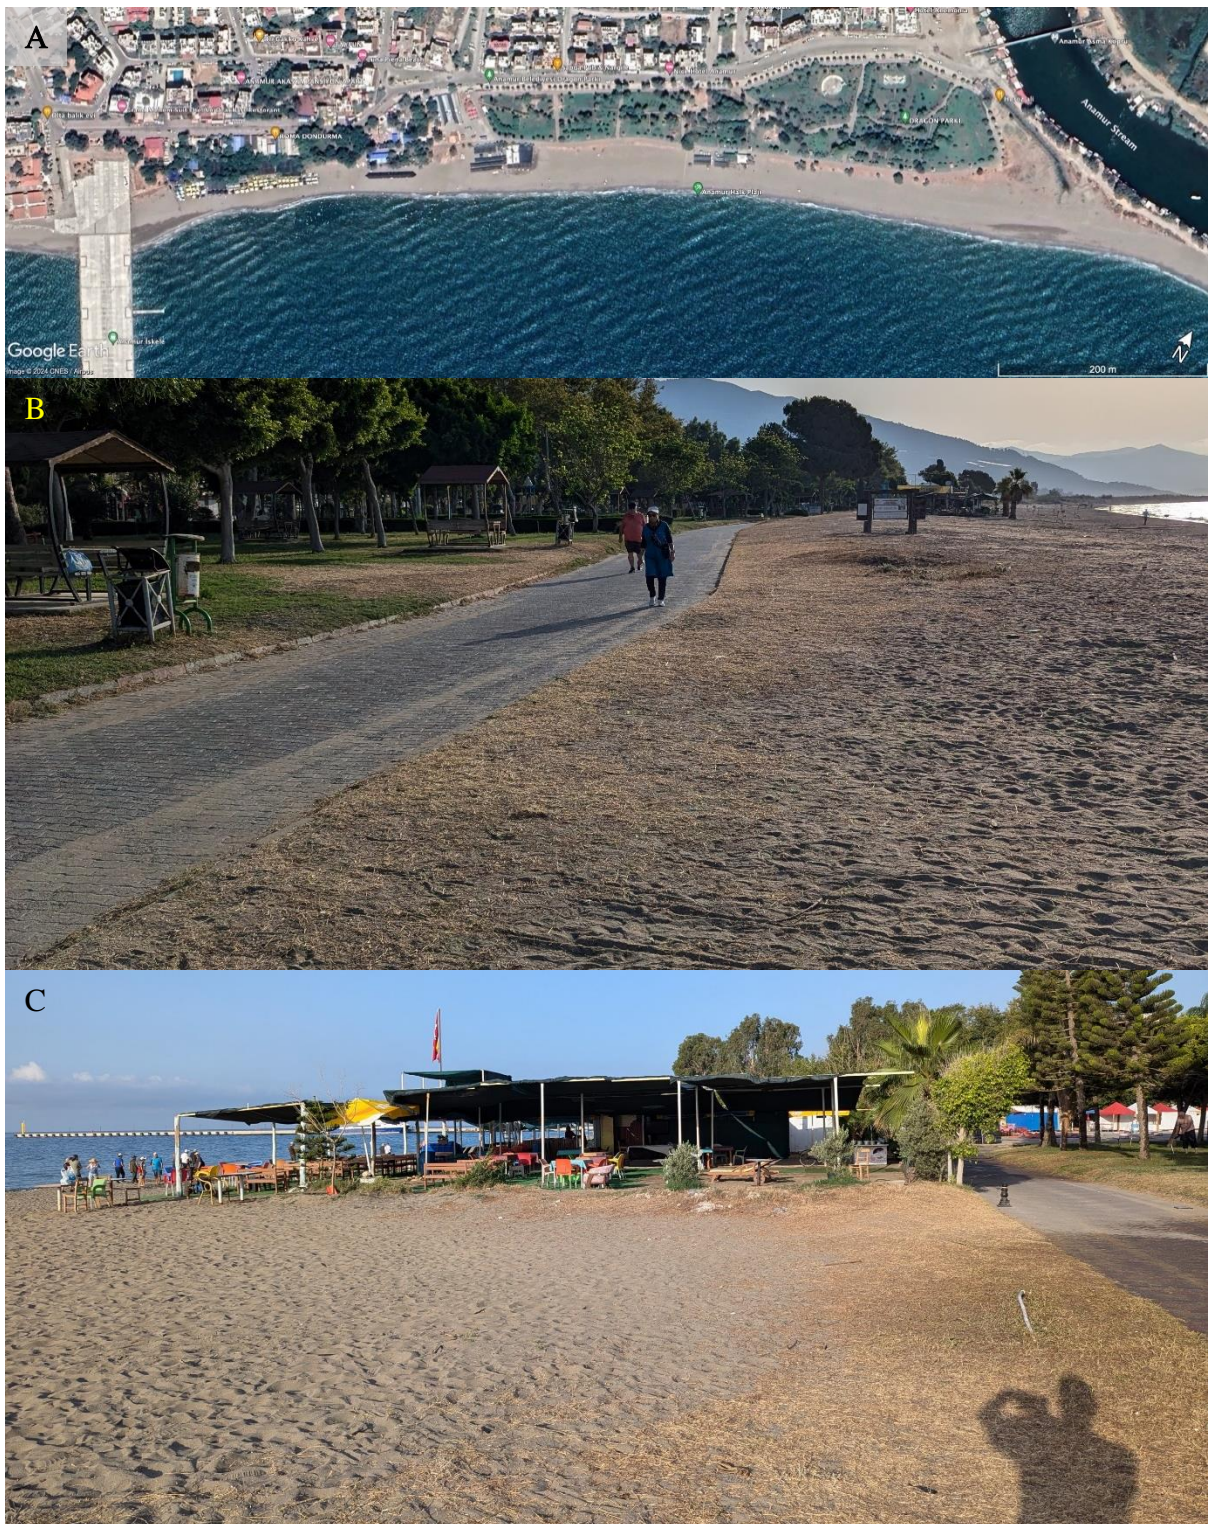
The section of beach designated as Stage 3 of the Coastal Arrangement Project needs improvement as tourist facilities cover large parts of the beach (Fig. 19). The current condition of beach shown in the middle image of Fig. 19 represents an interesting status of being artificially created but probably having little to no impact on turtle nesting. It includes a vegetation barrier reducing lighting from the built-up area behind reaching the beach and low-key infrastructure that encourages daytime and not night-time visits through provision of shade and no excessive illumination. Removal of restaurants and other paraphernalia from the beach (1st Zone of Protection) will greatly improve the conditions for turtles nesting in this area with little to no further development required.

Figure 19. Views of the coastal area planned to be revamped under Stage 3 of the coastal arrangement project.

A) Google Earth view (from 2021) of the beach section. Note the heavy exploitation of the beach to the left.

B) Example of current, modest, development; paved path, picnic shelters on lawns backed by numerous trees.

C) Large restaurant encroaching on the 1st Protection Zone and turtle nesting area.

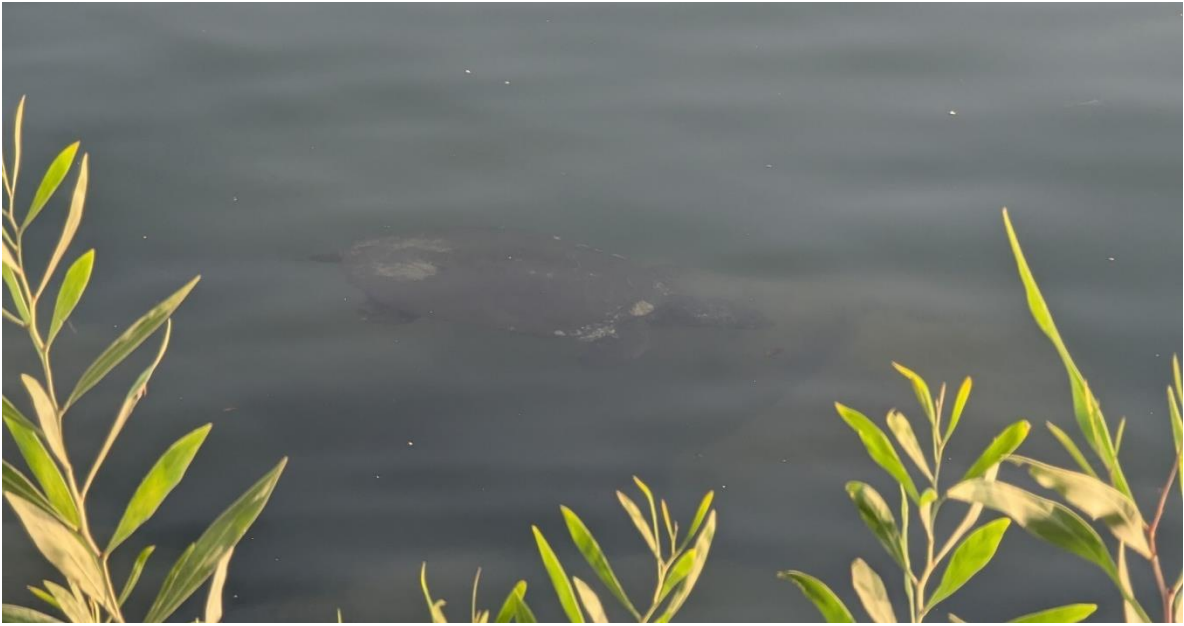
Figure 20. Large sized Nile soft shelled turtle observed near the mouth of Dragon River during the 3 July 2024 field visit of the OSA.

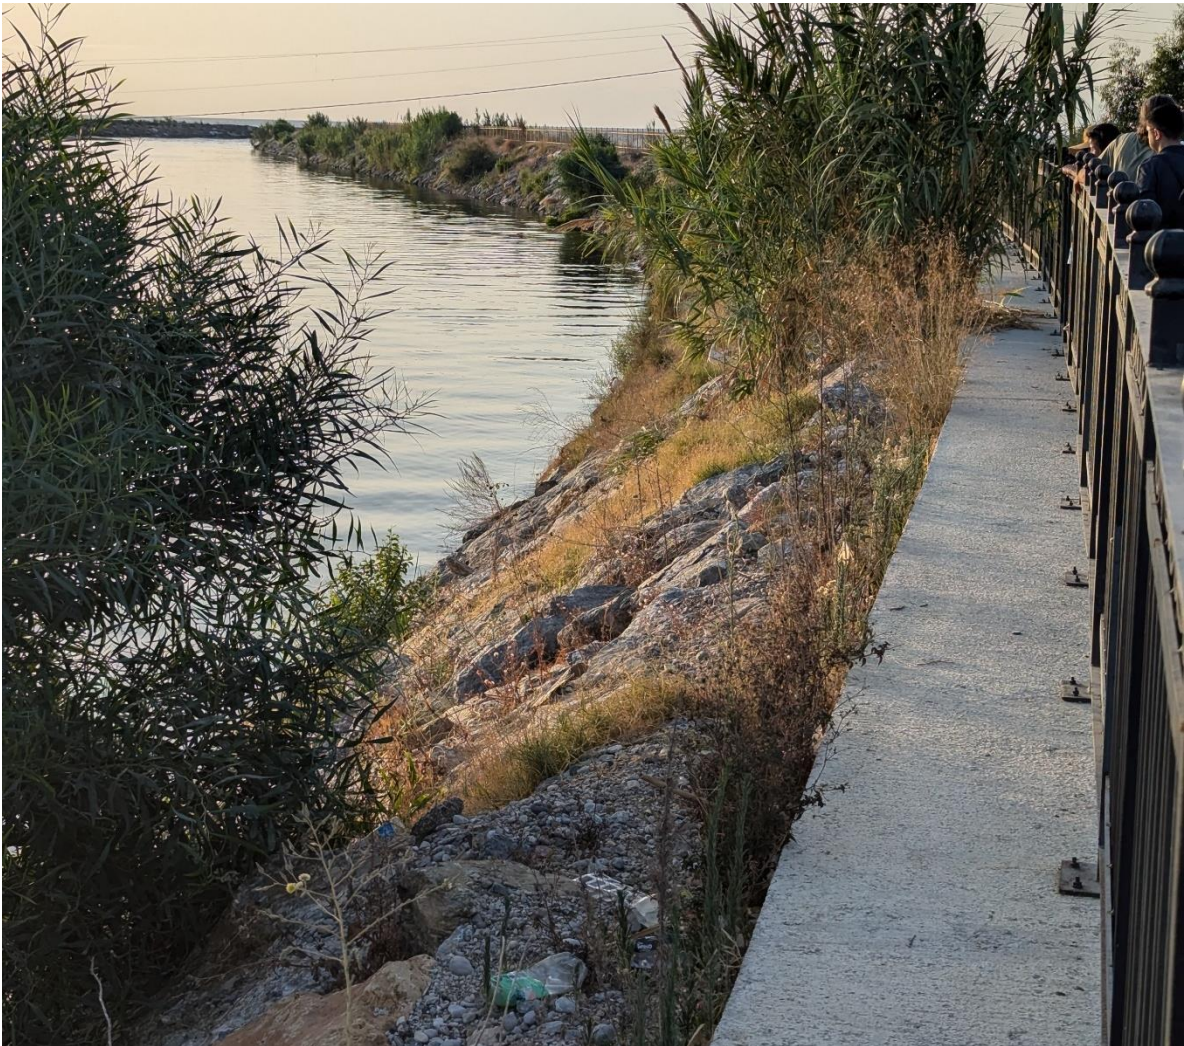
Figure 21. Example of the steep stone walled banks of Dragon River.

Restoration of the banks of Dragon River, and other Nile soft shelled turtle habitats, should be as feasible as the process used to create the walled areas. During the OSA, control of river channel location and river flow to avoid flooding were given as reasons that stone walls had been built and the steepness of the walls was defined by the potential river conditions and the need to manage water flow. Accepting these reasons as valid two options for partial remediation are evident. Firstly, additional stones can be placed along the riverbanks in such a way as to provide basking spots for the turtles and secondly the riverbank stone walls can be removed from the river mouth (at minimum from one side) back to the area behind the coastal beach, thus giving the Nile soft shelled turtle potential to nest without venturing into the sea.
