**Habitat destruction in Mersin Anamur Beach
(Turkey)**

- REPORT BY THE COMPLAINANT -

LOGGERHEAD SEA TURTLE (*CARETTA CARETTA*) & SOFT SHELL NILE TURTLE (*TRIONYX TRIUNGUIS*) CONSERVATION MONITORING IN ANAMUR, MERSIN, TURKEY

13 August 2021

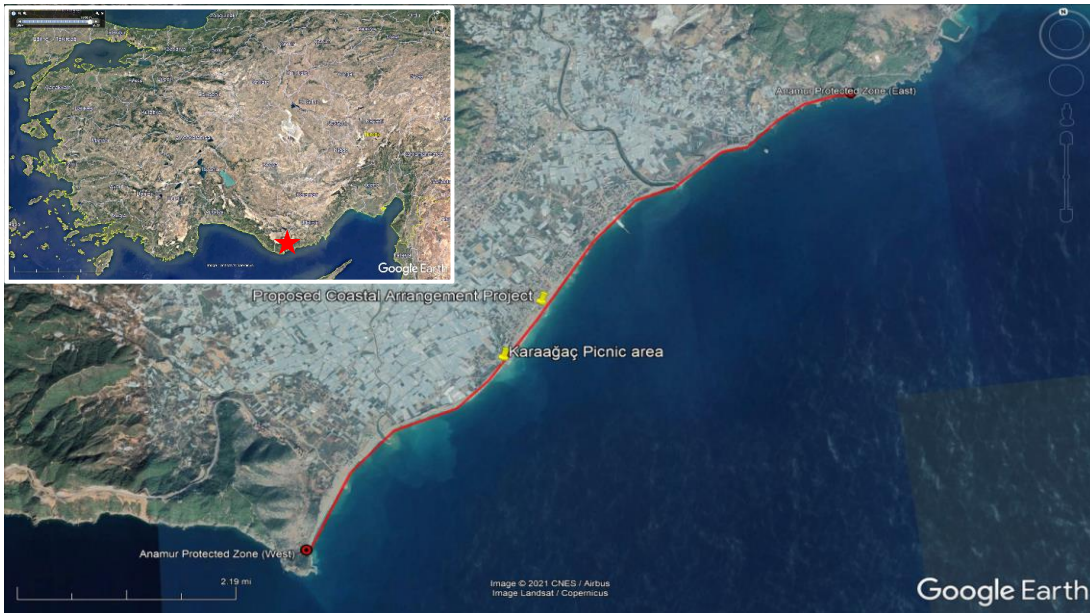
Fig. 1 | Google Earth image. Insert: Location of Anamur sea turtle nesting beach along the Mediterranean coastline of Turkey. **Main:** Red line depicts the 12km protected sea turtle nesting beach of Anamur and the locations (yellow pins) of illegal and proposed activities.

Anamur sea turtle nesting beach (Fig.1) is identified as the second most important *Caretta caretta* nesting beach in Turkey, supporting on average 791 nests annually (Casale *et al.* 2018). The 12km beach is one of 21 protected nesting beaches under the National Circular (2009/10), Ministry of Environment and Forestry #B.18.0.DMP.0.01.03/831.02, for the protection of Sea Turtles. Furthermore, the Creek, canals and streams in the surrounding area of Anamur nesting beach have been identified by MEDASSET as an important reproductive site for the Vulnerable Nile soft-shell turtle (*Trionyx triunguis*) (Kasperek 2000).

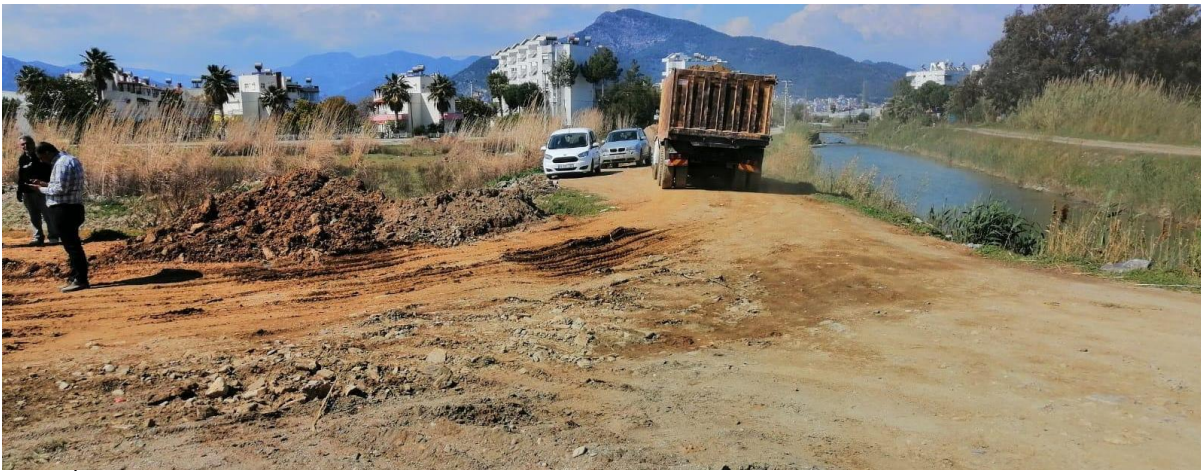
Despite the advice of the Bureau, **no collaboration or communication has occurred** between MERÇED and the authorities in regards to the recommendations of the Scientific Committee (ScC), for the on-the-spot-appraisal (OSA), the rehabilitation of the site or details of the work to be carried out to restore Karaağaç to its natural state. To date, heavy machinery has removed some of the soil placed (Fig. 2), but rubble and soil remains (Fig. 3) and the site has not been restored to its natural state.

Fig. 2 | Karaağaç 31 March 2021: Heavy machinery removing illegally placed soil for picnic area.

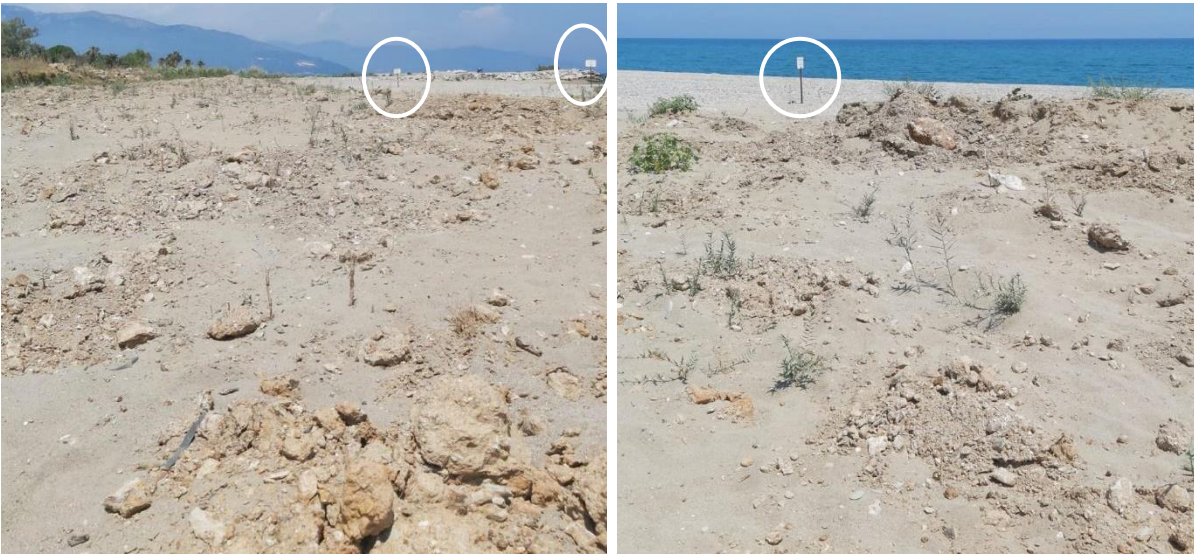
Fig. 3

Karaağaç 20th July 2021: Soil placed ontop of sand has been partially removed, but rubble remains and the site has not been fully restored to its natural state. Signs on beach mark turtle nests (circled).

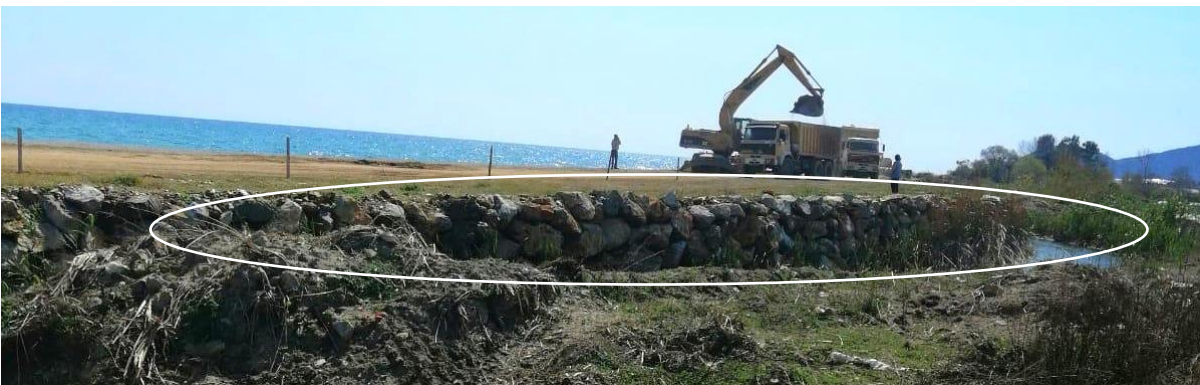
No restoration works have occurred for the stone wall built (Fig. 4), which replaced the natural reed bed bordering the Sarisu Creek, located directly behind the nesting beach. For 10 years, MERÇED volunteers have monitored the banks of Sarisu Creek for the presence of the Nile soft-shelled turtle, on average recording 4-6 individuals per year. Since the destruction of this natural habitat, no Nile soft-shelled turtles have been recorded.

Fig. 4 | Karaağaç 31 March 2021: No restoration works have occurred for Sarisu Creek- the stone wall still remains. Heavy machinery removing the soil from the back of the beach in the background.

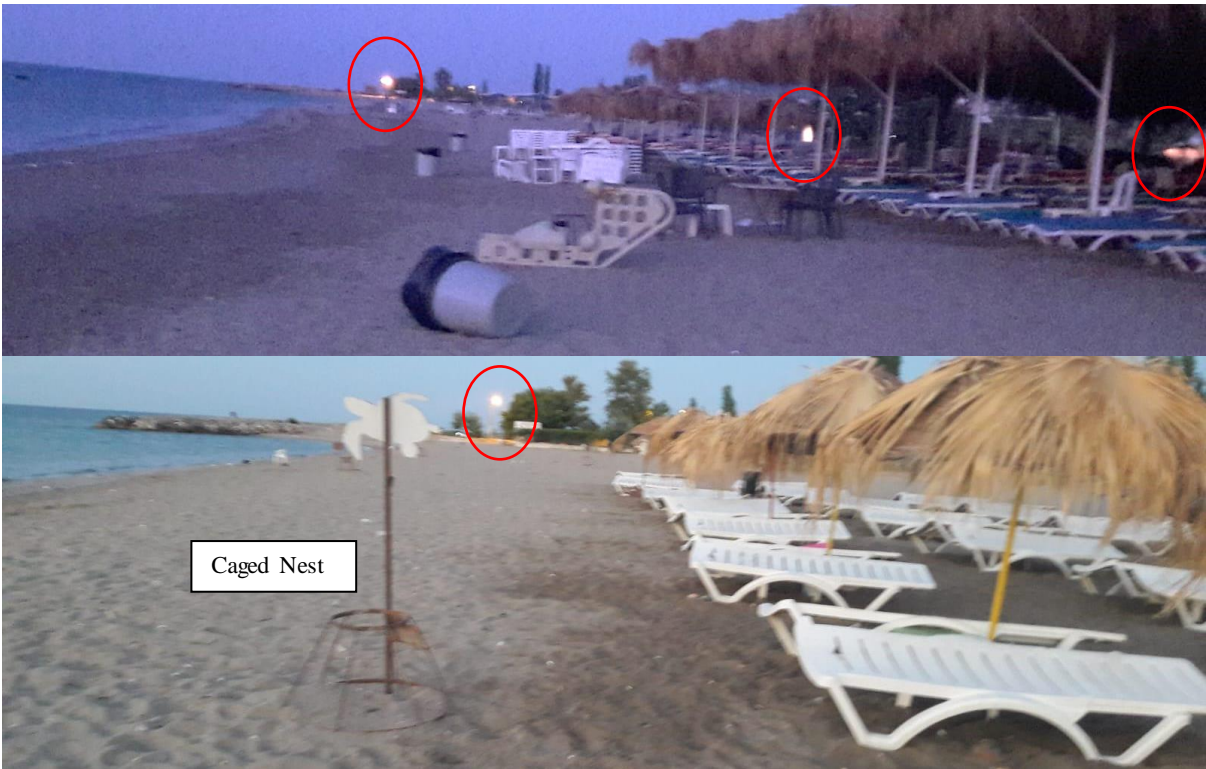
As stated in previous reports, the Municipality along with the Directorate of Nature Conservation and National Parks continues to fail to implement and enforce any adequate conservation measures to protect the nesting beach, despite publicly declaring to protect the nests (Fig. 5). Light pollution occurs along the nesting beach from apartments and local businesses (Fig. 6), and beach furniture is not removed from the nesting beach at night (Fig. 6 &7). Failure to implement conservation measures are presenting risks to nesting activity of both the adults and emerging hatchlings. Furthermore, the degradation of the nesting beach continues, with the unhindered expansion of businesses on the beach (Fig. 8) and the extraction of sand (Fig. 9), despite prohibited by National legislation.

Fig. 6 | Anamur 11 August 2021: Light pollution sources (Red circles) on and behind nesting beach from local businesses. Beach furniture is not removed from nesting beach at night.

- **Lights:** business owners should be required to screen or paint with dark colours all lights shining onto the beach that cannot be switched off during night hours during the nesting and hatching season. This does not incur a high cost and is feasible.

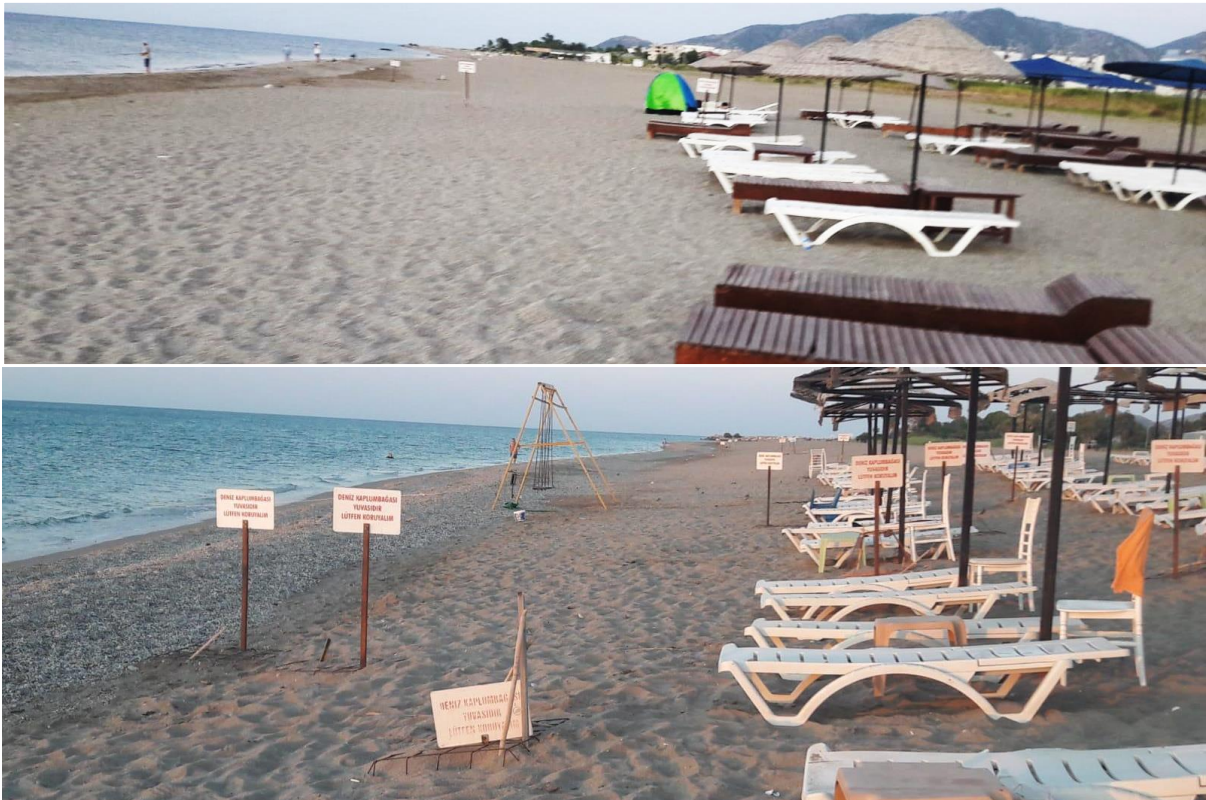
Fig. 7 | Anamur, 11 August 2021: Beach furniture is not removed by local businesses at night from nesting area. Signs mark sea turtle nests, as recorded by MERÇED volunteers.

- **Beach furniture, sunbeds and umbrellas etc.** should be zoned on the beach during the day to protect the nests and removed at night to eliminate obstacles to nesting females. Fixed structures, such as arboreal pavilions, and cabanas should not be allowed.

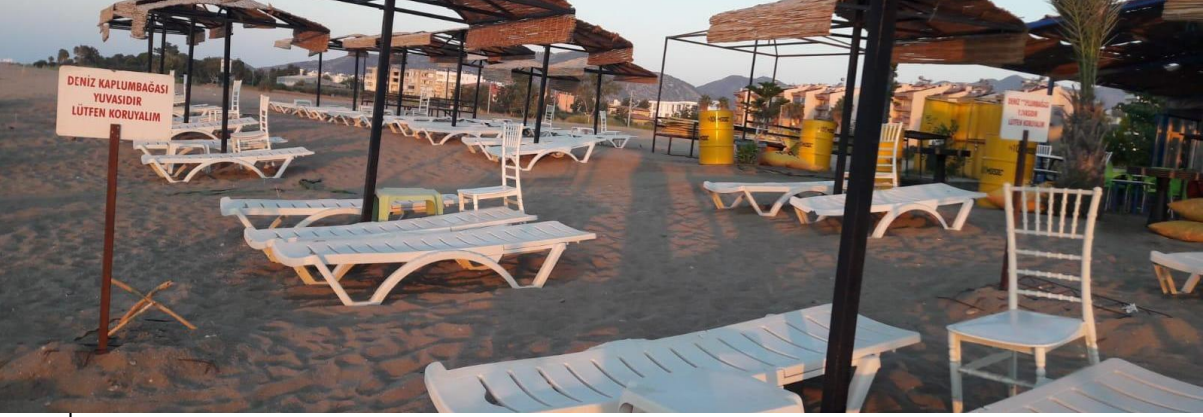
Fig. 8 | Anamur, 11 August 2021: MERÇED volunteers record the unhindered spatial expansion of businesses on the nesting beach. Signs mark sea turtle nests, as recorded by MERÇED volunteers.

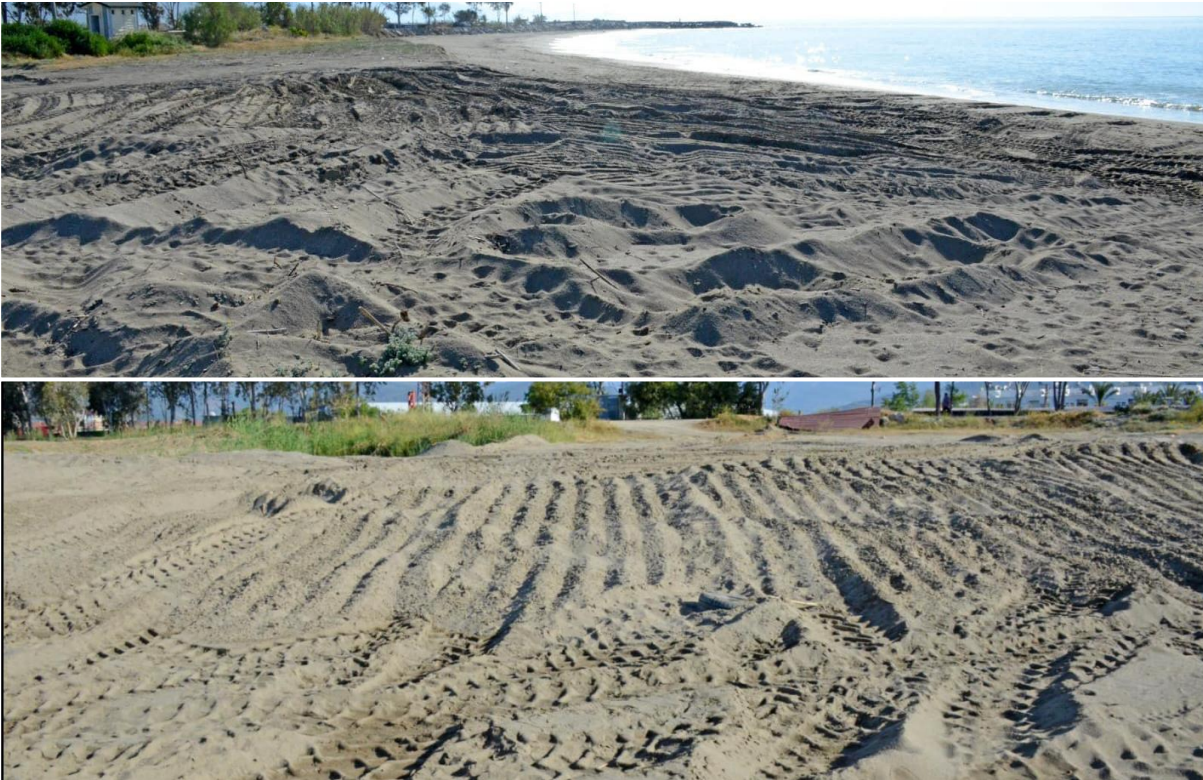
Fig. 9 | Anamur 27 April 2021: Use of heavy machinery on the beach for the removal of sand, prohibited under National Legislation.

- **Sand extraction** should be strictly prohibited and penalties applied to deter illegal activities.
- **Awareness Campaign** (workshops and seminars) to proactively engage the local community and tourists about the protection of sea turtles and wildlife of Anamur Beach.

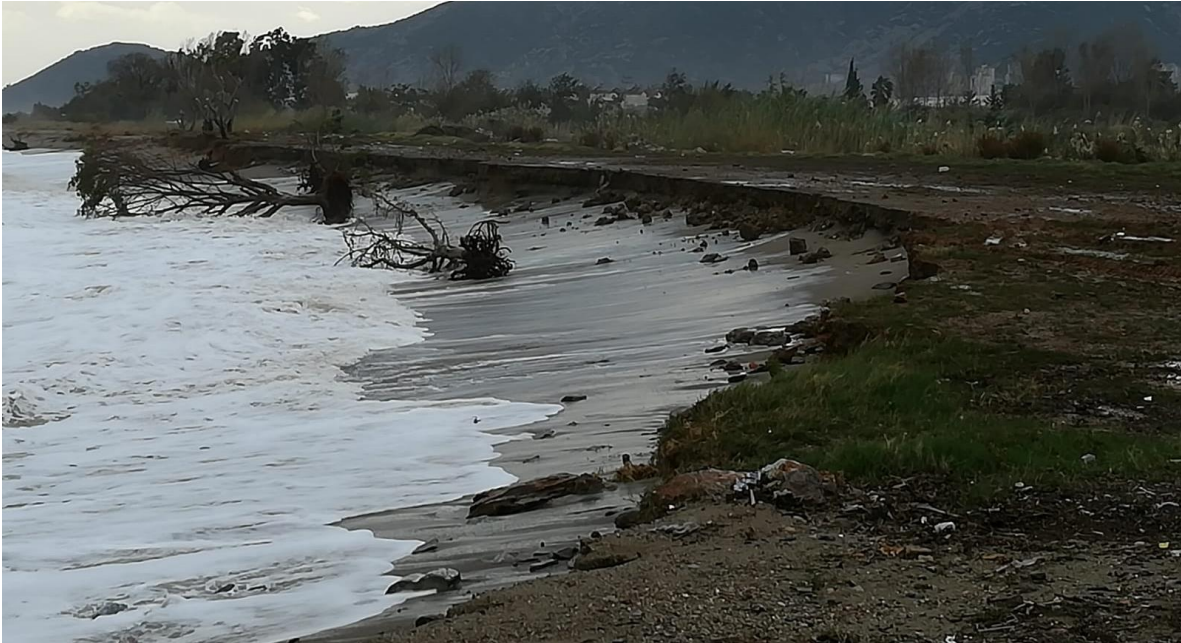
Fig. 1. Anamur nesting beach: Karaağaç Picnic Area. 14.12.2020. Waves uprooted planted trees.

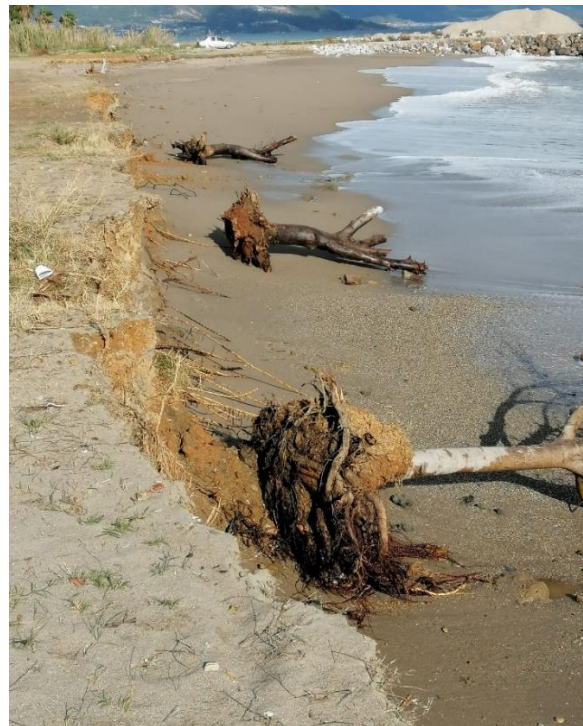
Fig. 2. Anamur nesting beach: Karaağaç Picnic Area. 15.01.2021. Waves uprooted more planted trees.

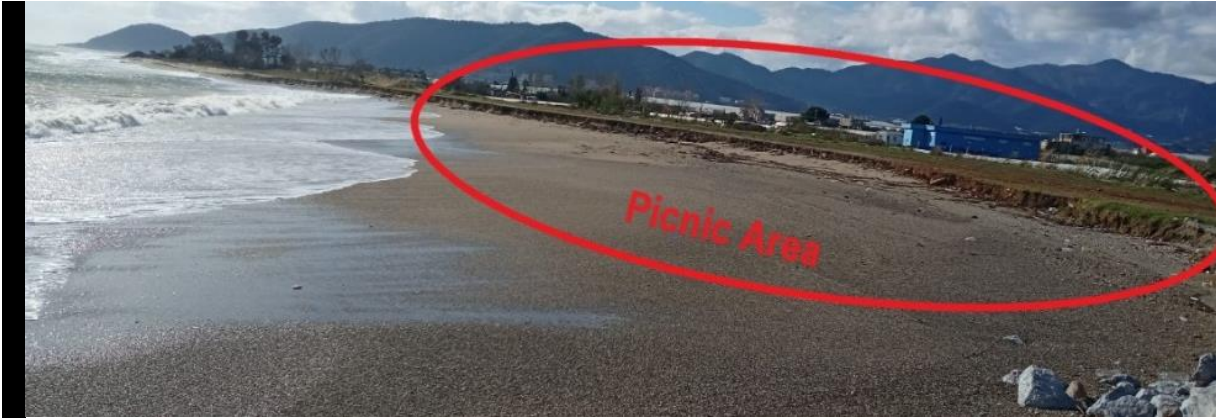
No habitat restoration has occurred and fines issued have not been paid by the Municipality. MERÇED are aware that the Municipality's court appeal was rejected, but have not seen or received any official documentation or communication. The NGOs have not been invited to any meetings or discussions with the authorities despite the encouragement of the Standing Committee in Dec.2020. The transferred trees (alien species) planted on the sand dunes were uprooted by local environmental conditions of winter storm tides [R1-2], highlighting the incompatibility of the development of the picnic area and the transferred alien plant species within the natural dynamic environment of the sand dune system (Fig. 1-3).

Fig. 3. Anamur nesting beach: Karağaç Picnic Area. 17.01.2020. View of the Picnic Area: no restoration has been implemented despite official orders.

- Damaged sand dunes and vegetated areas should be **restored** to their natural state.
- Remaining unbuilt beach areas should be **secured against development**.

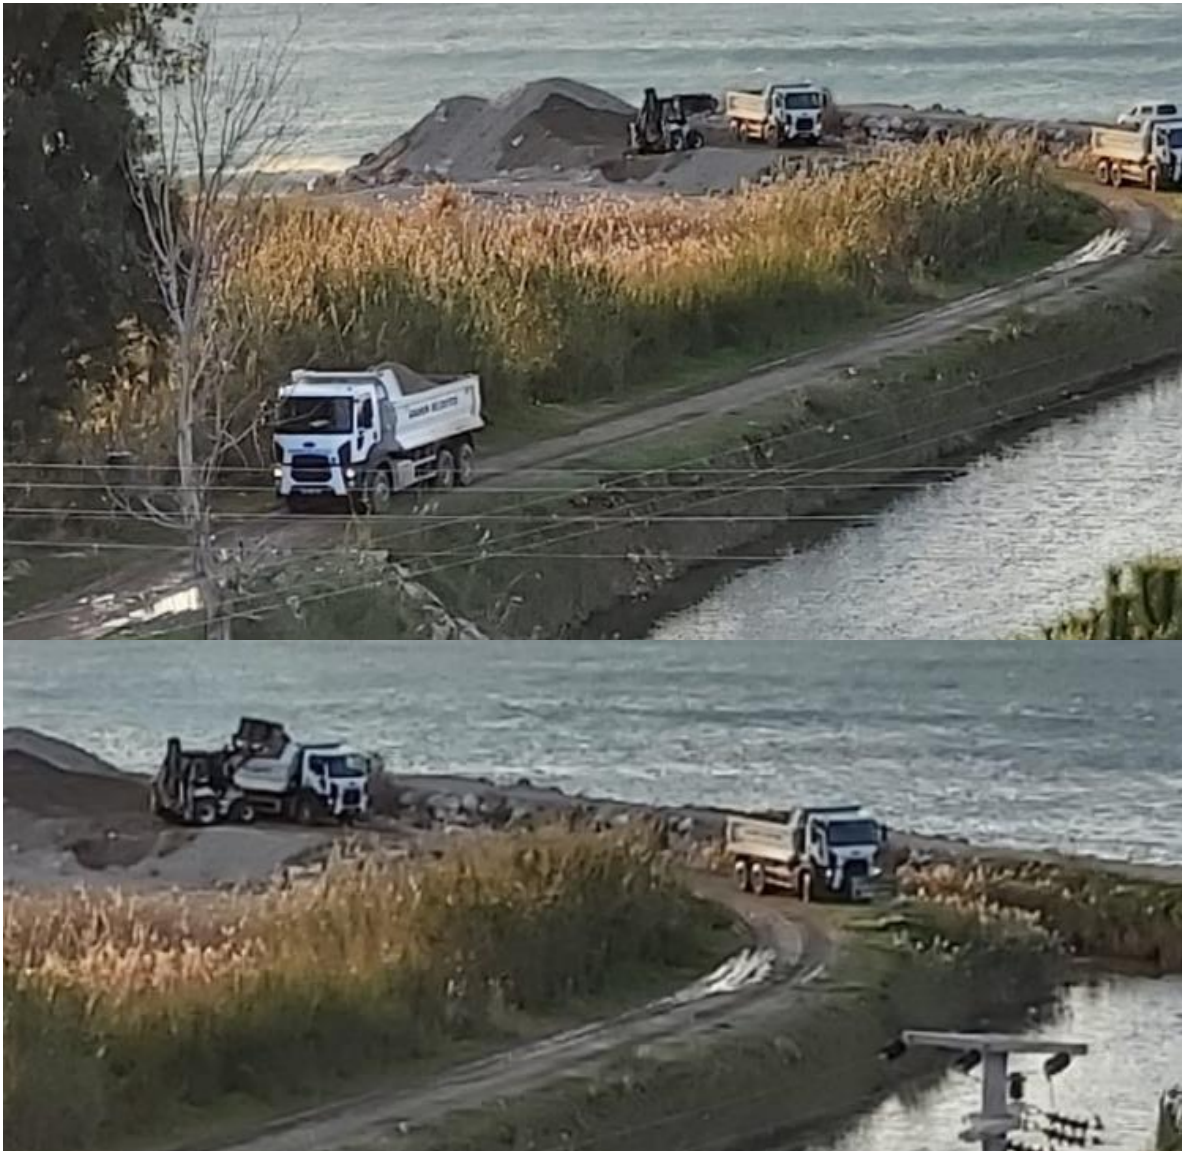
In disregard of Recommendation No. 66 (1998) and the Turkish Circular on sea turtle protection [R5], the Municipality was again observed extracting sand from within the 1st Protection Area of the nesting beach [R6] east of the Karaağaç picnic area (Fig. 4). The continual actions of sand extraction activities will have a detrimental impact on the nesting beach habitat. This beach not only provides nesting habitat for *Caretta caretta* but is also the natural habitat of endemic sand lilies.

Fig. 4. Anamur nesting beach. 22.01.2021. Lorries Carrying Sand Extracted from the Nesting Beach.

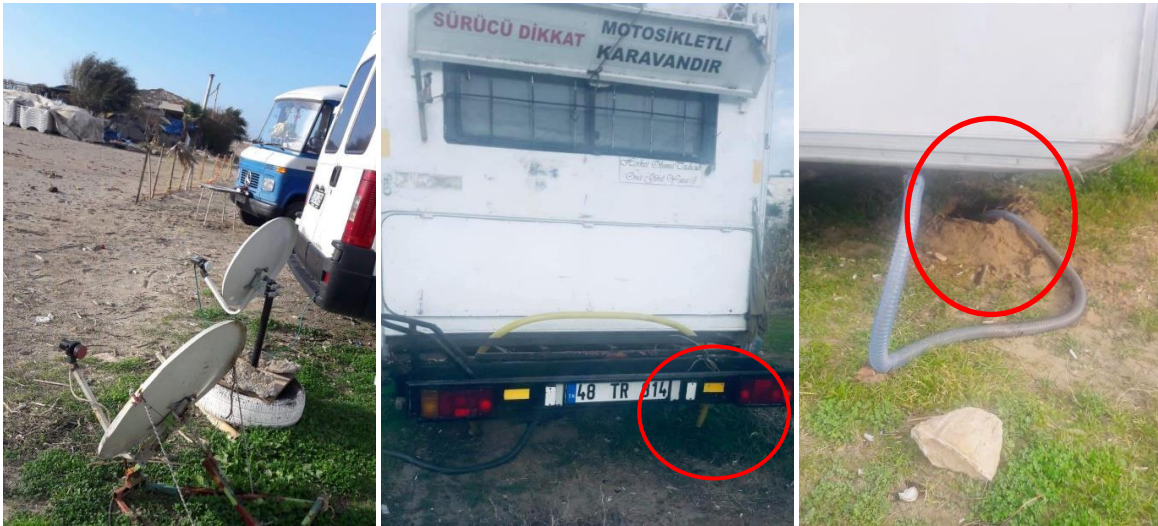
- "Mavi Tea Garden" leases beach plots to caravans, all year round [R7]. Occupants have been observed disposing of their waste directly onto the beach (Fig. 5).
- "Atalay Tea Garden" attempted to expand their car parking area to accommodate a higher number of tourists, by dumping soil on the sand of the protected nesting beach [R8] (Fig. 6a). Local environmentalists protested against the expansion, and the Head of the Nature Conservation and National Parks Department (Mr Mürsel BULUT) stated on February 5, 2021[R8], that the soil was removed by construction equipment. However, as seen in Fig. 6b, although most of the soil was removed, a significant part of it was further spread, covering the sandy area on the nesting beach.

Fig. 5. Anamur nesting beach. 31.01.2021. Beach business leases space for caravans that occupy the 1st Protection Area of the beach. The red circle shows a hose dumping waste (probably sewage or wastewater) into a hole dug in the ground.

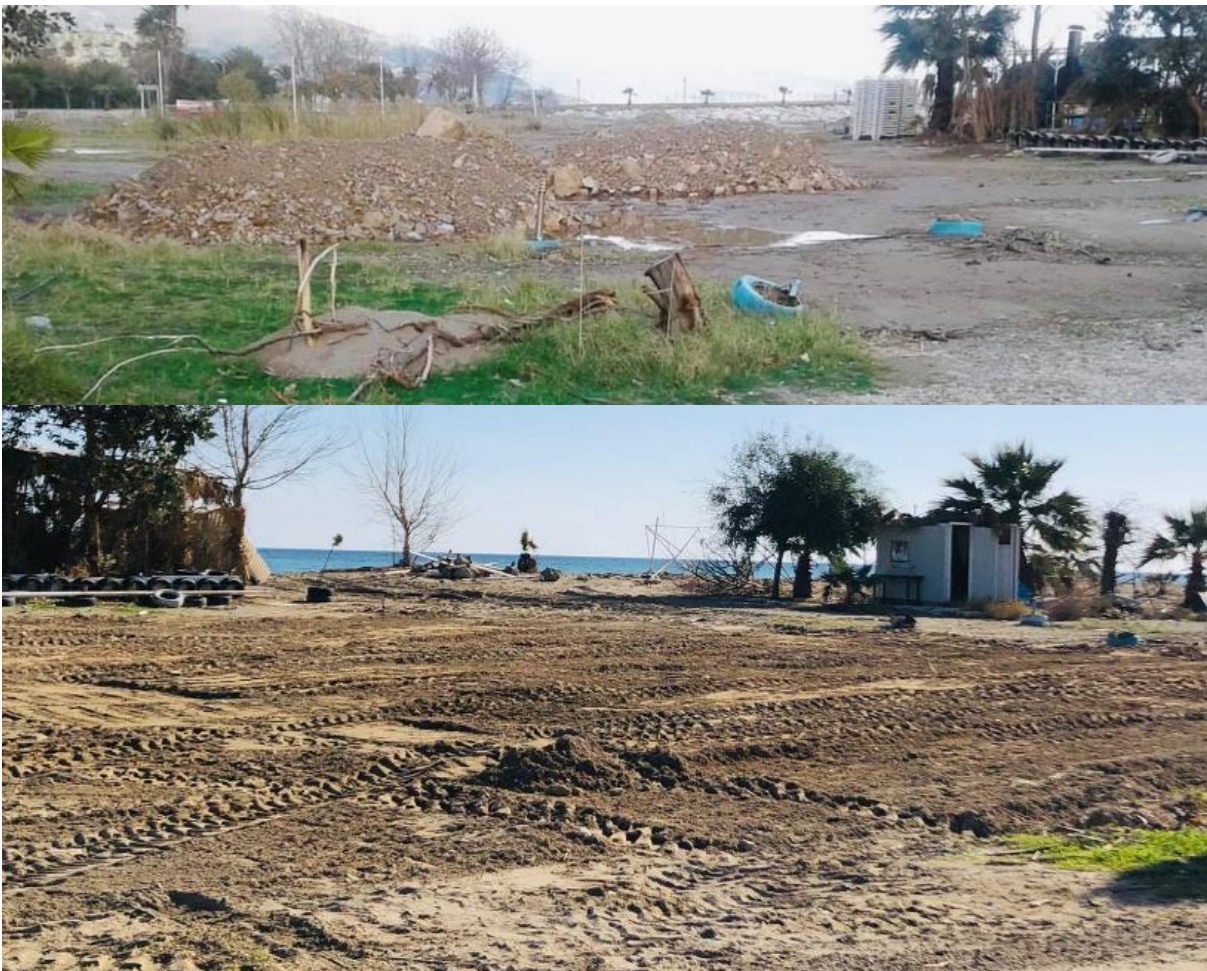
Fig. 6. Anamur nesting beach. Top(a): 31.01.2021. Bottom (b): 06.02.2021. Beach business increases occupied area and dumps soil on the nesting beach.

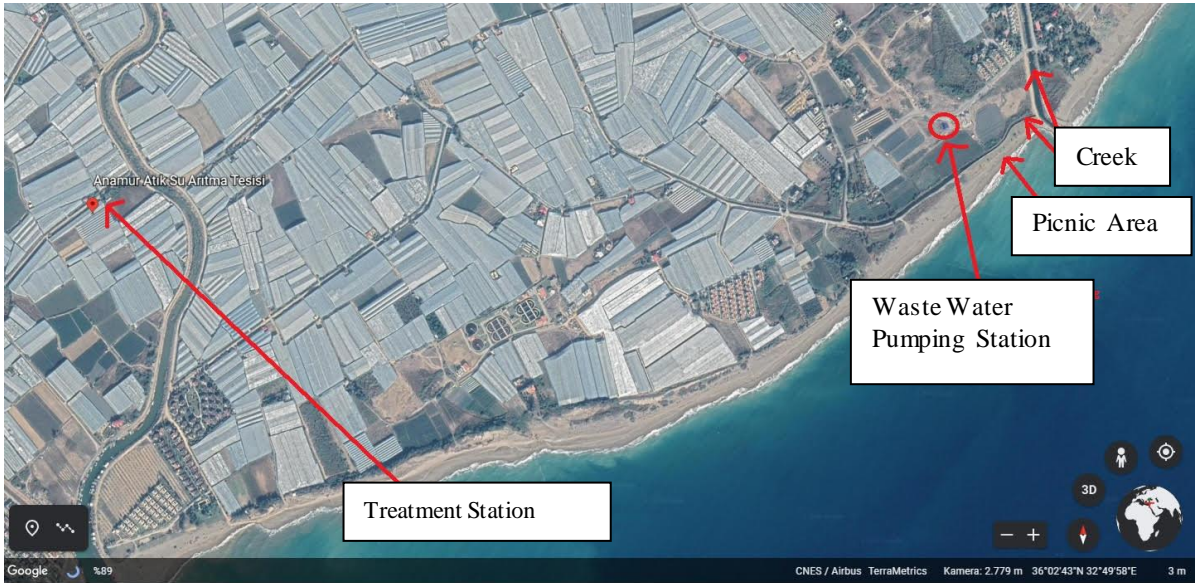
Re-occurring pollution events are caused by the release of untreated wastewater (including sewage) into the Sarisu Creek from the local Waste Water Pumping Station (Fig. 12-14). The pumping station transports wastewater to the Treatment Station, however, on several occasions this untreated wastewater has been released directly into the Creek. The most recent pollution event occurred for over a week during January 2021 due to maintenance repairs to the system. This creek is the natural habitat for the Critically Endangered Soft Shell Nile Turtle (*Trionyx triunguis*). This situation is in violation of Turkish regulations (Date: 31.12.2004 Issue: 25687 “Water Pollution Control Regulation” Updated at 13/2/2008 by change number 26786 - Article # 23).

Fig. 7. Anamur nesting beach. 07.01.2021. Location of the Waste Water Pumping Station and the Treatment Station that is polluting Sarisu Creek and the nesting beach.

- **Pollutants**, such as sewage, chemical, pesticide waste should not be released into the Canals, creeks, and streams
- **Illegal constructions** on the whole Anamur Beach and Dragon Çayı Rivulet should be removed.

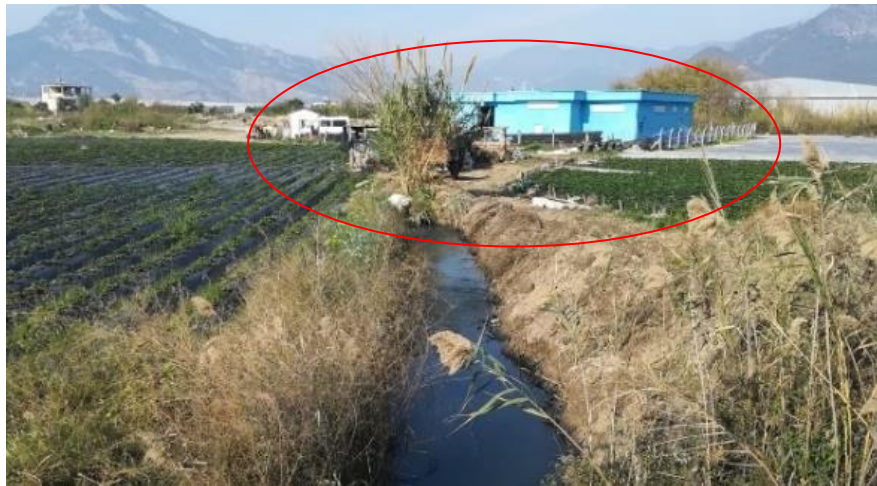
Fig. 8. Anamur nesting beach. Wastewater Pumping Station (red circle) adjacent to Sarisu Creek.

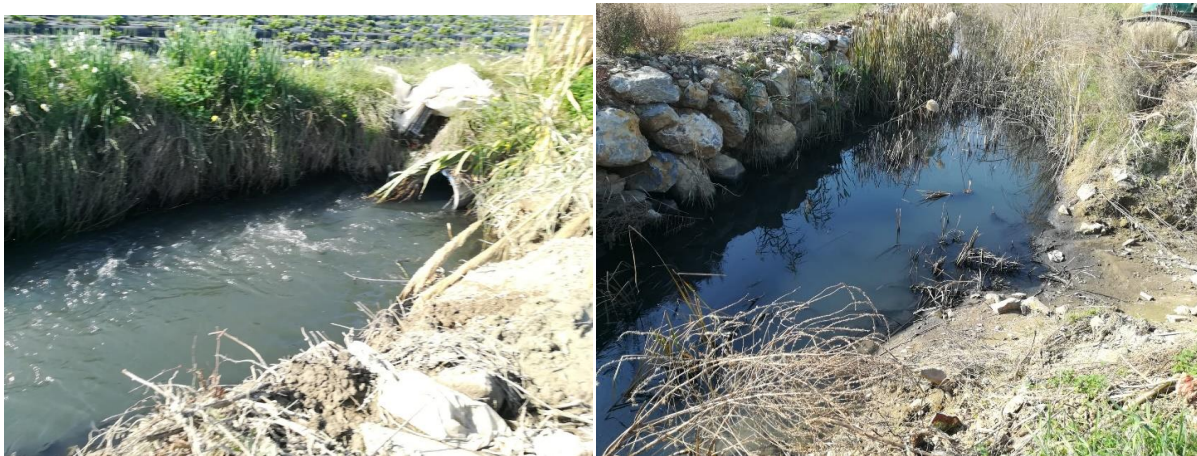
Fig. 9. Anamur nesting beach. 7.01.2021. Release of untreated wastewater into Sarisu Creek.
