**Integrated Rehabilitation Project Plan / Survey of the  
Architectural and Archaeological heritage (IRPP/SAAH)**

**Regional Programme  
for Cultural and Natural Heritage  
in South East Europe  
2003 - 2005**

**PRELIMINARY TECHNICAL ASSESSMENT REPORT  
ON THE RELIGIOUS BUILDINGS/ ENSEMBLES AND CULTURAL  
SITES DAMAGED IN MARCH 2004  
IN KOSOVO**

Immediate protection action plan and overall restoration perspectives

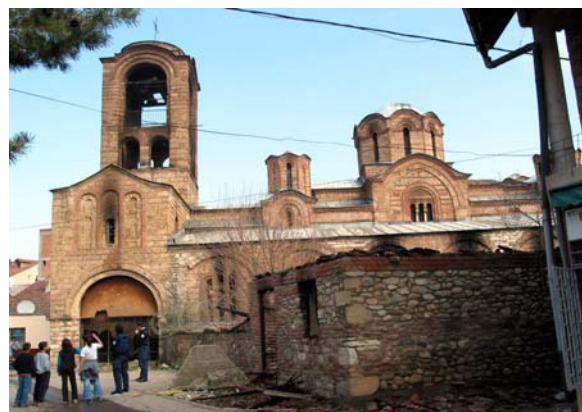
Photo after the riot

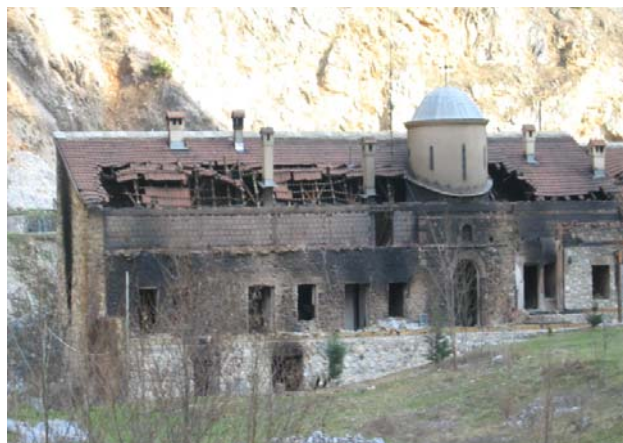
Photo after the riot

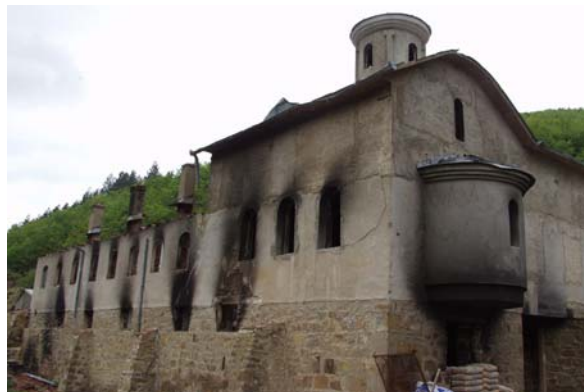
Photo after the riot

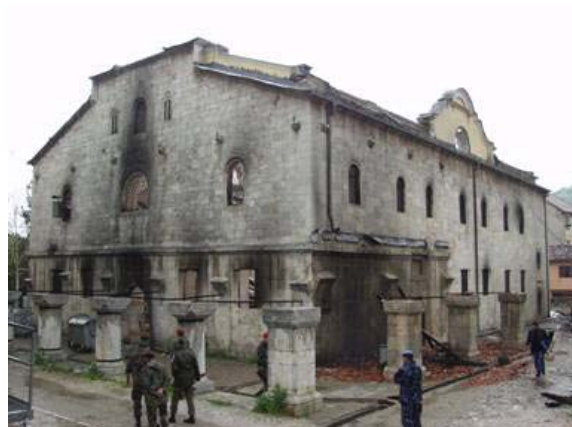
After the riot

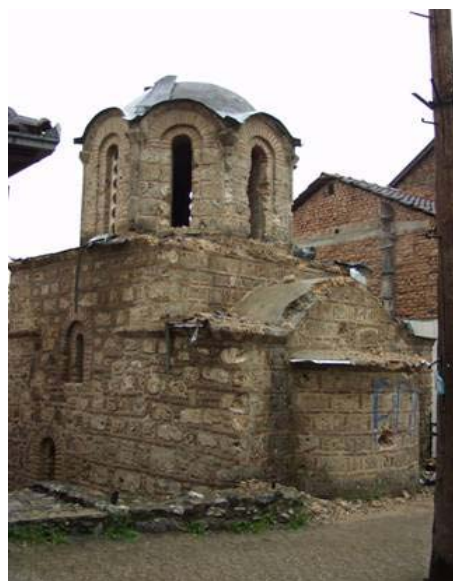
Photo after the riot

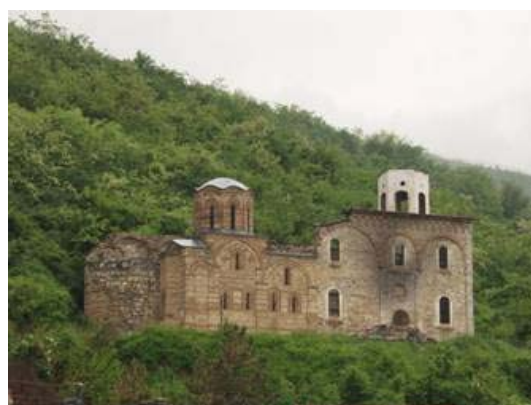
After the riot

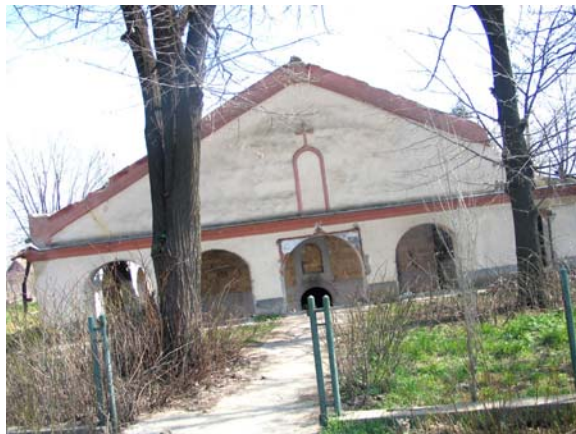
Picture taken during DoC & CHwB visit, 29<sup>th</sup> and 30<sup>th</sup> of March 2004.

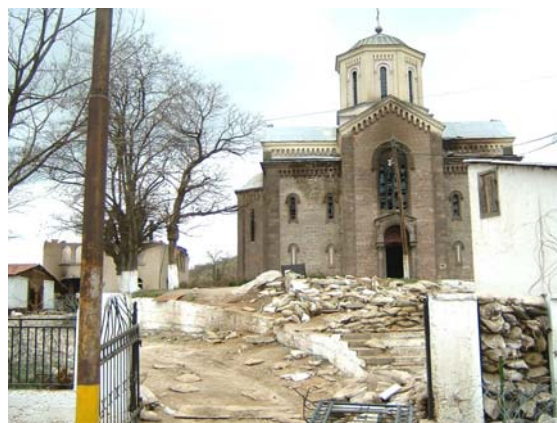
Photo after the riot

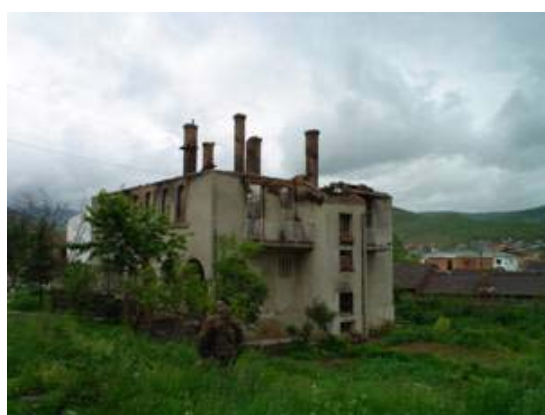
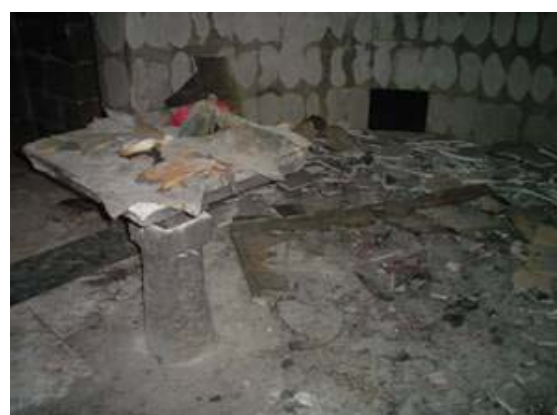
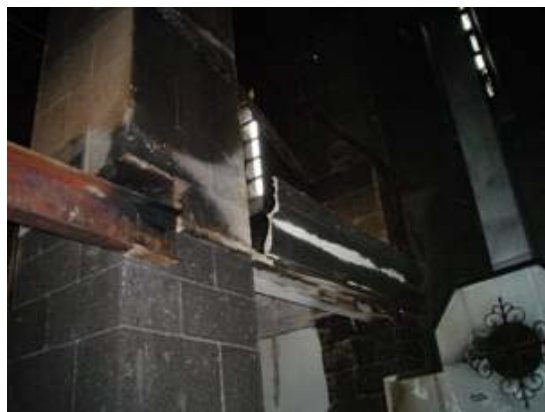
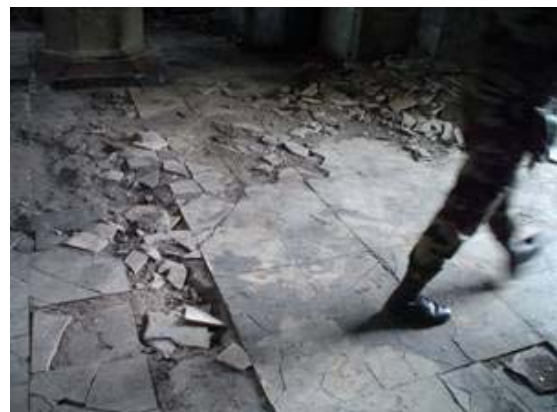
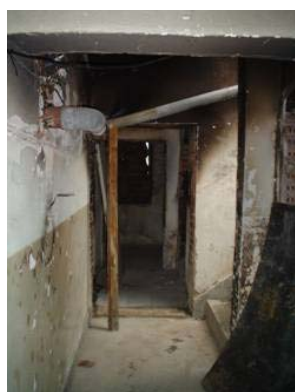
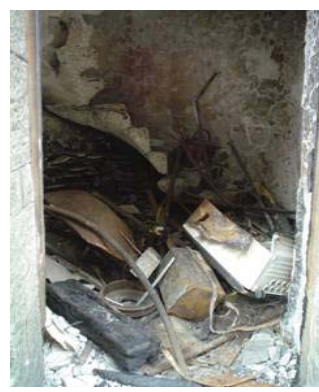
Photos by CoE, May 2004 (Interior of the bell tower and the priest's house)

Walls: External stone walling, part ashlar, part rubble dressed stone details to windows and doors. Metal windows and glass all damaged, fire damage throughout. Smoke damage to interiors. Plaster removed from sections of interior. Internal walls and aisle columns dressed stone. 2 steel beams inserted into existing structure, one detached.

The emporia (upper storey wooden floor with staircase at pronaos) is completely fire damaged and demolished.

Bell tower: external walls in good condition, internally the staircase collapsed due to the fire.

Fire damaged at base, joinery and spiral staircase damaged.

Repairs: Investigate and make safe steel beam in interior, secure windows and doors.

Repairs: Secure tower entrance.

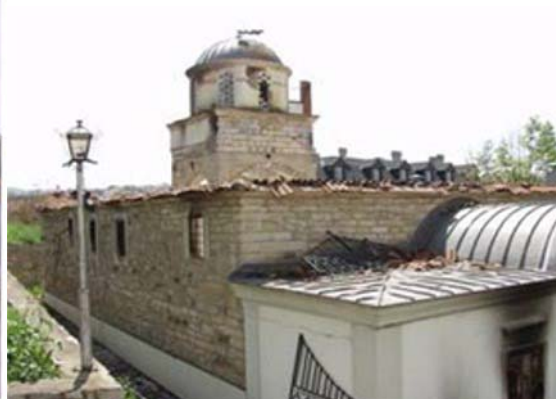
Photo after the riot  
(photo by CoE, May 2004)

Roof: completely burned down and collapsed.  
Walls: Only perimeter walls remain, with serious internal fire damage.  
Narthex with southern parecclesion: Destroyed by fire covering (made of concrete) in unstable condition.  
Dome: Later addition, carried on four concrete columns, unstable. Upper part (mixture of stone blocks and reinforced concrete), partly destroyed.  
Floor: not visible, covered by the materials of the ruined roof. Upper wooden construction storey (women's department) completely destroyed.  
Wall paintings: Interesting mid 19th c., damaged. Could be partially restored.

- Reconstruction of the dome (could be added latter).
- New concrete covering to the narthex and the southern parecclesion.
- Partial conservation, restoration of wall paintings.
- Reconstruction of the bell tower and mechanism.

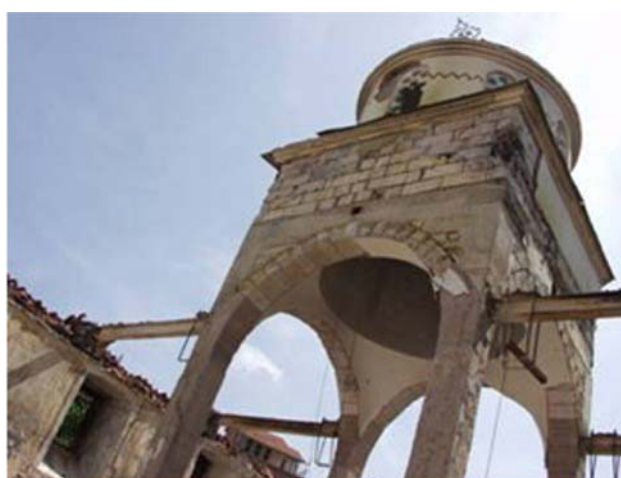
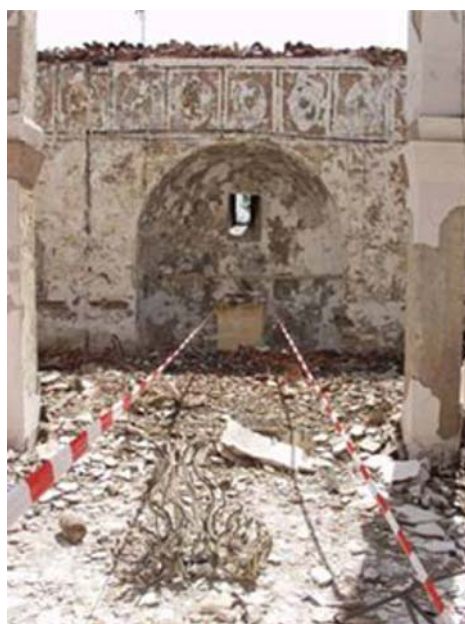
Photos by CoE, May 2004

Baptistery: contemporary construction, interior entirely burnt. Contemporary wall paintings damaged by fire. Cracks on E wall. Doors and windows burnt

- Reconstruction of interior of the baptistery.
- Cleaning and repairing of the wall paintings.
- New door and windows

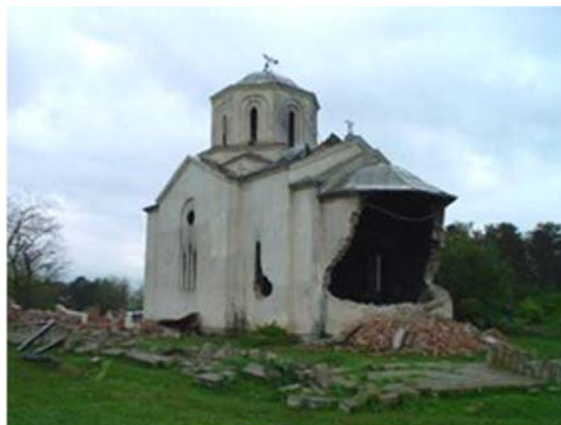
During riots interior got damaged by fire, part of apse wall collapsed by explosives. (From the revised DoC & CHwB list by András Riedlmayer 8 April 2004)

Photo after the riot (photo by CoE, May 2004)

Walls: Brickwork rendered wall construction, timber windows glass broken, plastered internally, partially removed. Apse demolished.

Repairs: Repair roofing, secure windows and door, rebuild apse, repair rainwater goods.

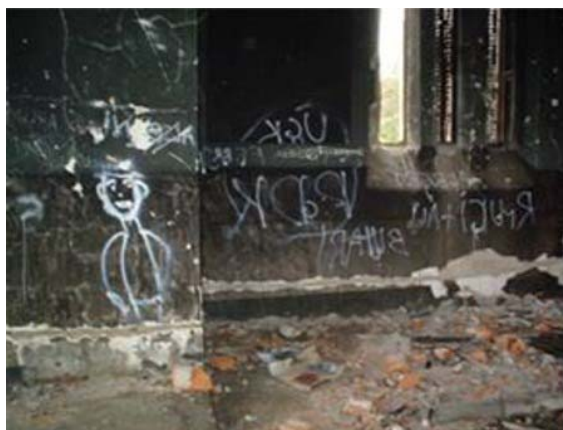
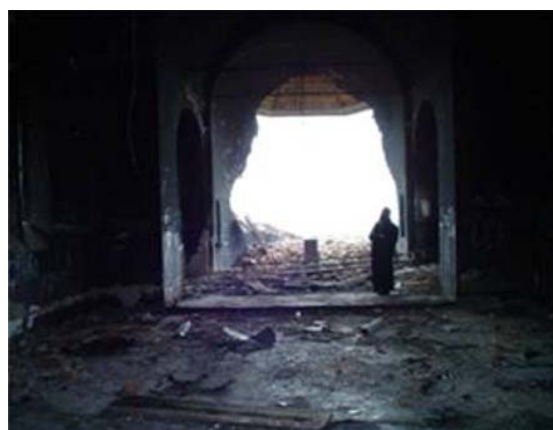
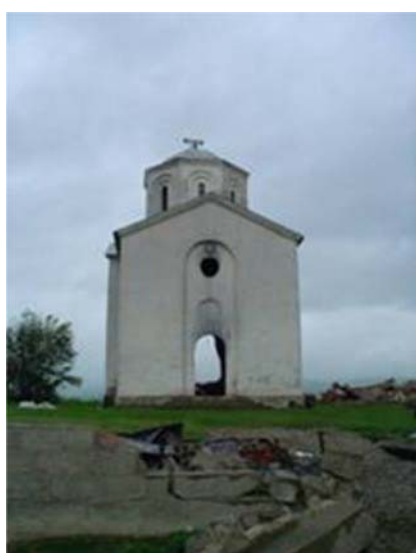
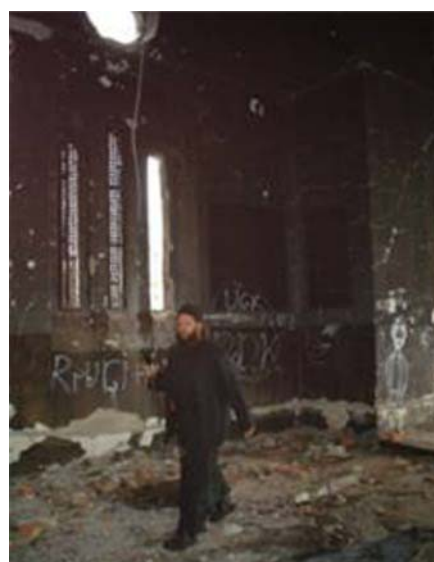
Photos by CoE, May 2004

Repairs: Remove debris, secure site

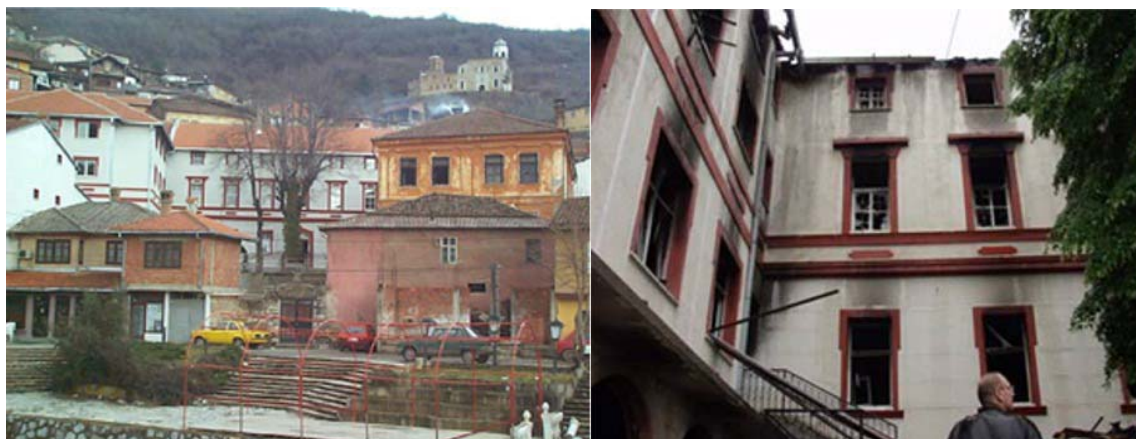
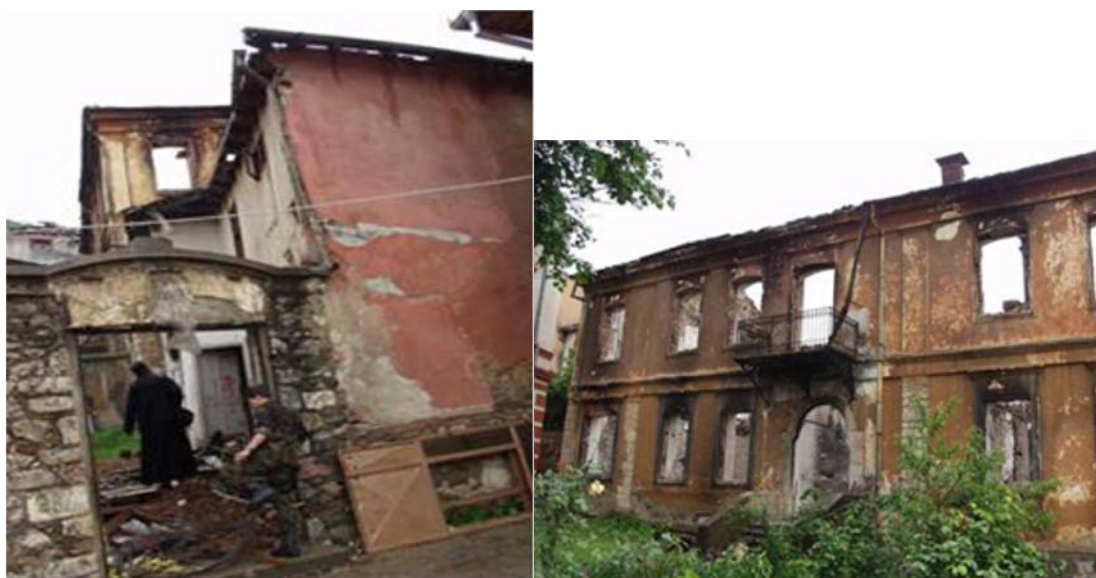
Pre- and post-war photos showing Orthodox Seminary complex (in foreground)

Burnt and collapsed. The perimeter walls only remain, badly damaged by fire. The facades have suffered damage by fire. Roofing, flooring and interior walls totally destroyed by fire and vandalism.

**Building No 4.** Dean's residence. Concrete constructed building of 1996. Only the perimeter walls and the concrete flooring remain, badly damaged by fire. Complete destruction of the interior and the roofing by fire.

- Clear site.
- Metal doors and windows with metal frames
- Repair of the perimeter walling and metal gate.

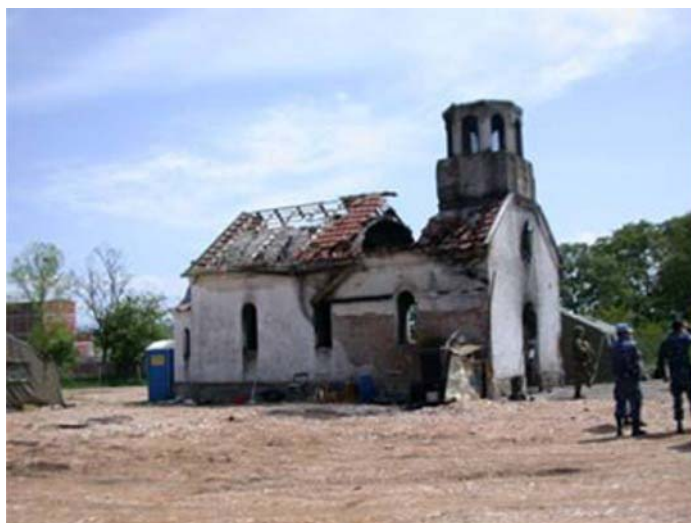
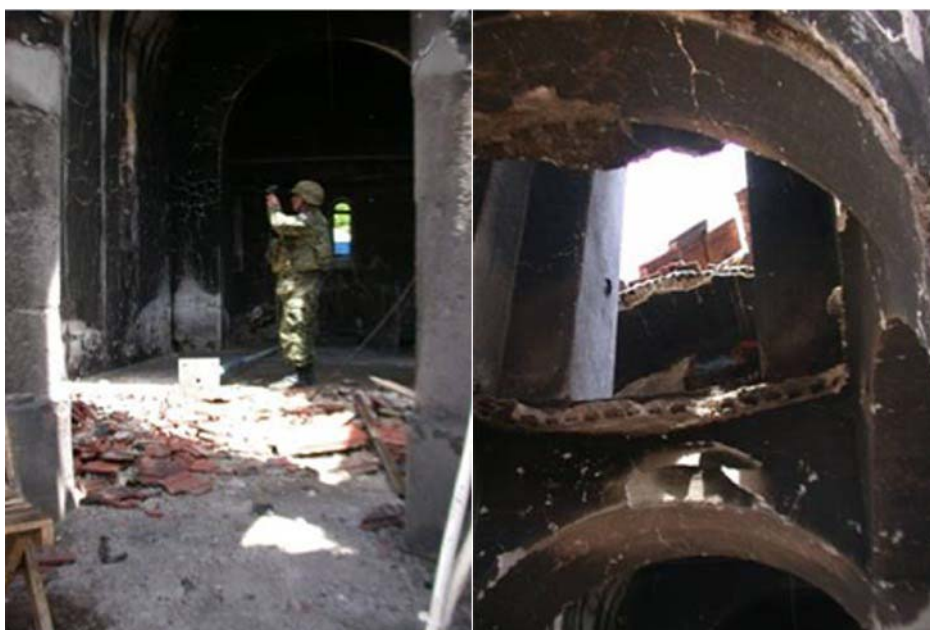
Photos by CoE, May 2004

Roof: Interlocking tiled roof over timber battens and rafters 100% damaged by fire. Evidence of structural collapse after March 2004. Metal roof over apse and all metal rainwater goods 100% damaged.

Repairs: Renew roof, rebuild external walls secure windows and door.

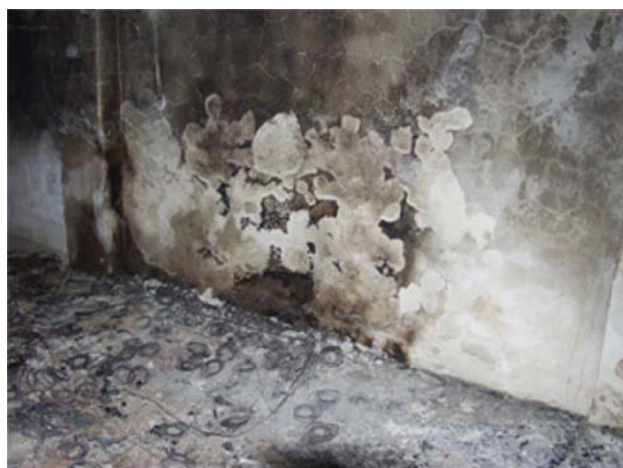
Photo after the riot

Conservation-restoration of the wall paintings inside the church and repair of the damaged walls (not possible to be estimated during this visit).

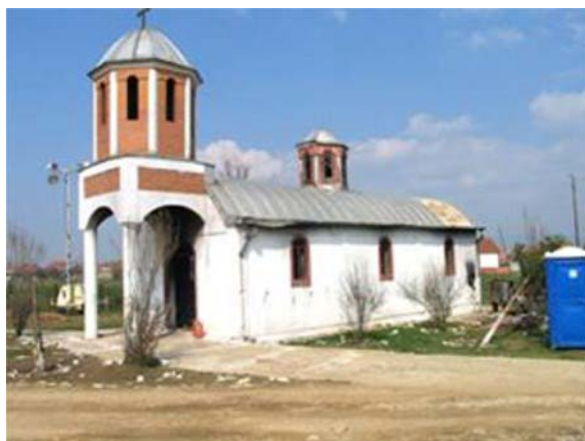
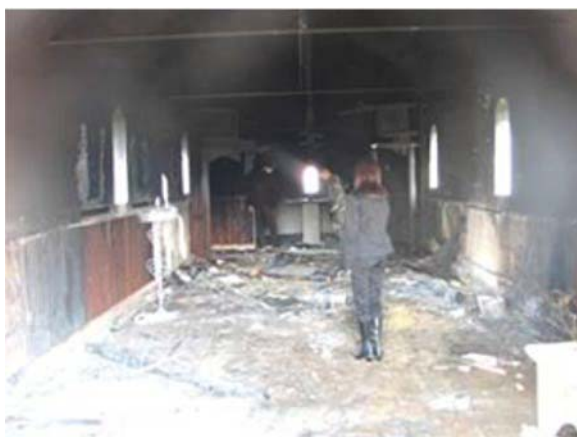
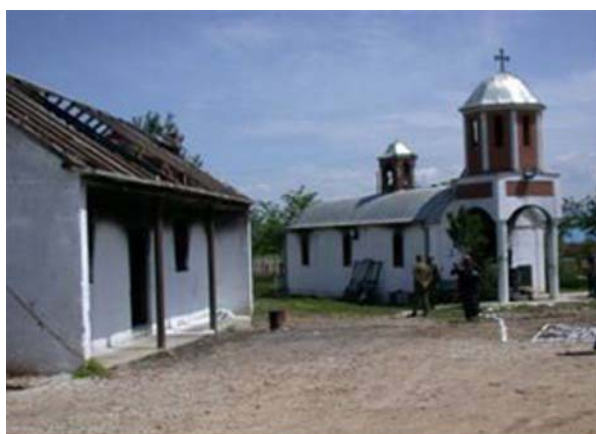
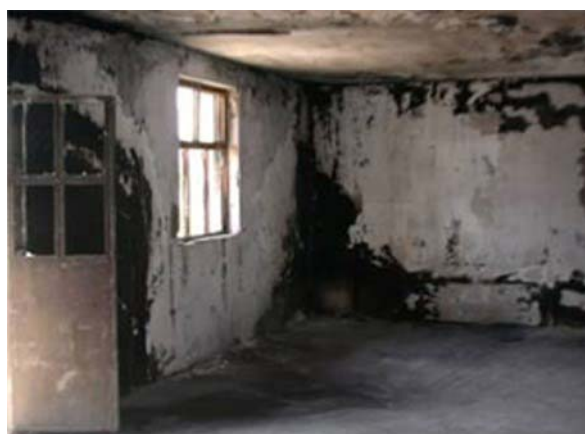
Walls: Rendered walls, scorch marks internally and externally, decorative timber wall panelling and altar screen fire damaged, metal windows; glass broken.

Floor: Ceramic tiles on concrete base, sections broken and partially removed.

Roof: Interlocking clay tile roof on timber battens on rafters approx 75% fire damaged, probable damage to wall plates, chimney part demolished.

Walls: Rendered walls, scorch marks internally and externally. Metal windows fire damaged, glass broken.

Ceiling: hollow pot ceiling partially exposed; significant cracking- possible structural failure.

Cemetery: large proportion of headstones damaged, small 20 sq.m building fire damaged.

Repairs: Repair damaged section of metal roof, secure windows and doors, remove generator to outside, remove fire damaged screens from interior.

Repairs: Renew roof, check ceiling construction, secure windows and door.  
Consider demolition of building.

Repairs: secure site, repair/consolidate headstones.

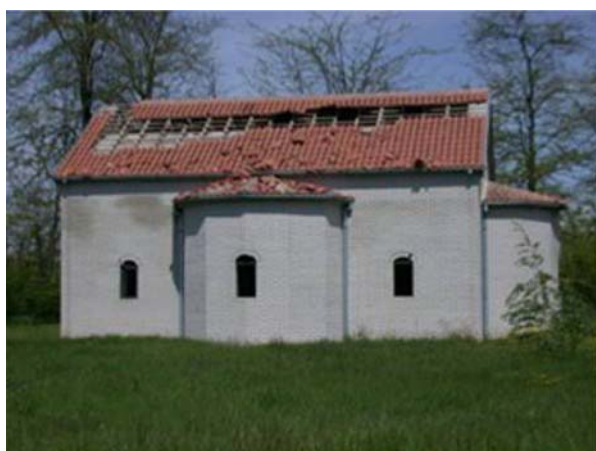
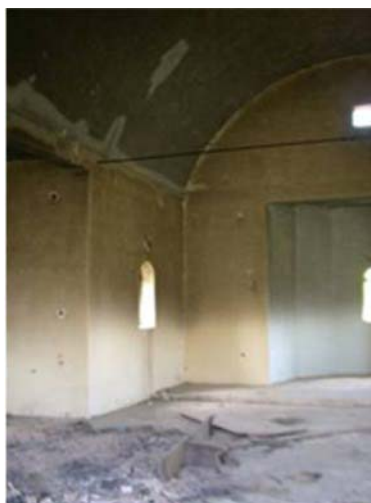
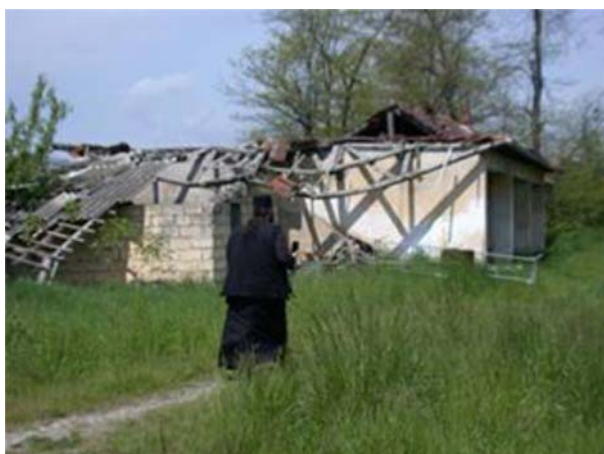
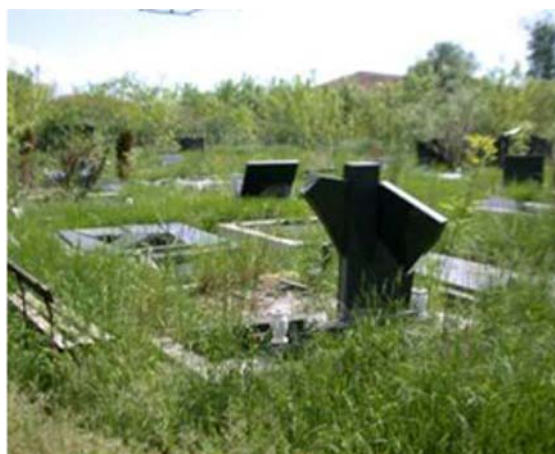
Roof: Interlocking tiles on battens on rafters, approx 25% damaged over concrete(?) barrel roof.

Walls: Solid walls concrete brick faced. Fire damaged internally. Metal windows, glass broken.

Roof: Interlocking tiles on timber structure, plaster lath ceiling 100% fire damaged.

Walls: Brick rendered walls, timber windows, glass broken.

Cemetery: large proportion of headstones damaged.

Repairs: Repair roof, secure windows and door.

Repairs: Renew roof, secure windows, doors.

Repairs: secure site, repair, consolidate headstones.

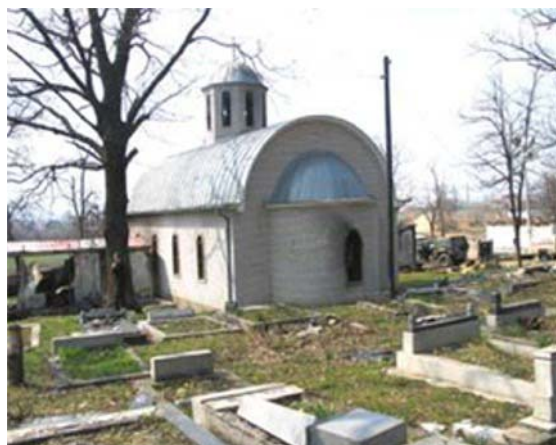
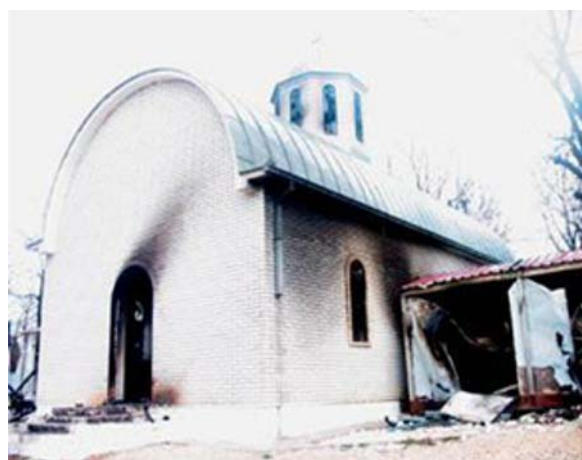
Fully damaged. Affected by fire. Cemetery desecrated and damaged. A little house by the Church burned. (DoC)

Walls: Concrete brick facing to solid wall construction, metal windows and doors fire damaged, glass broken. Internally, altar screen fire damaged.

Floor: Tiled floor over concrete slab partially damaged.

Cemetery: Headstones damaged.

Repairs: Secure windows, doors.

Repairs: repair/consolidate headstones, clear debris, secure site boundary.

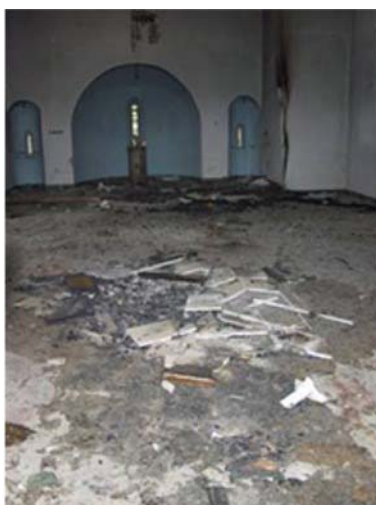
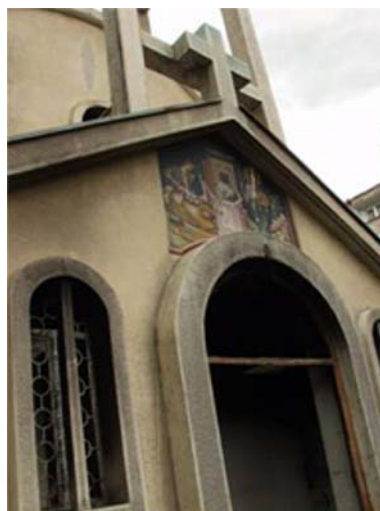
Exterior partial damage by fire.

Interior badly damaged by fire and looted.

Openings: Doors burned, windows destroyed.

- New door and windows with metal frames.
- Repair of the interior damages.
- Perimeter walling and fencing of the church site and a metal gate

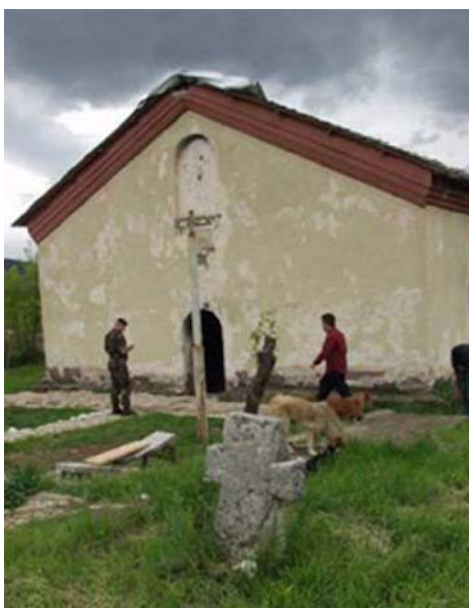
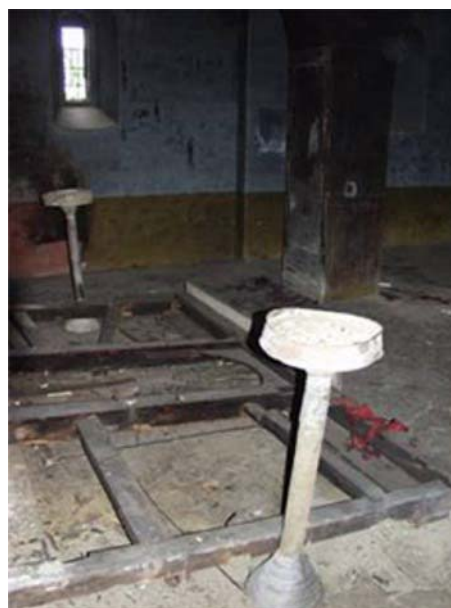
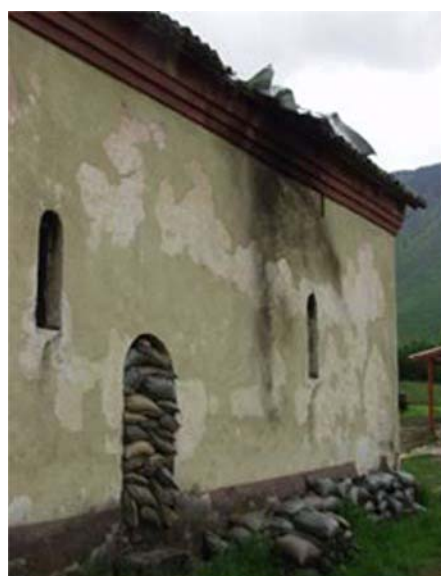
Exterior: damage to the W, E and S façades by fire.

Roofing: serious damage, some reportedly made during 1999 war. Immediate action required for the preservation of the monument.

Interior: Very badly damaged by fire (door, windows and roofing) and looted. Iconostasis burned. Parts of the wooden cross, together with some of the icons (in bad condition), saved and kept in Decani Monastery. Stone altar table destroyed.

Wall - paintings: Valuable, rich iconographic program from 16<sup>th</sup> c., very badly damaged by fire and smoke.

Openings: Southern door burned, protected by sand bags. Western door and windows damaged.

- New timber roofing.
- New external metal doors (western and southern) and repair of the historical 1866 door. Repair of the metal frames of the windows.
- Perimeter iron fencing (approx 1500m) to the church site and new metal gates.

- Cemetery: repair and consolidate headstones

- Repair of the internal damage , conservation of the wall paintings.

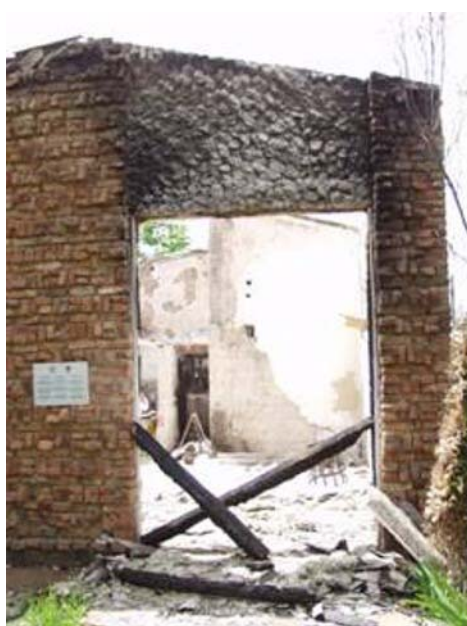
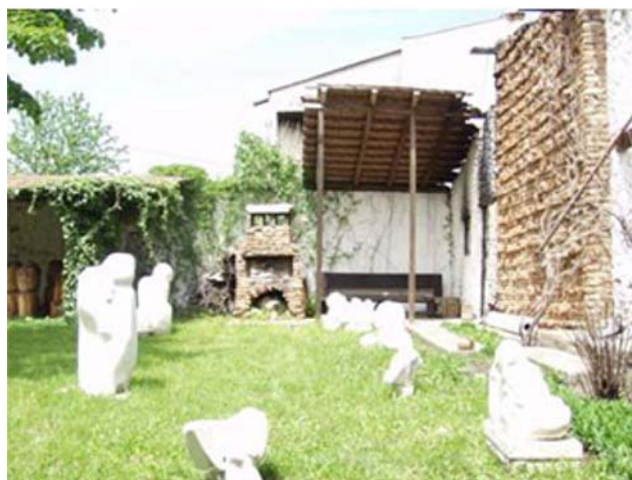
March 2004, fully damaged, affected by fire. (DoC)

The house is completely damaged by fire (approx 100 m2).

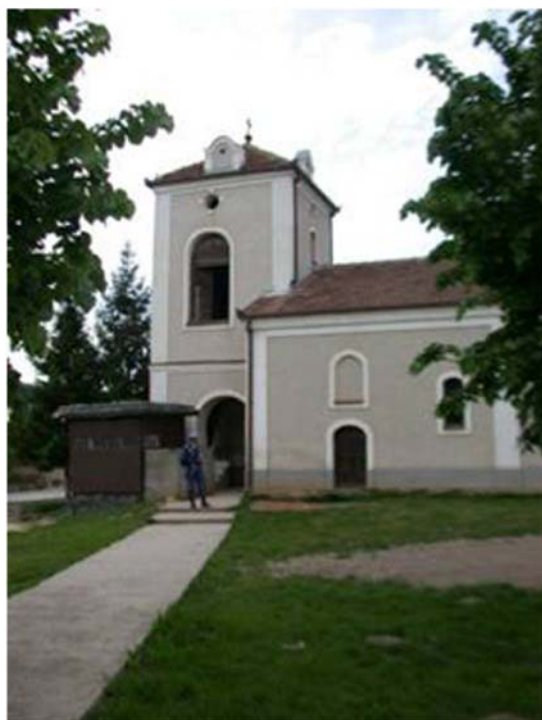
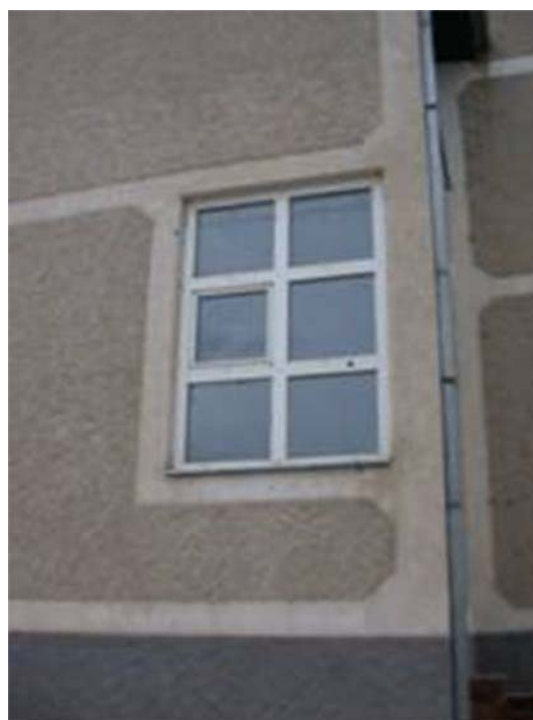
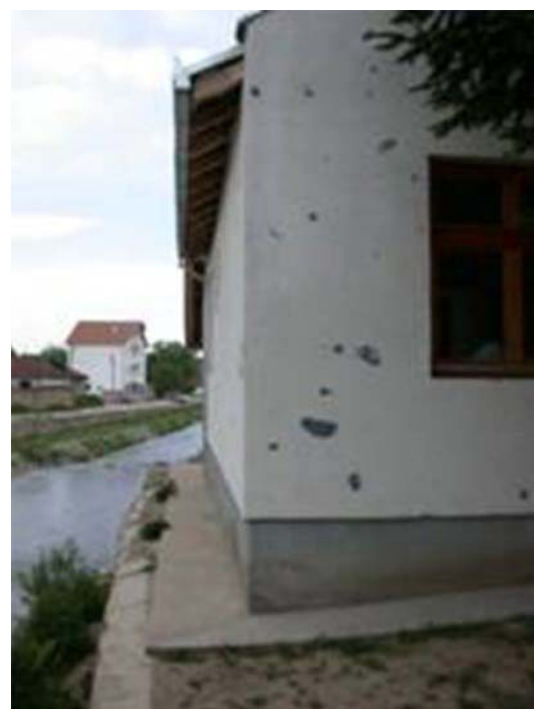
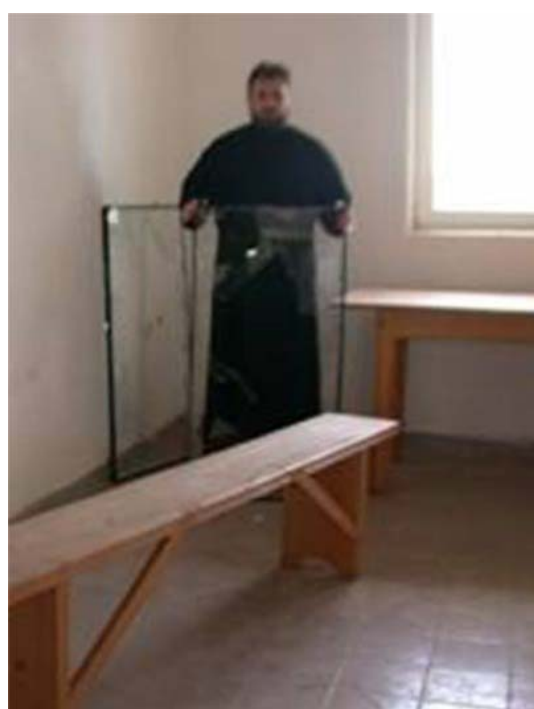
Photos after the riot  
(photos by CoE, May 2004)

Church and House stoned. Minor damage to church, glass to windows in Priest's House all broken, external cladding punctured. Windows repaired by Church. Evidence of earthquake damage in Church and loss of some roofing tiles.

Repairs: Repair external cladding.

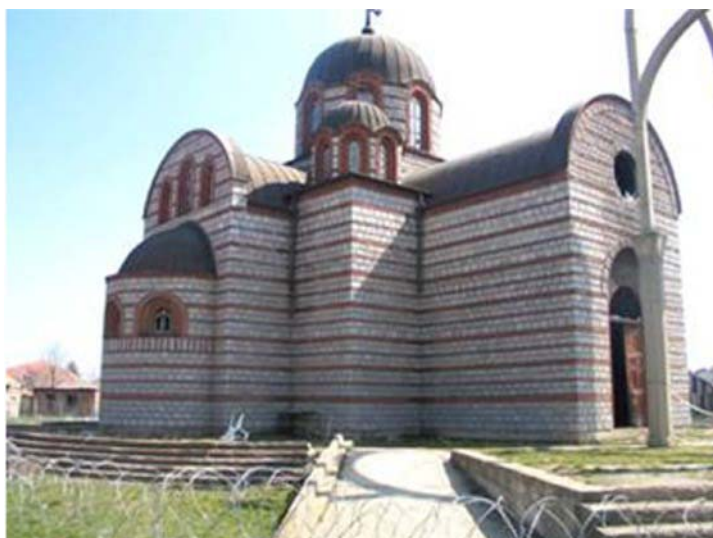
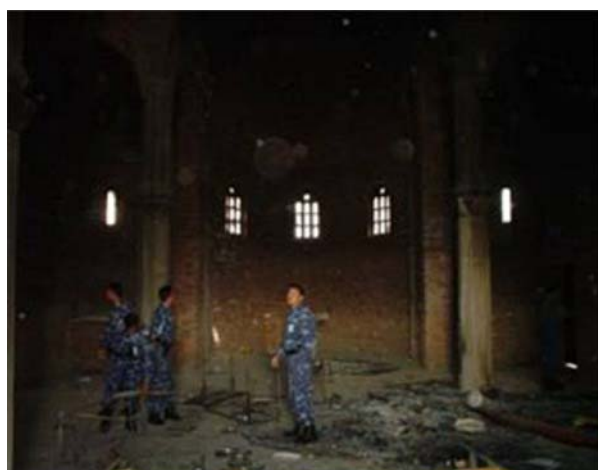
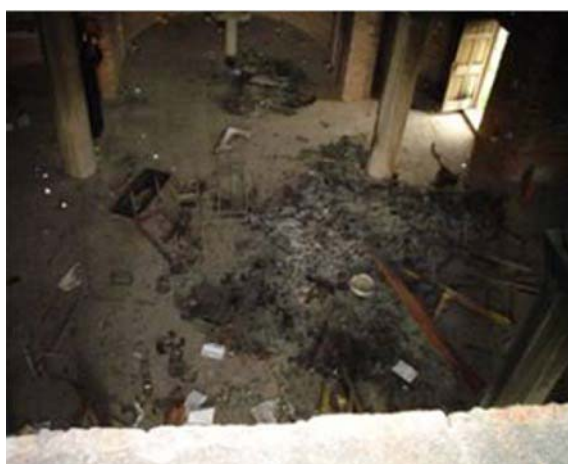
Photos after the riot  
(photos by CoE, May 2004)

Roof: Metal roof, rainwater goods damaged.

Walls: Timber windows, glass broken, brick vaulted internal walls, reinforced concrete frame smoke damaged. Doors fire damaged.

Repairs: Secure windows, doors

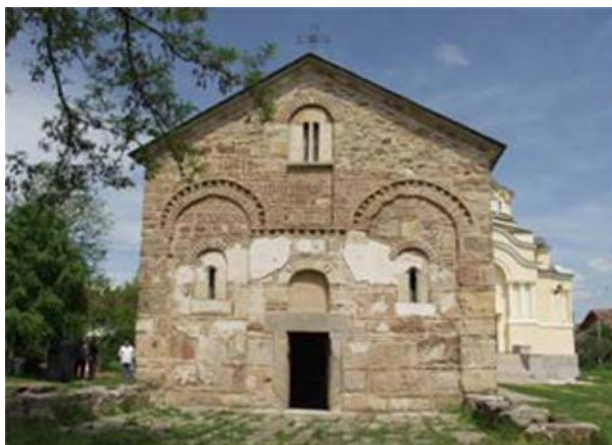
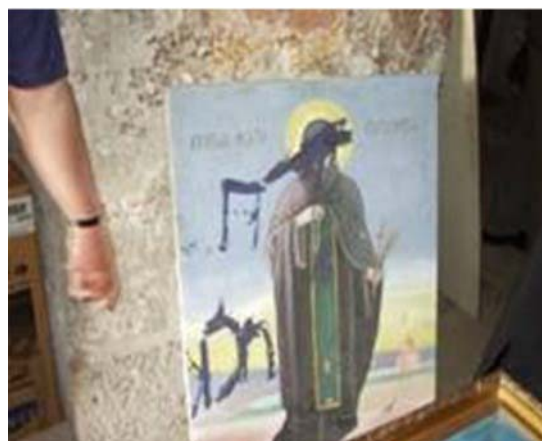
Photos by CoE, May 2004

Very small external damage to wall stones.

Small damage to contemporary icons.

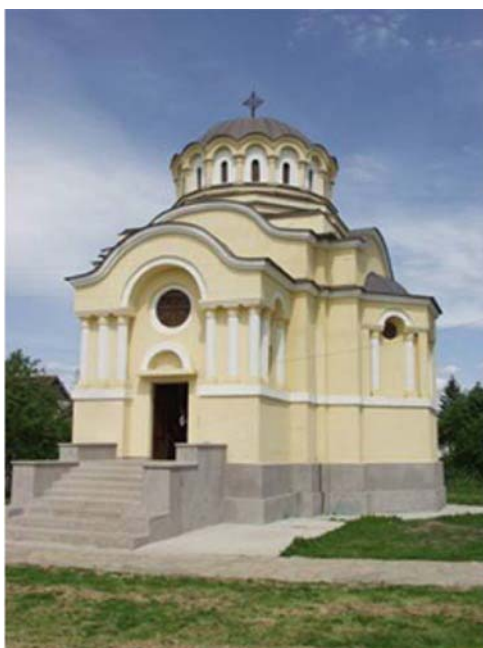
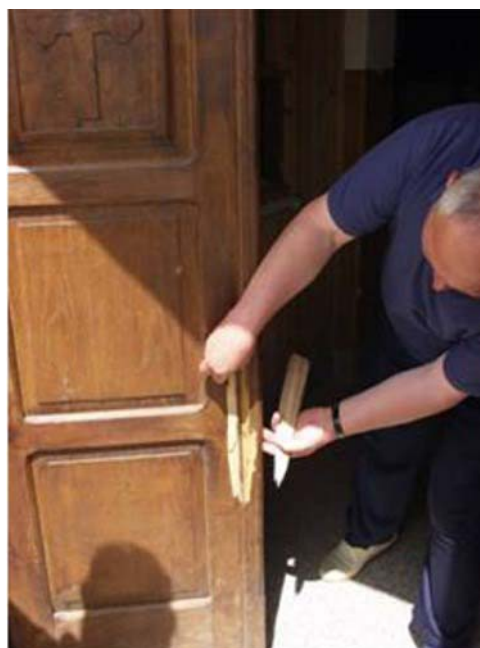
Photos by CoE, May 2004

Exterior damage almost invisible.  
Partial damage to the wooden door.

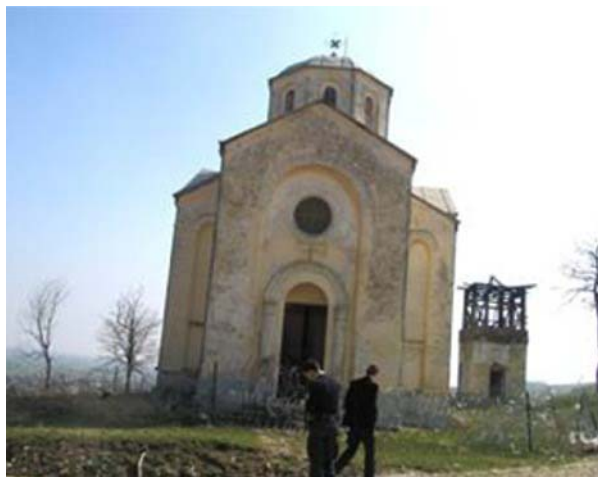
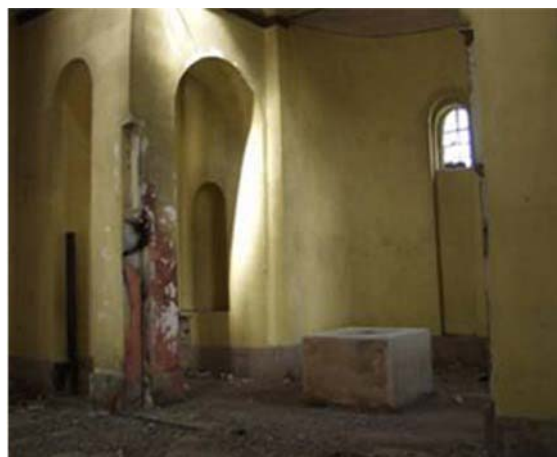
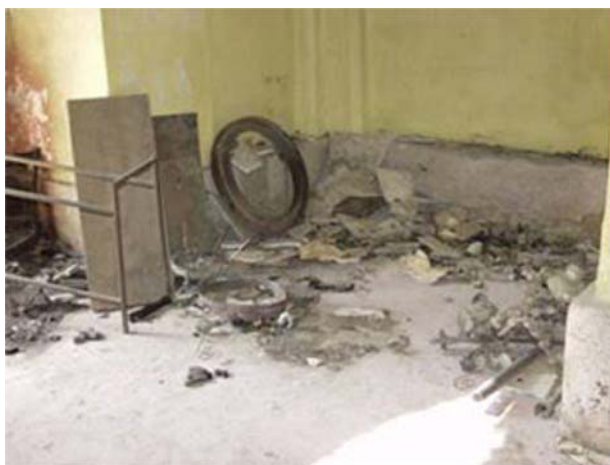
Photos by CoE, May 2004

Exterior in good condition, damaged partly by stoning.

Interior walls: Partially damaged by vandalism and fire.

Wall - paintings: Contemporary, completely damaged and vandalized.

Openings: Wooden door and windows damaged by stoning.

- Repair of internal damage
- Full reconstruction of the bell tower.

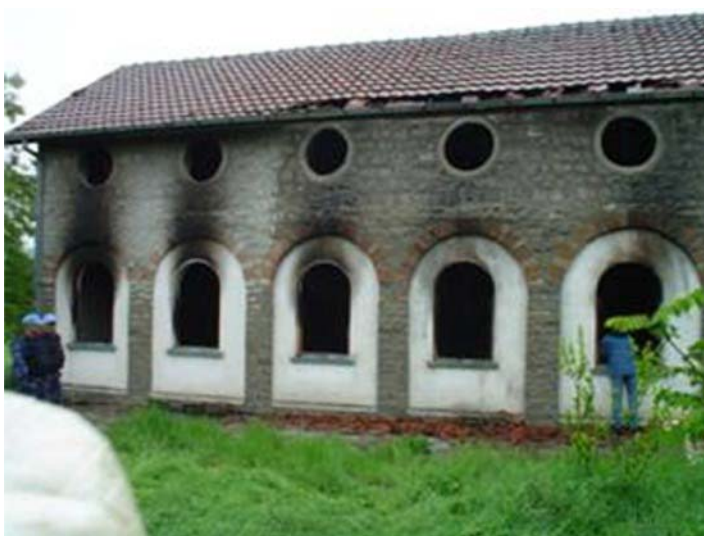
After the riot

Roof: Interlocking clay tile roof on timber structure. 10% roof tiles damaged by fire, and rafter ends burnt.

Walls: Entrance wall stone built, side walls concrete block., smoke damaged. Metal windows and door, glass broken.

Repairs: Repair roof, secure windows and door.

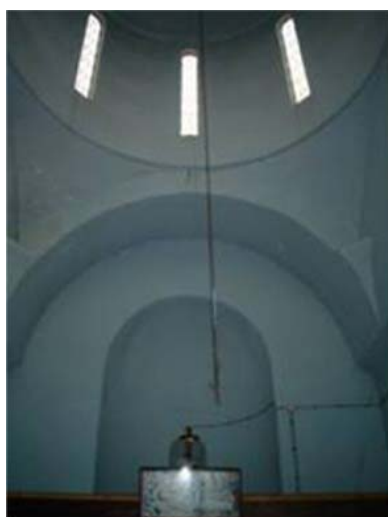
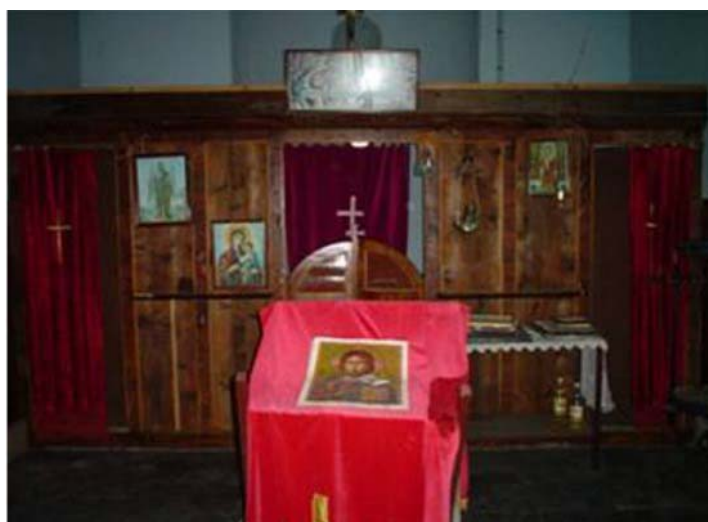
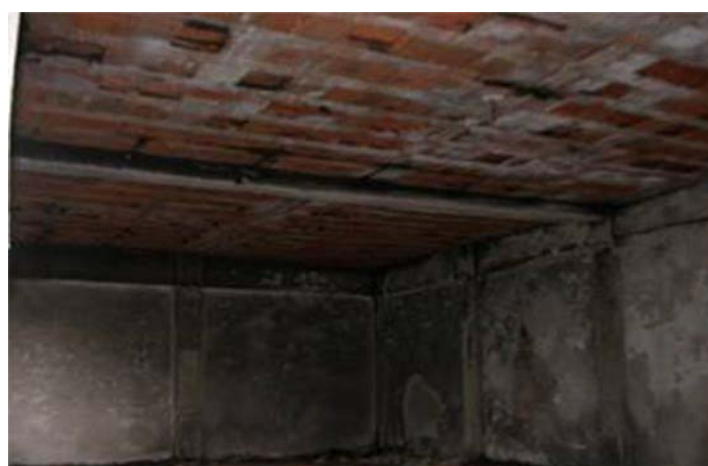
Photos by CoE, May 2004

Ceiling: Hollow pot ceiling, no apparent damage.

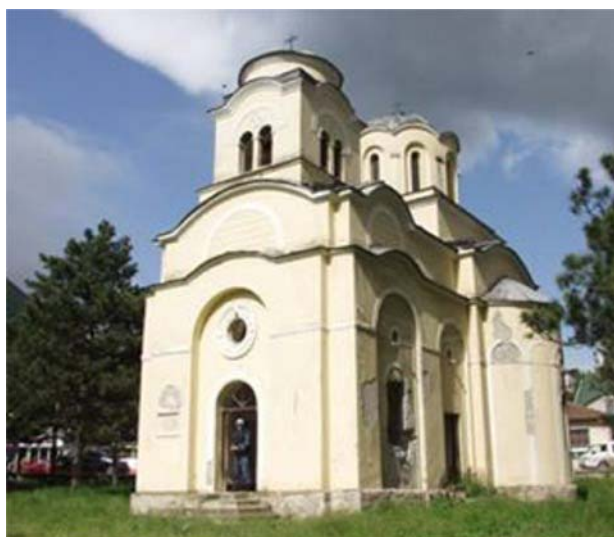
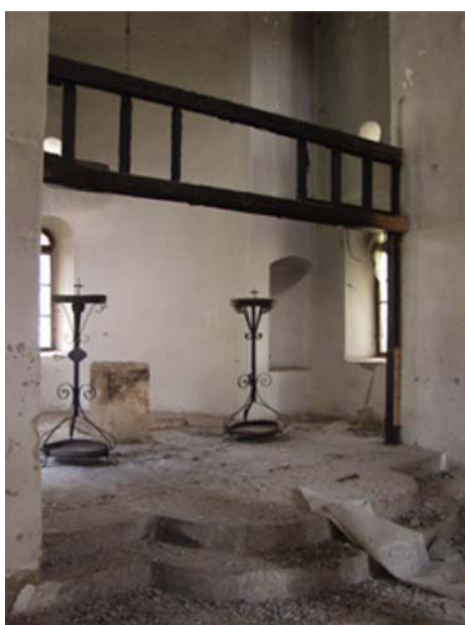
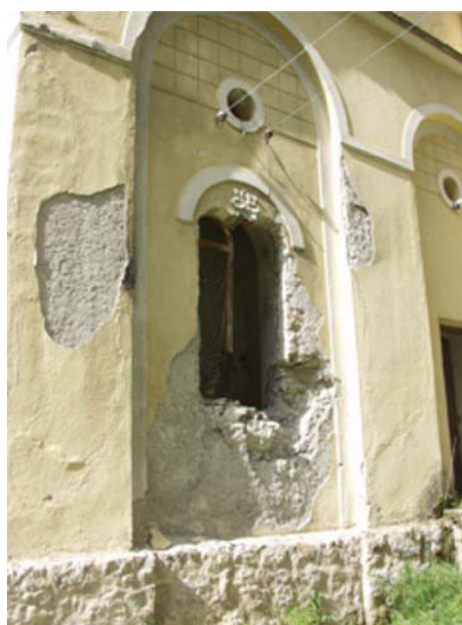
Photos after the riot (photos by CoE, May 2004)

Exterior: Major damage around southern window. Minor damages to W and E facades.

Interior partially damaged by fire (especially in southern part) and looted.

Interior walls: Partially destroyed by fire. Iconostasis burned. Altar temple destroyed.

- Reconstruction of the interior and repairing of the exterior
