Community-led Urban Strategies in Historic Towns (COMUS)

“Community-led Urban Strategies in Historic Towns (COMUS)” Preliminary Technical Assessment

Restoration of Carmelite church and the unique frescoes of the 17th century,
landscaping

Mscislaŭ, Belarus

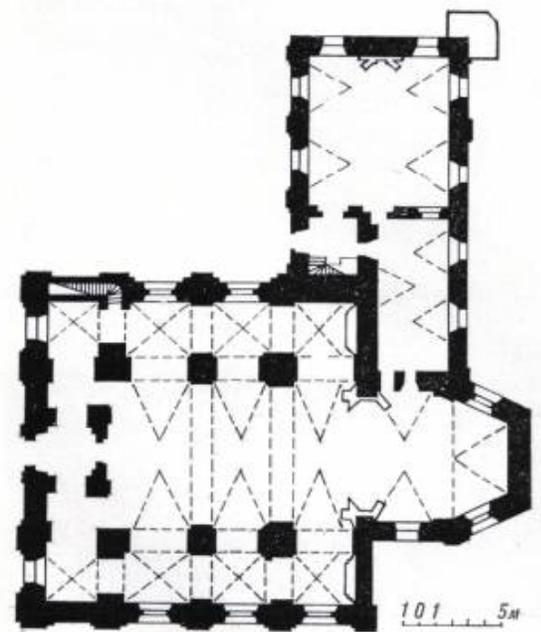
*Mscislaŭ. Carmelite Church of the Assumption of the Mother of God
The Plan*

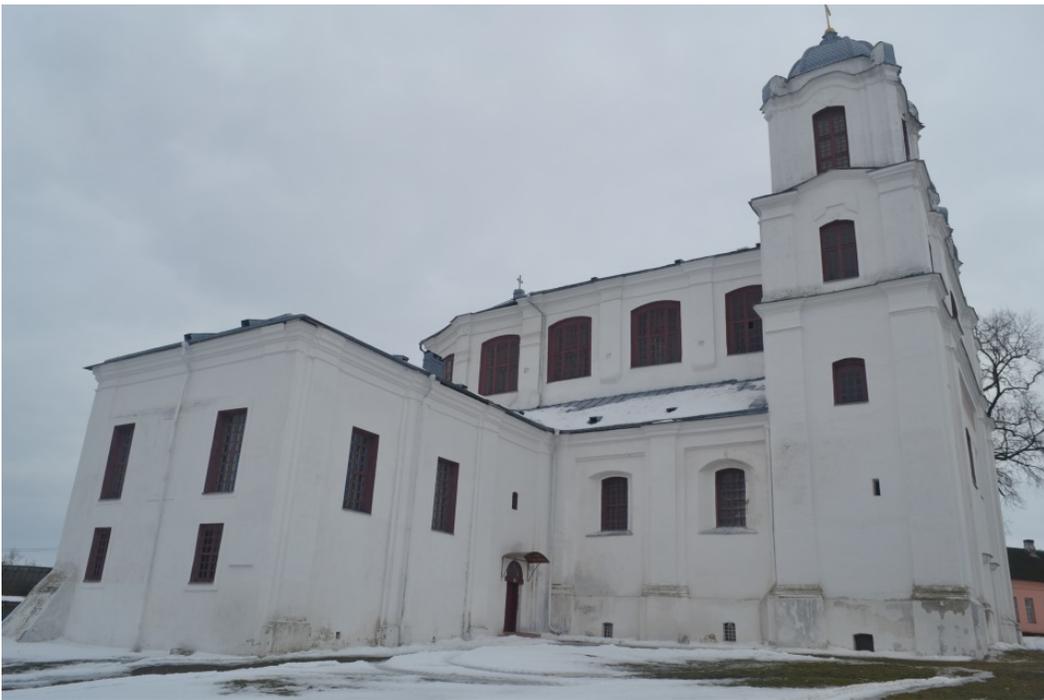
The Carmelite church. View to the north facade of the church and 2-storey annexe from the inside

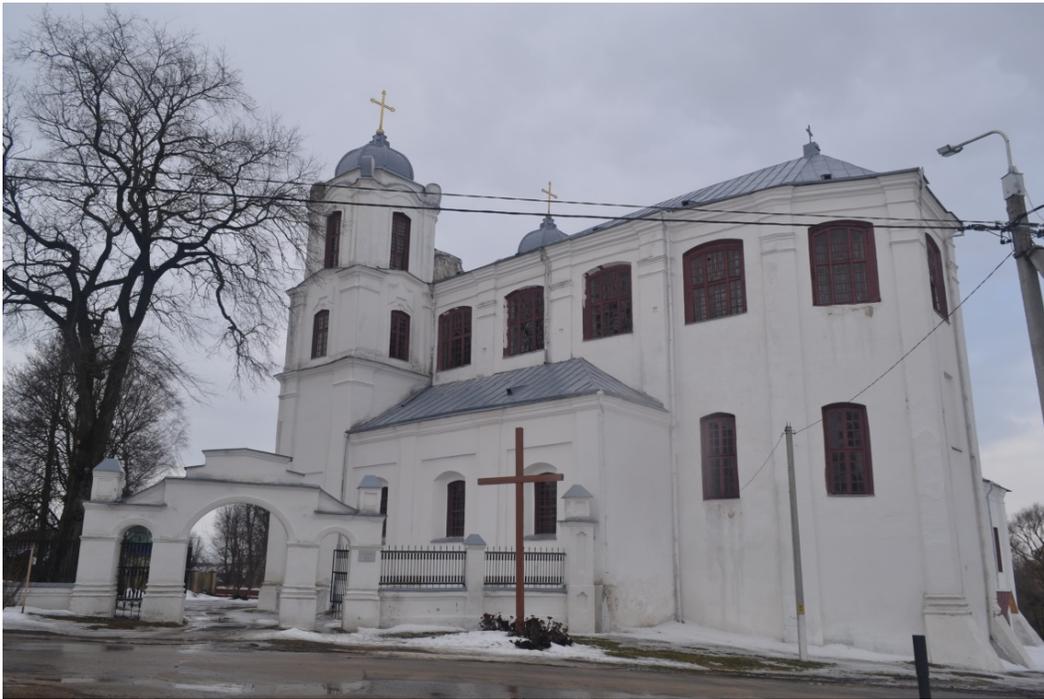
The Carmelite church. A view of the southern facade of the temple and the entrance gate from Kirava Str.

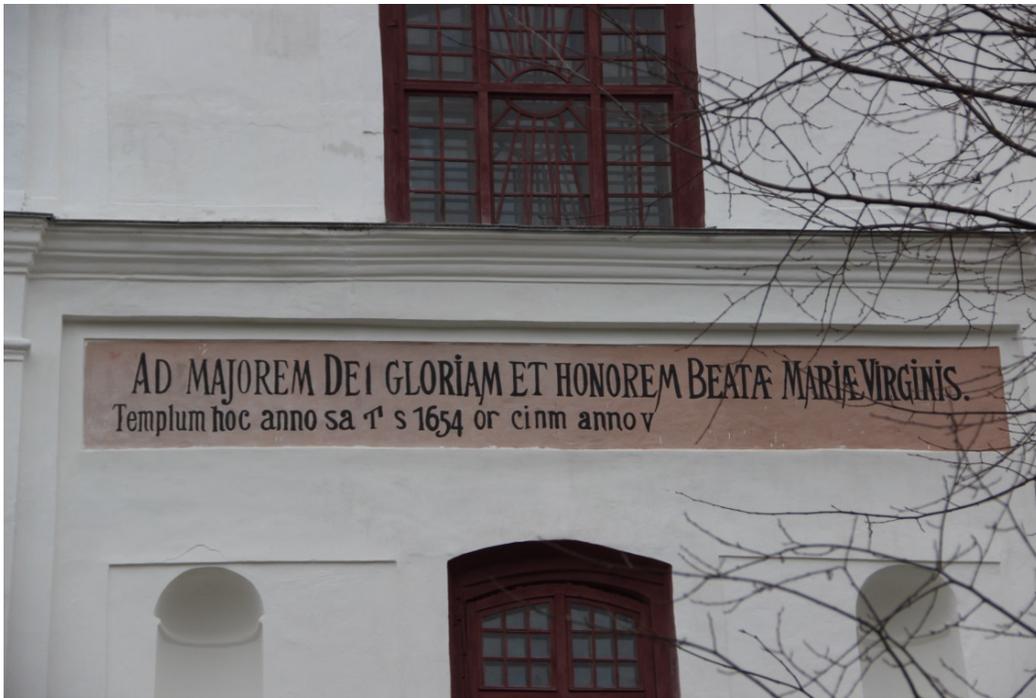
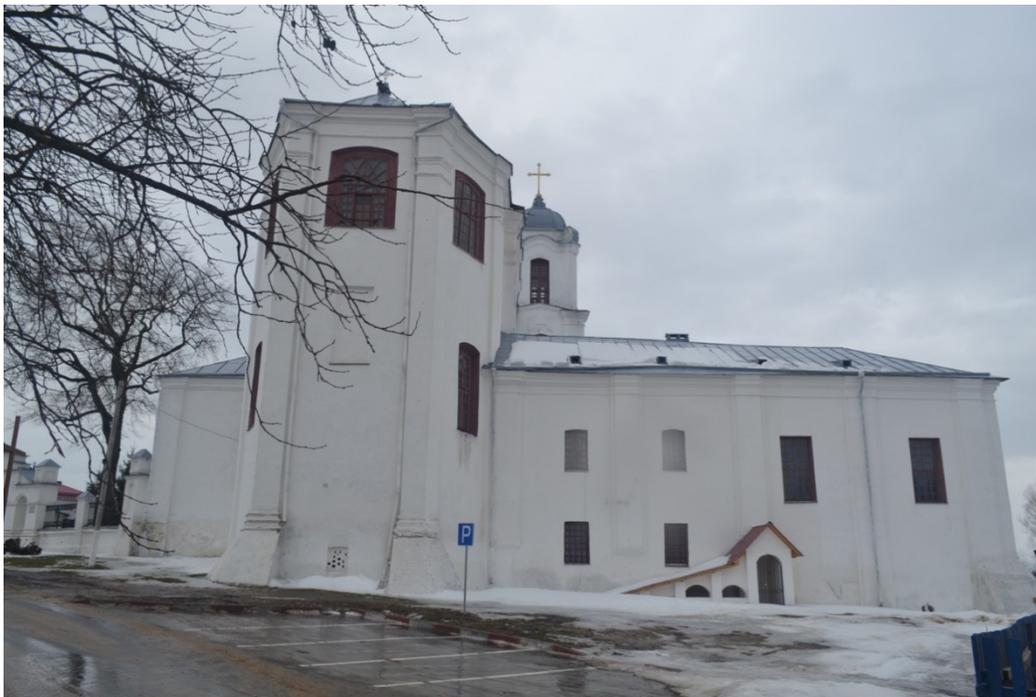
The Carmelite church. View of the east facade of the church from the side of the car park

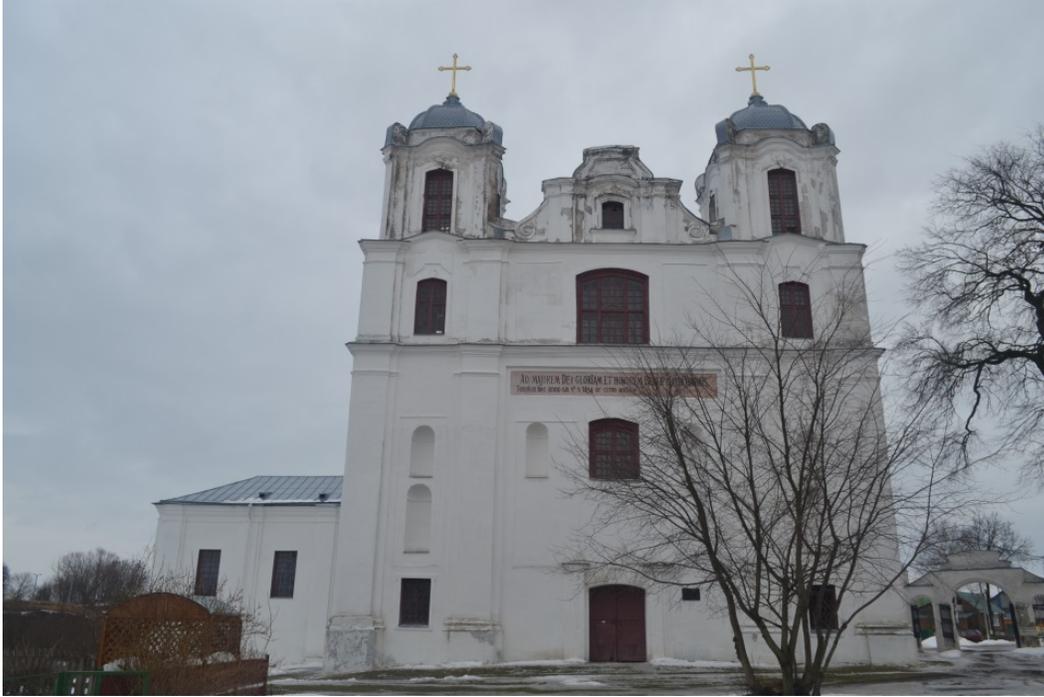
The Carmelite church. View of the west facade of the church

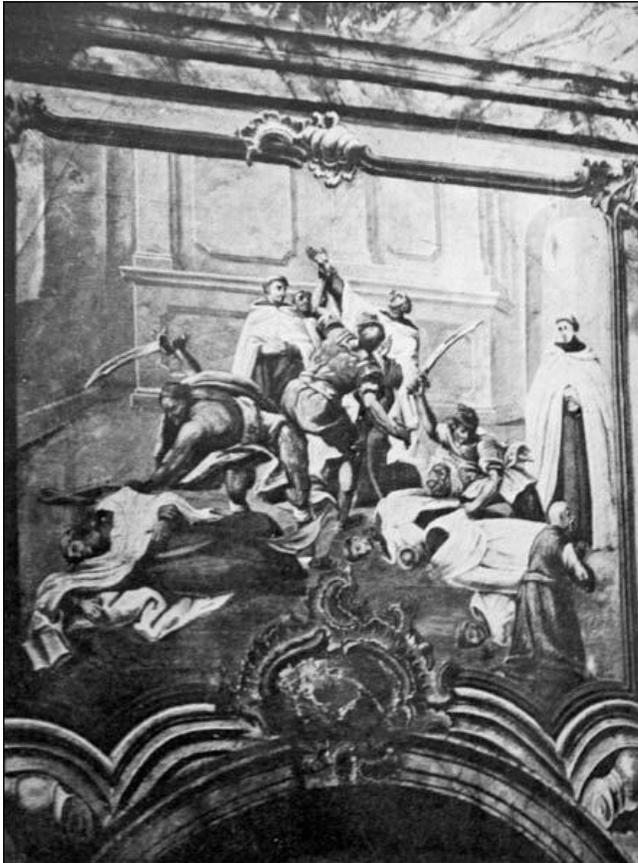
Fresco "Murder the Carmelite monks (" Trubetskaya Massacre "), photo of 1912

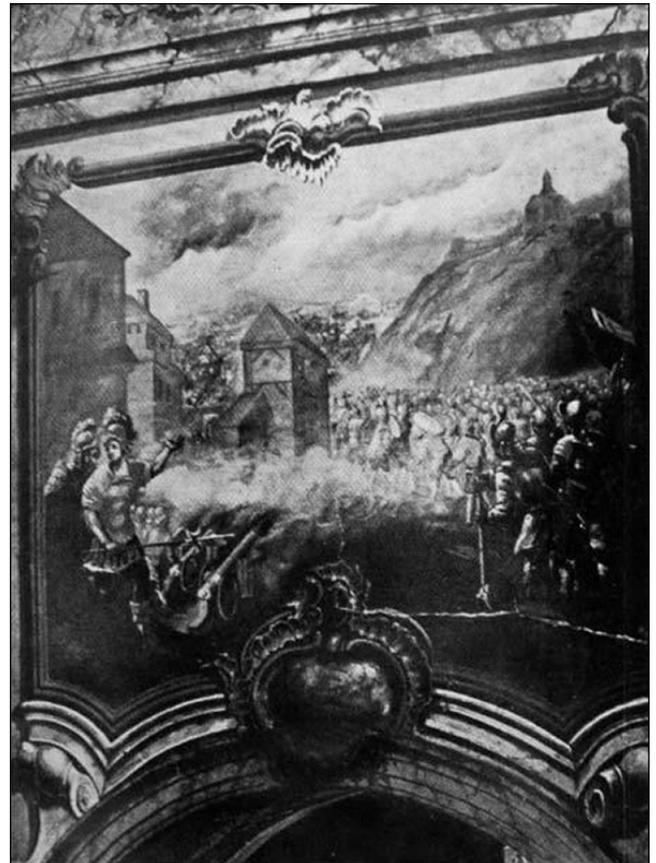
Fresco " Assault on Mscislau by Moscow army of prince Trubetskoi in 1654", photo of 1912.

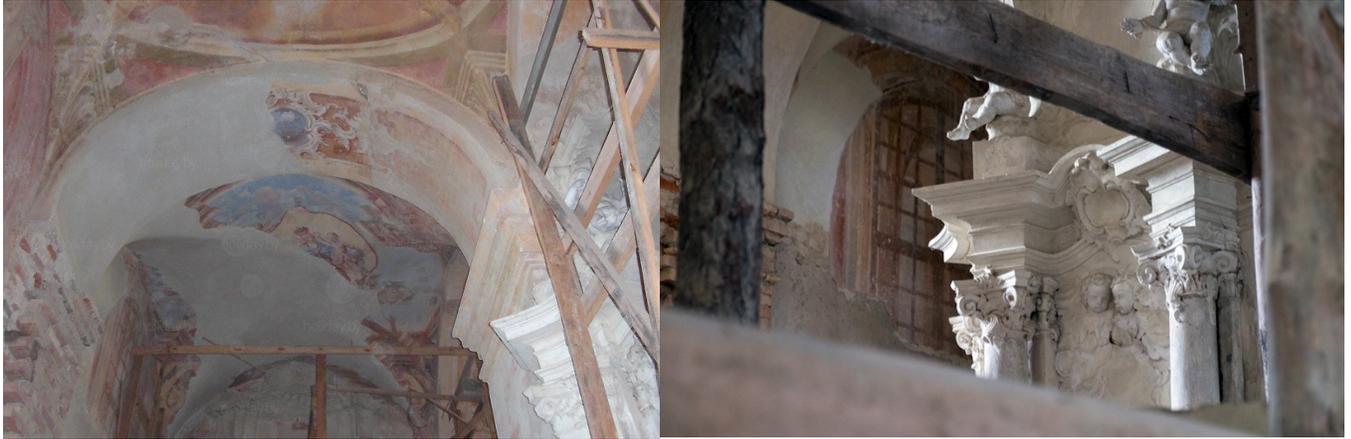
Fragments of the interior of the Carmelite church

The building of the Carmelite church itself is in satisfactory condition. During the 1990s the ceiling and the roof of the church were reinforced, the walls were fortified, and stucco restored, as well as the architectural details of the interior. Preservation and partial restoration of mural paintings was carried out. However, only about 30% of the planned restoration work was completed. Due to lack of funding, there is a risk that the benefits of the work carried out to date will be cancelled out or even damaged further. For example, in 2016 the facades of the church were painted with acrylic paint, without the consent of the restorers, which ultimately resulted in damage to the plaster. Another problem is that acrylic paint is very difficult to remove without further damage to the building's fabric.
