**Possible negative impact of hydro-power plant
development on the Neretva River (Bosnia &
Herzegovina)**

- COMPLAINANT REPORT -

Update Report dated 14 November 2025

Fish kill in the Neretva River in September 2025: Identifying water releases from the Ulog Hydropower Plant as likely cause

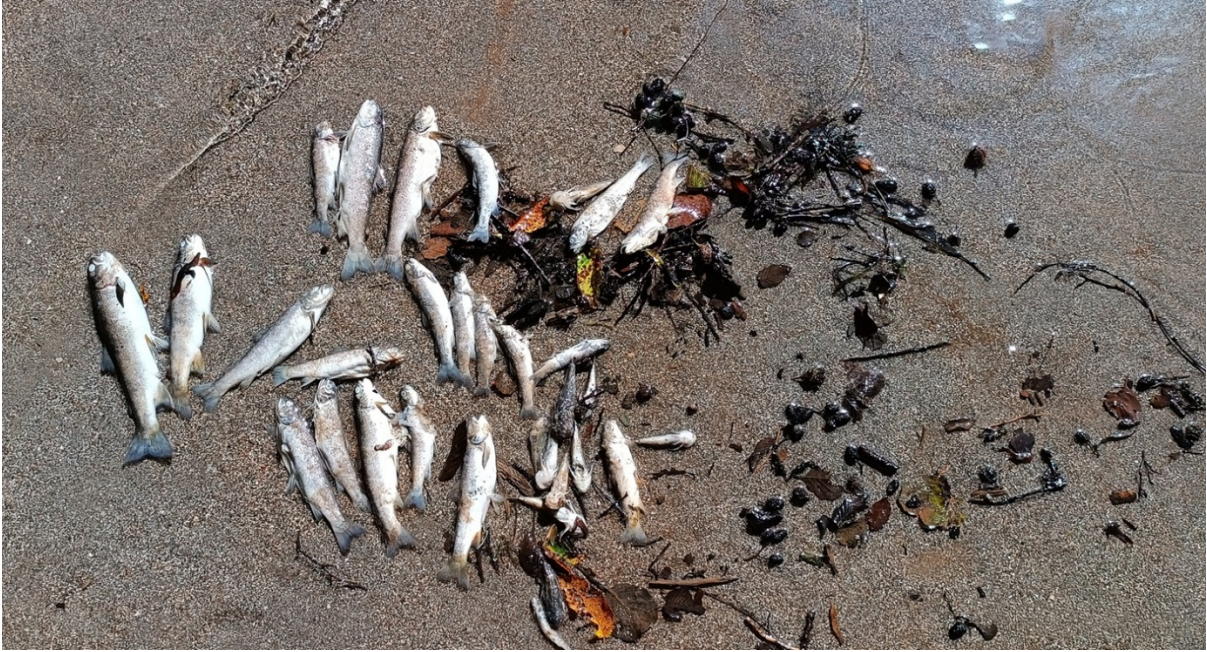
Annex 1: The tragic result of Ulog HPP releasing oxygen-depleted water: A mass fish kill on the precious Neretva.

However, we use this opportunity to report on the incident from 12th September 2025 that led to mass suffocation of fish downstream of HPP Ulog¹.

Photo of dead fish, © Hrabren Kapić, Organizacija Sportskih Ribolovaca Konjic

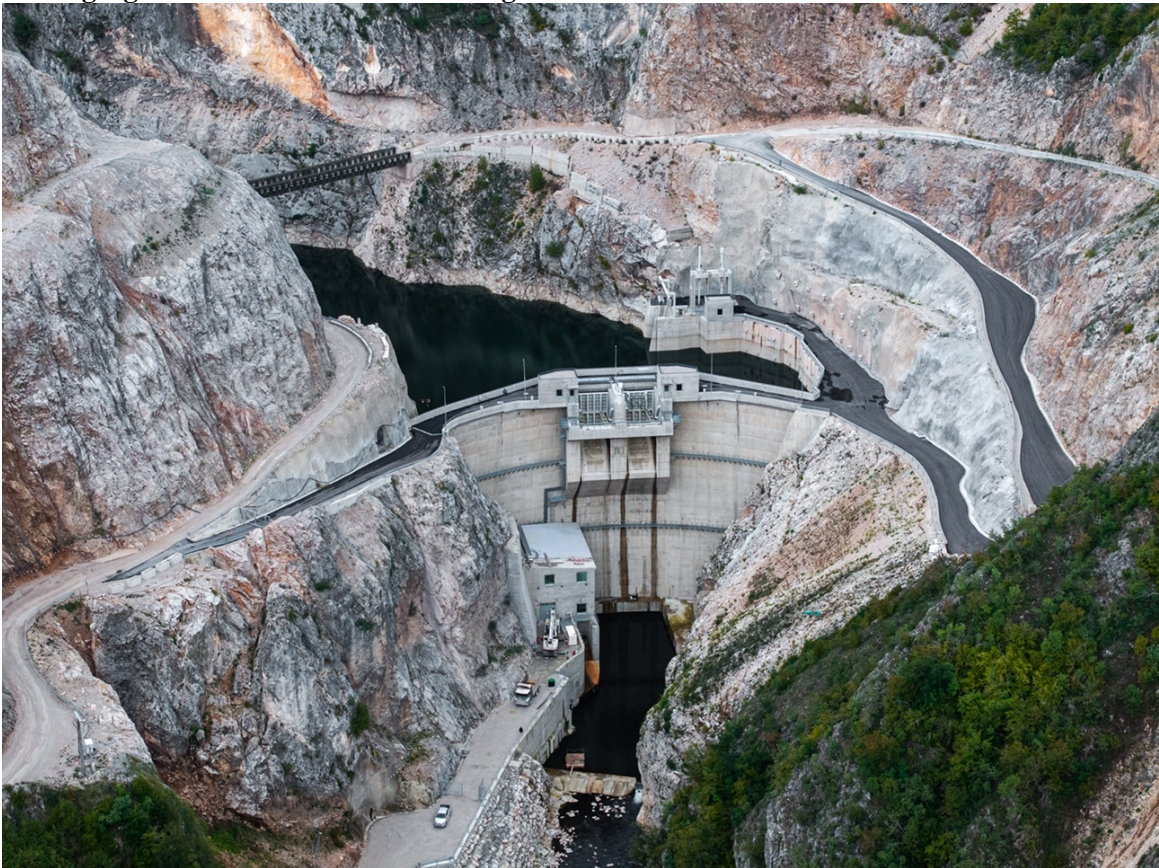
Annex 2: Despite years of resistance, the Ulog hydropower plant went into operation in 2025, causing significant environmental damage.

Photo of the Ulog HPP, © Bahrudin Bandić

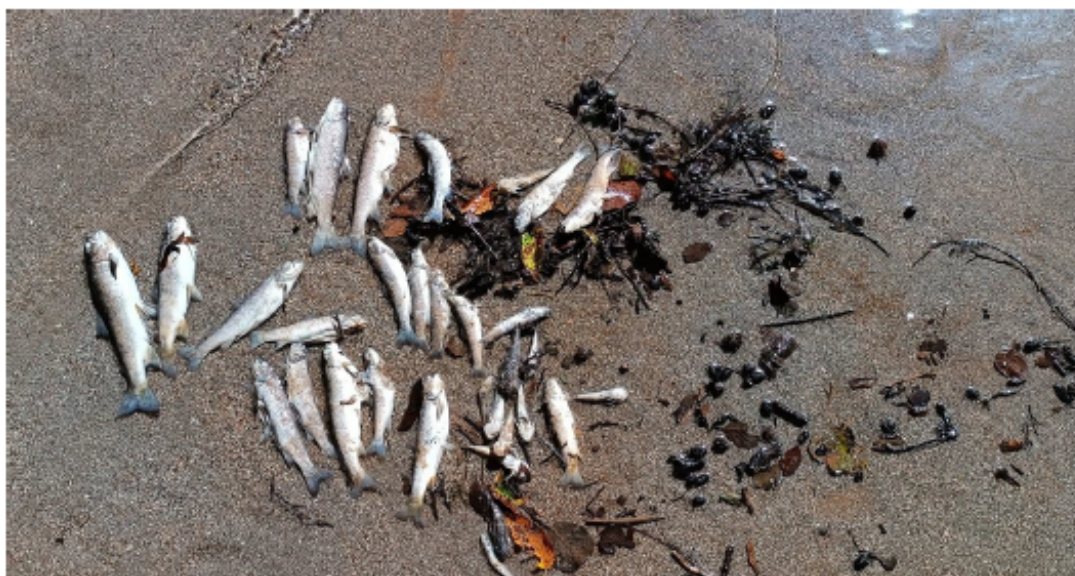
In early September, a fish kill occurred downstream of the Ulog Hydropower Plant, also claiming endangered softmouth trout and other endangered species. © Hrabren Kapić, Organizacija Sportskih Ribolovaca "Konjic"

- Stop hydropeaking and enforce the operation of the Ulog HPP in accordance with its environmental permit in run-of-the-river mode.
- Install a monitoring system in the reservoir and downstream of the dam, that transparently reports oxygen concentration, water temperature and discharge. Such data may also be used to guide HPP operations.
- Keep the remaining sections of the Neretva River network free-flowing to safeguard its unique biodiversity.

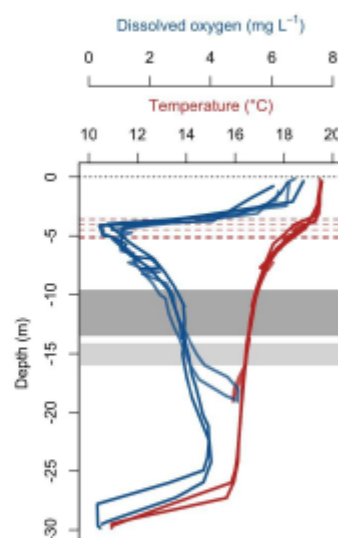
Figure 1: Depth profiles of temperature and oxygen in Ulog HPP reservoir.

1. Strong reservoir stratification caused oxygen depletion in deep water layers.

Depth profiles of temperature (red) and oxygen concentration (blue) in the reservoir near the dam (Figure 1), measured on 28 Sept 2025, indicate a clearly stratified water column. Temperature measurements reveal a warm, oxygenated surface layer, a sharp thermocline at 4-5 m depth (marked by horizontal red dotted lines), and a deep hypolimnetic layer isolated from atmospheric exchange. Oxygen concentrations show a pronounced minimum at the thermocline (as low as 0.68 mg L⁻¹) and remain below critical survival thresholds for trout throughout depths below 5 m—including the depth windows where water is drawn into the penstocks (dark grey bar at 9.6-13.5 m). While the shallow oxygen minimum reflects respiration of sinking algae from summer algal blooms, the low-oxygen conditions at greater depths are typical for newly flooded reservoirs with large amounts of decomposing organic matter from formerly forested land. The penstocks likely drew water from low-oxygen layers during the releases of early September, but if reservoir levels dropped—as confirmed by satellite data—extremely hypoxic water (<1 mg L⁻¹) may have reached the penstocks.

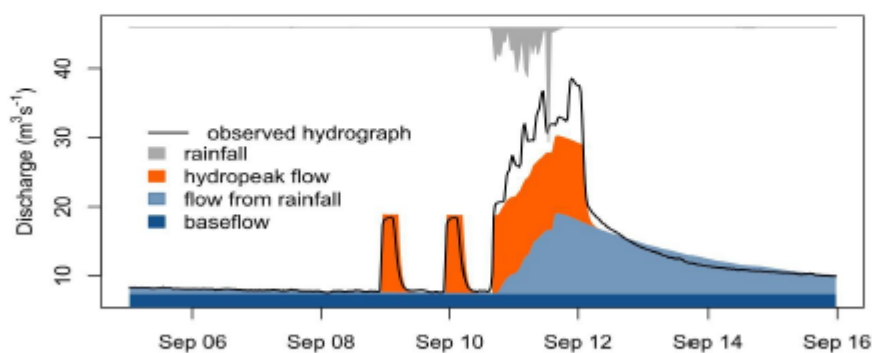
Figure 2: Results of hydrograph partitioning for flow during the fish kill incident.

- Analysis of public hydrograph data shows multiple sudden flow increases that cannot be explained by rainfall alone.** At the time of the fish-kill incident (Figure 2), two distinct hydropeaks raised the local discharge at the powerhouse by a factor of 15, thus creating sizeable and sudden flood events. These two hydropeaks were followed by a mixed discharge event, which could be decomposed into a rainfall-driven component and a longer than average hydropeak attributable to reservoir releases. The shape of the mixed event, in particular its rising and falling limbs, is inconsistent with natural flow patterns and strongly indicative of a substantial hydropeak that required ~34 hours of continuous reservoir release.
